[54] STEAM TURBINE BLADE ANTI-EROSION SHIELD AND METHOD OF TURBINE BLADE REPAIR

An arcuate anti-erosion shield of stellite or the like has an inner surface with a film supported adhesive attached thereto and gasket strips formed from a fluoro-elastomer along the edges thereof. The method of repair of an eroded shield is disclosed in which the eroded shield is removed, welding material dissolved by acid, and the blade sandblasted. The film is removed from the shield and the shield installed on the turbine blade. Pressure and heat is applied to the shield to thermoset the adhesive.

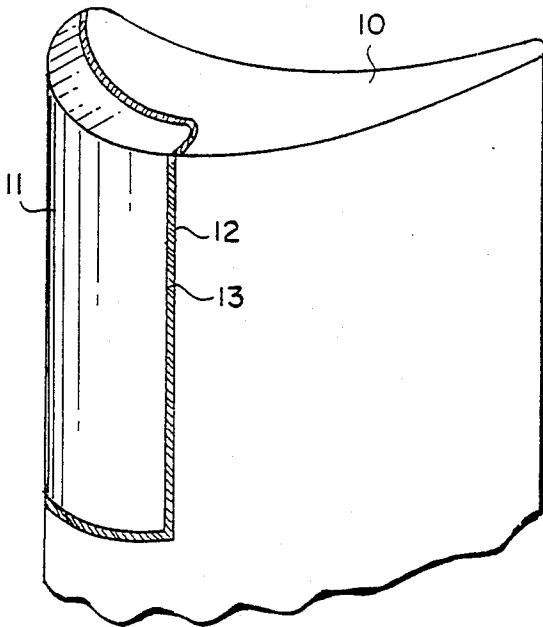
FIG. 2 is a perspective view of a prior art anti-erosion shield construction typical of General Electric Company steam turbine blades;

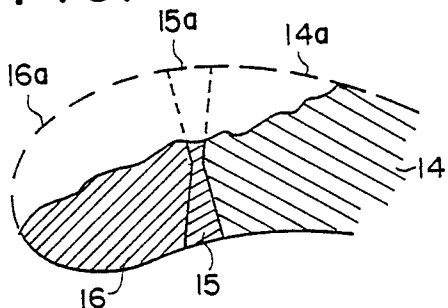
FIG. 9 shows the blade of FIG. 8 in which the eroded material has been replaced by a high temperature epoxy; and

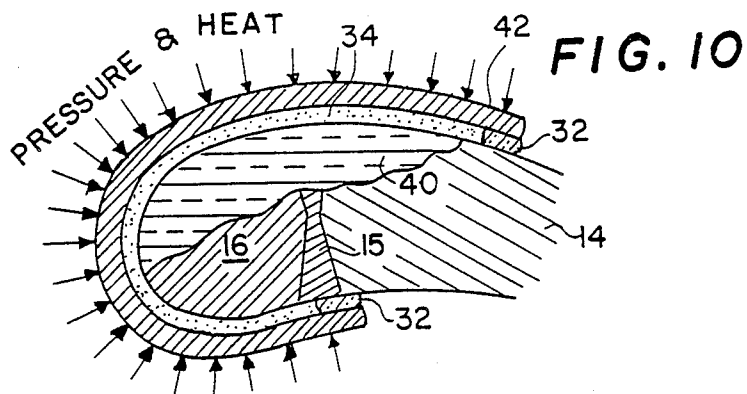
FIG. 10 shows the blade of FIG. 9 in which a wrap around type repair anti-erosion shield in accordance with the invention has been installed, and which illustrates the curing method.
