(54) **REFURBISHED CAMSHAFT AND METHOD**

A method of refurbishing a camshaft (100) having at least one defective portion (202, 206) includes removing material from the at least one defective portion (202, 206) to create a neck region (302). An alignment feature (402) is introduced in the neck region (302) according to a previous orientation of the defective portion (202, 206). A blank (508) is installed around the neck region (302) and oriented with the alignment feature (402).

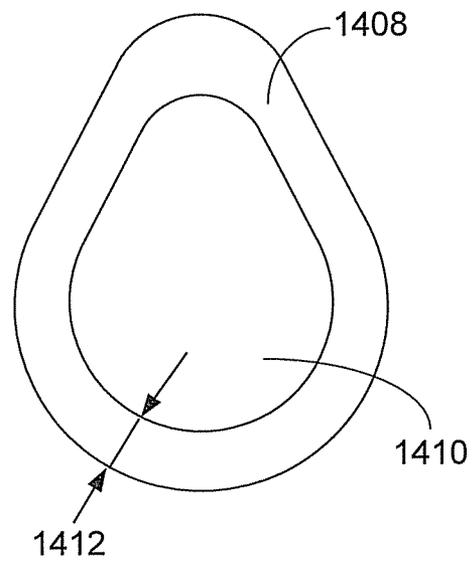
FIG. 14 is an alternate embodiment for a lobe blank having a lobe-shaped alignment feature in accordance with the disclosure.
