(54) **METHOD FOR REPAIRING A COMPONENT OF A TURBOMACHINE**

The invention relates to a method for repairing a damaged and/or aged component of a turbomachine, which is made at least in part of a ceramic composite material. The aim of the invention is to create a method which allows the downtime of the turbomachine caused by damaged components to be reduced while making it possible to repair damaged components. The abovementioned aim is achieved by a generic method for repairing a damaged component (1) of a turbomachine made of a ceramic composite material (4), comprising the following steps: the joint of the component is dissolved; the matrix (5) is extracted and/or the component is machined; infiltration to restore and/or renew the ceramic matrix (5) of the component; and the joint is re-established.

The present invention relates to a method for repairing a damaged and/or aged component of a turbomachine which is at least partially made of a composite ceramic material.

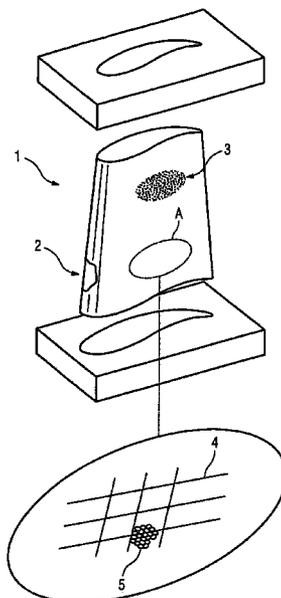
FIG 1

FIG. 1 shows a first configuration of a method according to the invention for repairing a component which is installed in a gas turbine and has been damaged by the effect of foreign bodies.

FIG. 1 shows a first method according to the invention for repairing a guide vane 1 (FIG. 7) of a gas turbine (not represented in further detail), which has been damaged during operation in the gas turbine. The guide vane 1 presented here consists of a ceramic material, for example silicon nitride, silicon carbide, aluminum oxide, zirconium oxide, mullite, glass, glass ceramic and/or the like. This material is conventionally referred to as a matrix. In order to improve the brittle fracture behavior, the matrix material is provided with fiber reinforcement which, for example, may consist of glass, glass ceramic, silicon carbide, silicon nitride or the like, as well as a combination of these, so that a quasi-plastic deformation behavior can be achieved. Besides this, instead of or in addition to the fibers, it is also possible to introduce short fibers i.e. whiskers into the matrix. For environmental reasons, however, the first version is preferred. Gas turbines equipped with such vanes allow a high inlet temperature into the turbine region of from 1100° C. to 1350° C., in which case efficiencies of 31%, 40% or more can be readily achieved.

and mechanically processed or excavated in a first step, as represented in FIG. 1. This is followed by local reconstruction of the ceramic matrix using infiltration or paste application. The repaired region of the component is subsequently sintered and the wall element with the guide vane 1 is reinstalled at its position in the turbine. Depending on the accessibility of the components inside the turbine, the repair may also be carried out when the component is in the installed state.

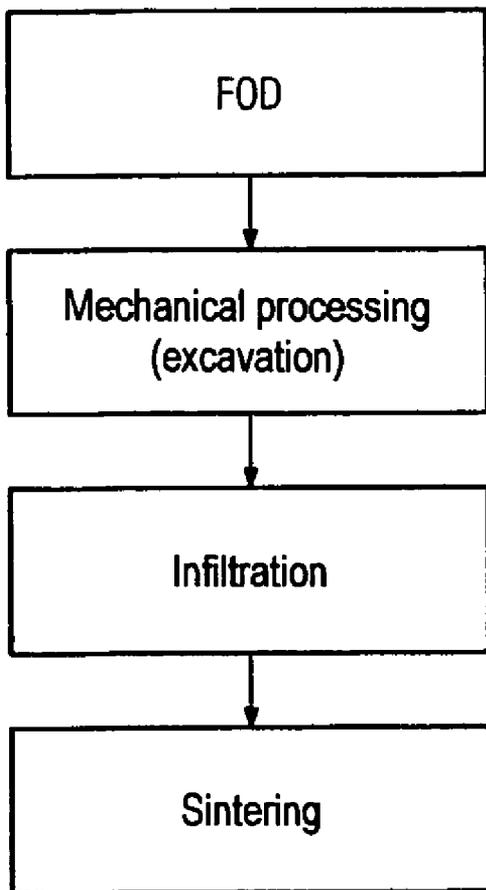
FIG 2

FIG. 2 shows a second method according to the invention for repairing a component installed in a gas turbine,

Another method is proposed according to FIG. 2, the matrix of the damaged component 1 being leached out locally in a first step (FIG. 8). The fibers are inserted in a further step, in which case it is possible to achieve improved mechanical properties compared to the ceramic matrix 5. The steps of infiltration and sintering are subsequently carried out as in the previous example of FIG. 1.

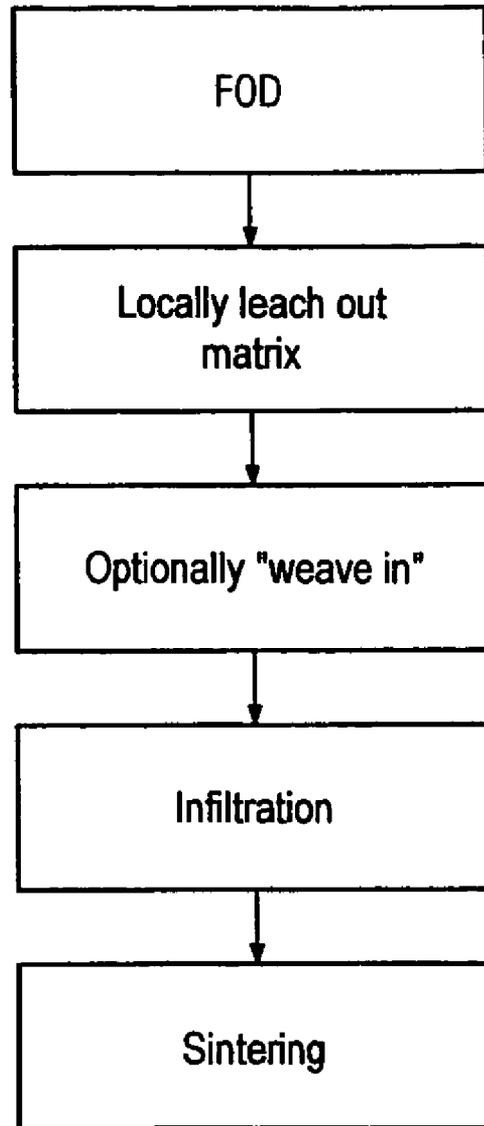
FIG 3

FIG. 3 shows a third configuration of a method according to the invention, for repairing a component extracted from a gas turbine,

FIG. 3 shows a method for removing an ageing effect of the guide vane 1, which has occurred owing to sintering of the ceramic material on the guide vane 1. In order to remove this damage, in a first step the joint is dissolved and the guide vane 1 is subsequently decoated.

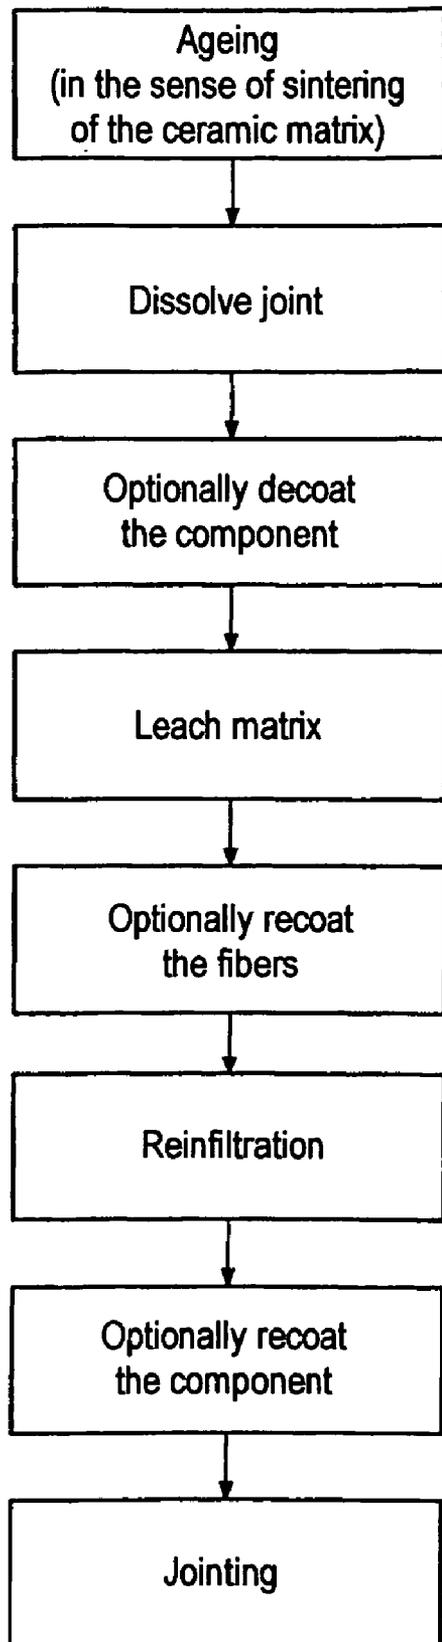
FIG 4

FIG. 4 shows another method according to the invention for repairing a component extracted from a gas turbine,

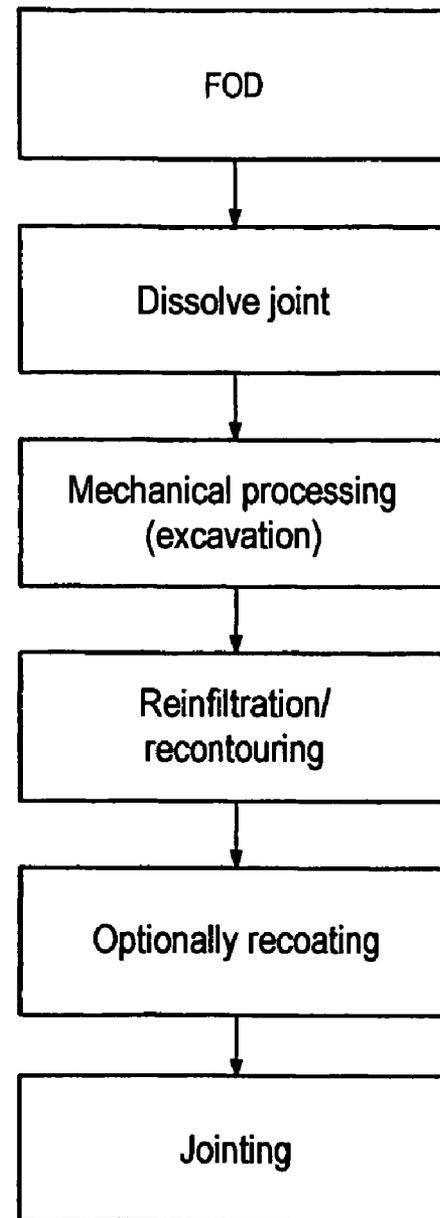
FIG 5

FIG. 5 shows a method according to the invention for repairing a component extracted from a gas turbine, with the production of subsequent surface protection,

Another method sequence according to the invention is represented in FIG. 6, in which recoating of the fibers is provided in contrast to the method sequence represented in FIG. 5.

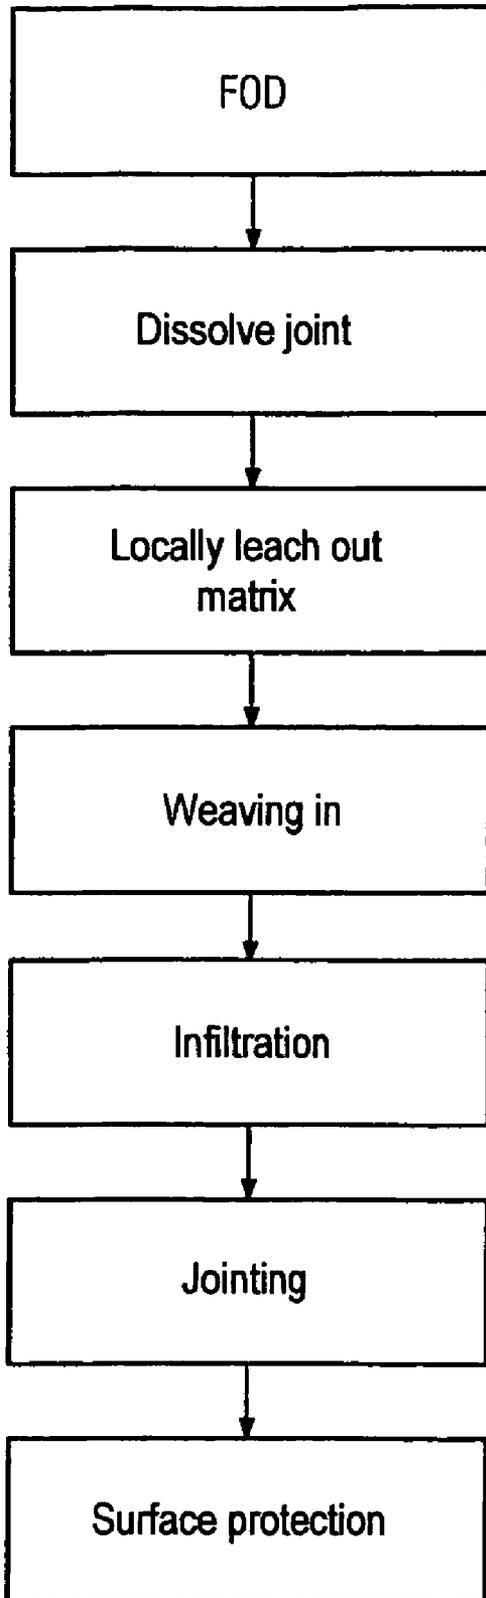
FIG 6

FIG. 6 shows a method for repairing a component with coating of the fibers and surface protection,

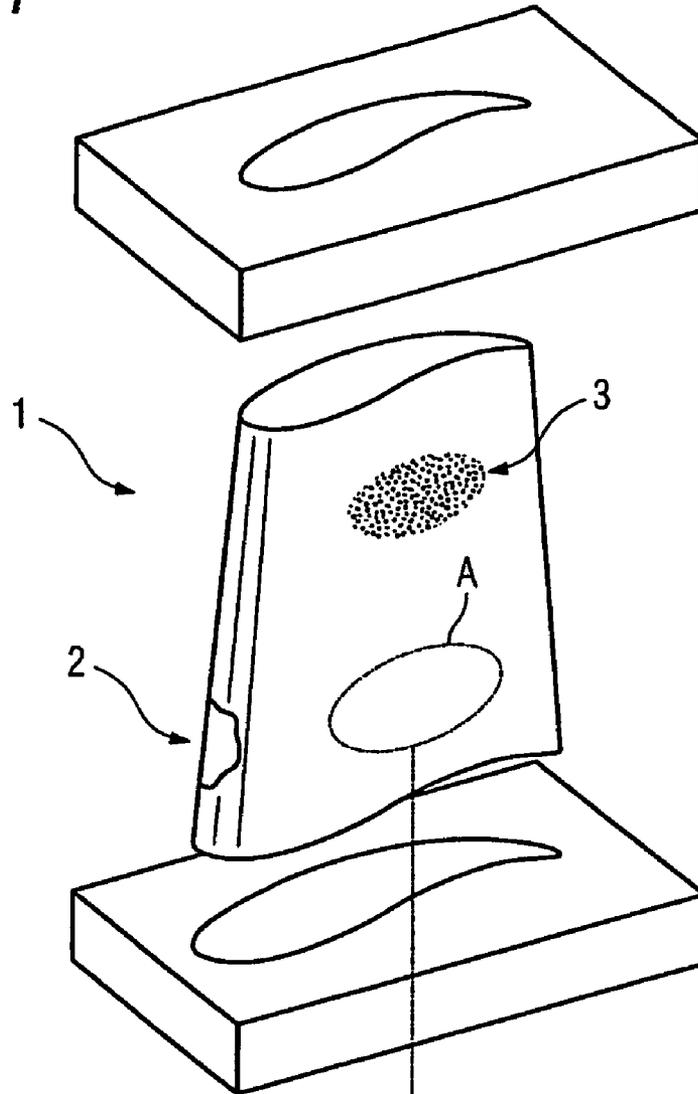
FIG 8

FIG. 8 shows an enlarged detail of the region A in FIG. 7, and

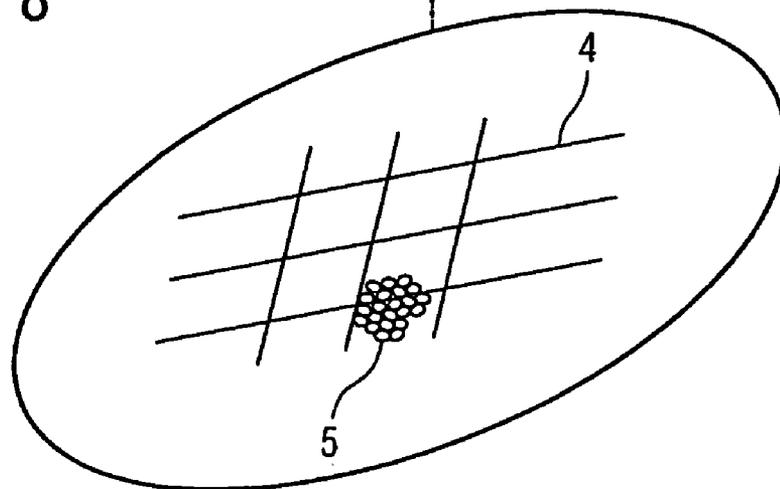
FIG 9

FIG. 9 shows a site to be repaired.
