- [54] **ENVELOPE FOR PROTECTING DISASSEMBLED STATOR COIL**
- [75] **Inventor:** Daniel Klawitter, Fond du Lac, Wis.
- [73] **Assignee:** Brunswick Corporation, Skokie, Ill.
- [21] **Appl. No.:** 297,990
- [22] **Filed:** Jan. 17, 1989
- [51] **Int. Cl.⁵** B23P 19/04; B65D 33/16
- [52] **U.S. Cl.** 29/722; 29/700; 206/349; 383/86
- [58] **Field of Search** 29/156.4 R, 700, 722, 29/729, 760; 206/349; 383/84, 86, 86.1, 86.2, 99

A repair aid and method is provided for a two-cycle marine engine (10) having a stator coil (16) dangling by electrical wires (22) during repair of the engine and subject to damage and abrasion. The stator coil is inserted into a protective envelope (24) which is closed around the stator coil, with the wires extending outwardly therefrom and remaining attached to the engine such that the envelope is retained on the stator coil to provide protection during repair.

ENVELOPE FOR PROTECTING DISASSEMBLED STATOR COIL

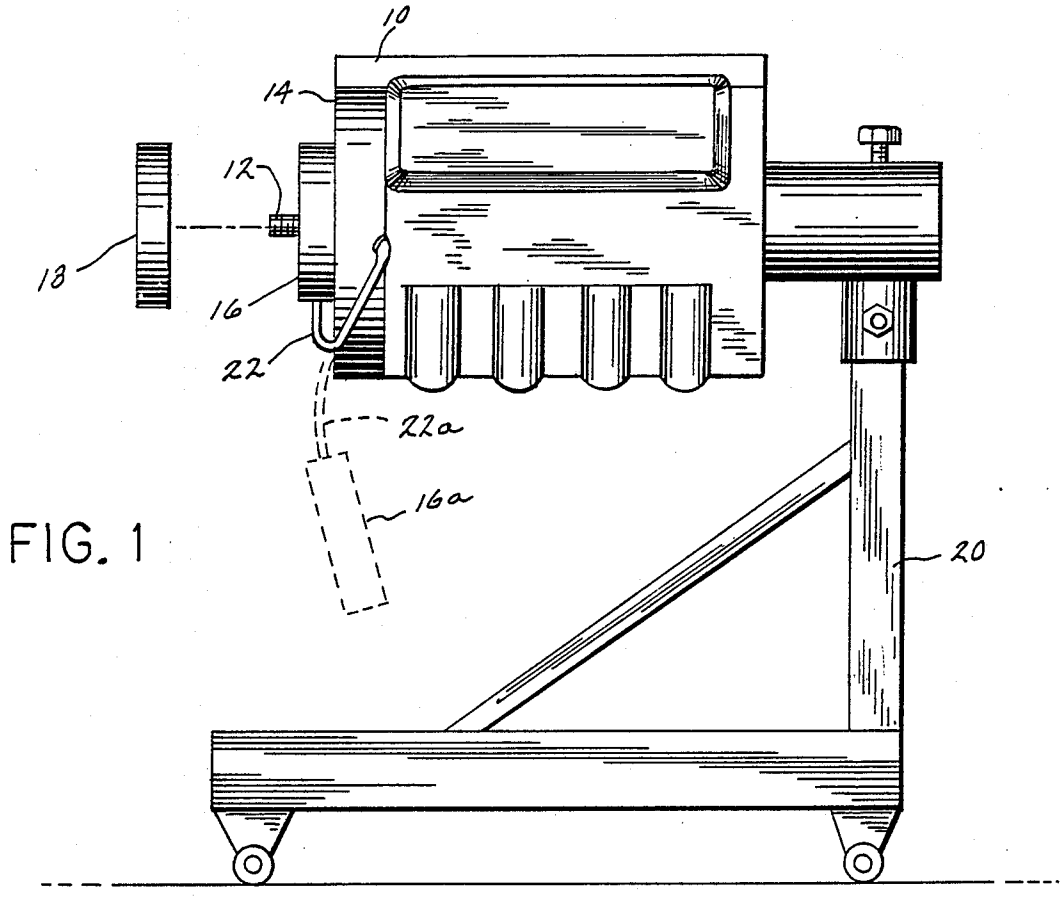
FIG. 1 is a side elevation view schematically showing a marine engine on a repair stand.

FIG. 1 shows a two-cycle internal combustion marine engine 10 having a crankshaft 12 extending through a crankcase 14 and an alternator stator coil 16, and having a flywheel 18 mounted on the end thereof, all as is known in the art, and for which further reference may be had to U.S. Pats. 4,418,677, 4,325,350, 4,160,435, 4,093,906, 3,937,200, 3,105,474, 2,945,138, incorporated herein by reference, and for example as shown in Mercury Marine Parts Catalog 9013292, Aug. 1985, pages 6, 7, 22, 23, 28, 29, and Mercury Marine Service Manual Models V-135 thru V-225, Parts Catalog 90-97658-3, 1988, pages 2A-6 thru 2A-9. The engine is mounted on a repair stand 20 which typically allows tilting or rotation of the engines along various axes for various repair procedures. In other procedures, the engine is merely

supported on the floor or on a workbench. During repair, flywheel 18 is removed from crankshaft 12, followed by removal of stator coil 16 from the crankshaft.

In the present invention, stator coil 16 is placed in a protective envelope 24, FIGS. 2 and 3, to protect the stator coil from damage and abrasion during movement of the engine during repair while stator coil 16 dangles from the engine by wires 22, as shown at 22a, FIG. 1, and is subject to striking miscellaneous objects in the immediate vicinity, as noted above. The envelope also protects the stator coil when on a workbench or stored on a shelf, etc. The envelope is closed, with wires 22 extending outwardly therefrom and remaining attached to the engine such that the envelope is retained on the stator coil to provide protection during repair. The envelope is closed at fasteners 26, 28, 30 to enclose the stator coil, and to retain the envelope on the stator coil. The fasteners are hook and loop type fasteners, for example as known under the trademark VELCRO, snaps, or other suitable attachment or closure structure. The envelope is opened following the engine repair, and the stator coil is removed from the envelope and replaced on the crankshaft.

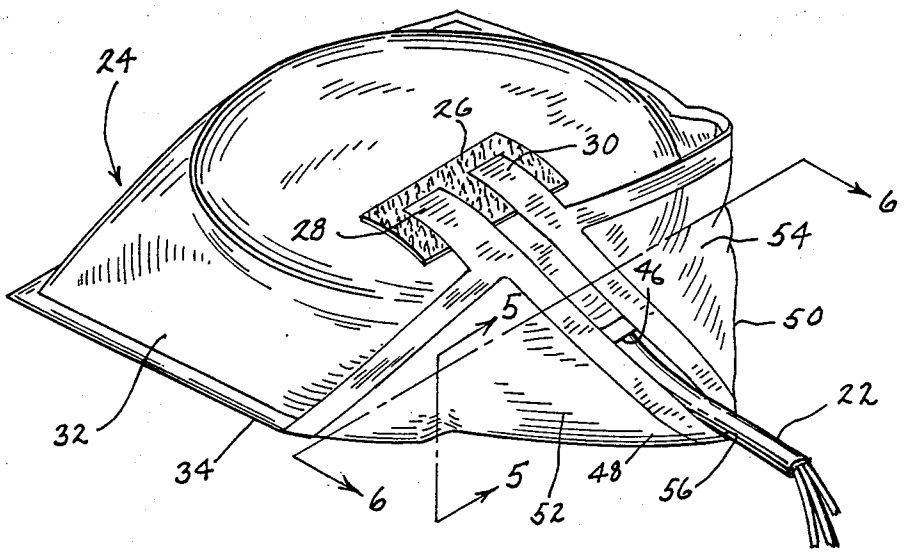
FIG. 2 shows a stator envelope in accordance with the invention, with a stator coil therein.

Envelope 24 is a canvas or the like material and has a frontwall 32 and a backwall 34 forming an open-topped pocket 36 therebetween, FIG. 3, receiving stator coil 16. Frontwall 32 has an upper flap folded over stator coil 16 along fold lines 38 and 40 forming first and second folded flap portions 42 and 44 defining a slit 46 therebetween through which wires 22 extend outwardly, FIG. 4. Backwall 34 has an upper flap folded over the folded flap of the frontwall and over stator coil 16 along fold lines 48 and 50 forming folded flap portions 52 and 54 defining a slit or opening 56 therebetween, FIG. 2, through which wires 22 extend outwardly.
