# United States Patent [19]

[11] Patent Number: 4,837,389

[54] COMPOSITE ALLOY STRUCTURES

A dimensional composition, a dimensionally restored alloy structure and a method of dimensionally restoring gas turbine and the like components that will be subsequently coated which includes low-pressure plasma spraying onto a damaged vane or other components, an alloy composition consisting essentially by weight of 1 to 4% aluminum, 0 to 1.5% hafnium and 0 to 20% nickel in the base composition of the cobalt alloy component, grinding to final dimension and diffusion coating. Tantalum is substituted for columbium where the base composition of the alloy contains columbium.

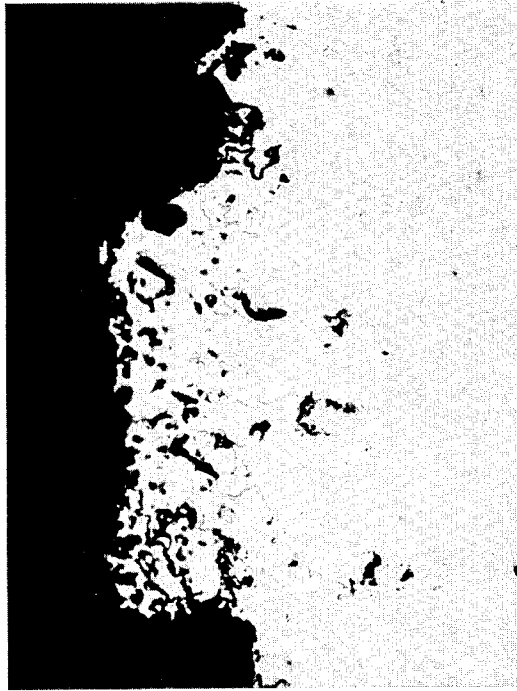
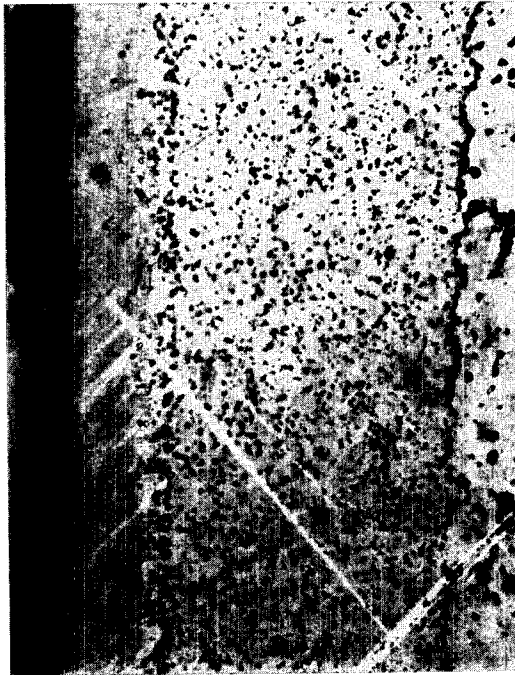
FIG.3

500 X

FIG. 3 is a micrograph of a section as in FIG. 2 with a PWA252 coating compared with an original WI-52 cobalt alloy vane coated with PWA252 coating and subject to 2000° F. static oxidation test;

These recast vanes were subject to the usual tests including metallography and a 2000° F. static oxidation test and it was found that all of the deficiencies previously associated with recase vanes had been overcome and in fact the C-29 coating was found to be unexpectedly more stable in oxidation environment than new coated vanes of unmodified WI-52 alloy in side-by-side tests. A typical micrograph of a WI-52 recast vane according to this invention is shown beside a micrograph of a new WI-52 vane after 2000° F. static oxidation in FIG. 3.
