(71) Demandeur/Applicant:  
NIPPON STEEL CORPORATION, JP

(54) Title: METHOD FOR DETECTING DEFECT IN MATERIAL AND SYSTEM FOR THE METHOD

A defect on the surface or in the surface layer of a moving material can be detected by using a method comprising steps of: heating the surface of the material, obtaining thermal image data of the surface of the material using an infrared thermography camera

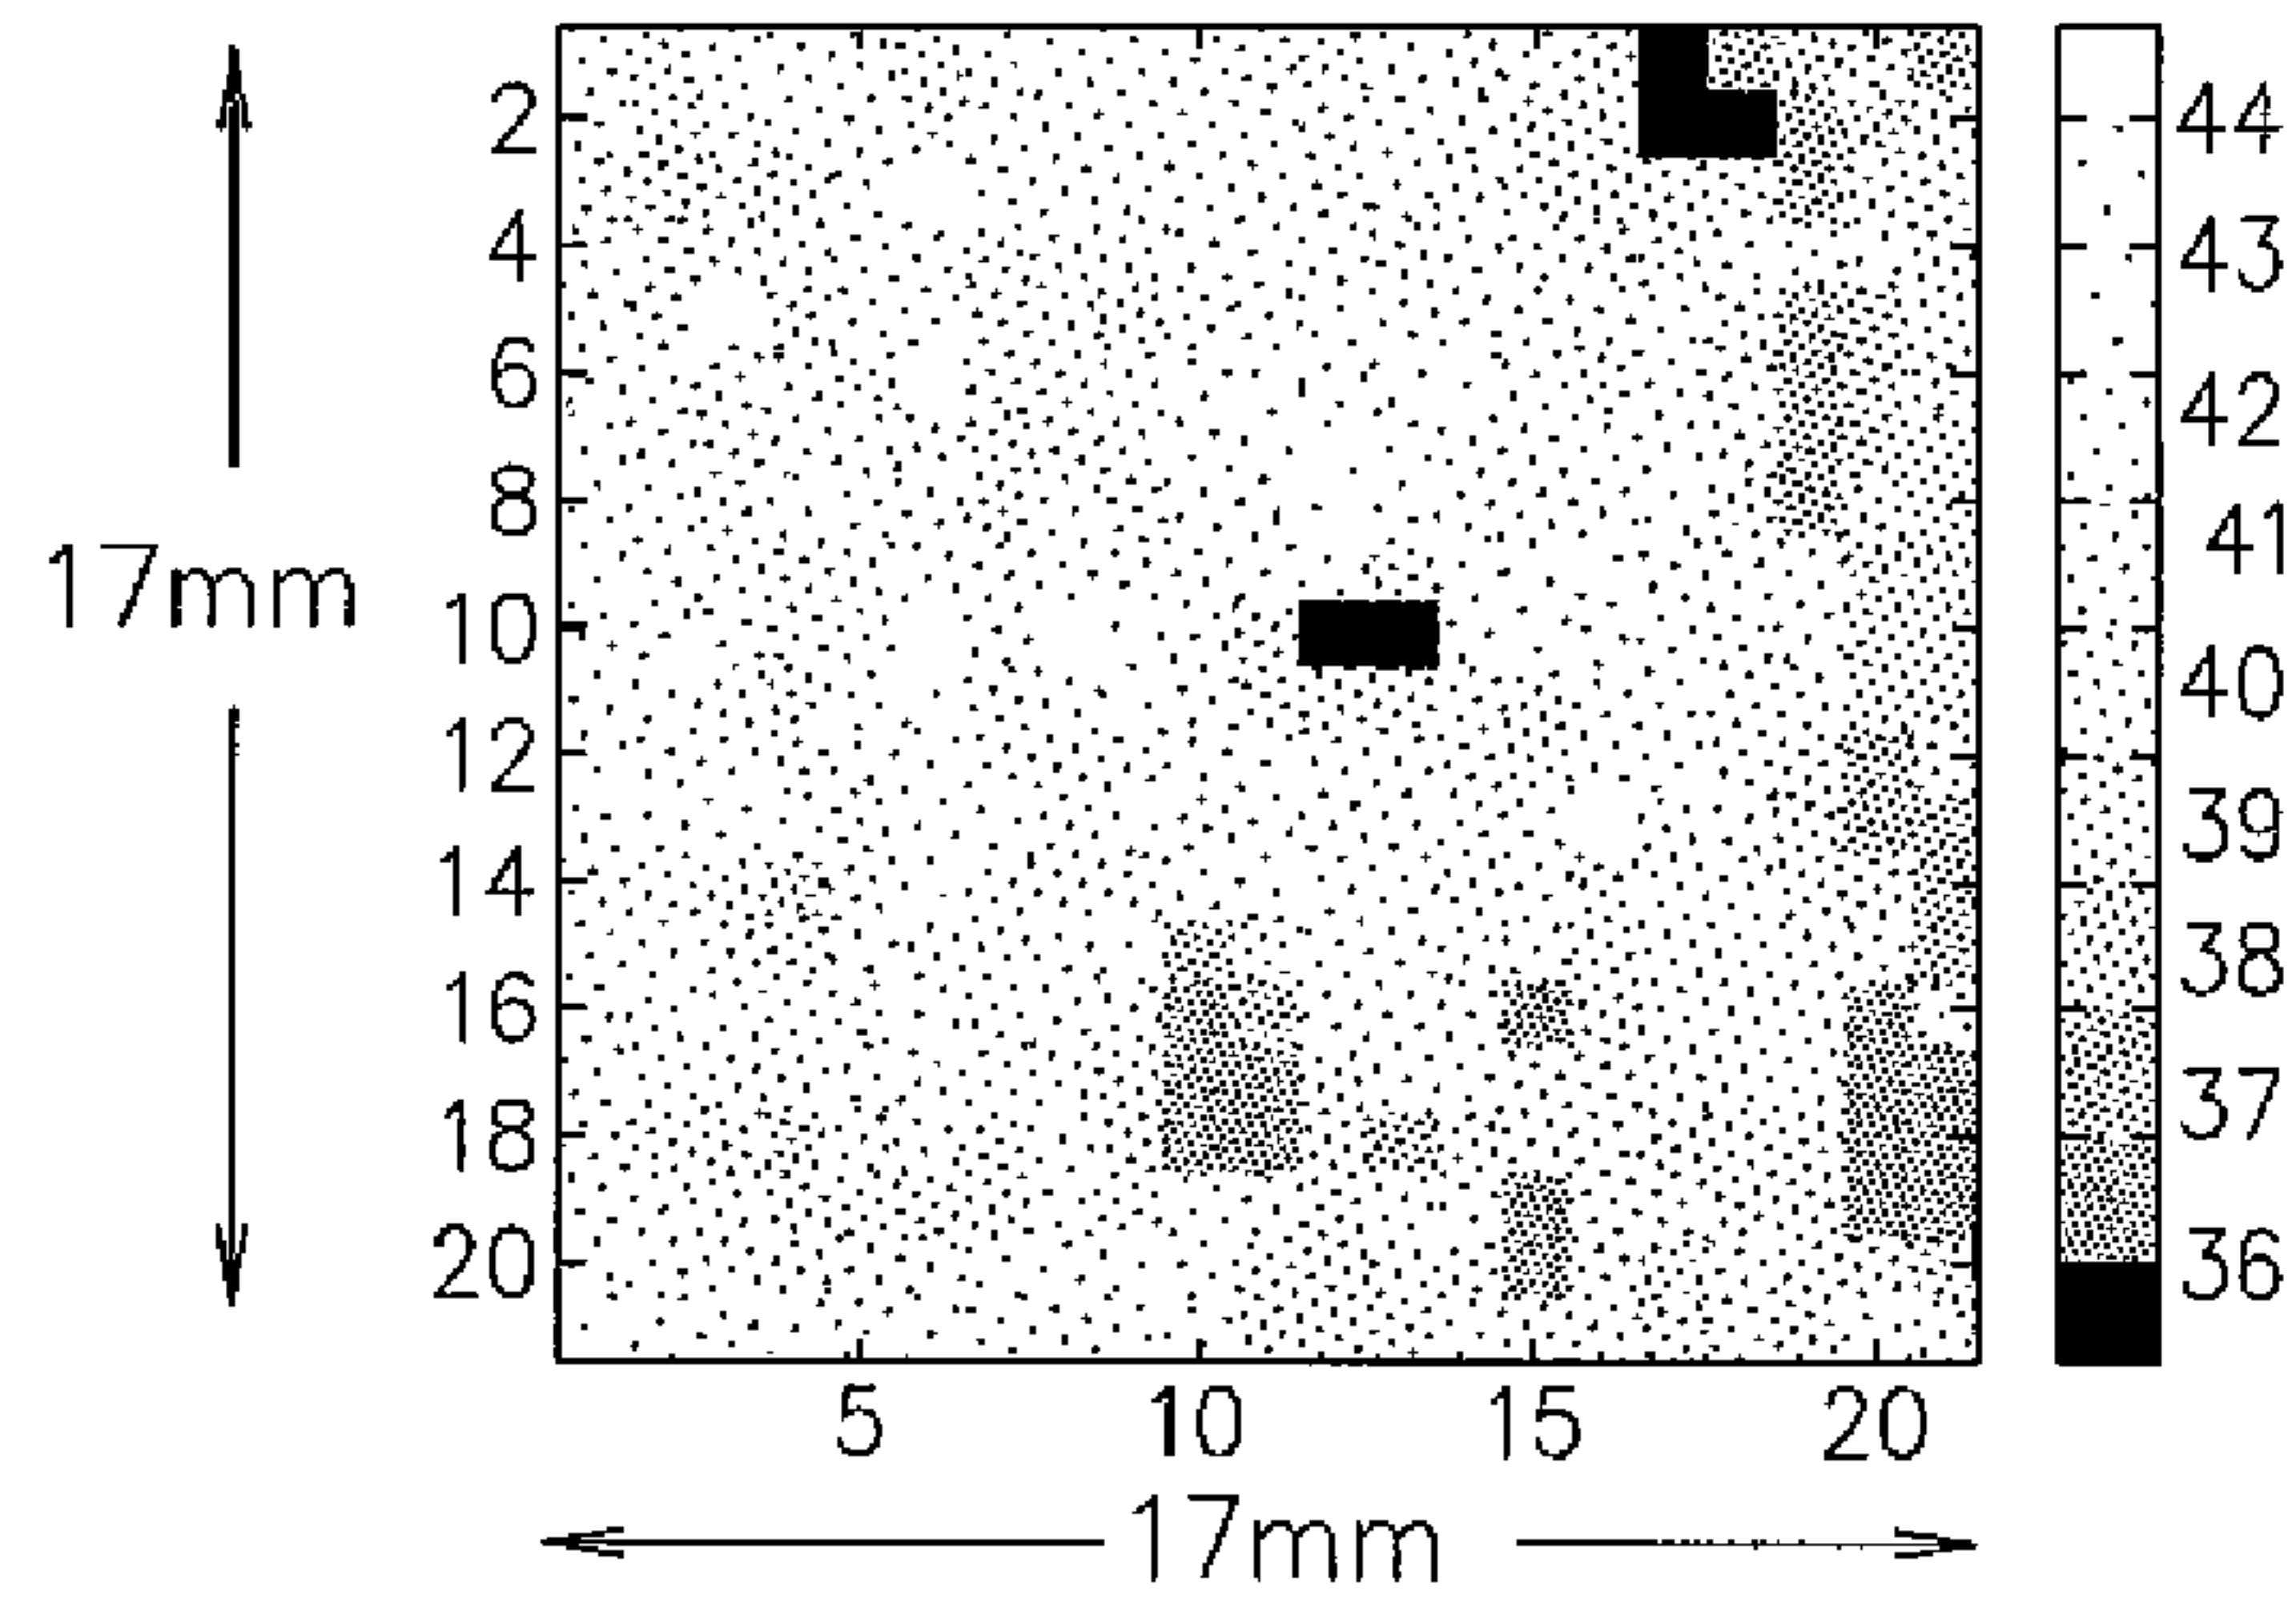
FIG. 17A is thermal image data taken by the infrared thermography camera, FIG. 17B is a Laplacian processed image of the thermal image data, and FIG. 17C is a binarized image of the Laplacian processed image data. FIGS. 17A, 17B and 17C are schematic diagrams made from an actually obtained image (zoom-up image). FIG. 17C shows the image where defects 1701 (a minute sharp dent) are extracted to be clearly viewed.

FIG. 17 shows an example where defect detection was made with respect to a steel sheet sample (test piece) having a defect shown as FIG. 3C, i.e., a minute sharp dent formed on the surface of the steel sheet. Thermal image data of the steel sheet sample was taken by an infrared thermography camera while the steel sheet sample was being heated up to about 40°C. The number of pixels of the infrared thermography camera is 256 x 256, the size of the pixel is 0.8 mm, and the distance between the camera and the steel sheet sample was 60 cm. The angle between the heating direction by the heating device and the steel sheet surface is 60°, and the angle between the optical axis direction of the camera and the steel sheet surface is 90°.

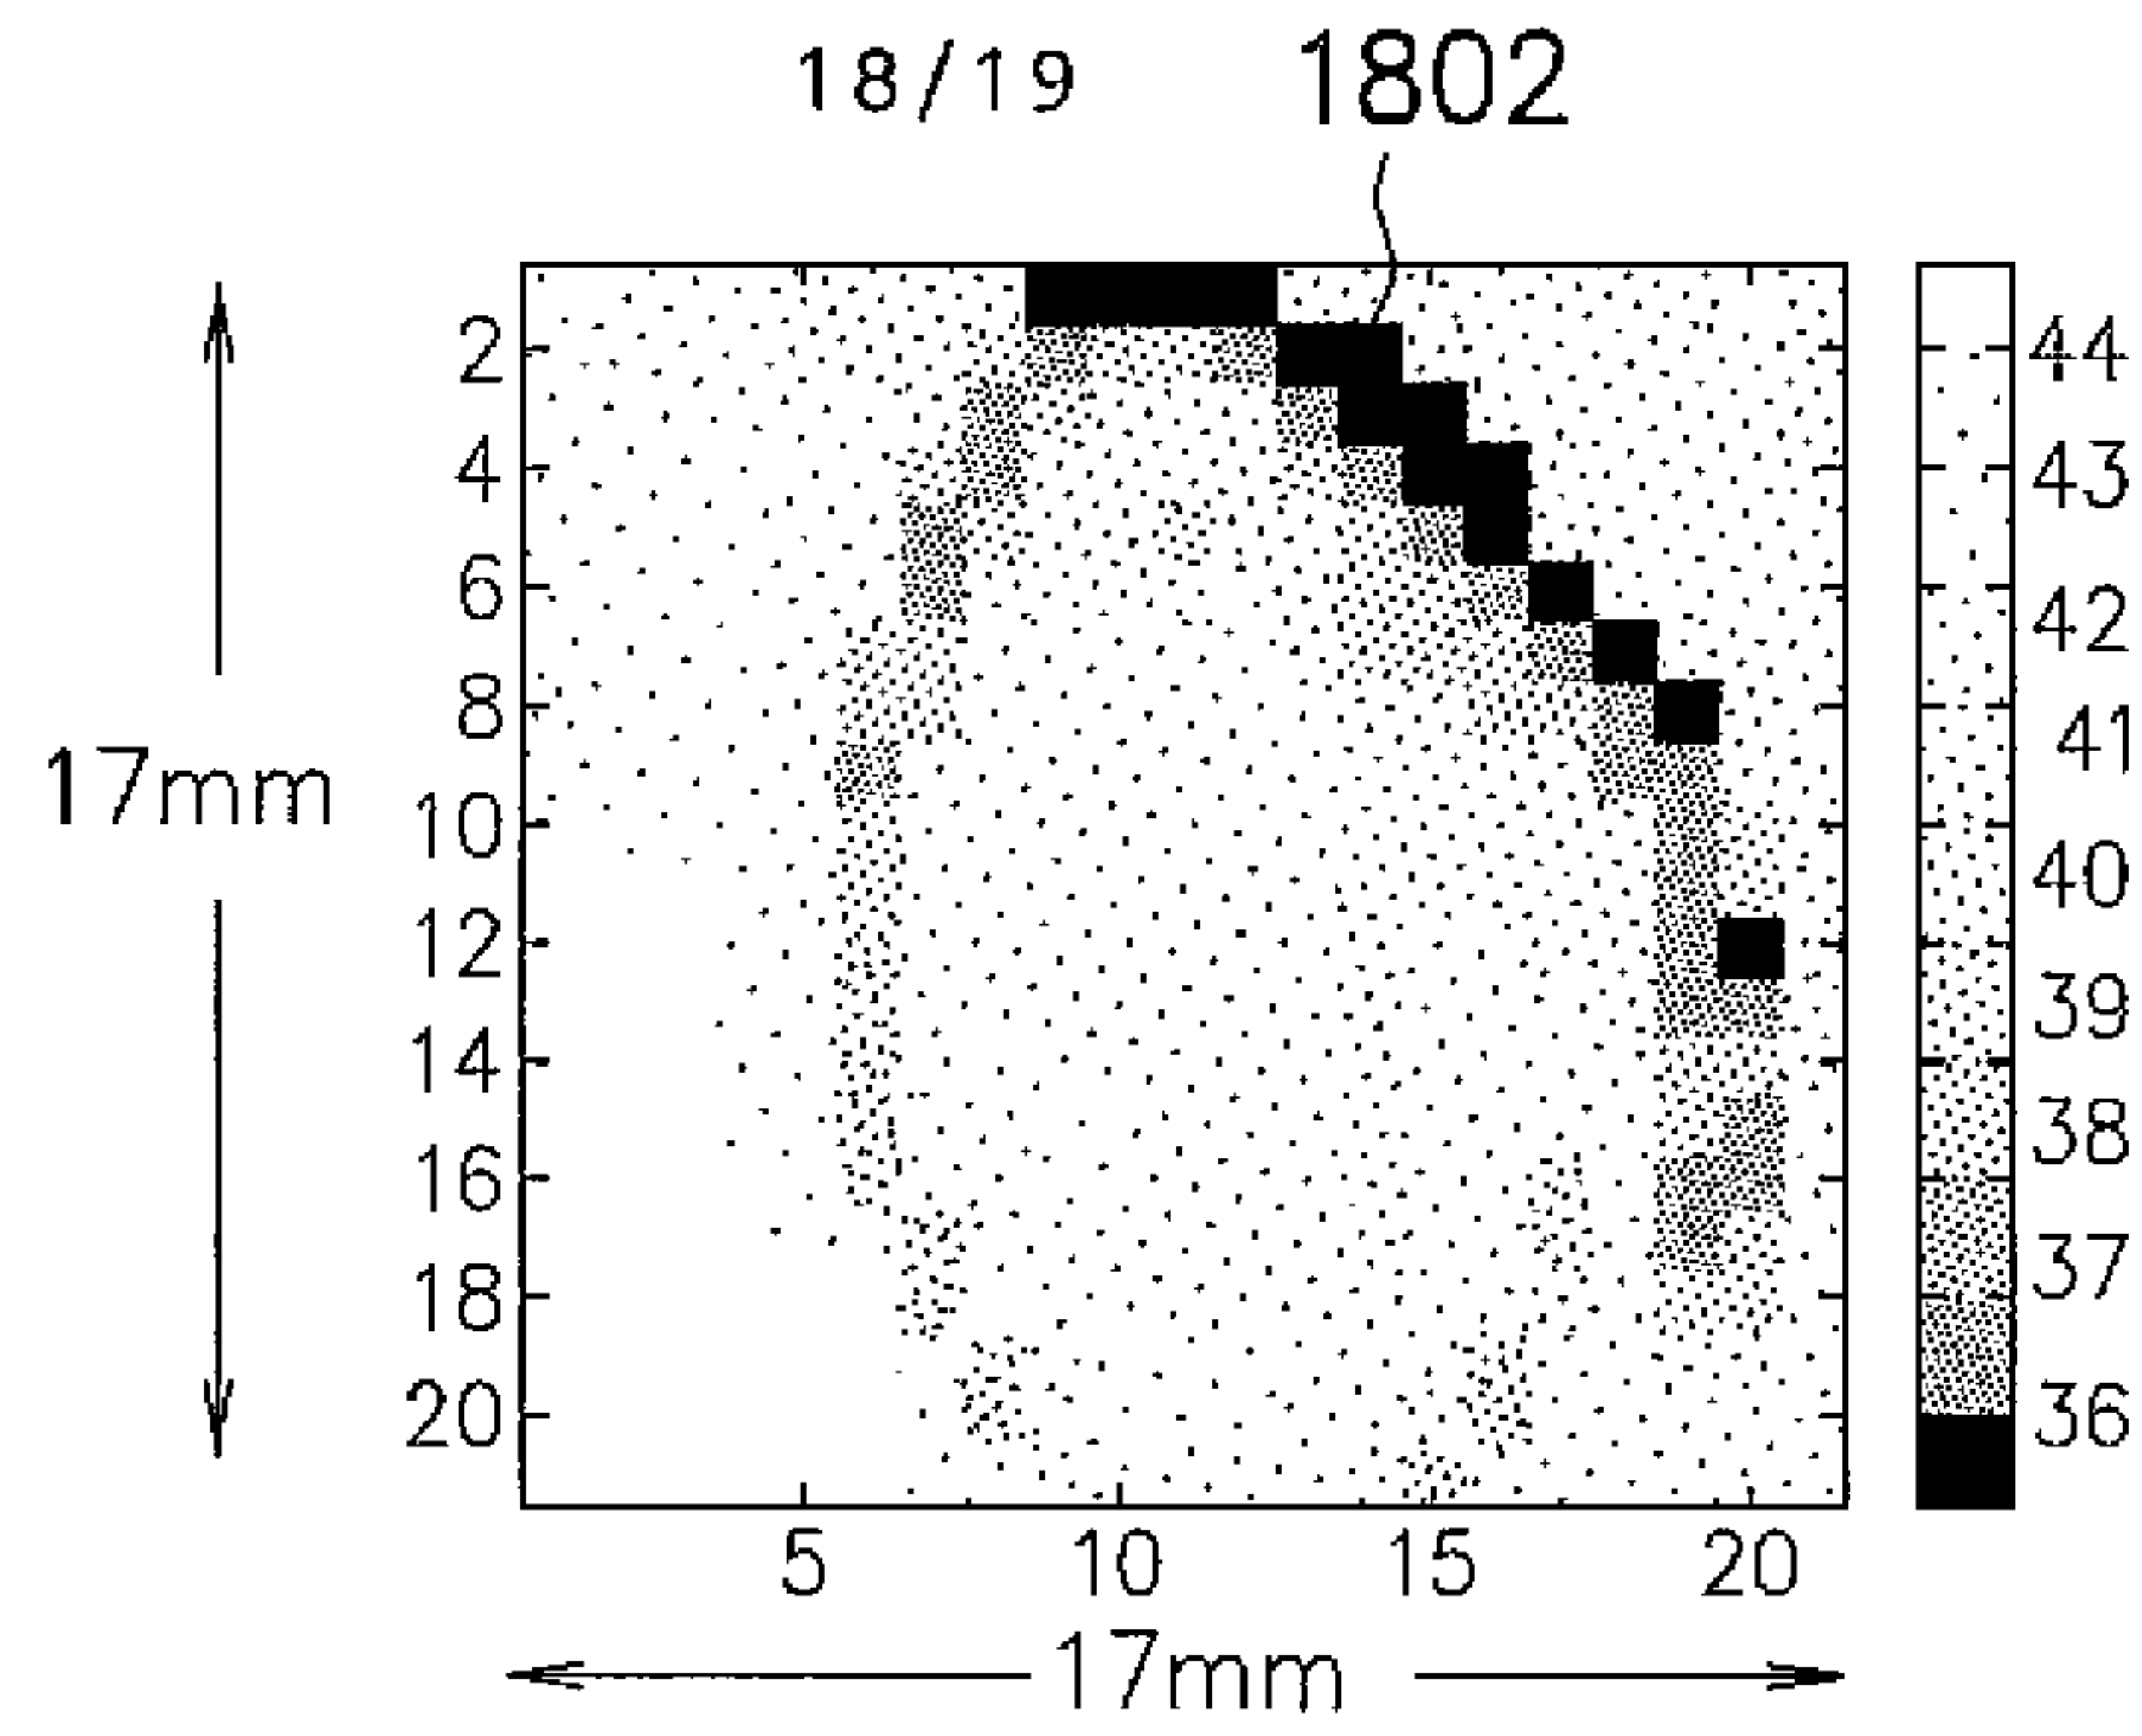
FIG.18A

FIG. 18A is thermal image data taken by the infrared thermography camera, FIG. 18B is a Laplacian processed image of the thermal image data, and FIG. 18C is a binarized image

FIG. 18 shows an example where defect detection was made with respect to a steel sheet sample (test piece) having a defect shown as FIG. 3D, i.e., a foreign material attached to the surface of the steel sheet. Thermal image data of the steel sheet sample was taken by an infrared thermography camera while the steel sheet sample was being heated up to about 90°C. The number of pixels of the infrared thermography camera is 256 x 256, the size of the pixel is 0.8 mm, and the distance between the camera and the steel sheet sample was 60 cm. The angle between the heating direction by the heating device and the steel sheet surface is 60°, and the angle between the optical axis direction of the camera and the steel sheet surface is 90°.

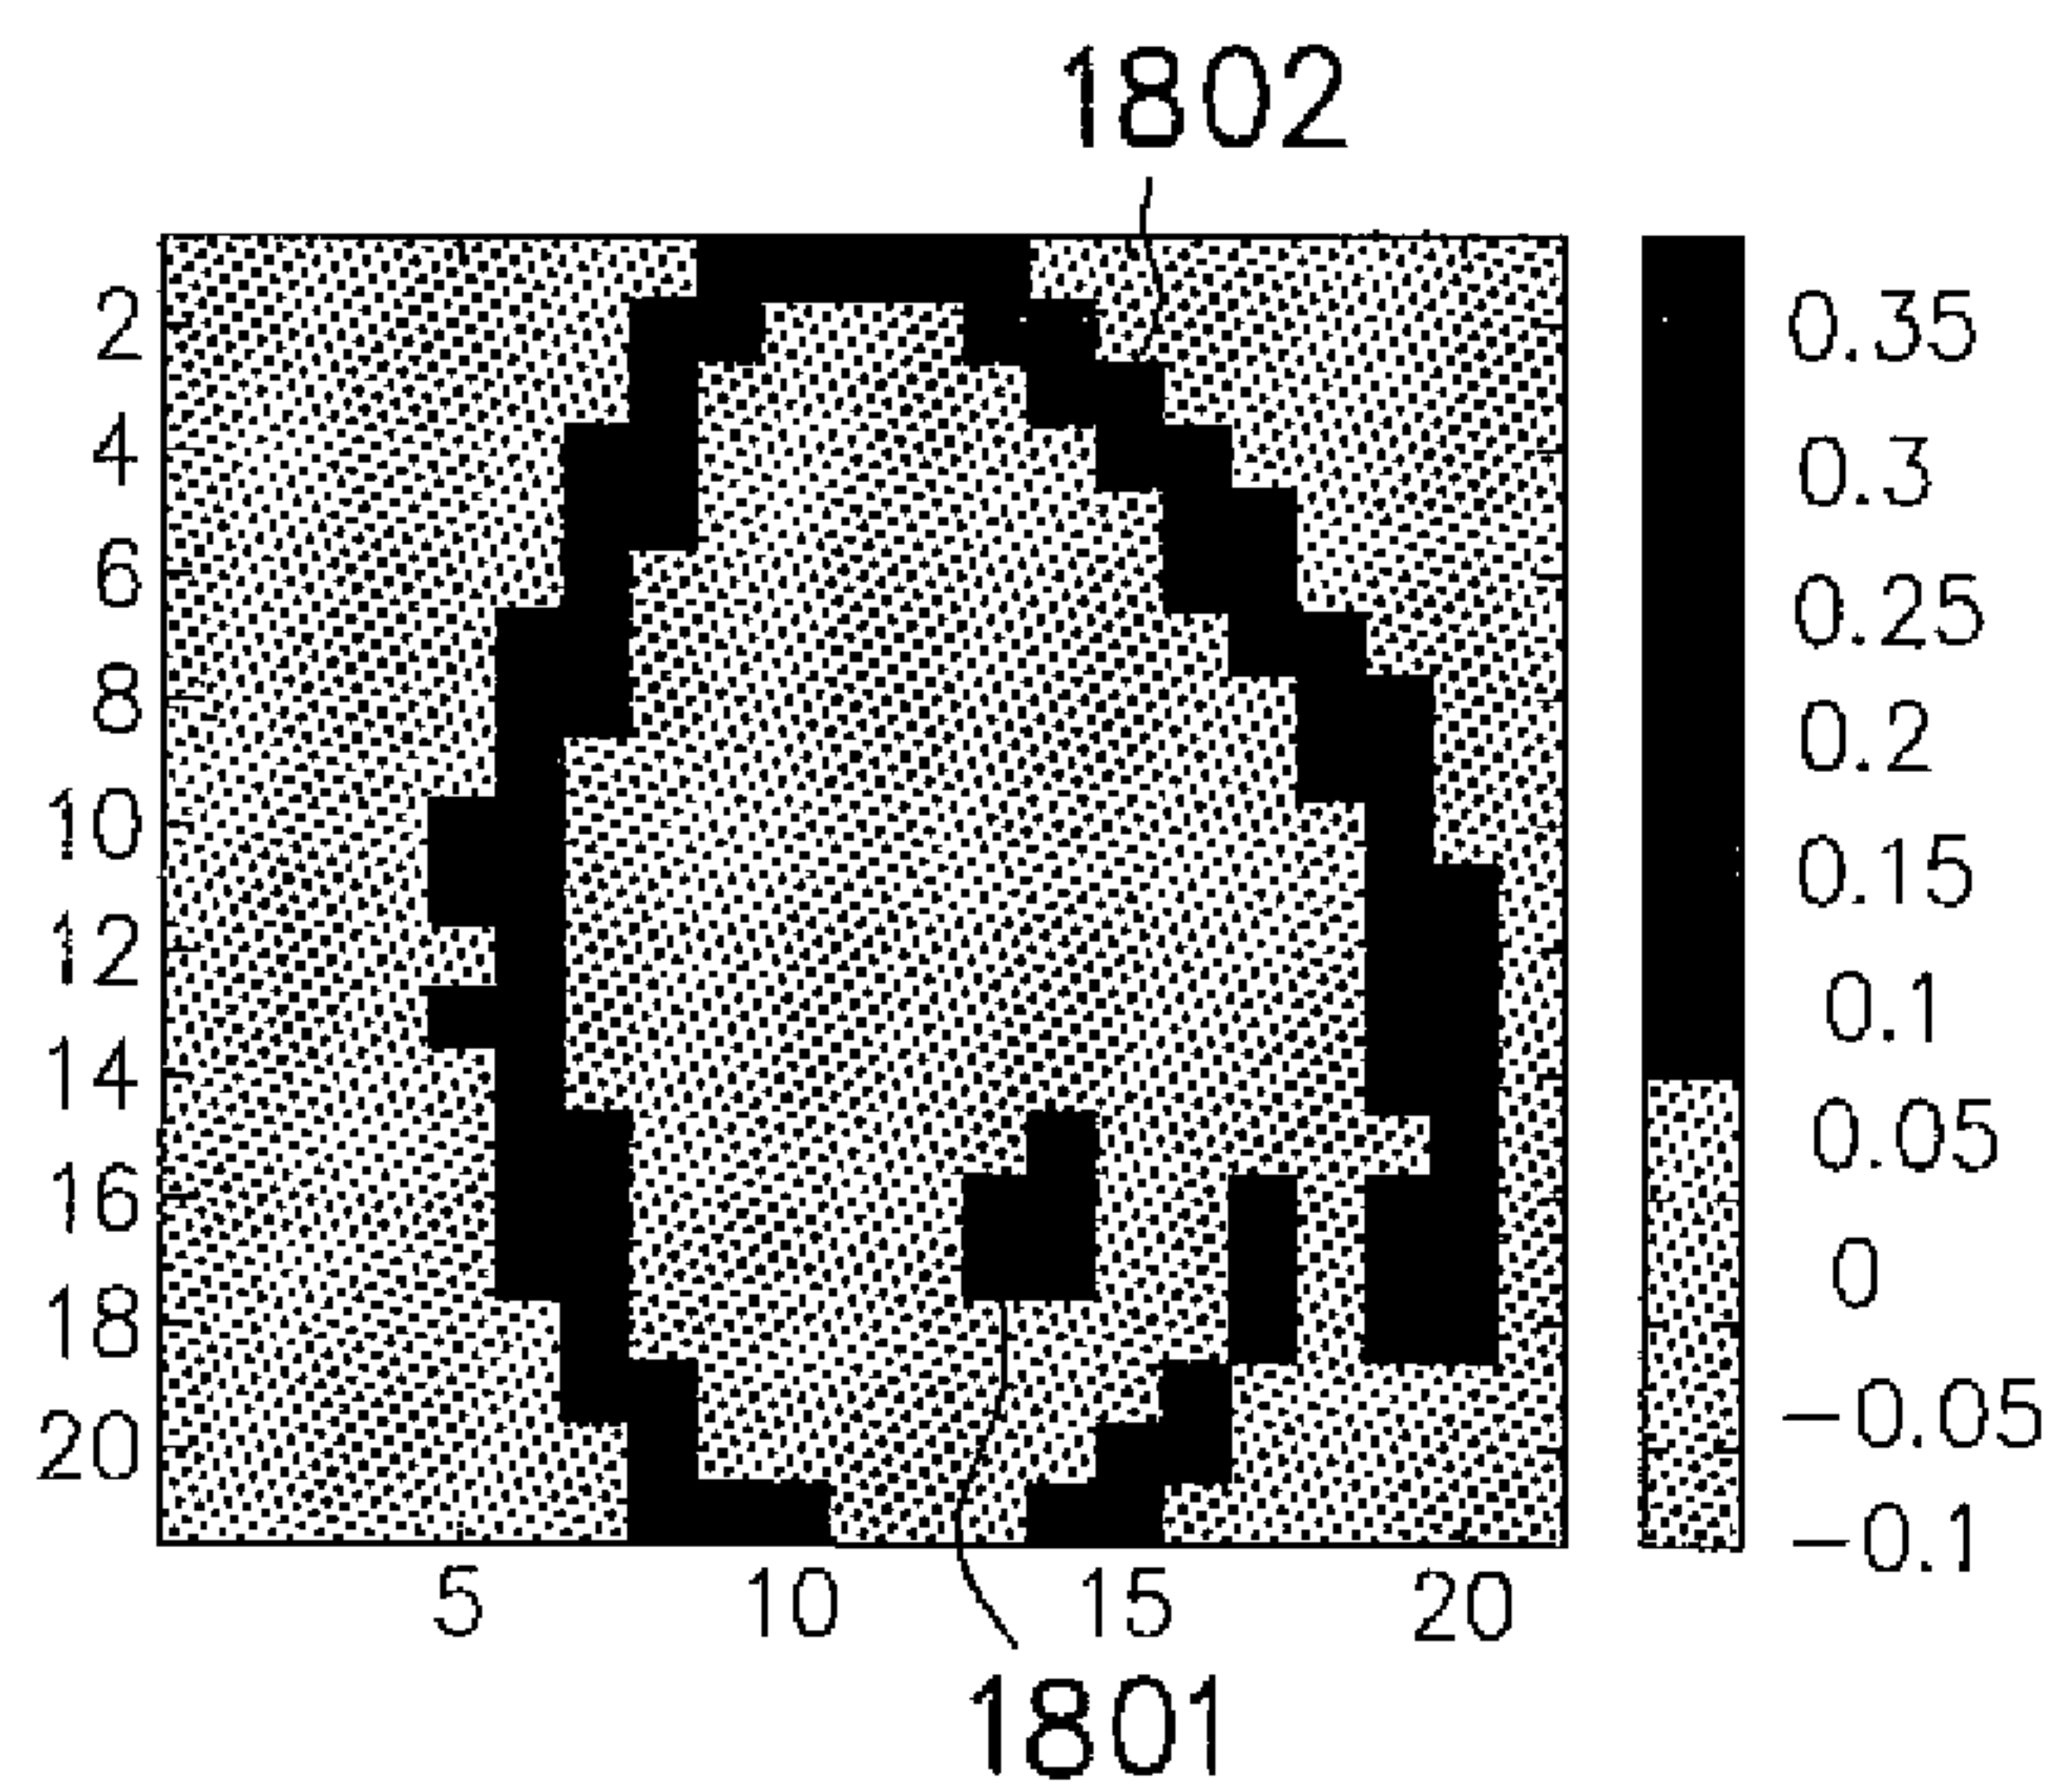
FIG.18C

of the Laplacian processed image data. FIGS. 18A, 18B and 18C are schematic diagrams made from an actually obtained image (zoom-up image). FIG. 18C shows the image where defects 1801 (a foreign material attached) are extracted to be clearly viewed. A line pattern 1802 viewed in FIGS. 18A, 18B and 18C is a marking line written on the sample in advance to indicate a portion having the defects after finding the defect by doing a visual check, but not any kind of erroneous detection.

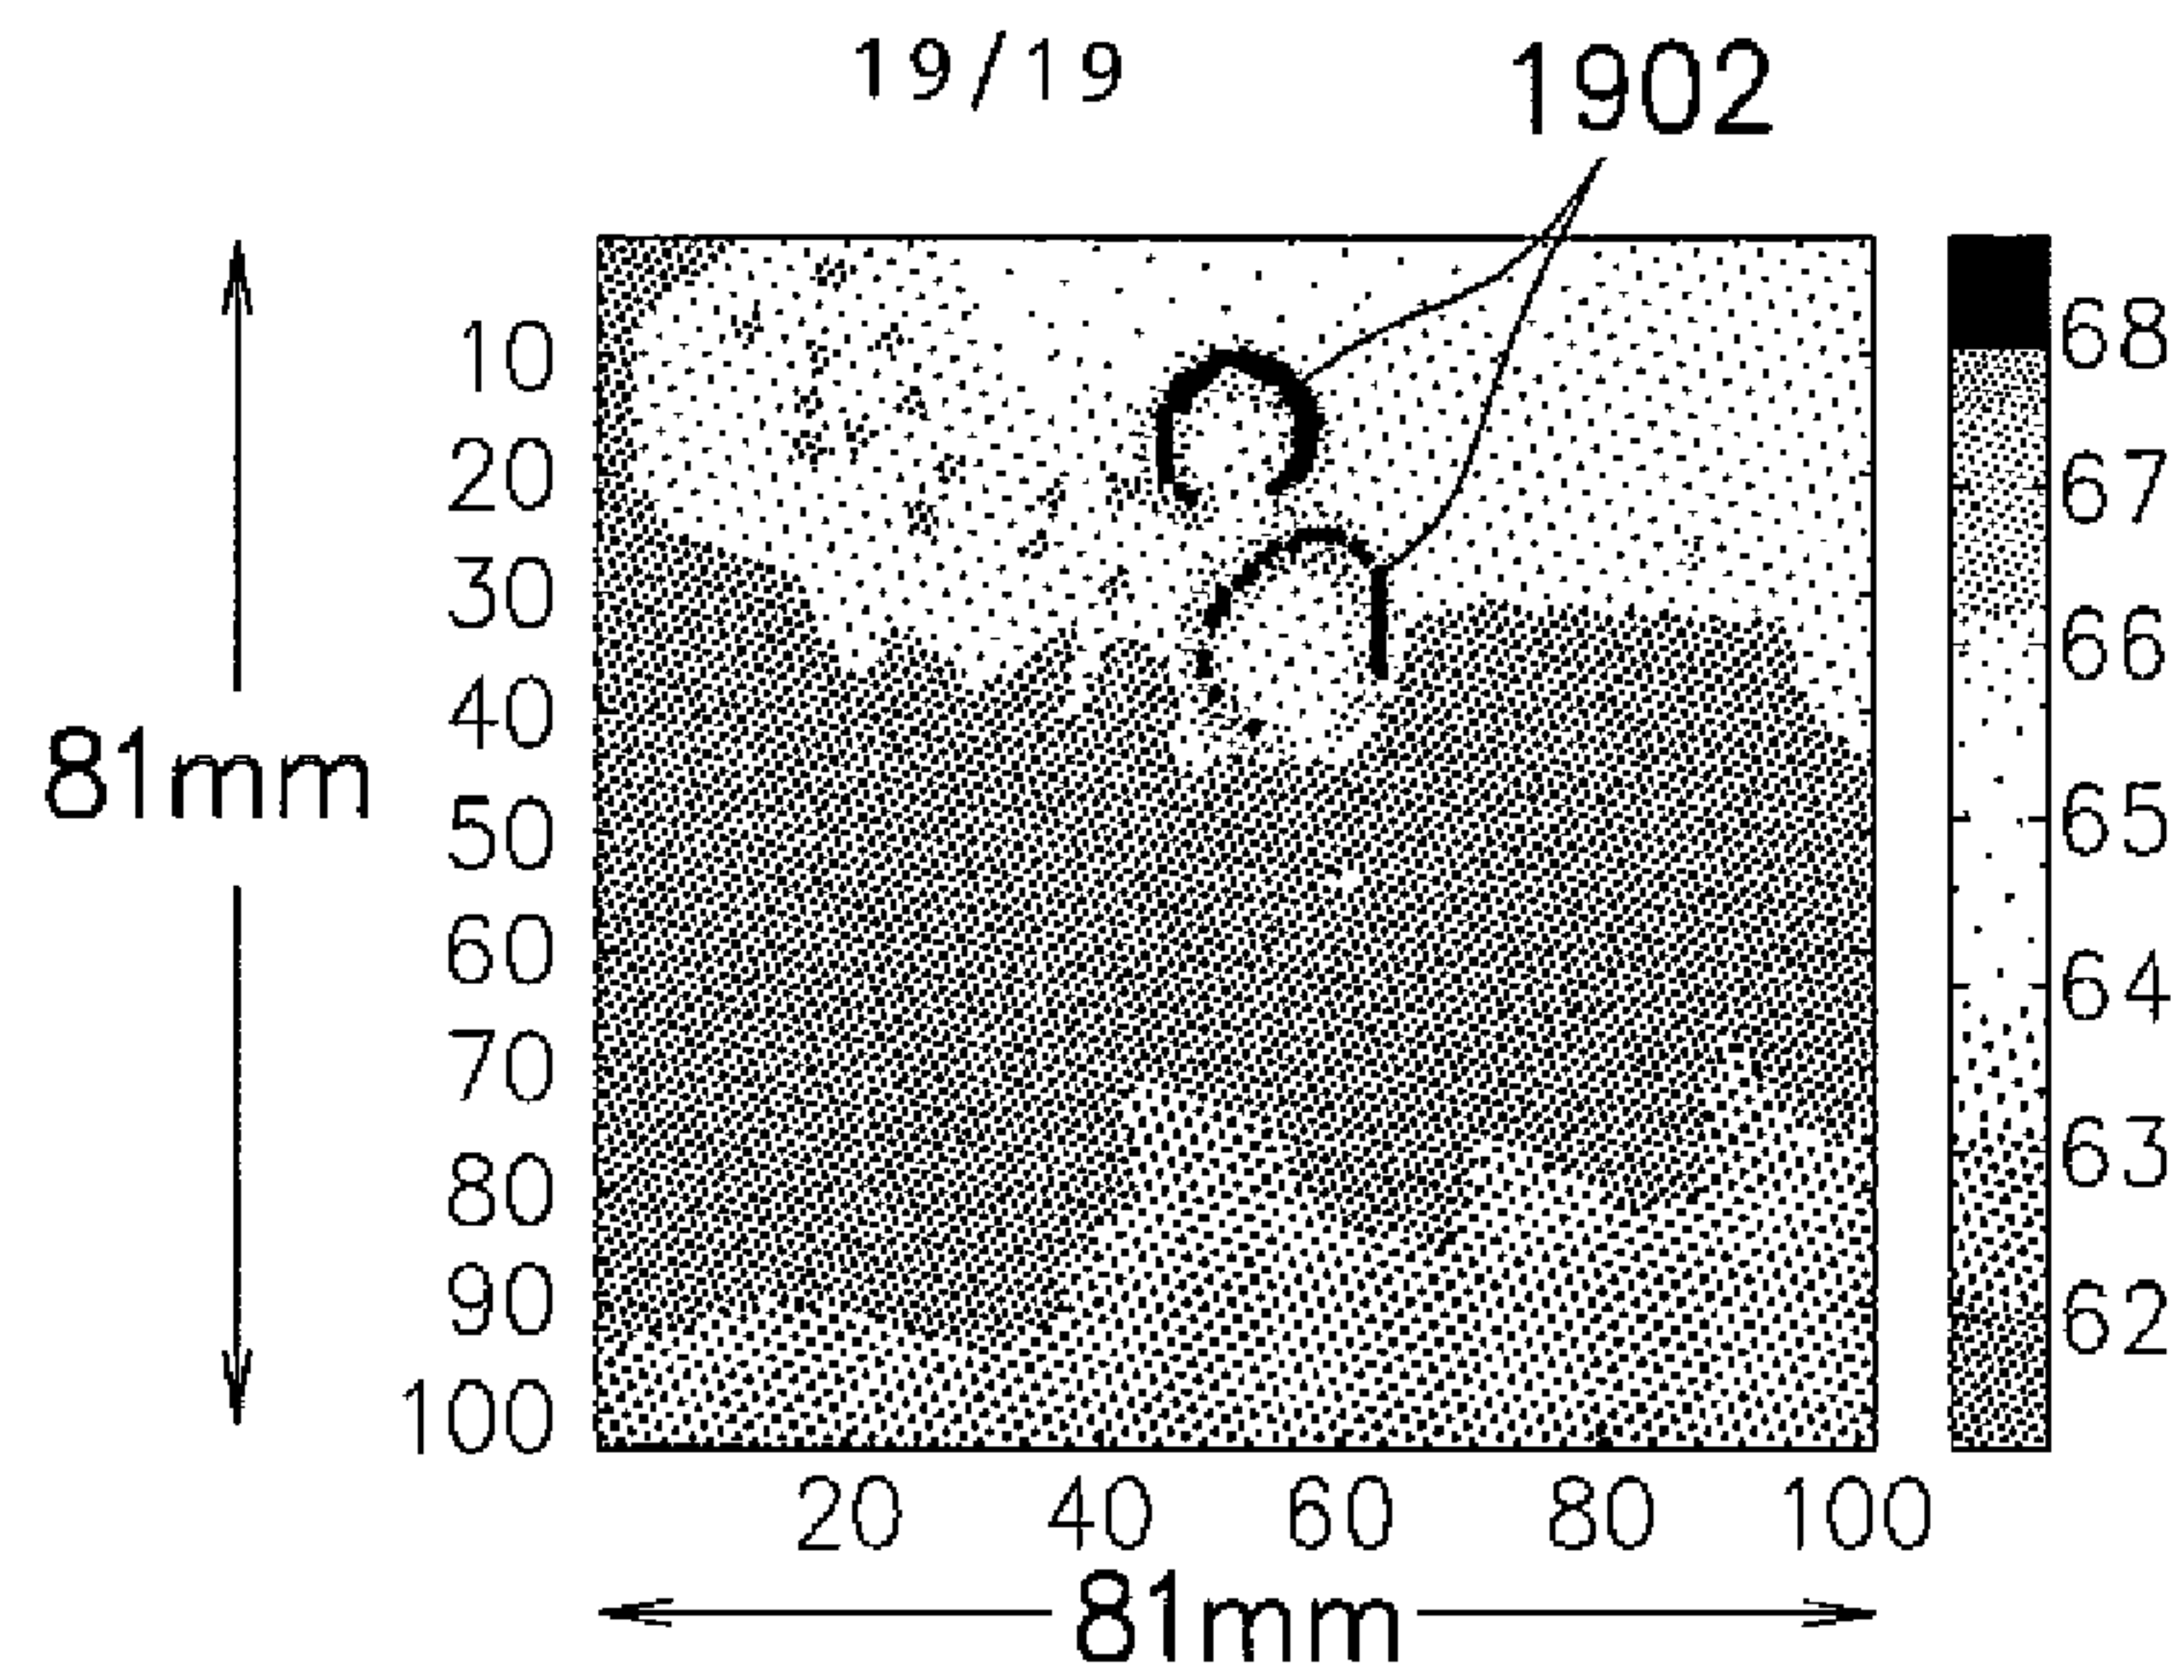
FIG.19A

FIG. 19A is thermal image data taken by the infrared thermography camera, FIG. 19B is a Laplacian processed image of the thermal image data, and FIG. 19C is a binarized image of the Laplacian processed image data. FIGS. 19A, 19B and 19C are schematic diagrams made from an actually obtained image (zoom-up image). FIG. 19C shows the image where defects 1901 (a foreign material in the surface layer) are extracted to be clearly viewed. A ring pattern 1902 viewed in FIGS. 19A and 19B is a marking line written on the sample in advance to indicate a portion having the defects after finding the defect by doing a visual check, but not any kind of erroneous detection.

This invention can be applied to other types of material. FIG. 19 shows an example where defect detection was made with respect to a sample of a resin fuel tank for an automobile having a foreign material in the surface layer of the tank shell in place of the steel sheet. Thermal image data of the fuel tank sample was taken by an infrared thermography camera while the fuel tank sample was being heated up to about 70°C. The number of pixels of the infrared thermography camera is 256 x 256, the size of the pixel is 0.8 mm, and the distance between the camera and the steel sheet sample was 60 cm. The angle between the heating direction by the heating device and the steel sheet surface is 60°, and the angle between the optical axis direction of the camera and the steel sheet surface is 90°.
