(12) **EUROPEAN PATENT APPLICATION**

(71) Applicant: **The Boeing Company**
Chicago, IL 60606-1596 (US)

(54) **Ultrasonic inspection and repair mode selection**

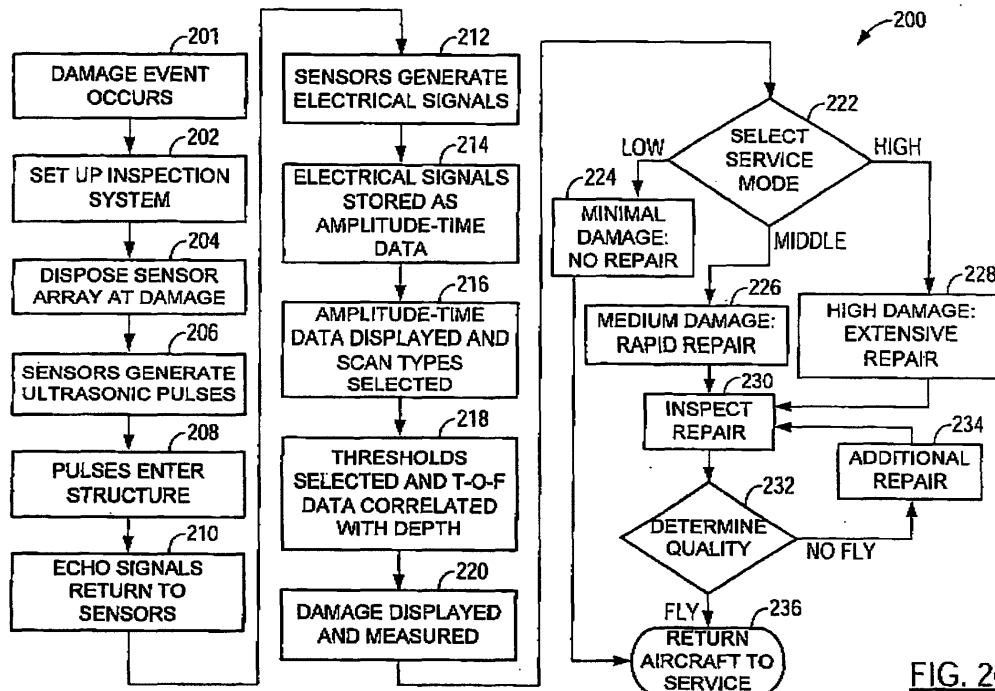
FIG. 20 is a flowchart representation of a method of inspecting an aircraft structure according to an embodiment of the present invention.

(57) A method (200) of inspecting an aircraft structure, the method comprising: disposing (204) a two-dimensional array (12) of ultrasonic pulse-echo sensors (18) onto a surface (70) of an aircraft structure; sending (206, 208) from each particular sensor (18) an ultrasonic pulse into the surface (70); receiving (210) by each particular sensor (18) an ultrasonic echo signal resulting from the sending of the ultrasonic pulse by the particular

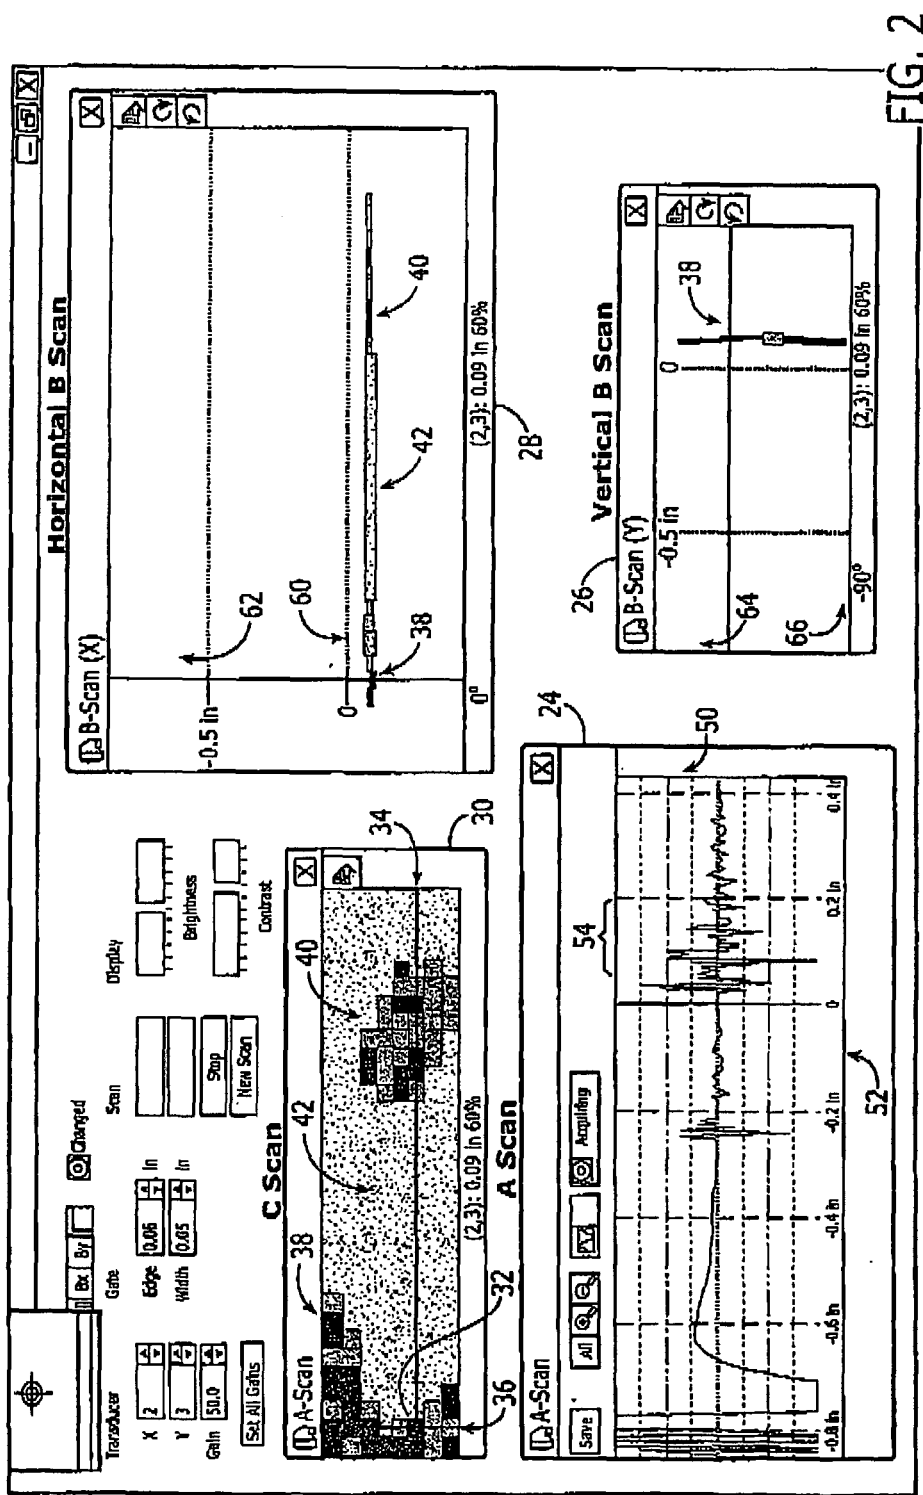
[0024] An understanding of the C-scan image FIG. 2 may be gained by considering the A-scan window 24. A particular sensor, which corresponds to the pixel under the cross-hair cursor 32 in C-scan window 30, sent an ultrasonic pulse into a structure and an ultrasonic echo signal returned to the sensor. The sensor received the echo signal and generated an electrical signal as represented by the waveform plot that represents signal amplitude on a vertical axis 50 and time on a horizontal axis 52 in the A-scan window 24. The C-scan window 28 displays an echo amplitude C-scan image in that the coloration of each pixel therein corresponds to an amplitude of a portion of an echo signal. In particular, the coloration of the pixel under the cross-hair cursor 32 in the C-scan window relates to the amplitudes of echo pulses present in a time-gated portion 54 of the waveform plot in the A-scan window. The amplitude within the time-gated portion can be derived from a smoothed and integrated function of the waveform plot according to known mathematical principles. For example, smoothed and integrated functions are shown as dashed curves and their corresponding waveform plots are shown as solid curves in FIGS. 4 and 6. The time-gated portion 54 in FIG. 2 is selected according to considerations that may be understood by considering FIGS. 3-6.

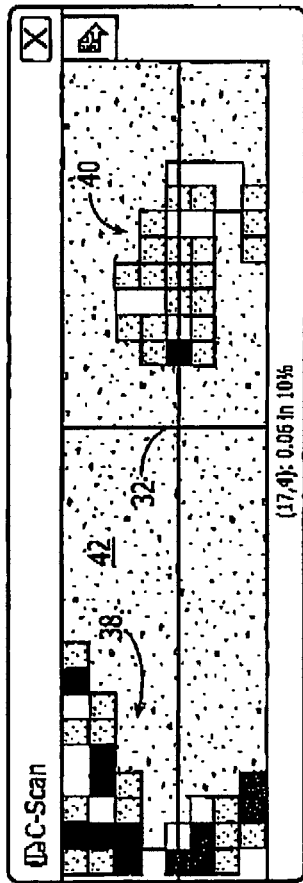
FIG. 3 shows the simulated C-scan image of FIG. 2 with the cross-hair cursor therein disposed at a pixel corresponding to a sensor disposed at an undamaged structure location;

[0025] The C-scan window of FIG. 3 displays the same C-scan image as that of the C-scan window 30 in FIG. 2, however, the cross-hair cursor 32 is disposed over a different pixel which corresponds to a different particular sensor and therefore a different location of an inspected structure. In FIG. 2, the cross-hair cursor in the C-scan window is disposed at a pixel in the damaged portion 38 and the waveform plot in the A-scan window represents the electrical signal generated when the corresponding sensor received an echo signal from the damaged portion of the inspected structure. In FIG. 3 the cross-hair cursor in the C-scan window is disposed at a pixel in the undamaged background area 42 and the waveform plot in the A-scan window of FIG. 4 represents the electrical signal generated when the corresponding sensor received an echo signal from the undamaged area of the inspected structure.

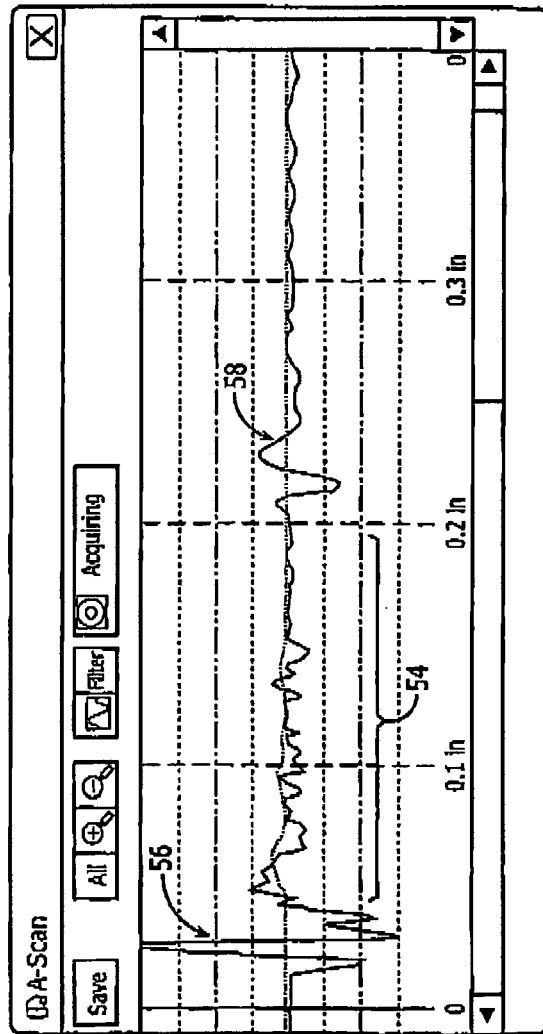
FIG. 4 shows a simulated A-scan waveform plot representing data collected by the sensor at the undamaged sensor location corresponding to the cursor position in FIG. 3;

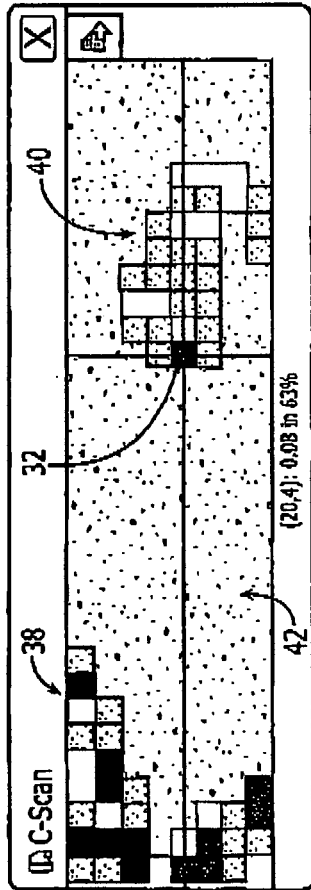
FIG. 5 shows the simulated C-scan image of FIG. 2 with the cross-hair cursor therein disposed at a pixel corresponding to a sensor disposed at a damaged structure location;

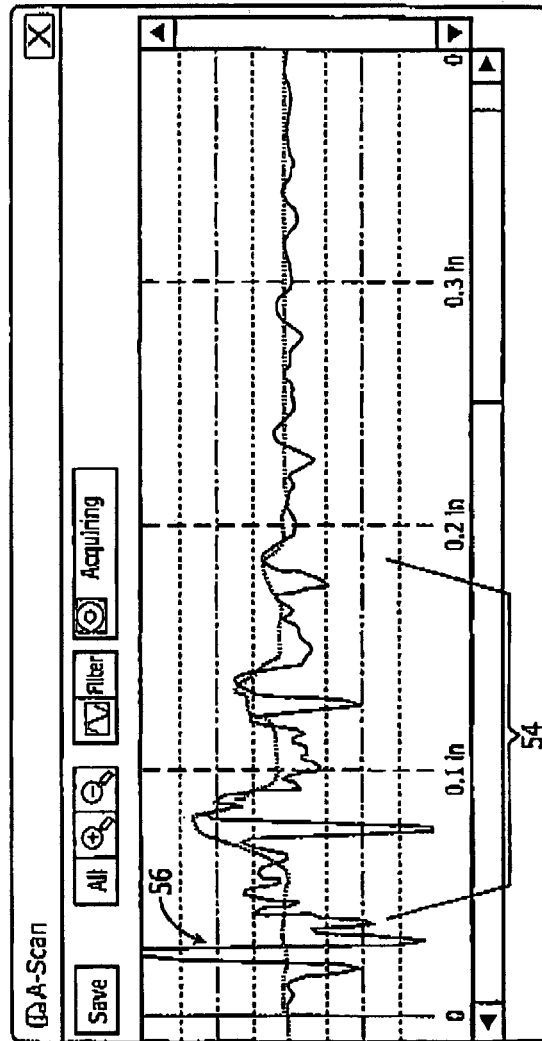
FIG. 6 shows a simulated A-scan waveform plot representing data collected by the sensor at the undamaged sensor location corresponding to the cursor position in FIG. 5;

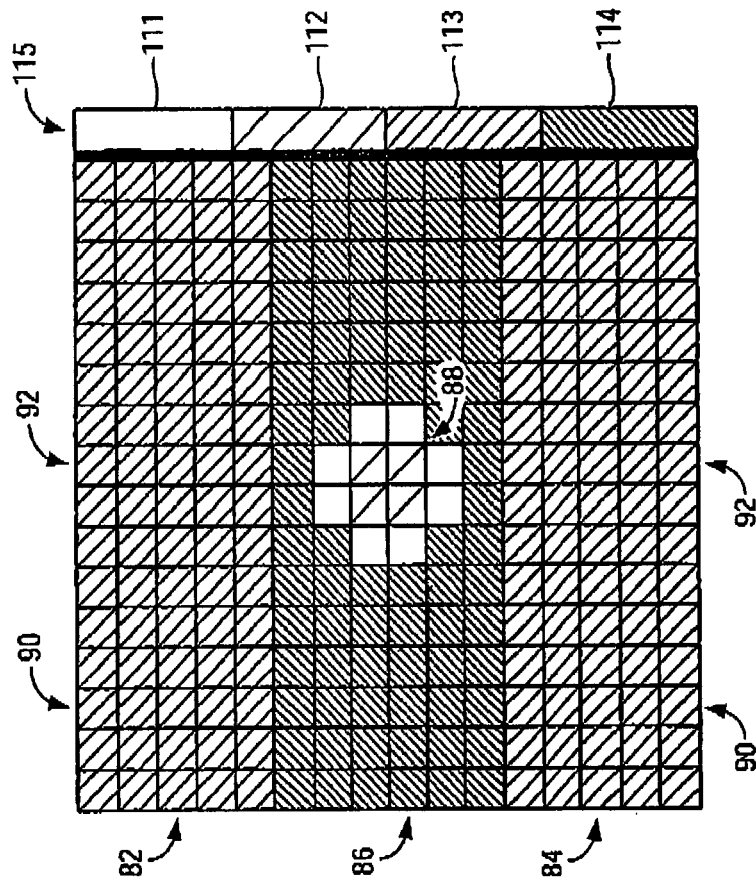
FIG. 9 is a simulated C-scan image representing data generated by disposition of the sensor array across the panel as shown in FIG. 8;

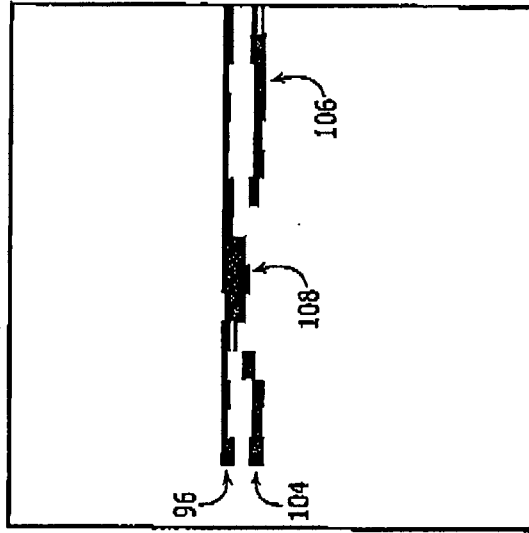
FIG. 13 is a simulated B-scan threshold image corresponding to FIG. 11;

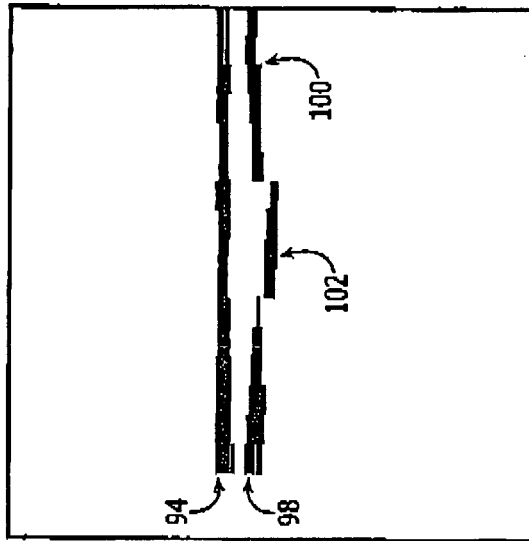
FIG. 12 is a simulated B-scan threshold image corresponding to FIG. 10;

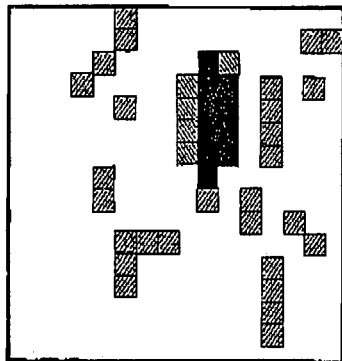
FIG. 14 is a simulated C-scan image of a portion of an inspected aircraft structure, the image showing simulated features including an elongate damage;

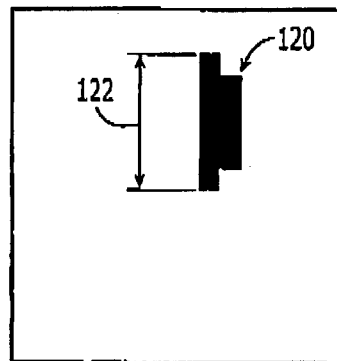
FIG. 17 is a simulated C-scan threshold image corresponding to FIG. 14, wherein a longest chord of the simulated damage is measured;

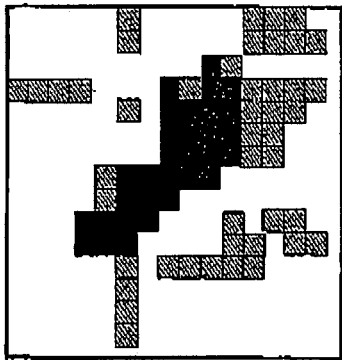
FIG. 15 is another simulated C-scan image of another portion of an inspected aircraft structure, the image showing simulated features including damage distributed across an area;

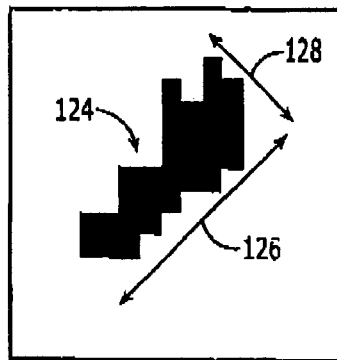
FIG. 18 is a simulated C-scan threshold image corresponding to FIG. 15, wherein perpendicular chords are measured to determine an area encompassing the simulated damage;

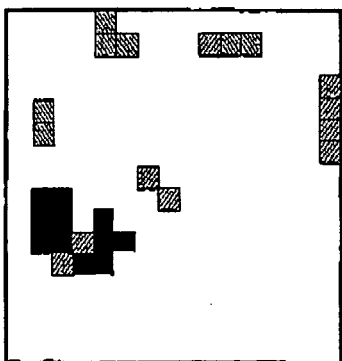
FIG. 16 is a simulated C-scan image of yet another portion of an inspected aircraft structure, the image showing simulated features including a damage cluster;

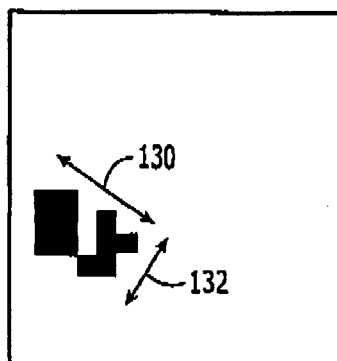
FIG. 19 is a simulated C-scan threshold image corresponding to FIG. 16, wherein chords are measured to determine an area encompassing the simulated damage cluster; and

FIG. 19, a longest chord 130 and a second chord 132, which is perpendicular to the longest chord, are measured in order to determine an area encompassing the damage cluster.
