(10) **Patent No.:** **US 10,103,608 B2**
(45) **Date of Patent:** **Oct. 16, 2018**

(54) **GENERATOR ROTOR FRETTING FATIGUE
CRACK REPAIR METHOD**

This invention relates to generator rotors and specifically, to the repair of generator rotors that have experienced fretting damage and/or cracks in the rotor teeth located at the butt joints of the axially aligned rotor wedges.

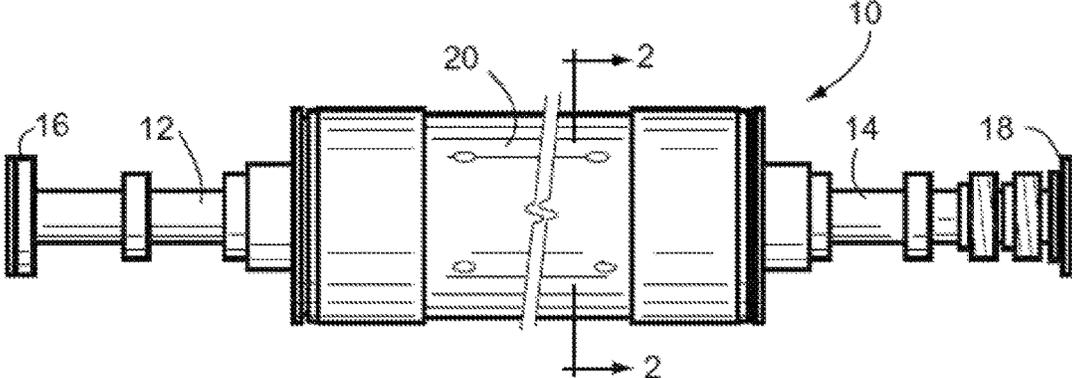
FIG. 1
(PRIOR ART)

FIG. 1 is a side elevation of a conventional generator rotor including radially oriented coil slots;

FIGS. 1 and 2 illustrate a typical rotor 10 for a dynamo-electric machine wherein the rotor includes conventional elements such as rotor end shaft portions 12, 14 and couplings 16, 18 for connection with a turbine or gear reduction unit. Of particular significance here are the axially oriented coil slots 20 arranged circumferentially about the mid-section of the rotor, that are used for holding the copper field windings or coils.

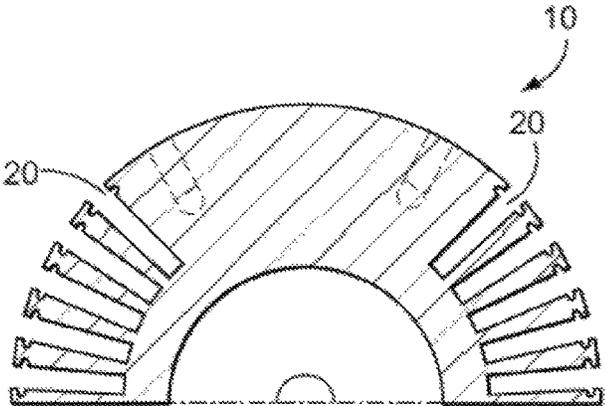
FIG. 2
(PRIOR ART)

FIG. 2 is a partial cross section of the rotor body taken along the lines 2-2 of FIG. 1;

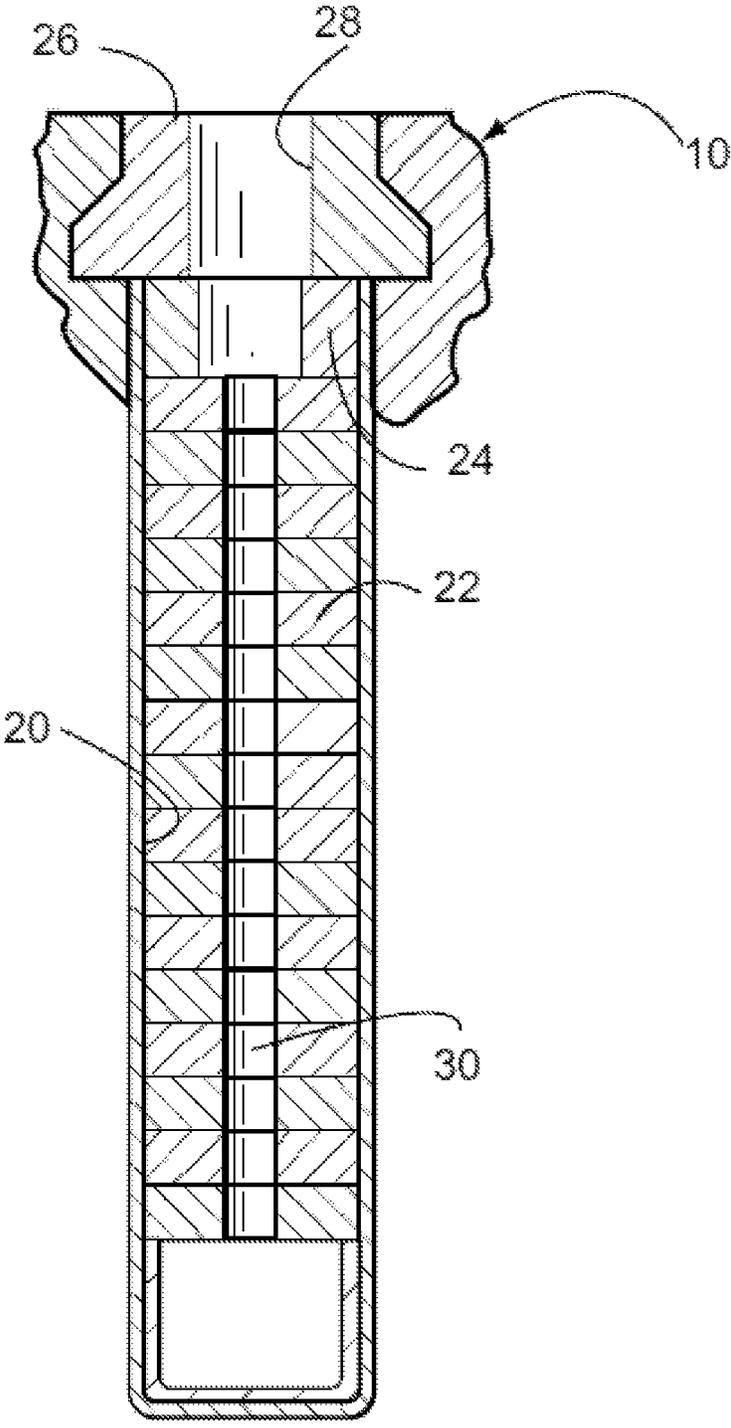
FIG. 3
(PRIOR ART)

FIG. 3 is a cross section through a typical coil slot and contents thereof;

With further reference to FIG. 3, the coil slots 20 are each radially directed and typically contain, in a radially outward sequence, insulated copper coils 22, a creepage block 24, and a plurality of axially aligned slot wedges 26. The wedges have a generally dovetail shape in cross section, and are located and arranged so as to maintain the copper coils 22 and creepage block 24 in place while the rotor is spinning. The slot wedges 26 may also contain ventilation holes 28 (one shown) which are in general alignment with ventilation channels 30 (one shown) which pass through the copper conductors or coils, as well as through the creepage block 24.

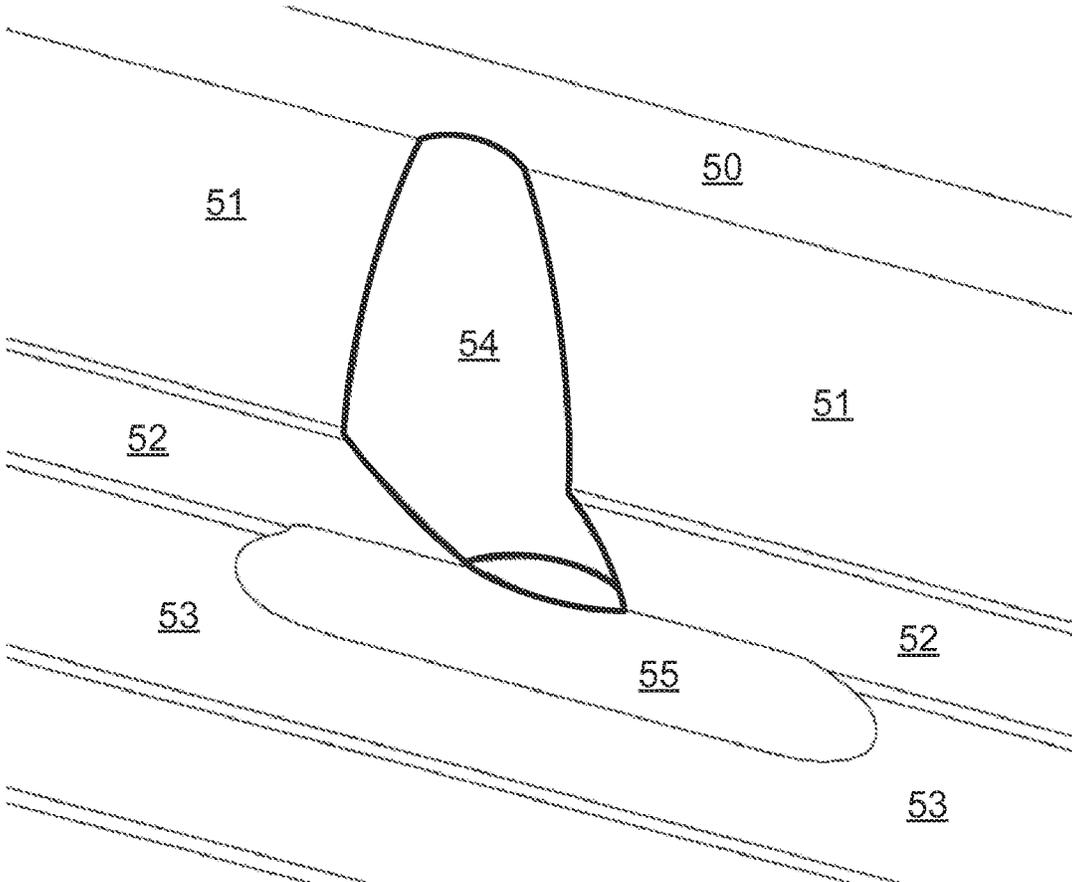
FIG. 6 is a perspective view of the rotor slot, showing damaged areas machined away from the slot wall, according to an aspect of the present invention;

FIG. 6 is a perspective view of the rotor slot, showing damaged areas machined away from the slot wall (as shown in cross-section by FIG. 5). The first groove 54 extends from the outer rotor surface 50 and/or radial entry surface 51 in a linear manner until it reaches the intermediate radial surface 53. The first groove 54 may be configured to be wider than the second groove 55. For example, if the height (measured radially) of the second groove 55 is about 0.35 inches, then the width (measured axially) of the first groove 54 may be

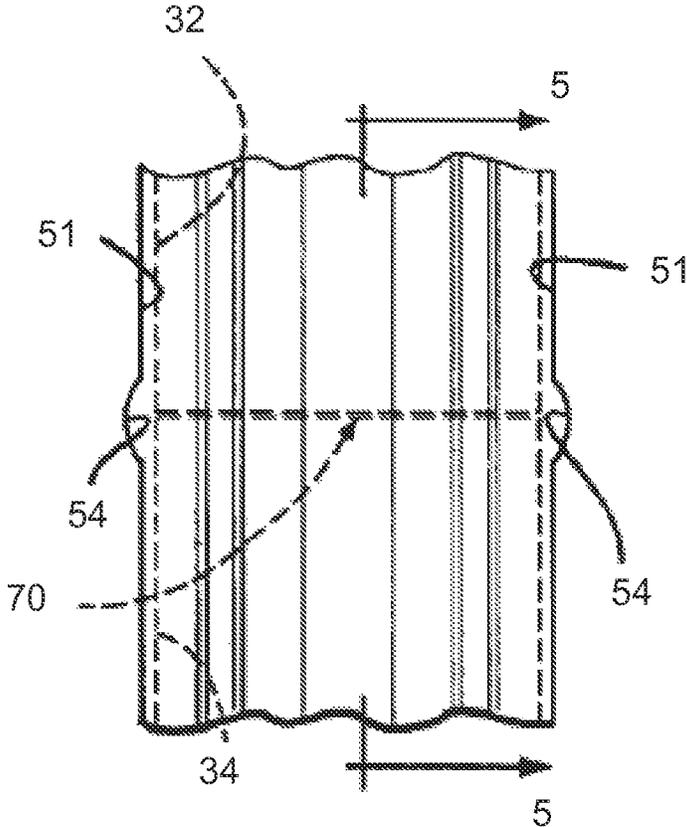
FIG. 7 is a plan view of the rotor slot shown in FIG. 6, with adjacent wedges shown in phantom, according to an aspect of the present invention; and

Fretting fatigue damage has occurred in the coil slots 20, specifically in the slot walls, at the butt joints of the axially adjacent steel rotor wedges 26 (a butt joint 70 between a pair of adjacent wedges 32, 34 is shown in phantom in FIG. 7). Fretting occurs whenever a junction between components is subjected to a cyclic load that leads to small tangential displacement over part of the interface. A two dimensional (radial-axial) finite element fretting model was developed to model the mechanics of contact between the rotor slot 20, and particularly the dovetail-shaped portion 36 of the slot wail 38 (see FIGS. 4 and 5) and the wedge 26, where fretting initiated cracks were observed in the rotor. The model provided a qualitative understanding of the fretting mechanism, and provided a basis for preliminary assessment of various wedge redesign options.

FIG. 7 is a plan view of the rotor slot shown in FIG. 6, with adjacent wedges shown in phantom. A butt joint 70 is shown between two axially adjacent rotor wedges 32, 34. The first groove 54 is centered on and located across from the butt joint 70, as this is the region most likely to experience fretting damage. Thus, the machined first and second grooves 54, 55 take the shape of an inverted "T," with first groove 54 serving as the stem and second groove 55 serving as the cross member of the "T". It is also noted that the centerline through grooves 54, 55 may, again, be aligned with the butt joint between the wedges, or axially offset therefrom.

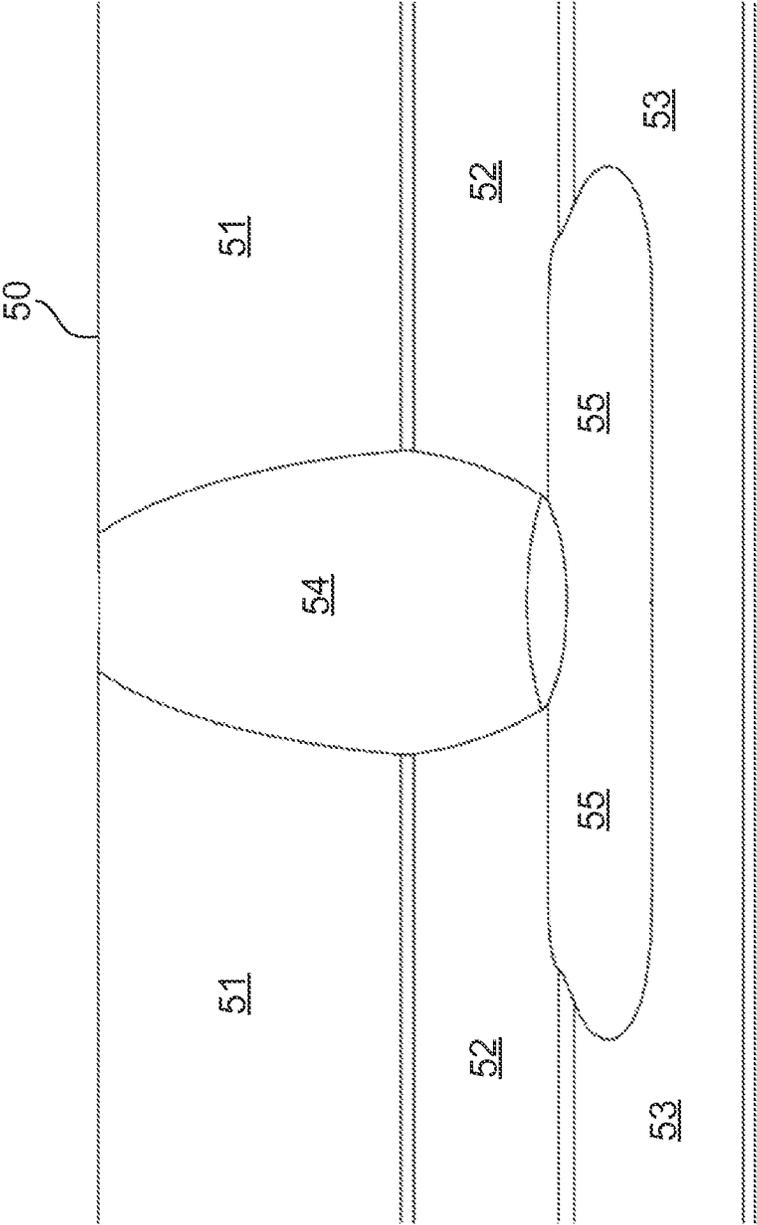
FIG. 8 is a side view of the rotor slot, showing the first and second grooves machined into the slot wall, according to an aspect of the present invention,
