(12) **United States Patent**  
**Krizansky et al.**

(10) **Patent No.:** **US 9,018,560 B2**  
(45) **Date of Patent:** **Apr. 28, 2015**

(54) **REPAIR ALIGNMENT METHOD AND APPARATUS FOR TURBINE COMPONENTS**

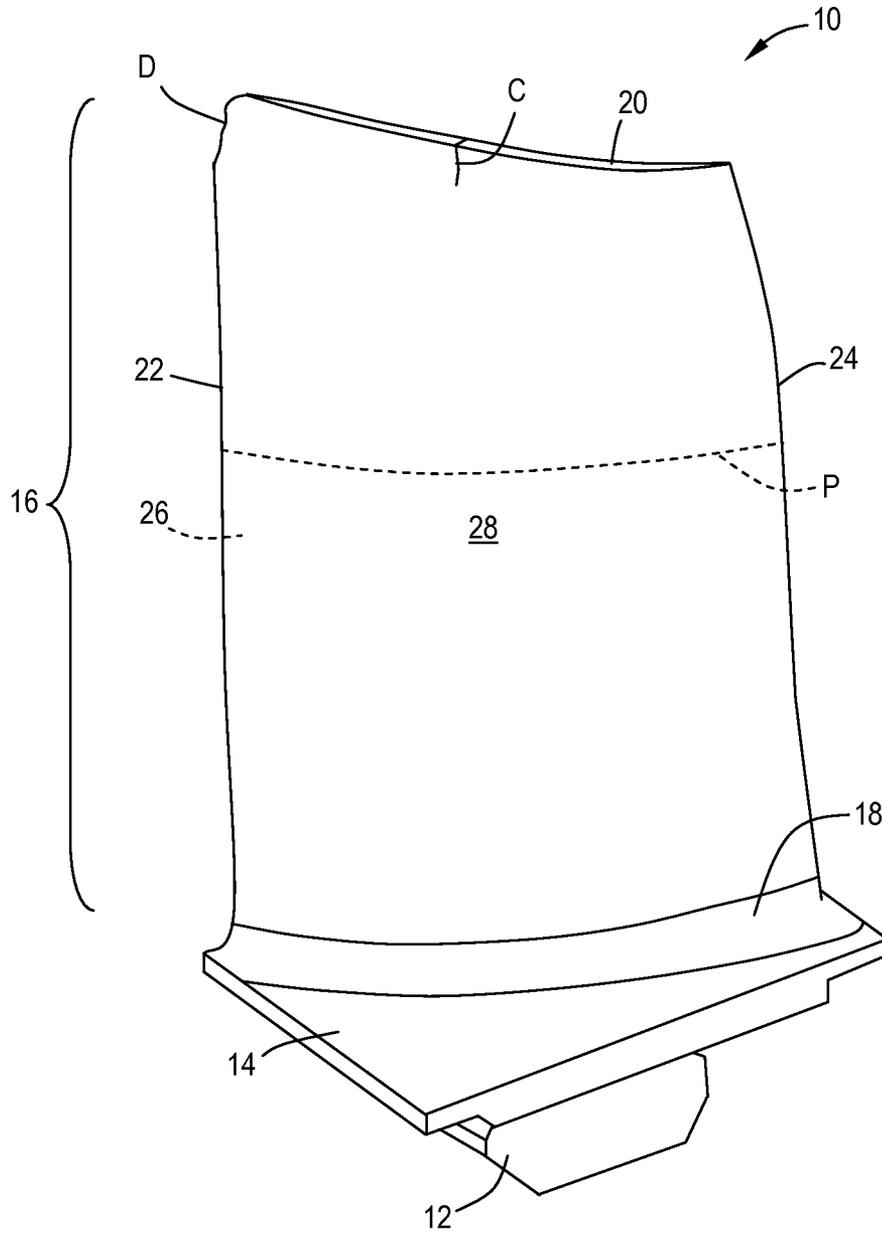
FIG. 1 is a perspective view of an engine-run turbine compressor blade, exhibiting damage from use;

views, FIG. 1 shows a compressor blade 10 of a gas turbine engine. It will be understood that the principles of the present invention are also applicable to other kinds of airfoils. The blade 10 includes a dovetail 12 used to mount the blade 10 to a compressor disk wheel (not shown), an arcuate platform 14, and an airfoil 16 having a root 18, a tip 20, a leading edge 22, a trailing edge 24, a concave pressure side 26 and a convex suction side 28.

In operation, the blade 10 is subject to damage, especially tip and erosion damage from abrasive materials and/or foreign object impacts. The blade 10 in FIG. 1 is shown to include both a crack "C" and a damaged area "D" where material is missing.

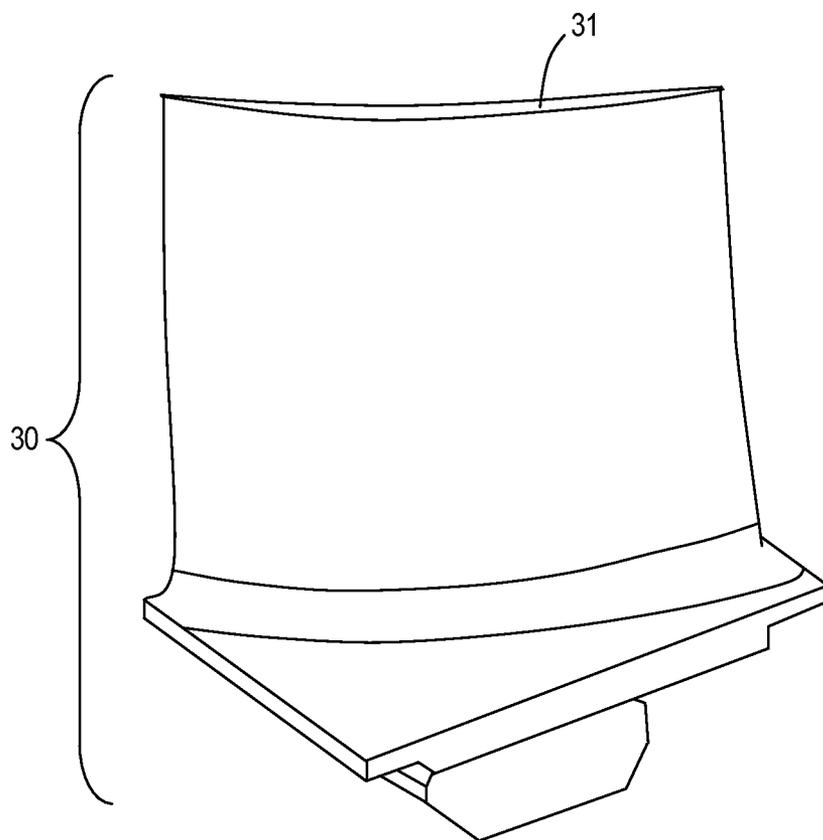
FIG. 2 is a perspective view of the blade of FIG. 1 after being prepared for a welding operation;

FIG. 2 shows the blade after it has been prepared for a subsequent welding process by cutting, grinding, machining, or otherwise working it to remove the spanwise outer portion along a predetermined cutting plane P (seen in FIG. 1). As thus prepared, the remaining portion of the blade 10 is referred to as a "field item" 30. The preparation process exposes a faying surface 31. The cutting plane P is selected so that pressure applied to on the field item 30 along its spanwise or stacking axis during a welding process will not end to cause misalignment. The remainder of the airfoil 16 is referred to herein as a "root portion".

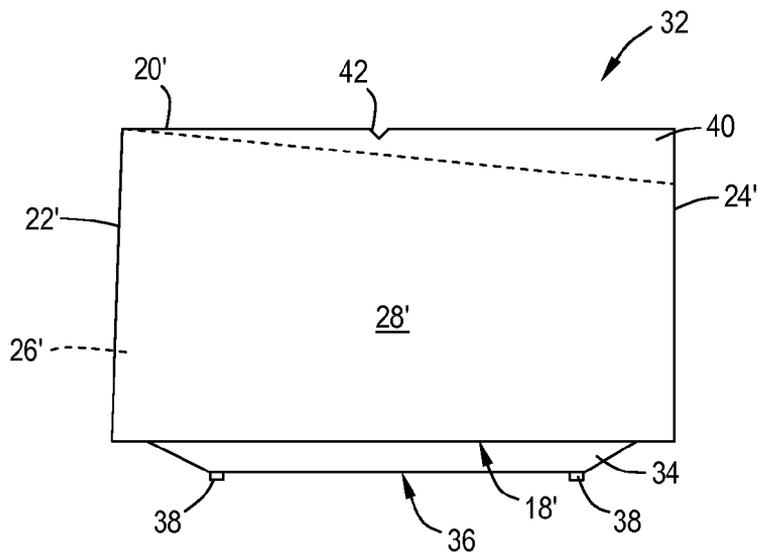
FIG. 3 is a side view of a repair section for use with the blade of FIG. 1;

FIGS. 3 and 4 illustrate a repair section 32 for use to replace the removed portion of the airfoil 16. This type of repair section may also be referred to as a "SPAD", from the term "spare part assembly detail" or "spare part assembly drawing". The repair section 32 mimics the spanwise outer portion of the airfoil 16 (referred to herein as a "tip portion") and includes a leading edge 22', a trailing edge 24', and opposed pressure and suction sides 26' and 28'. In the radial or spanwise direction, it extends between a tip 20' and a base 18'. An integral sacrificial projection 34 extends from the base 18'. The projection 34 is generally trapezoidal in shape, with its cross-sectional area being tapered down as it extends away from the rest of the base 18'. The projection 34 incorporates a faying surface 36 which is planar or otherwise complementary to the faying surface 31 of the field item 30, as is the base 18'. The dimensions and exact shape of the projection 34 are selected to provide for an appropriate amount of material extrusion for a specific application. A pair of small cross-section tabs 38, for example a few thousands of an inch in length, extend from the base 18' of the repair section 32. The repair section 32 may include a sacrificial portion 40 adjacent the tip 20'. The inner boundary of the sacrificial portion 40 coincides with the finished tip profile, and its outer boundary is parallel to the faying surface 36. A notch 42 is formed in the tip 20'. In the illustrated example the notch is V-shaped.

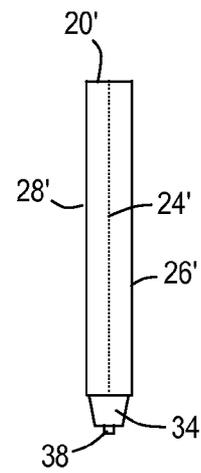
FIG. 4 is a rear elevational view of the repair section of FIG. 3;

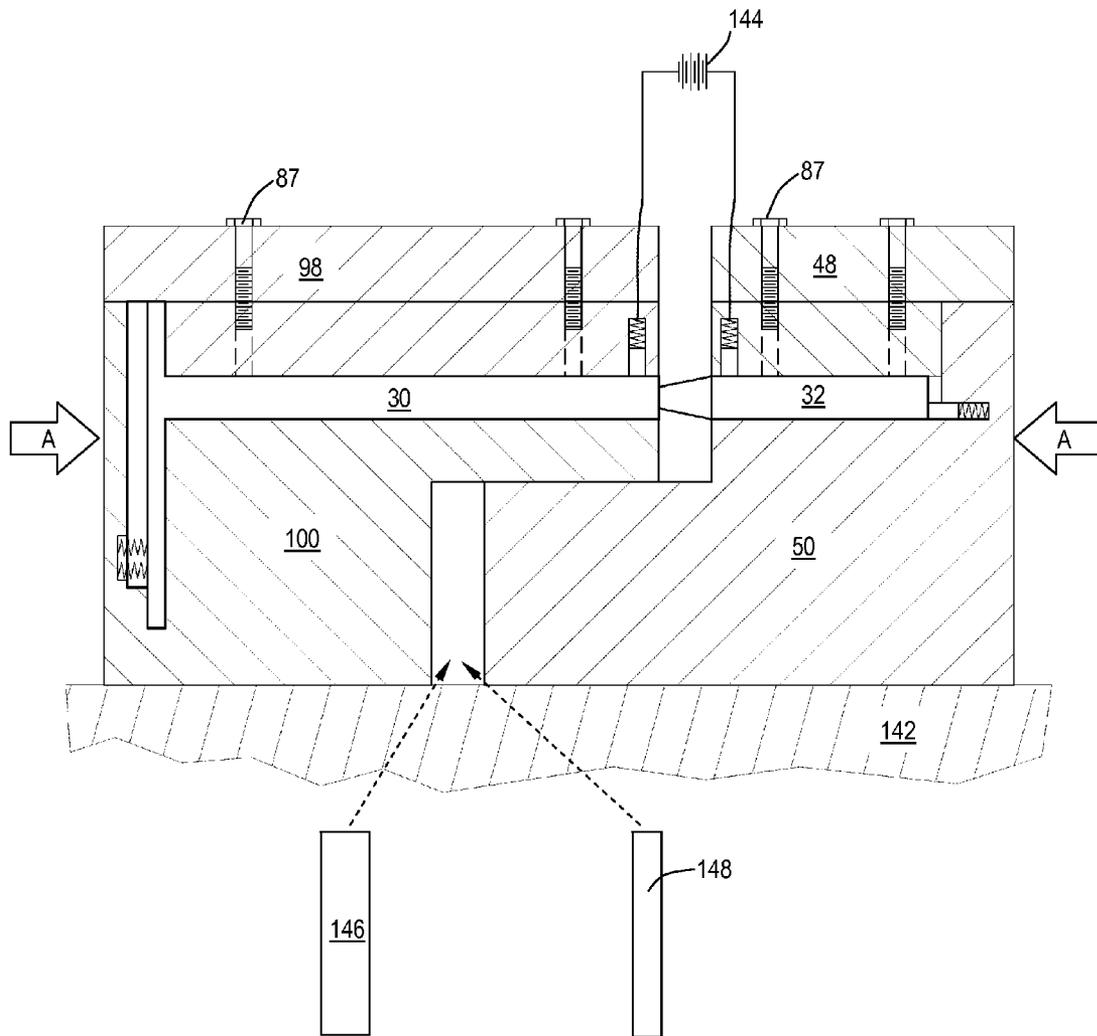
FIG. 12 is a cross-sectional view of the fixture assembled during a welding process.

Referring now to FIG. 12, the male half **48** of the repair section die **44** is next mounted to the female half **50**. It may be secured using bolts **87**. Alternatively, clamps, or hydraulic or pneumatic clamping means may be used to secure the two halves together. The two die halves securely clamp the repair section **32**.

Next, an electrical power supply **144** such as a welding power supply (shown schematically in FIG. 12) is connected to the contacts **84** and **136**.
