(54) **SYSTEM AND METHOD FOR GROUND BASED INSPECTION OF WIND TURBINE BLADES**

A ground based wind turbine blade inspection system and method consists of a thermal imaging camera configured to detect propagating defects by acquiring thermal imaging data from a wind turbine blade when it is substantially at thermal equilibrium with respect to surrounding air and analyzing the thermal imaging data with a processor to identify thermal effects associated with latent defects caused by internal friction due to cyclic gravitational stresses and wind loads during normal turbine operation. The system permits latent defects to be identified using a ground-based in situ inspection before they become visually apparent, which allows repairs to be made economically while the blade is in place.

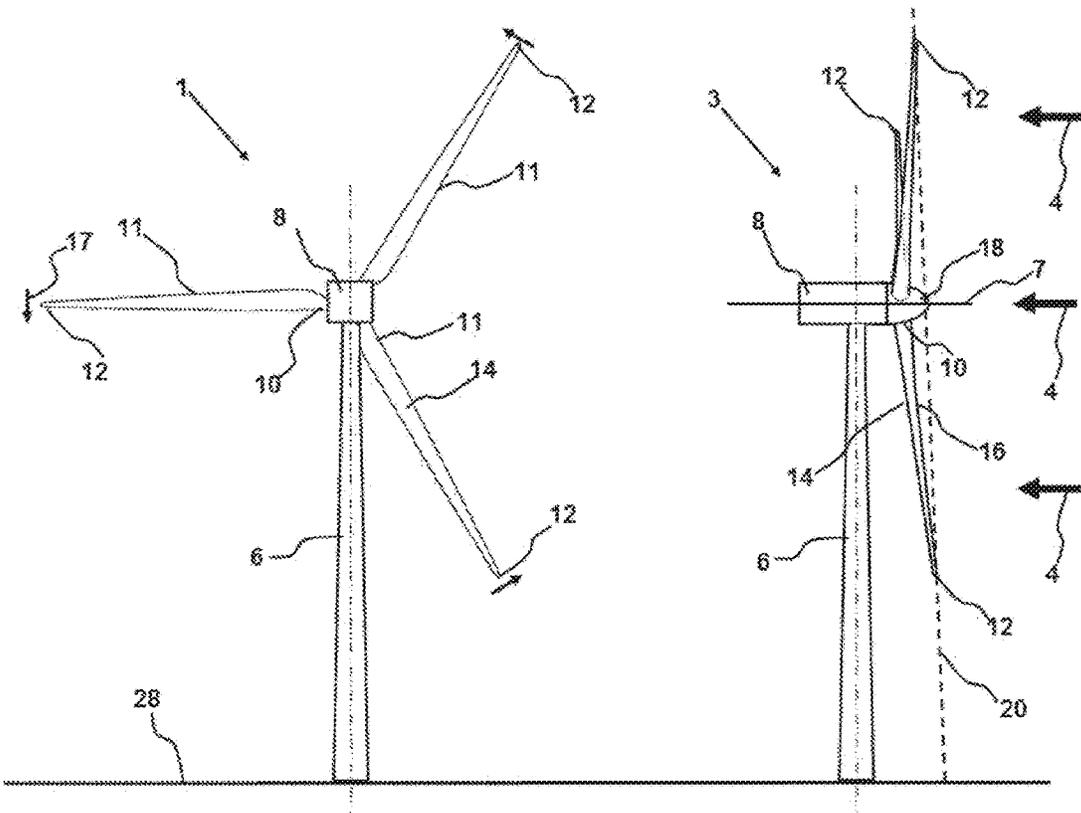
Fig. 1

FIG. 1 is a schematic representation of a utility scale, horizontal axis, wind turbine generator;

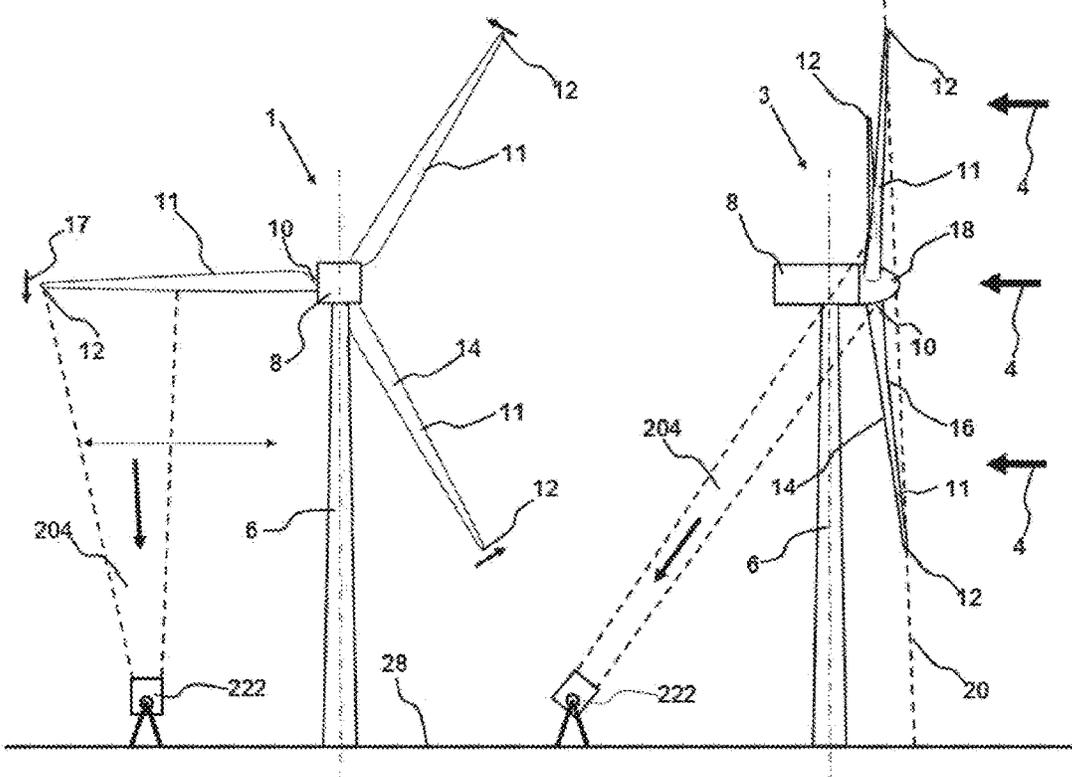
Fig. 3

FIG. 3 is a schematic diagram showing the relative location of a thermal camera for inspecting the wind turbine blades that are oriented so as to be substantially perpendicular with respect to the ground or sea level;

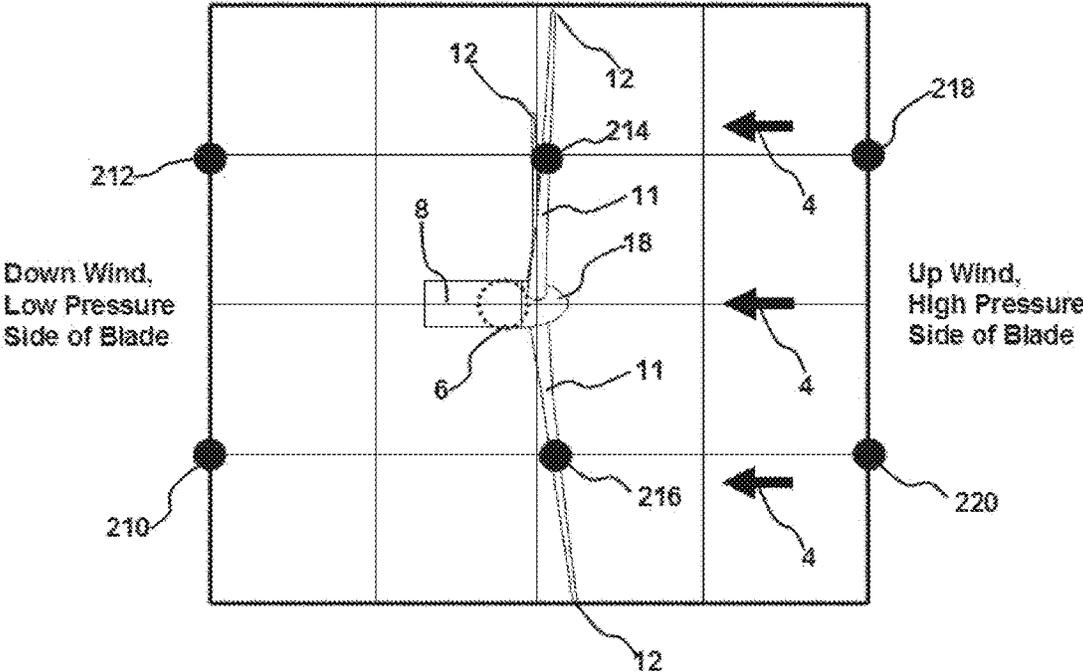
Fig. 4

FIG. 4 is a diagrammatical plan view of a wind turbine site with an indication of six placement locations for the thermal camera to view various locations on the blades;

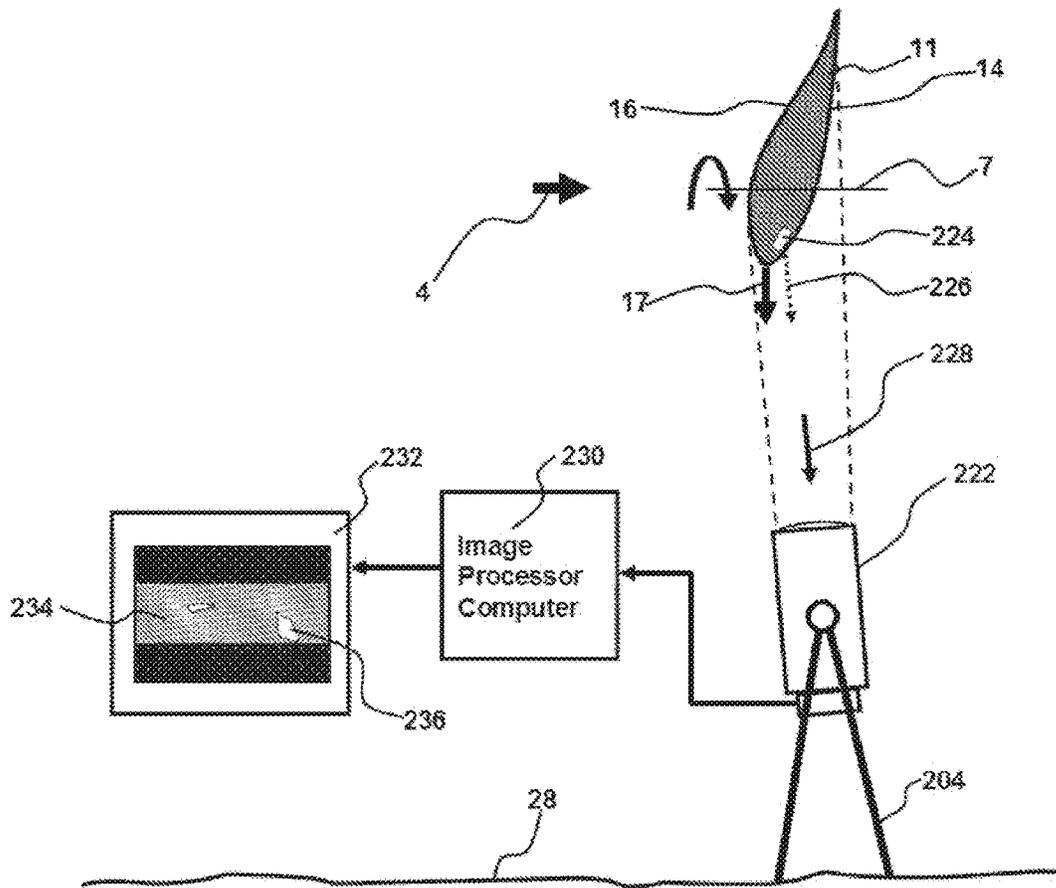
Fig. 5

FIG. 5 shows a basic thermal system including an image processing computer that is suitable for direct viewing and recording blade surfaces in or near a wind turbine site;

FIG. 5 is a schematic diagram showing a thermal camera 222, positioned to receive low level thermal radiation 228 from the blade 11 due to thermoelastic emission from the stresses acting on the blade material due to gravitational forces from the blade rotation motion 17.

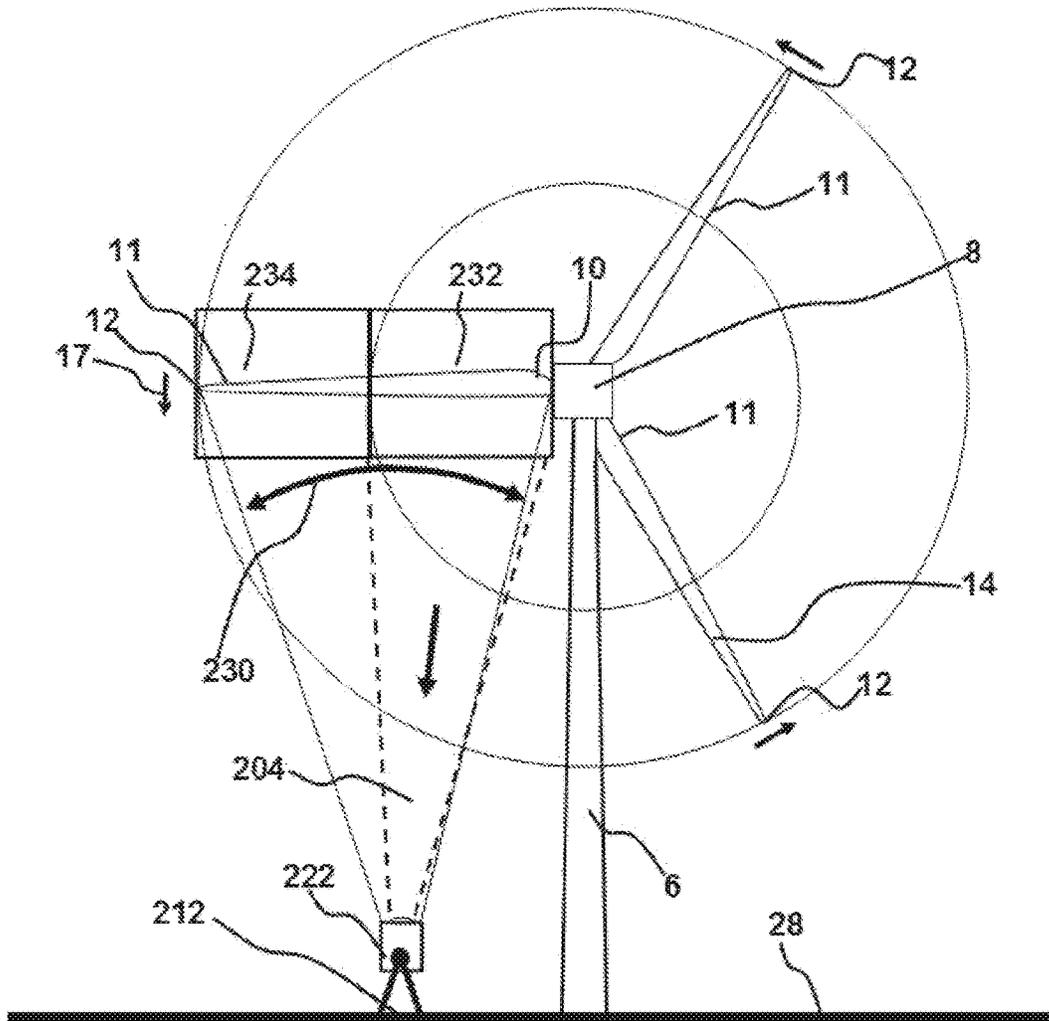
Fig. 6

FIG. 6 is a schematic showing the thermal camera viewing a low pressure, or suction side of a blade in the horizontal position;

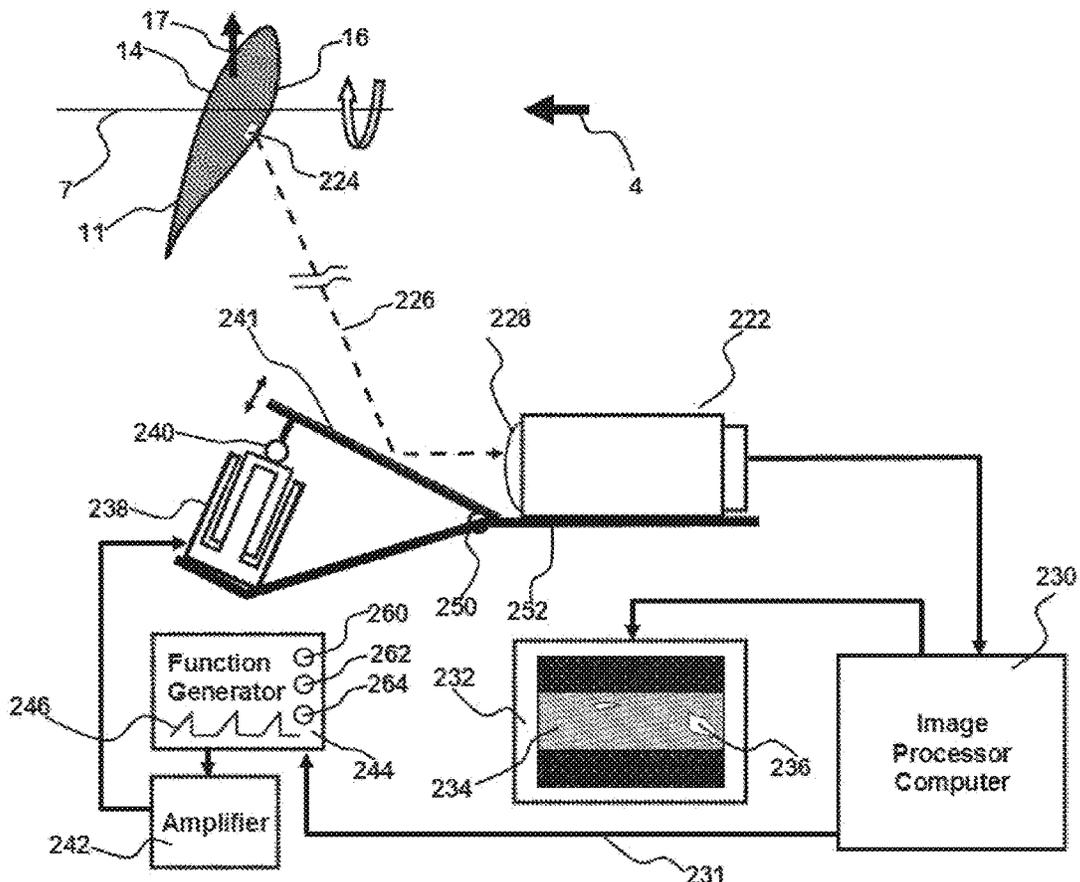
Fig. 8

FIG. 8 is a schematic diagram of a manually controlled moving mirror assembly mounted in front of the thermal camera to stabilize, or derotate, thermal images of a rotating turbine blade and suitable for use when the blade is in approximately a horizontal orientation;

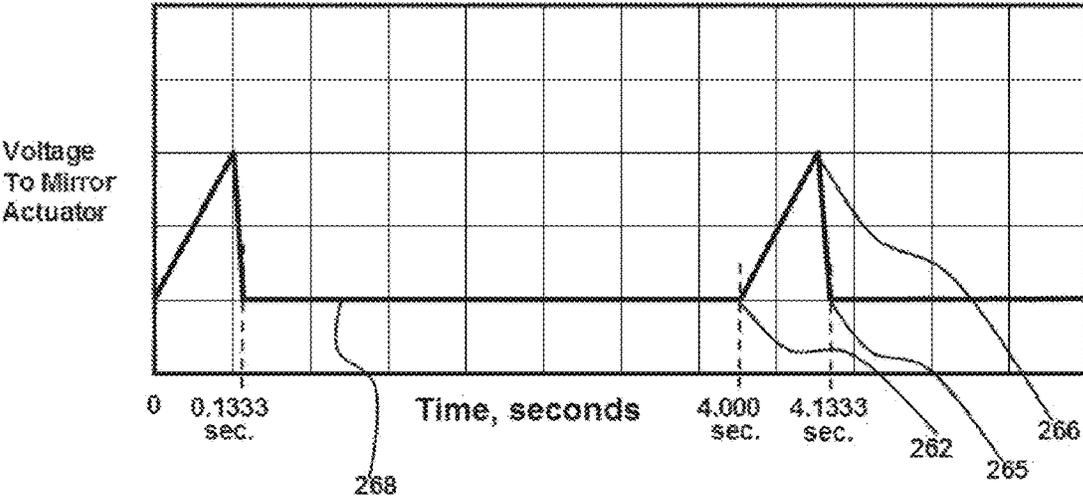
Fig. 10

FIG. 10 shows the timing of the ramp voltage waveform used to drive the linear motor to drive the hinged plate supporting the thermal camera to track one blade only turning with a period of four seconds;

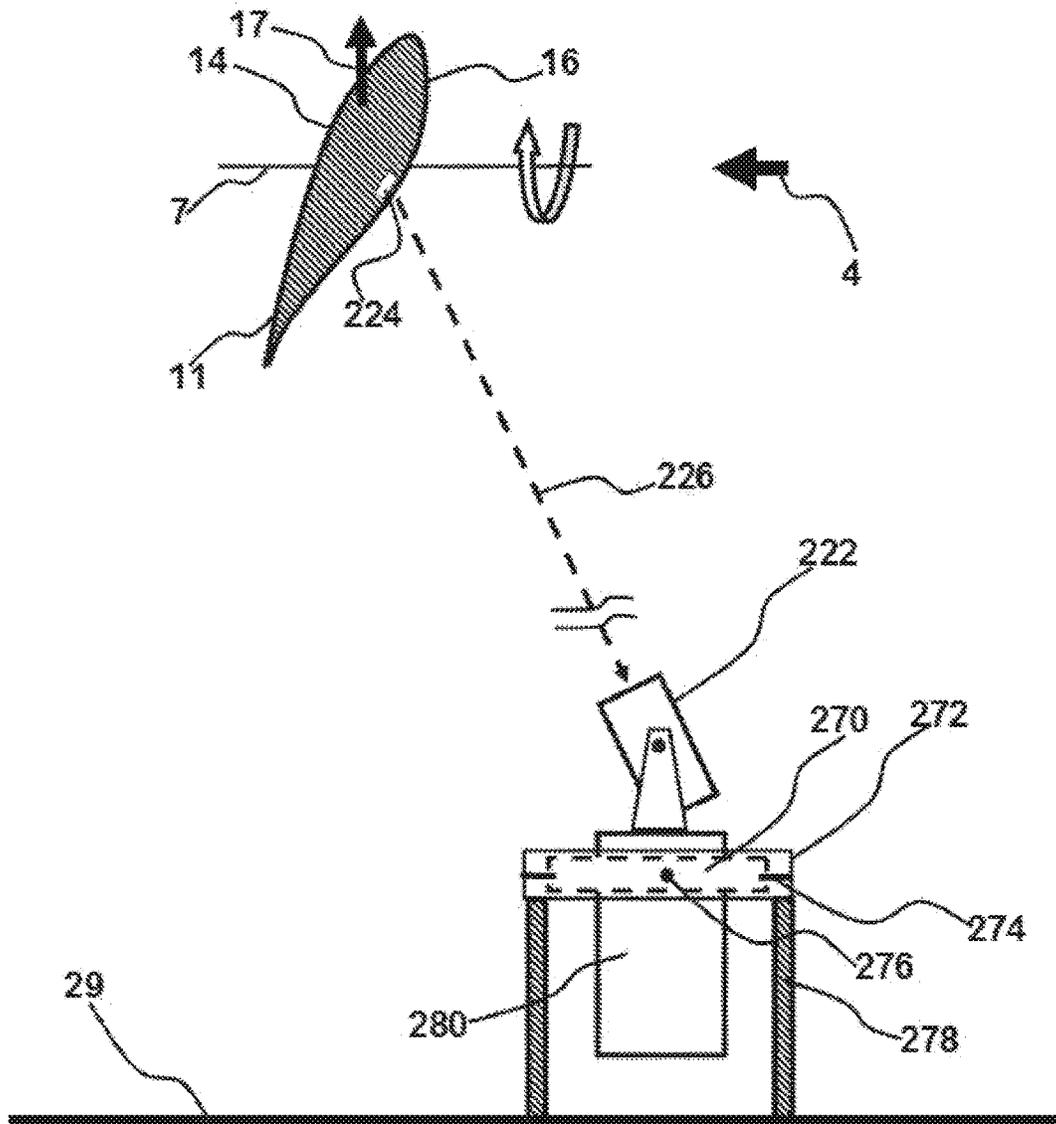
Fig. 11

FIG. 11 is a schematic diagram of a gimbal mounted thermal camera for testing off shore wind turbine blades from a boat or ship;

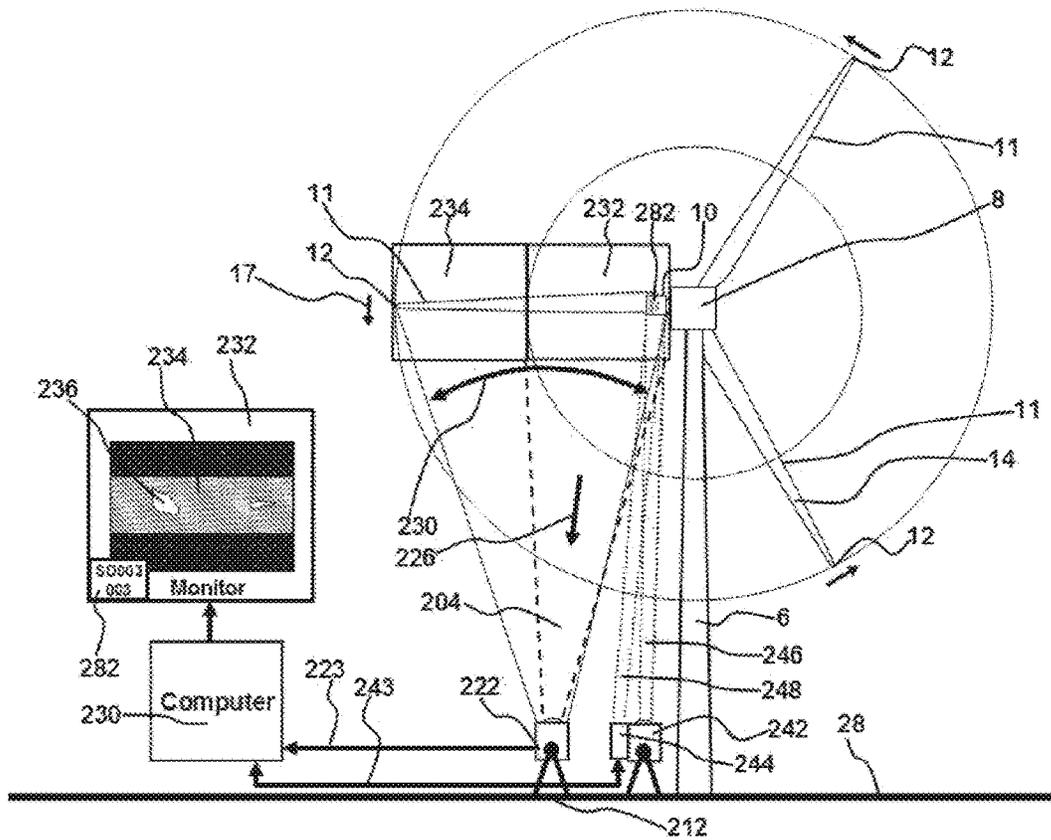
Fig. 12

FIG. 12 is a schematic diagram of a thermal camera testing a blade with a visible light camera and light source to image the serial number of the blade and showing the image of the serial number presented with the test images of the blade;

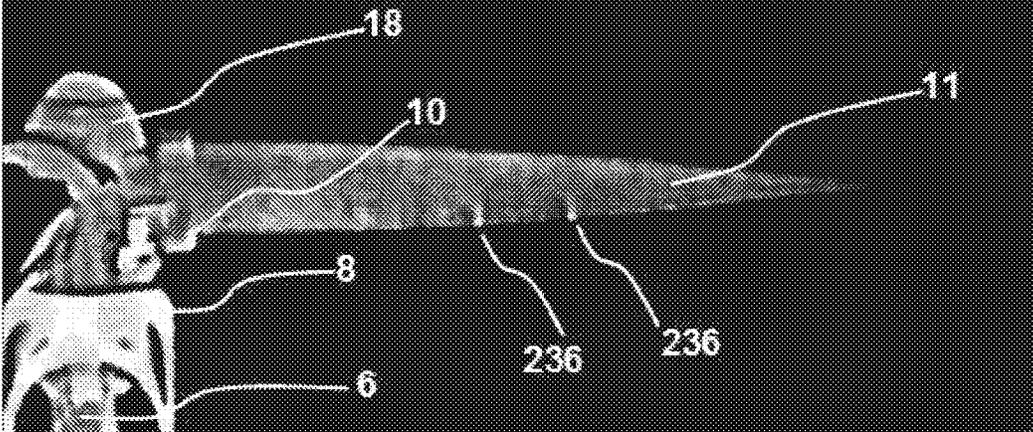
Fig. 13

FIG. 13 includes two images of a wind turbine blade exhibiting defect indications following inspection according to embodiments of the present invention;

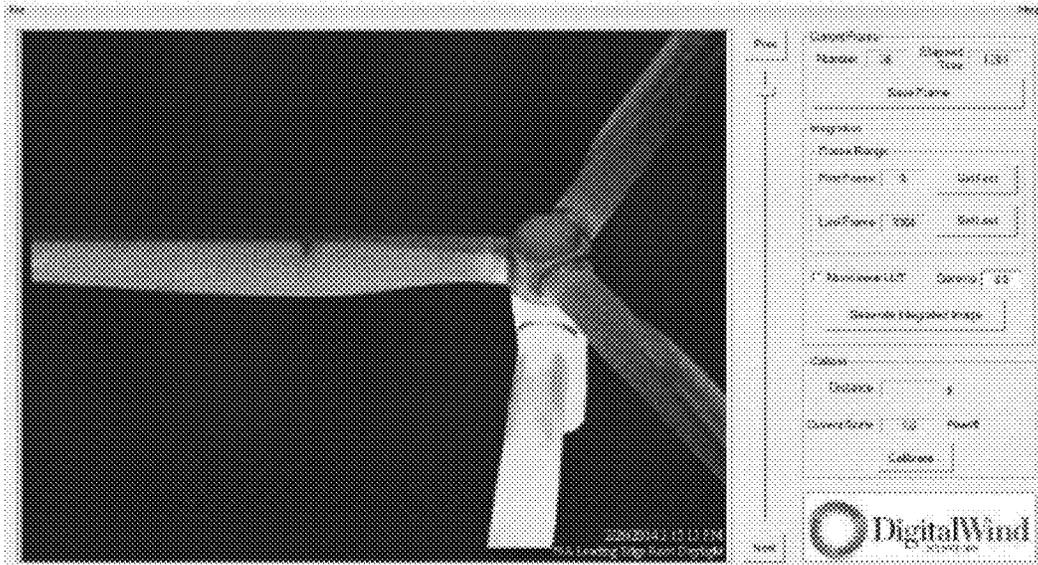
Fig. 14

FIG. 14 is a screenshot of a display image generated by the image processing computer showing a thermal image of the high pressure side of an operating wind turbine rotator with a video frame selected with the blade positioned horizontally blade showing a dark defect during nighttime;

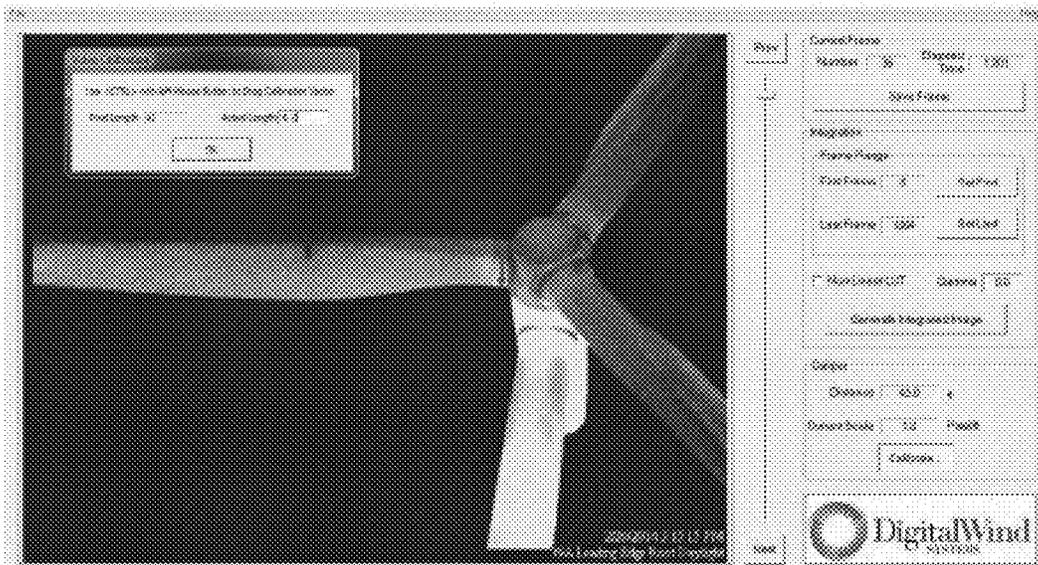
Fig. 15

FIG. 15 is a screenshot of a display image generated by the image processing computer showing the use of a caliper overlay function to mark on the digital image the width or diameter of the cylindrical root end of a blade;

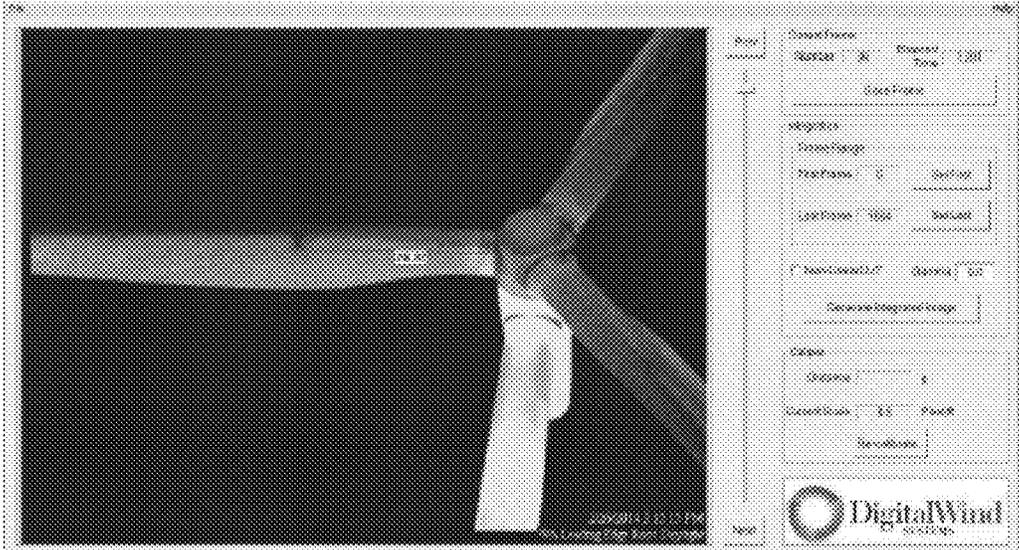
Fig. 16

FIG. 16 is a screenshot of a display image generated by the image processing computer showing the use of the caliper overlay function to determine a distance between the blade root end and the black indication of a defect in a wind turbine blade;

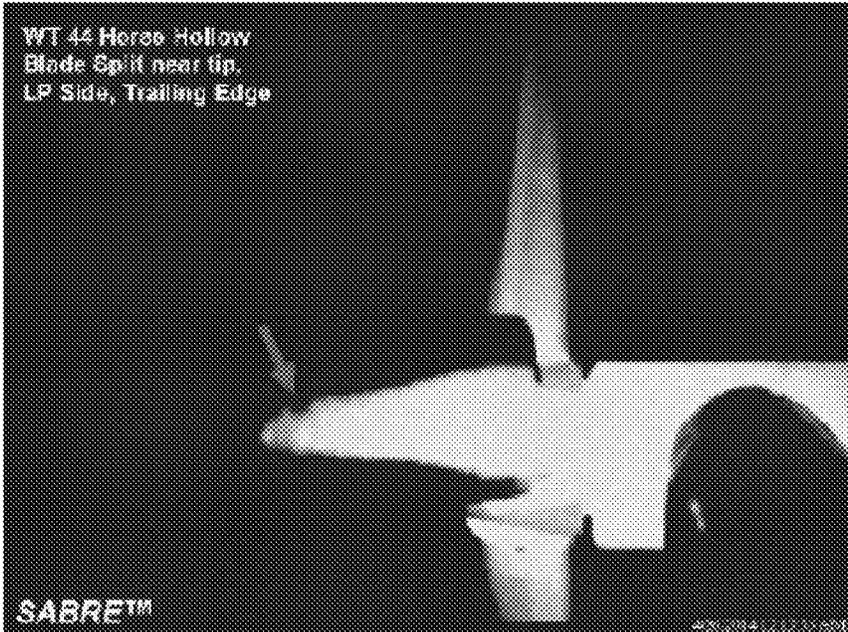
Fig. 17

FIG. 17 is an infrared image showing a flaw in a wind turbine blade near the tip of the blade;

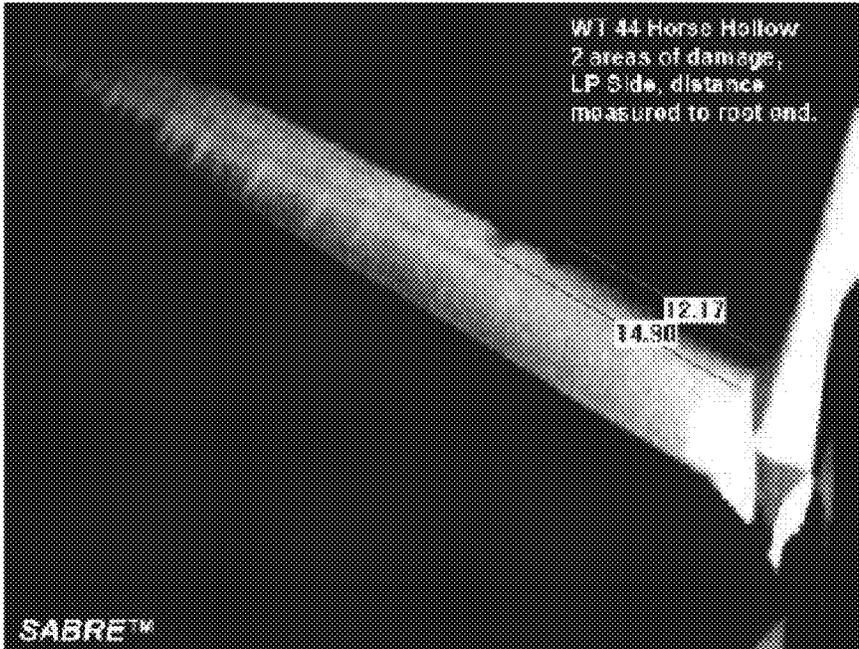
Fig. 18

FIG. 18 is an infrared image showing the caliper overlay function being used to measure the location of two areas of damage on a wind turbine blade with respect to the blade root end; and

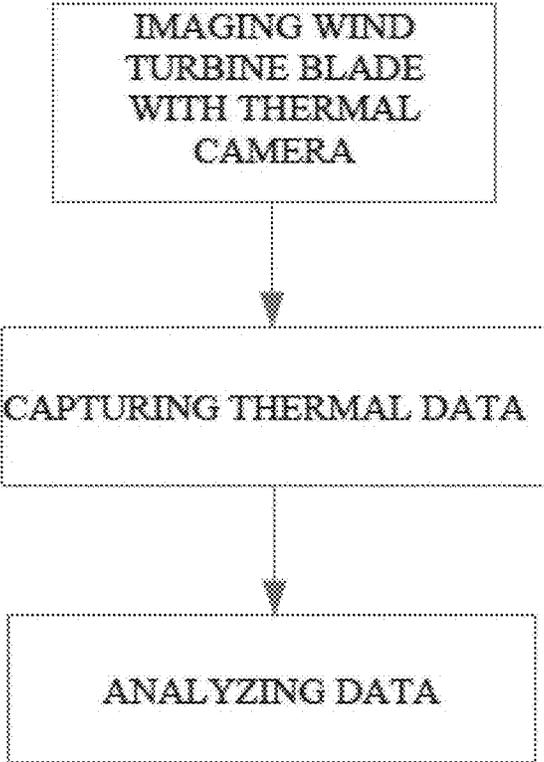
Fig. 19

FIG. 19 is a flowchart depicting a method according to a preferred embodiment of the invention.
