(54) **DEEP TRAILING EDGE REPAIR**

A method for repairing a blade tip of a turbine blade based on welding below and above a designated depth recommended for repair of turbine blades. A damaged portion of the turbine blade is inspected to identify a standard cut portion and an angled cut portion. The standard cut portion is damaged above a standard cut line and the angled cut portion is damaged below the standard cut line. The damaged portion of the turbine blade is removed. The standard cut portion is removed using a first removal process and the angled cut portion is removed using a second removal process. The angled cut portion is built up with a first weld repair process. The angled cut portion is built up to the standard cut portion. The standard cut portion and the angled cut portion are built up with a second weld repair process.

The present invention generally relates to repairing deep damage on the trailing edge of turbine blades. More specifically, the present invention relates to welding below and above a designated depth recommended for repair of turbine blades.

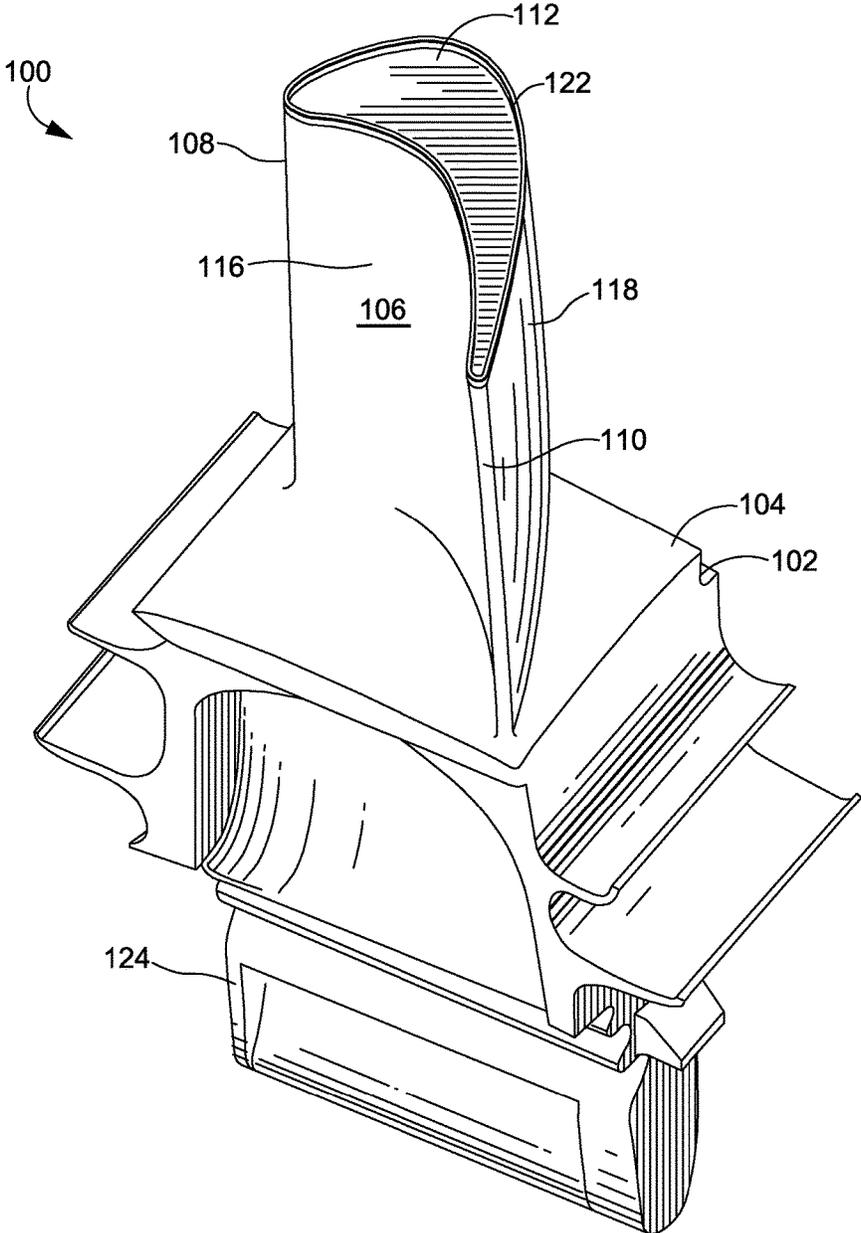
FIG. 1 is a perspective view of a turbine blade in accordance with an embodiment of the present invention;

Referring initially to FIG. 1, a gas turbine blade 100 includes a platform portion 102 having a generally planar gas path surface 104 and an airfoil 106 extending radially outward from the platform. The airfoil 106 includes a leading edge 108, a trailing edge 110, and a tip plate 112. In embodiments, the turbine blade 100 may further include a plurality of cooling passages 120 forming one or more ribs 114, as best shown in FIG. 2, and a squealer tip 122 extending above the tip plate 112. The airfoil 104 further includes a first sidewall 116 and a second sidewall 118. The first sidewall 116 is concave and defines a pressure side and the second sidewall 118 is convex and defines a suction side. The first sidewall 116 and second sidewall 118 extend longitudinally and radially outward from a root 124 to the tip plate 112. The tip plate 112 defines a radially outer boundary of airfoil 106. The tip plate 112 extends between the leading edge 108 and the trailing edge 110. The one or more ribs 114 of the plurality of cooling passages extend from the interior of the blade between the leading edge and the trailing edge.

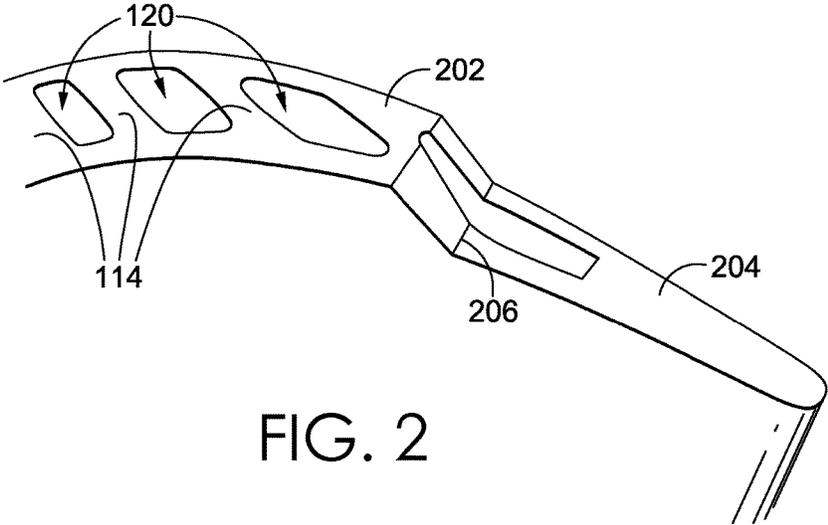
FIG. 2 is a perspective view of a turbine blade in repair, in accordance with an embodiment of the present invention;

With continued reference to FIG. 2, the damaged portion of the blade is removed. The damaged portion may include the squealer tip 122 and the tip plate 112 of the blade tip. The damaged portion may include a standard cut portion and an angled cut portion. The standard cut portion is removed with a first process and the angled cut portion is removed with a second process. The standard cut portion may be cut at or above the standard cut level 202. The standard cut portion may be cut using a grinding or Electrical Discharge Machining process (EDM) process, or similar process, to cut the damaged portion at the standard cut level 202. The angled cut process may use a machining process or similar variation thereof to cut the angled cut portion. The machining process may be a wire EDM to create a deep angled cut 204 to an angle cut level 206 made extending away from the lead edge towards the trailing edge. The angled cut 204 may be a specific angle from the vertical. This angled cut 204 may vary depending on the location of the deep damage of at the trailing edge. Advantageously the angle cut 204 is at least 90 degrees calculating from the trailing edge to the leading edge. The angled cut 204 may also be a curve from the vertical extending toward the trailing edge.

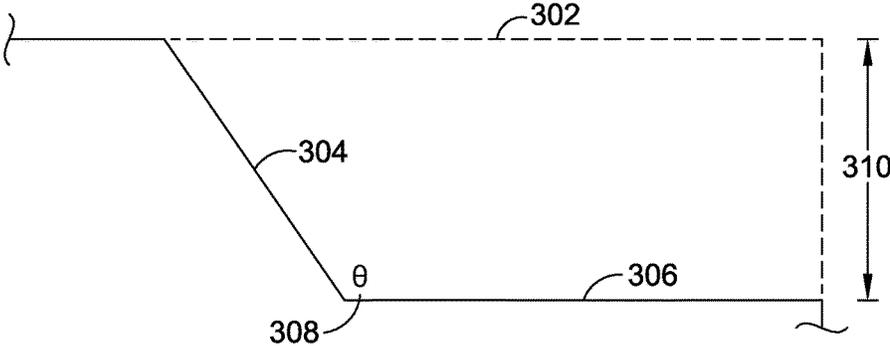
FIG. 3 is a schematic drawing of a turbine blade in repair, in accordance with an embodiment of the present invention;

With reference to FIG. 3, FIG. 3 illustrates the standard cut level 302 where the standard cut portion is removed. Upon removing the standard cut portion, the angled cut portion is removed with angled cut 304 down to the angled cut level 306. The angled cut 304 may create an angle 308 extending from the angled cut 304 down to the angle cut

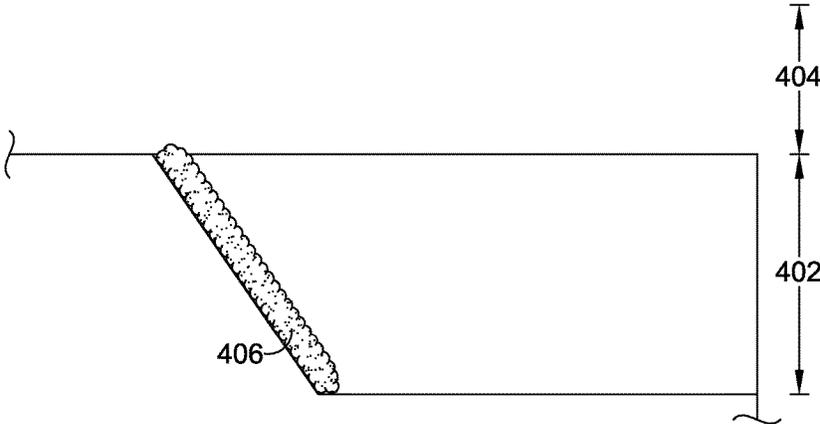
FIG. 4 is a perspective view of a turbine blade in repair, in accordance with an embodiment of the present invention;

With reference to FIG. 4, initially the damaged portion of the tip blade is weld repaired. The weld repair may perform an angled cut portion repair **402** and a standard cut portion and angle cut repair **404**. The angled cut repair **402** may be a laser cladding process or by weld deposition process. In particular, the laser cladding that builds up cladding above the angled cut to build up the angled cut portion to the standard cut level. A composition **406** is provided initially in the form of a powder and is applied (e.g., as a layer) to the angled cut portion by fusing the powder to the angled cut portion. The weld deposition process may include providing the composition in a convenient physical form to feed it into a welding torch on the surface of the angled cut portion. Advantageously, the initial welding process may include the following parameters found to limit the amount of cracking and over deposit of filler material during the weld process. Filler material may include Merl 72, Haynes 230, Haynes 282 or other materials of similar composition. The filler material is close in composition to the base material of the blade. The base material may be, for example, a nickel-based super alloy. The laser or manual welding process may require power between 30 W and 12000 W and preferably 300 W to 9000 W at a travel rate 0.3 inches per minute to 500 inches per minute and a shield gas of CO<sub>2</sub> or Ar or any combination thereof. If there are internal cooling passages in the turbine blade the openings are reopened as necessary by a technique such as EDM.

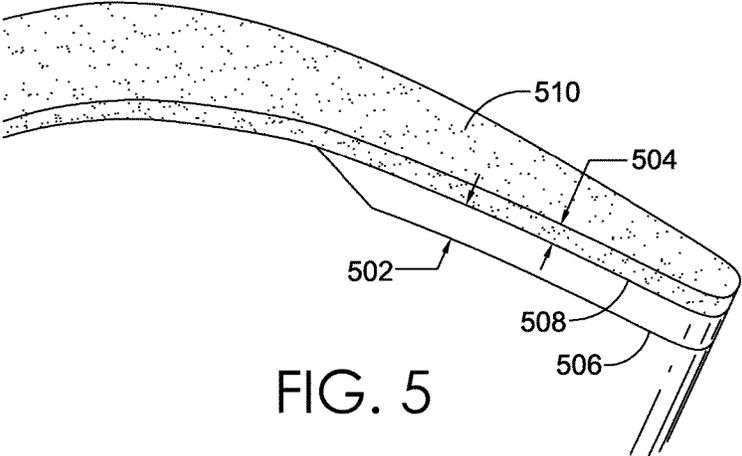
FIG. 5 is a perspective view of a turbine blade in repair, in accordance with an embodiment of the present invention; and

With reference to FIG. 5, a standard cut repair **504** process may be used to repair the blade above both the standard cut level **508** and the angled cut level **506** in combination, upon completion of the angled cut repair process **502**. After the angled cut repair **502** process, the repaired portion above the angled cut level **506** may be machined to provide contouring. Next, the standard cut repair is performed. The standard cut repair **504** process may include known methods for repairing blade above the standard cut line. For example, laser cladding may be used to create a build up **510** above the base in order to repair to the tip of the blade. Laser cladding may be performed using a second material as described hereinabove.
