(10) **Patent No.:** **US 8,108,979 B2**
(45) **Date of Patent:** **Feb. 7, 2012**

(54) **USING A STIFFENER TO REPAIR A PART FOR AN AIRCRAFT ENGINE**

A method of repairing a part, which has a first side, a second side opposite of the first side, and an aperture that makes the part susceptible to cracking, includes the steps of forming a slot in the first side of the part near the aperture, inserting a stiffener into the slot, and attaching at least one repair ply onto the first side of the part to cover the stiffener.

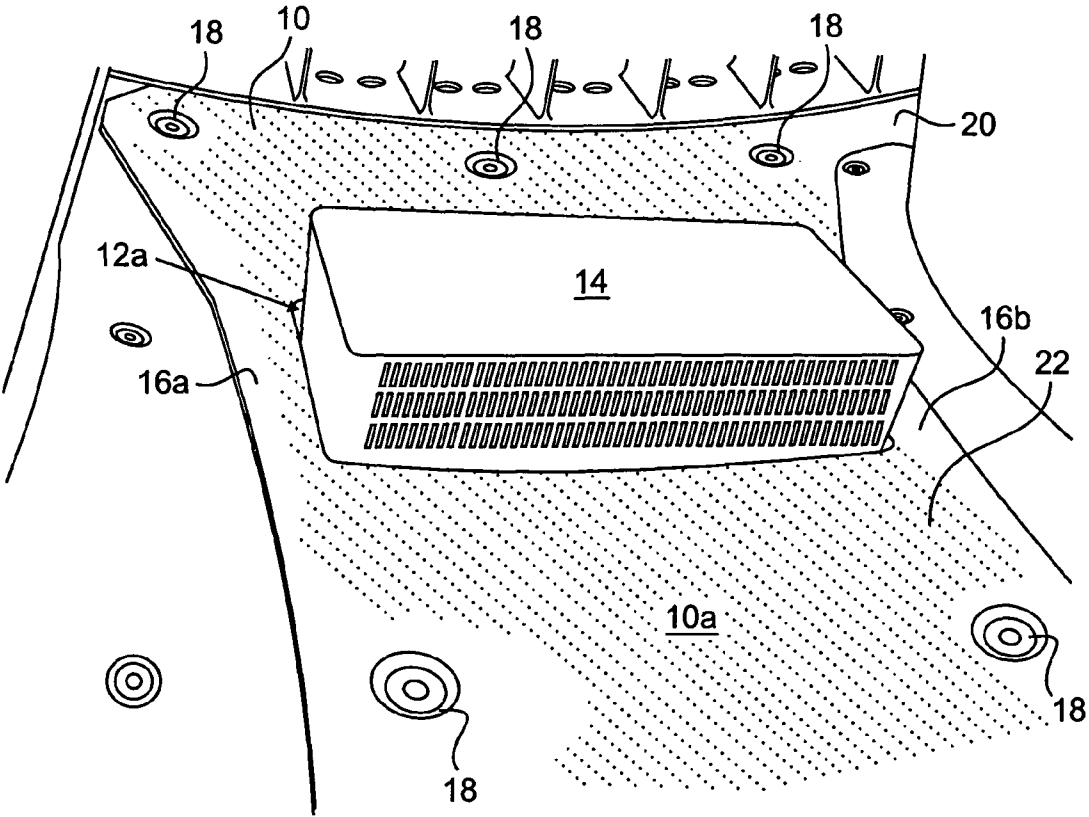
FIG. 1 is a perspective view of an acoustic liner of a gas turbine engine having a large cut-out or aperture for receiving an air-oil cooler.

FIG. 1 is a perspective view of acoustic liner 10 which includes an acoustic side 10a (also known as an airflow side)

and a non-acoustic side 10b (shown in FIG. 2). Acoustic liner 10 is typically a composite. In an exemplary embodiment, acoustic liner 10 may include an aluminum core, and acoustic side 10a may include a perforated skin, which may commonly be formed from fiberglass. Acoustic liner 10 includes aperture 12, which is a large cut-out configured to receive air-oil cooler 14. In a gas turbine engine, acoustic liner 10 is typically one of a plurality of acoustic liners or panels that are inserted between the struts of the intermediate case (not shown) and bolted to an inner or outer case (also not shown). (These component cases are part of an intermediate case assembly.) The other acoustic liners used in conjunction with acoustic liner 10, however, do not usually include aperture 12 since typically only a single air-oil cooler is used in the intermediate case assembly.

Due to the large size of aperture 12, side portions 16a and 16b of liner 10, which are located on each side of aperture 12, are thin and structurally weakened by aperture 12. As such, acoustic liner 10 may be prone to cracking in portions 16a and 16b. Typically, cracking occurs similarly or uniformly across portions 16a and 16b. As shown in FIG. 1, acoustic liner 10 includes a plurality of bolt holes 18 at both top portion 20 of liner 10 and bottom portion 22 of liner 10. Bolt holes 18 are used to secure liner 10 to the inner or outer case. However, if a crack forms in side portions 16a and 16b, such that liner 10 is essentially in two pieces, liner 10 may not remain static. In that case, bending moments of liner 10 may result in cracking of the inner or outer case to which liner 10 is attached. To avoid damage to the case, it may be necessary to repair or replace a cracked acoustic liner. Because it is costly to replace liner 10, it is preferable to repair liner 10. A repair process is described herein in which the repaired acoustic liner is structurally stronger, as compared to the original design of liner 10.

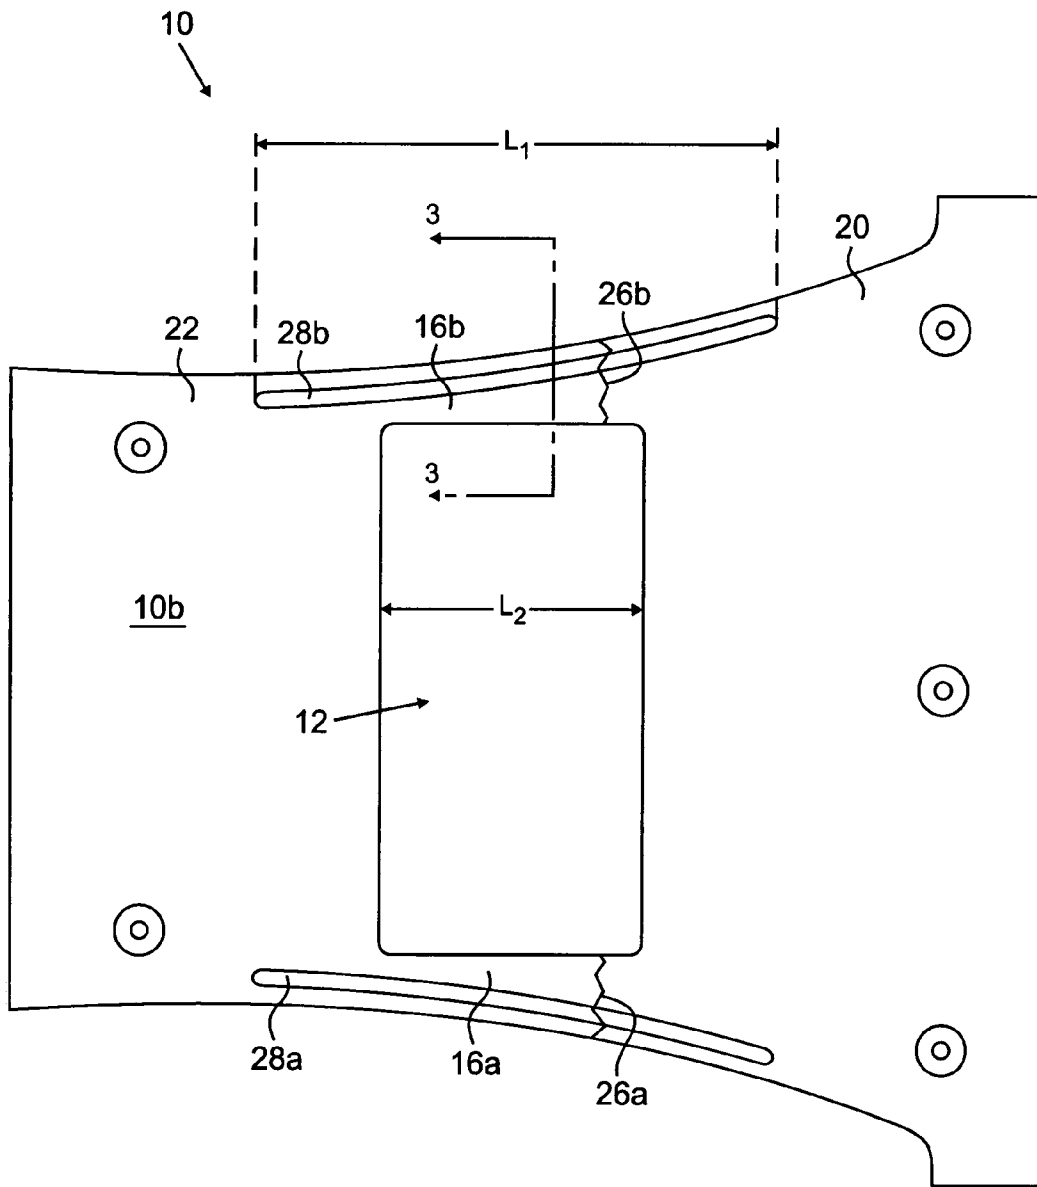
FIG. 2 is a back-view of the acoustic liner of FIG. 1 showing a first step in a repair process when a crack forms in the acoustic liner.

FIG. 2 is a back-view of acoustic liner 10 of FIG. 1, which may be referred to as non-acoustic side 10b of liner 10. (Air-oil cooler 14 has been removed for clarity.) In contrast to acoustic side 10a, non-acoustic side 10b is typically not perforated, but side 10b may still commonly include a fiberglass skin. As shown in FIG. 2, side portions 16a and 16b of liner 10 include cracks 26a and 26b.

Slots 28a and 28b may then be formed in any number of ways, including, but not limited to, routing or milling. As detailed below in reference to FIG. 3, slots 28a and 28b are formed by removing a portion of the skin of non-acoustic side 10b and the aluminum core. The perforated skin of acoustic side 10a is not removed from slots 28a and 28b. After slots 28a and 28b are formed, liner 10 is removed from the tool and cleaned to remove any debris residing in or around slots 28a and 28b.

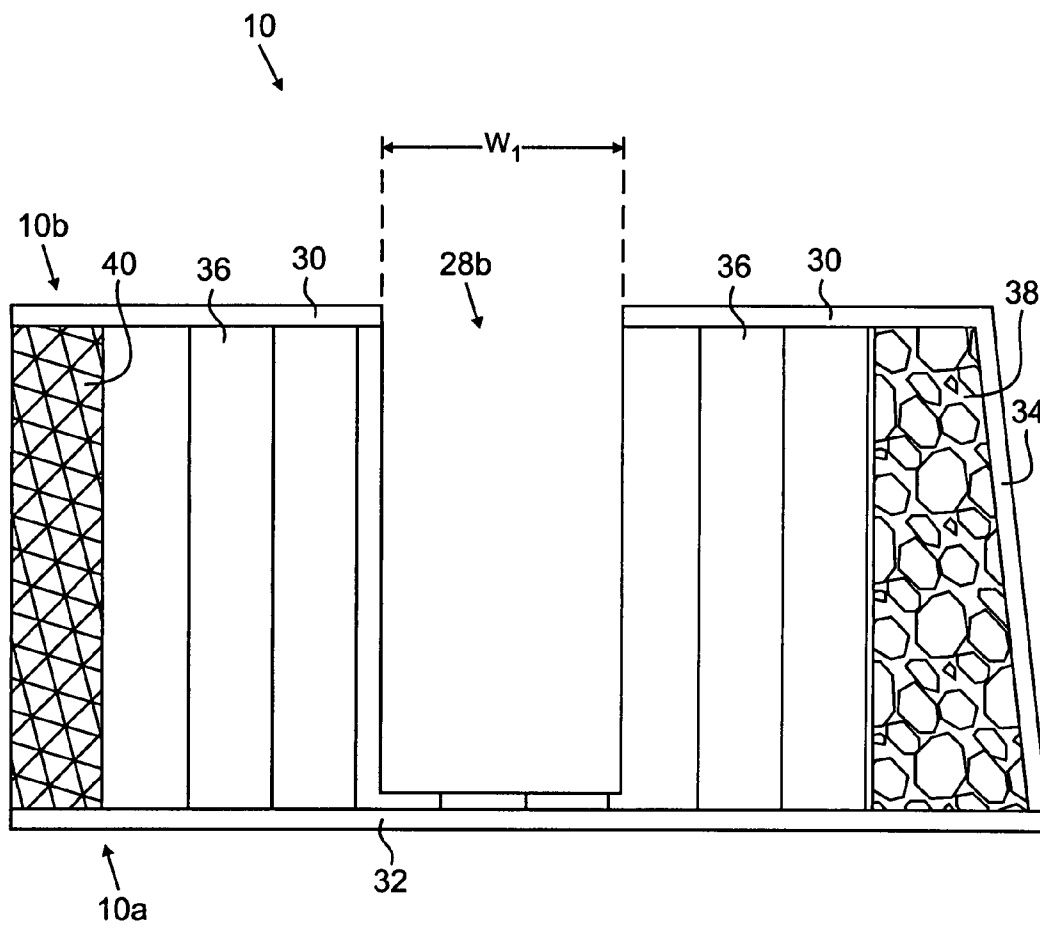
FIG. 3 is a cross-sectional view of a portion of the acoustic liner of FIG. 2 illustrating a slot formed in the acoustic liner (a first step in the repair) for receiving a stiffener.

FIG. 3 is a cross-sectional view of side portion 16b of liner 10 taken through section 3-3 of FIG. 2 and rotated 90 degrees

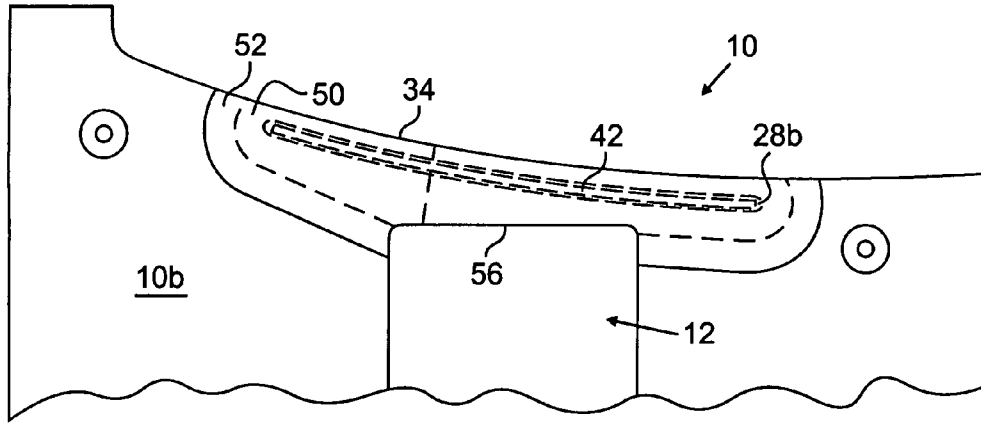
FIG. 7 is a back-view of the acoustic liner following the repair steps illustrated in FIGS. 4-6.

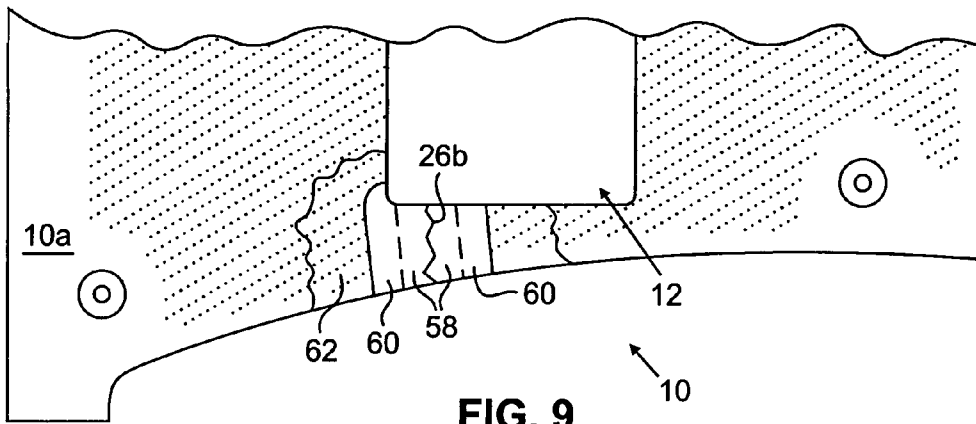
FIG. 9 is a front-view of the acoustic liner following the step illustrated in FIG. 8.

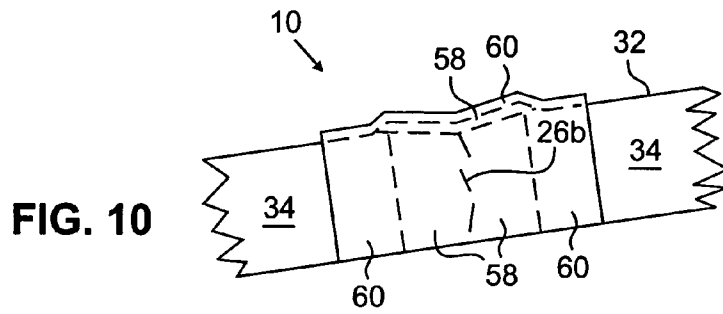
FIG. 10 is a side-view of a portion of the acoustic liner of FIG. 9.

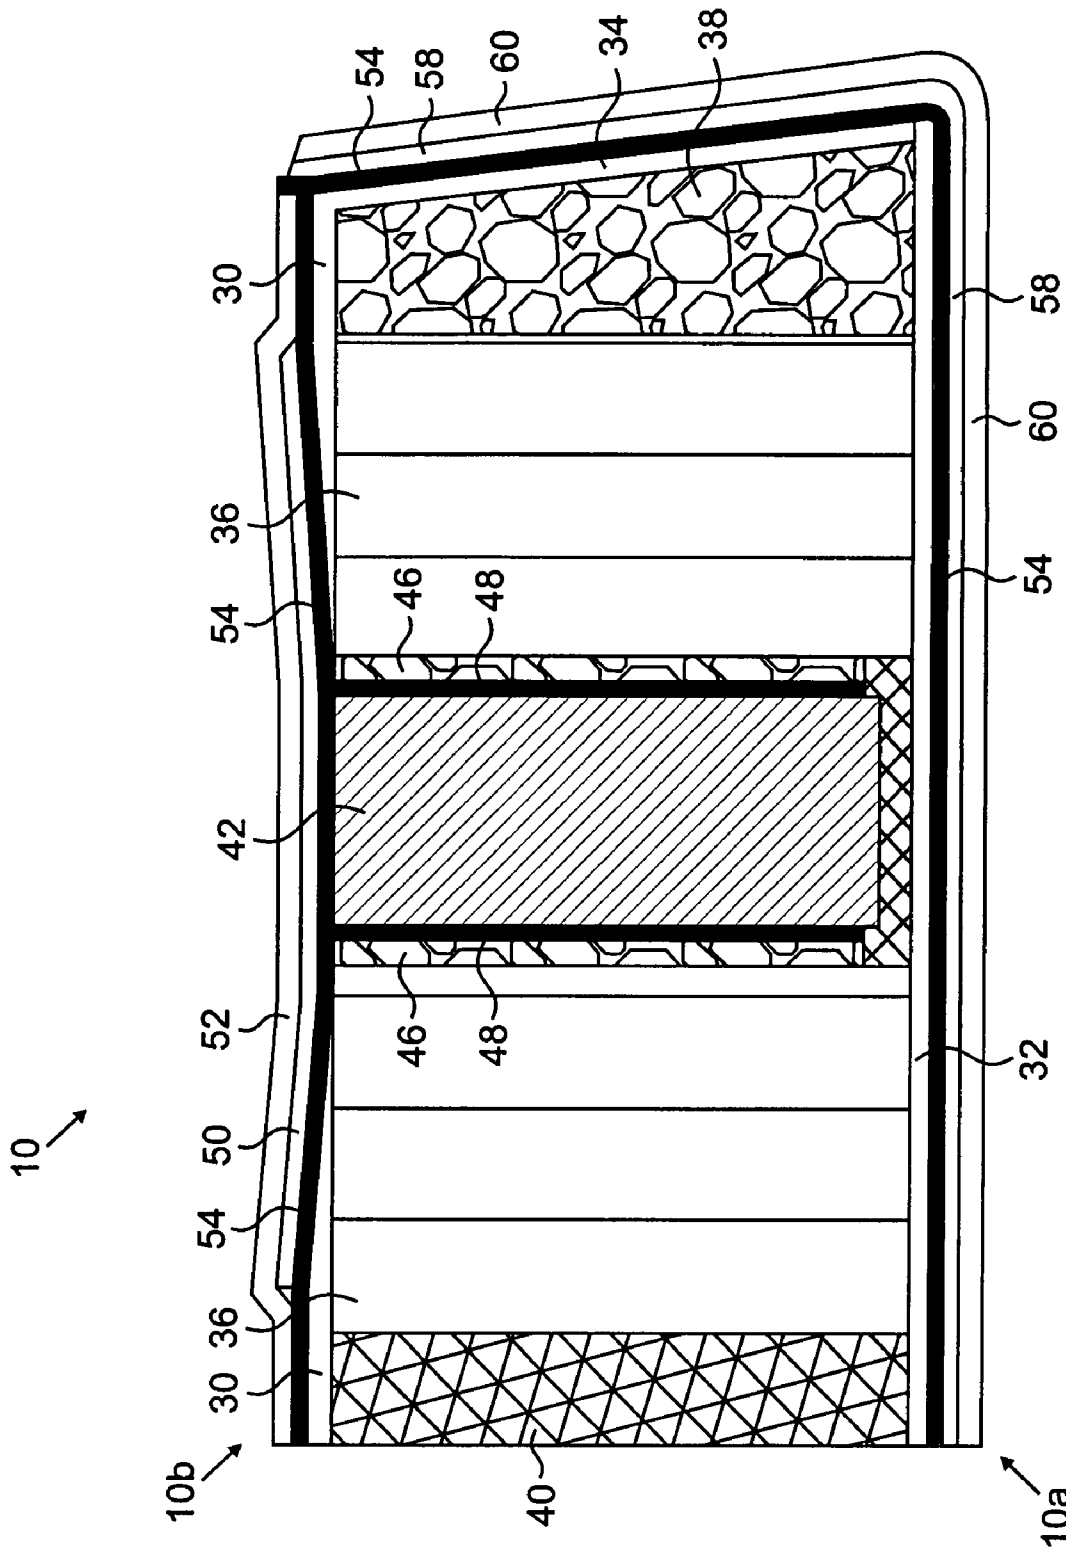
FIG. 8 is a cross-sectional view of the portion of the acoustic liner shown in FIGS. 2 and 4-6 illustrating a final step in the repair process.

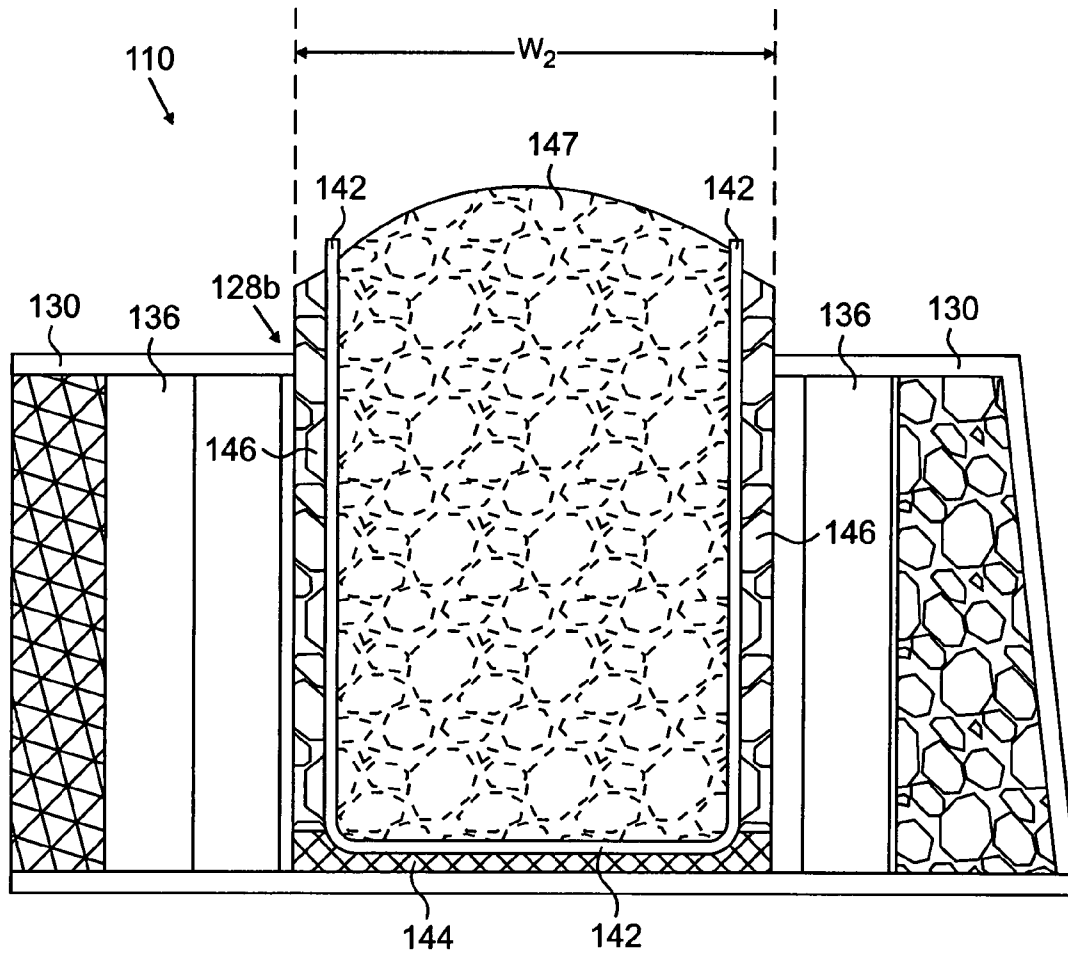
FIG. 11 is a cross-sectional view illustrating another embodiment of the present invention.
