US011982207B2

(54) **TIP REPAIR OF A TURBINE COMPONENT USING A COMPOSITE TIP BORON BASE PRE-SINTERED PREFORM**

(71) Applicant: **Siemens Energy, Inc.**, Orlando, FL (US)

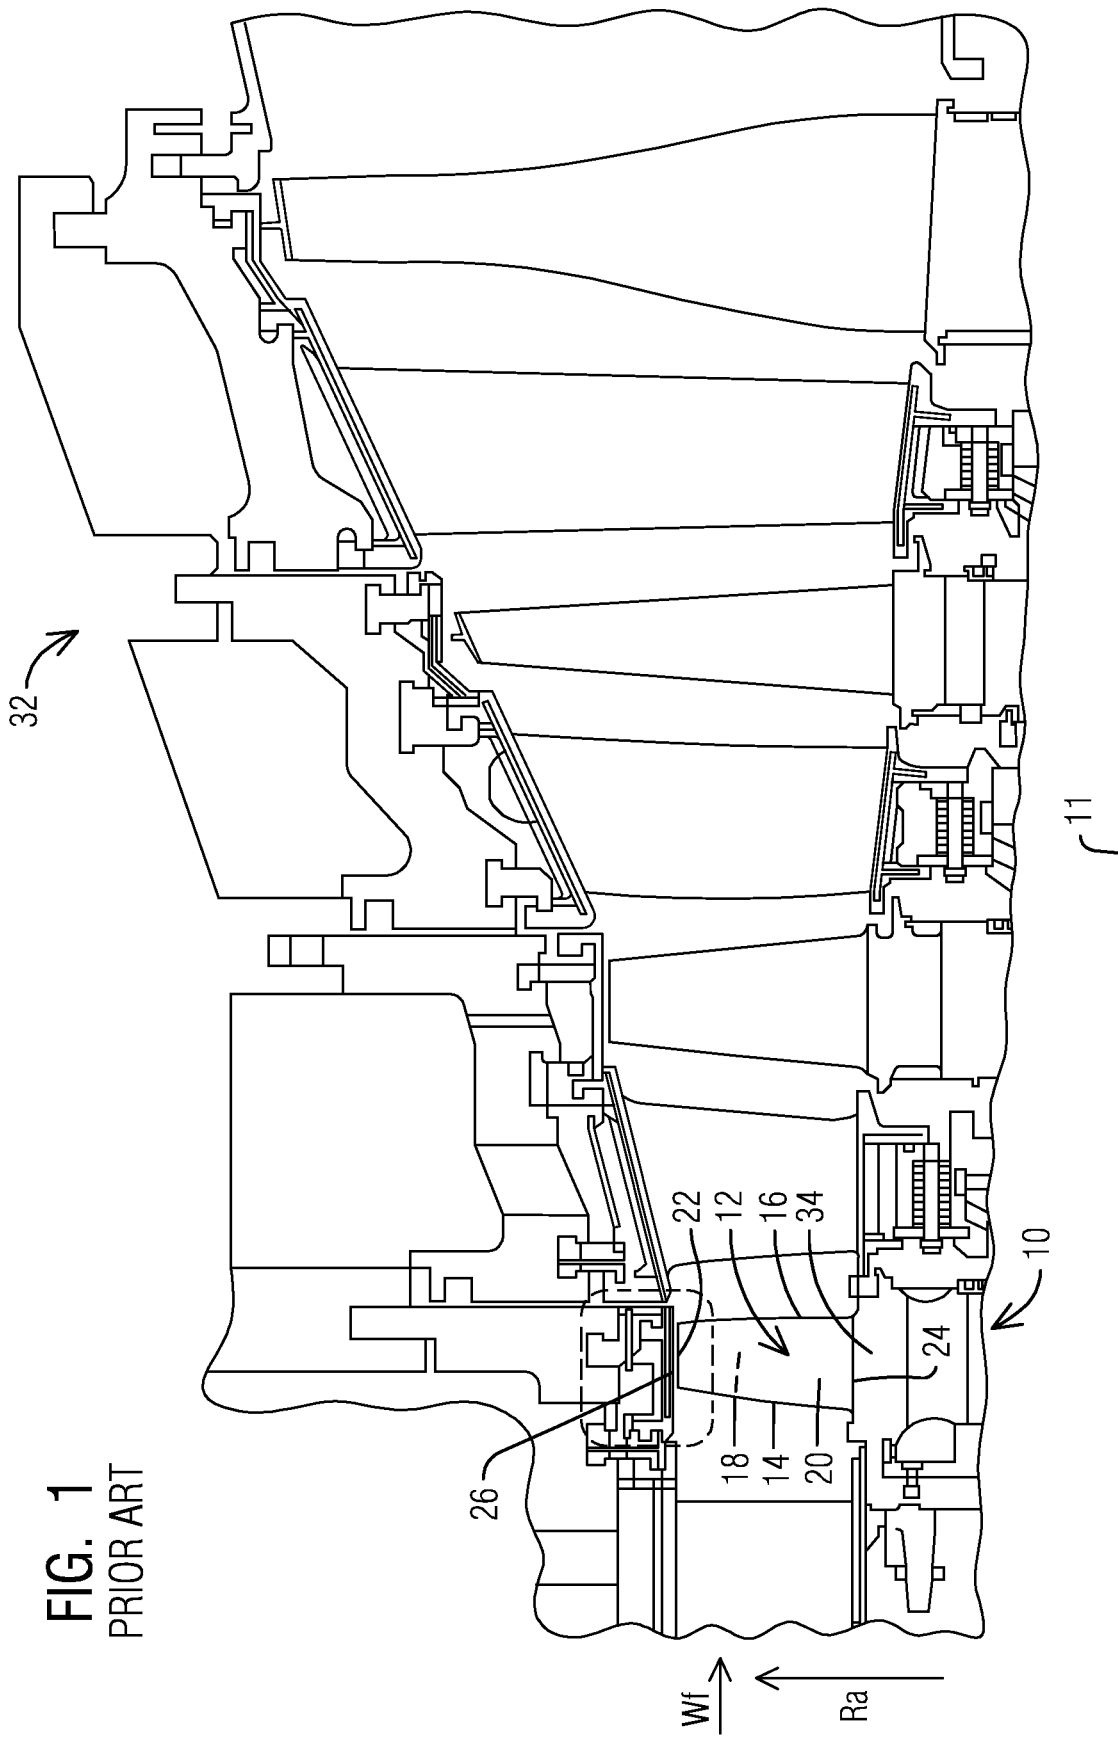
FIG. 1
PRIOR ART

FIG. 1 is an axial cross-sectional view of a gas turbine engine with a row of turbine blades wherein embodiments of the present invention may be incorporated,

Referring to FIG. 1, a portion of a turbine engine 32 is shown. A centerline 11 is shown to represent an axial center of the turbine engine 32. A radial direction Ra is shown in a direction that is radially outward. Further, a working fluid Wf direction is shown. A turbine blade 10 is formed from a root portion 34 coupled to a rotor disc (not shown) and an elongated portion forming an airfoil 12 that extends outwardly from a platform 24 coupled to the root portion 34. At an opposite end of the turbine blade 10, the blade 10 is composed of a tip 22 opposite the root section 34, a leading edge 14, and a trailing edge 16. Connecting the leading edge 14 and the trailing edge 16 is radially extending a pressure side 18 and a suction side 20 of the airfoil 12. Along the tip end 22 of the turbine blade 10 is a tip feature in position to reduce the size of the gap between ring segments 26 and blades 10 in a gas path of a turbine to prevent tip flow leakage, which reduces the amount of torque generated by the turbine blades 10. The tip feature is referred to as a squealer or squealer tip and is incorporated onto the tips of blades to help reduce aerodynamic losses between turbine stages. These features are designed to minimize the leakage between the blade tip 22 and the ring segment 26.

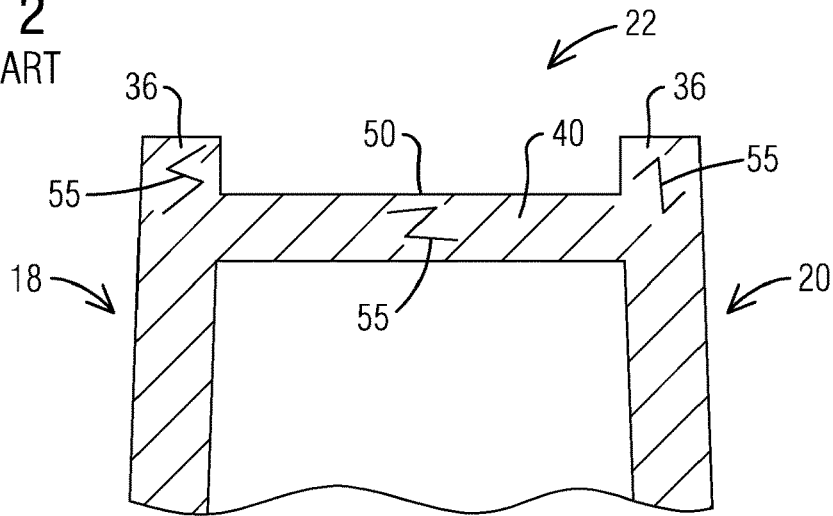
FIG. 2
PRIOR ART

FIG. 2 is a partial cross-sectional view of a configuration of a tip portion of a turbine component,

FIG. 2 represents a conventional squealer tip 36 location where spaced apart tip walls extend directly up from and extending the length of the pressure side 18 and suction side 20 of the blade 10. At the tip end 22 lying in between the squealer tip walls 36 lies a tip shelf 40 having a tip shelf surface 50.

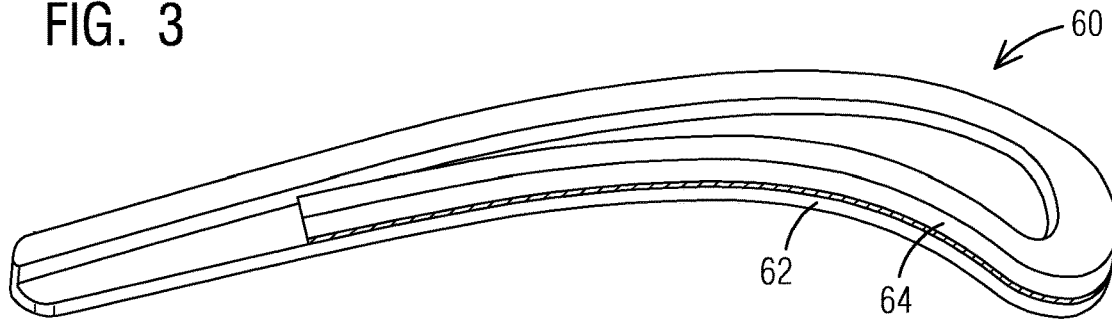
FIG. 3 is a perspective view of a PSP composite tip coupon according to an embodiment of the present invention,

FIG. 3 illustrates a composite PSP tip coupon 60 that will be used to repair a turbine component. The composite tip coupon 60 includes a tip shelf (cap) portion 62 and a squealer portion 64. The tip shelf portion 62 comprises a first composition and the squealer portion 64 comprises a second composition. In an embodiment, the first composition and the second composition are different. Each portion of the PSP may comprise a powder mixture comprising braze particles and superalloy particles formed into the tip shelf shape and a squealer tip shape, respectively, and configured to mate to a remaining portion of a turbine component such as a blade airfoil. In an embodiment, a first thickness of the tip shelf portion 62 may be in a range 0.030 in. to 0.050 in. while a second thickness of the squealer portion 64 may be in a range 0.060 in. to 0.140 in. If the blade shelf is very thin, for example 0.040 in., its base thickness may be increased by attaching additional shelf PSP material 62 to the existing shelf portion before attaching the composite coupon.

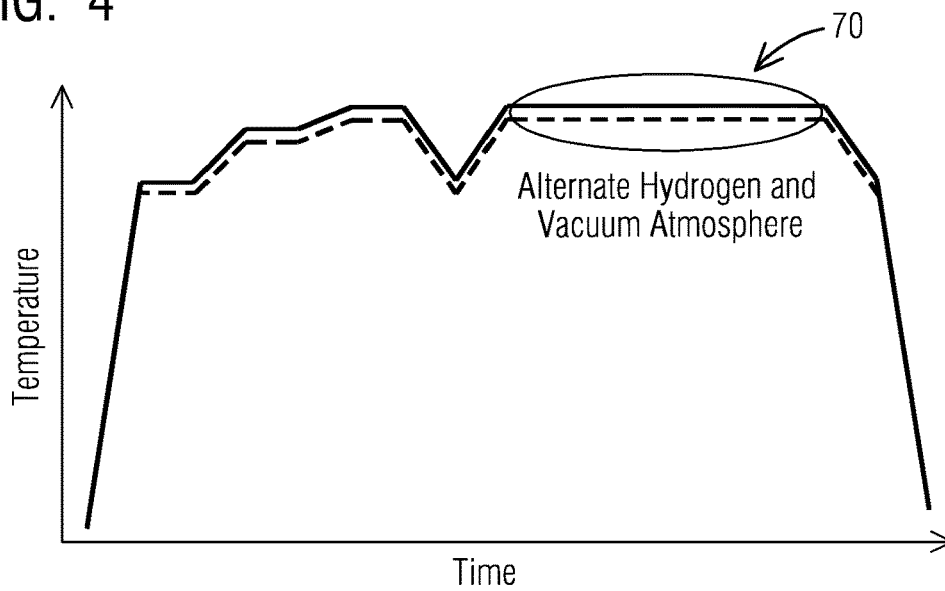
FIG. 4 is a graph depicting an embodiment of a brazing heat treatment cycle, and

Once the PSP tip coupon **60** containing braze material has been applied as desired or necessary, the turbine blade along with the PSP is subjected to a heat treatment (referred to herein as ‘brazing’ or a ‘brazing process’) in order to at least melt the braze material and allow the molten braze material to flow into the defect. In an embodiment, the brazing heat treatment may be a controlled heat process as described in PCT/US2018/020170, Brazing of Superalloy Components with Hydrogen Addition for Boron Capture. The main difference between this heat treatment and other brazing heat treatment processes is that the component, e.g., the turbine blade and the affixed PSP, are subjected to alternating stages within a hydrogen environment (‘hydrogen stage’) and within a vacuum environment (‘vacuum stage’) while heating the braze material and at least a portion of the turbine blade. This alternation process **70** may be seen in the Braze Heat Treatment Chart seen in FIG. 4. Alternating between a hydrogen stage and a vacuum stage helps to eliminate centreline eutectics and improve remelt properties post braze due to deboronization of the low melt portion of the braze mixture. Elimination of centreline eutectics avoids brittle zones in the repair area which tend to crack during service conditions.

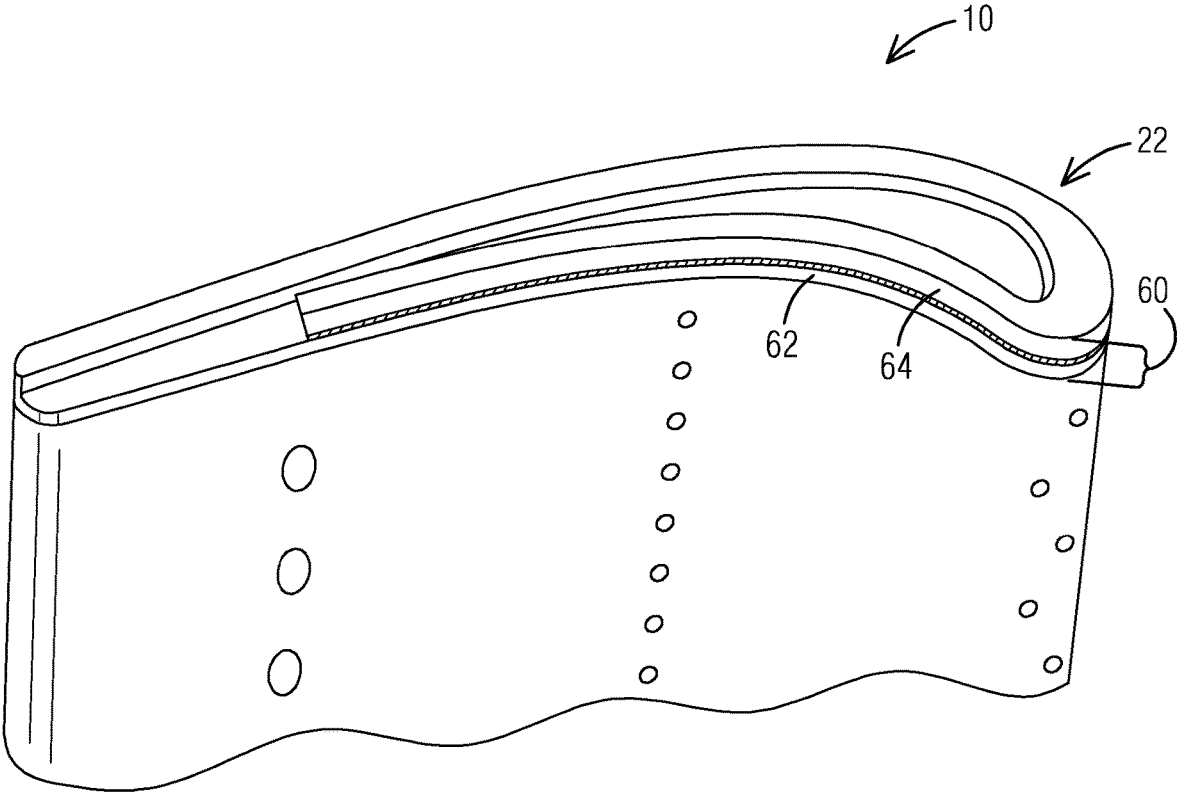
FIG. 5 is a perspective view of a turbine blade repaired utilizing a composite PSP coupon according to an embodiment.

FIG. 5 illustrates a perspective view of a turbine blade **10** repaired utilizing a composite PSP coupon **60**. FIG. 5 shows the tip **22** after the brazing. In certain embodiments, finishing processes such as blending, machining, cooling hole drilling and coating operations may be performed as applicable depending on the desired final blade configuration.
