(54) **LEAK DETECTION IN COMPOSITE STRUCTURES**

A leak through the thickness of a structure is detected from one side of the structure using a leak detection layer. The leak detection layer exhibits visually observable changes when exposed to an air leak.

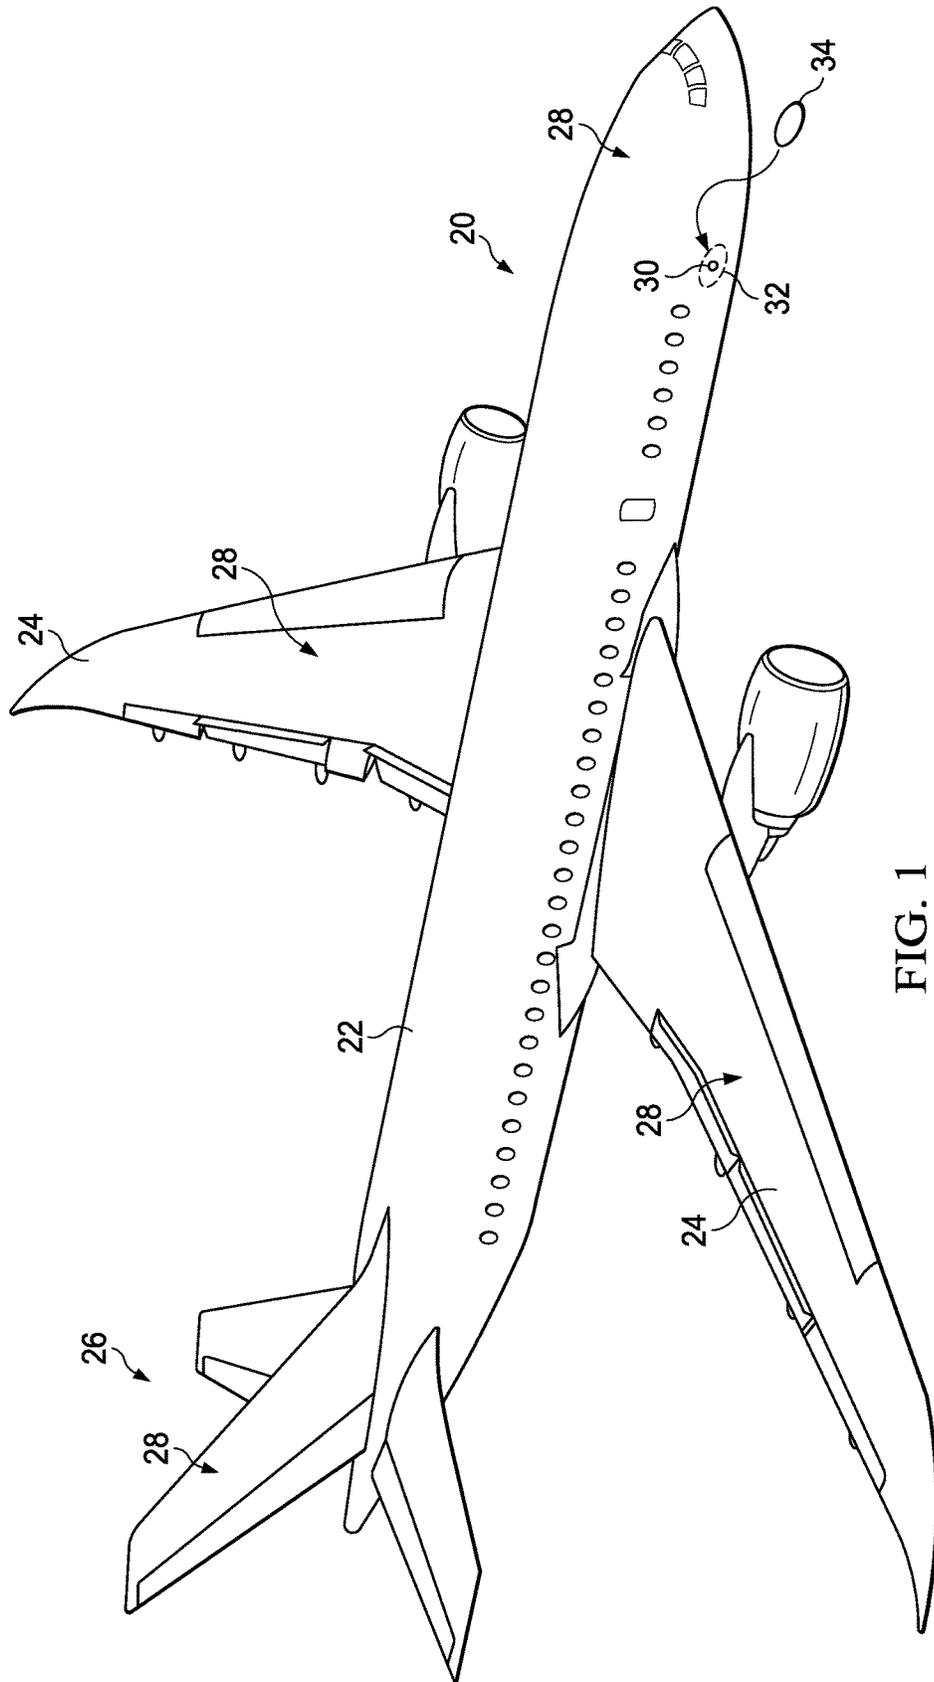
FIG. 1 is an illustration of a perspective view of an aircraft having a composite laminate skin requiring local rework to eliminate a non-conformity.

The disclosed embodiments relate to a method of testing a structure for leaks, and reworking the structure to reduce or eliminate non-conformities, including any leaks that may be detected. For example, referring to FIG. 1, an aircraft 20 includes a fuselage 22, a pair of wings 24 and a tail assembly 26, any of which may be covered with a structure such as a composite laminate skin 28, hereinafter sometimes also referred to as a "structure" 28 or a "composite laminate" 28. The skin 28 may contain one or more local non-conformities caused by events such as impacts which occur either while the aircraft 20 is being manufactured, or later, after the aircraft 20 has been placed in service. These non-conformities 30 may include, without limitation, inconsistencies, damage, voids, dents, cracks, fractures, to name only a few.

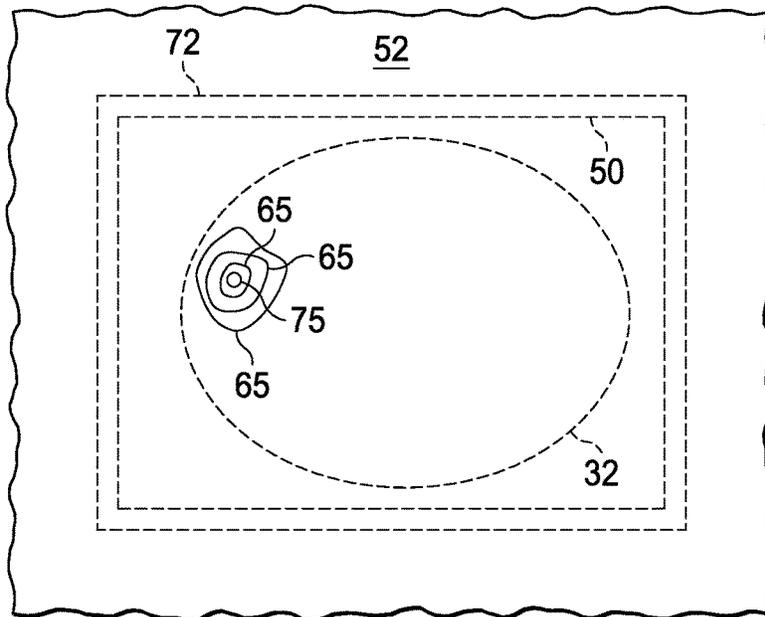
FIG. 5 is an illustration of a diagrammatic view of an image recorded by the camera in FIG. 4 showing the location of an air leak in the structure.

Images of the LDL 50 recorded by the camera 60 may be viewed on a display 67. FIG. 5 illustrates an image of a typical air leak 75 in the structure 28, corresponding to the location of the through-the-thickness void 44 shown in FIG. 4. The location of the air leak 75 may be manifested as a series of bands 65 of differing colors, brightness, contrast or color saturation levels which surround the point of the air leak 75.

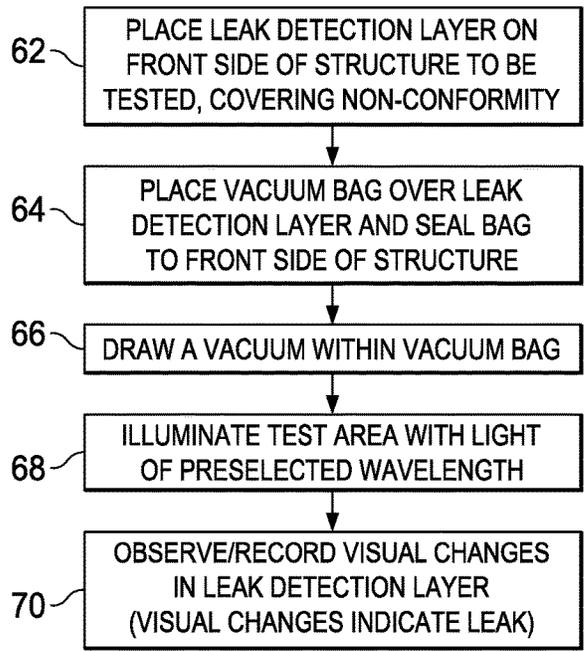
FIG. 6 is an illustration of a flow diagram of a method of detecting leaks through a structure from one side of the structure.

FIG. 6 illustrates the overall steps of a method of detecting leaks in a structure 28, such as a composite laminate skin 28 of the aircraft 20 shown in FIG. 1. Beginning at step 62, an LDL 50 is placed on the frontside 36 of the structure 28 to be tested, covering an area 32 that is to be potentially reworked to eliminate non-conformities therein. At step 64, a vacuum bag 52 is placed over the LDL 50 and sealed to the frontside 36 of the structure 28. At 66, a vacuum is drawn within the vacuum bag 52, and at step 68, the area being tested is illuminated with light having a preselected wavelength. At step 70, visual changes in the LDL 50 are observed or recorded which indicate the presence and location of an air leak 75 in the structure 28.

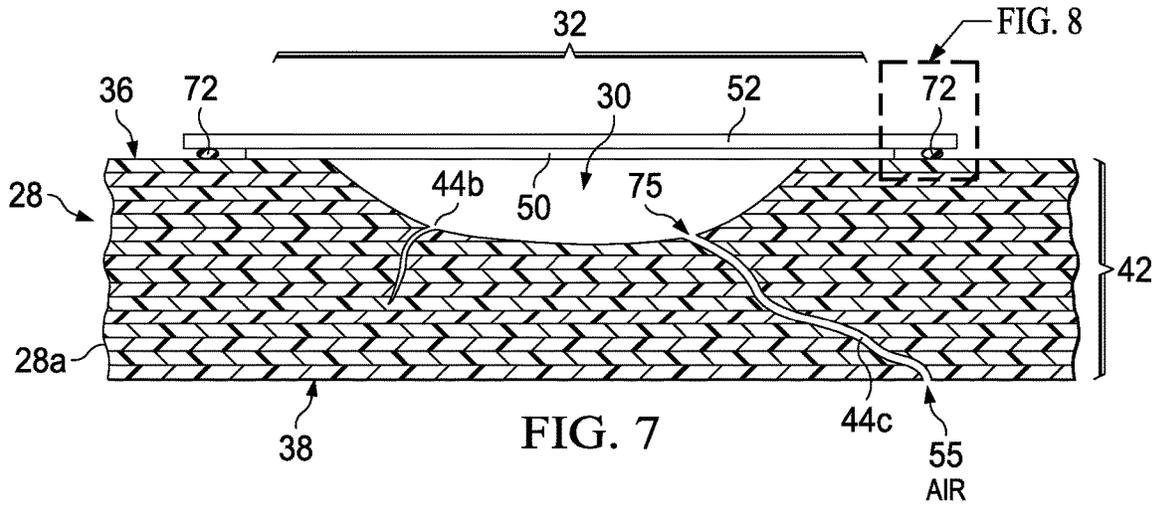
FIG. 7 is an illustration of a sectional view of an area of a composite skin having a void extending through the thickness of thereof, a leak detection layer and vacuum bag having been installed.

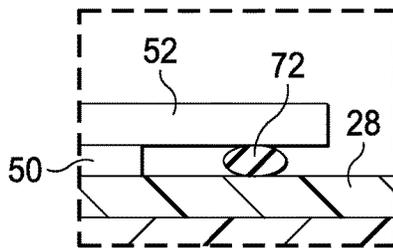
FIG. 8 is an illustration of the area designated as FIG. 8 in FIG. 7.

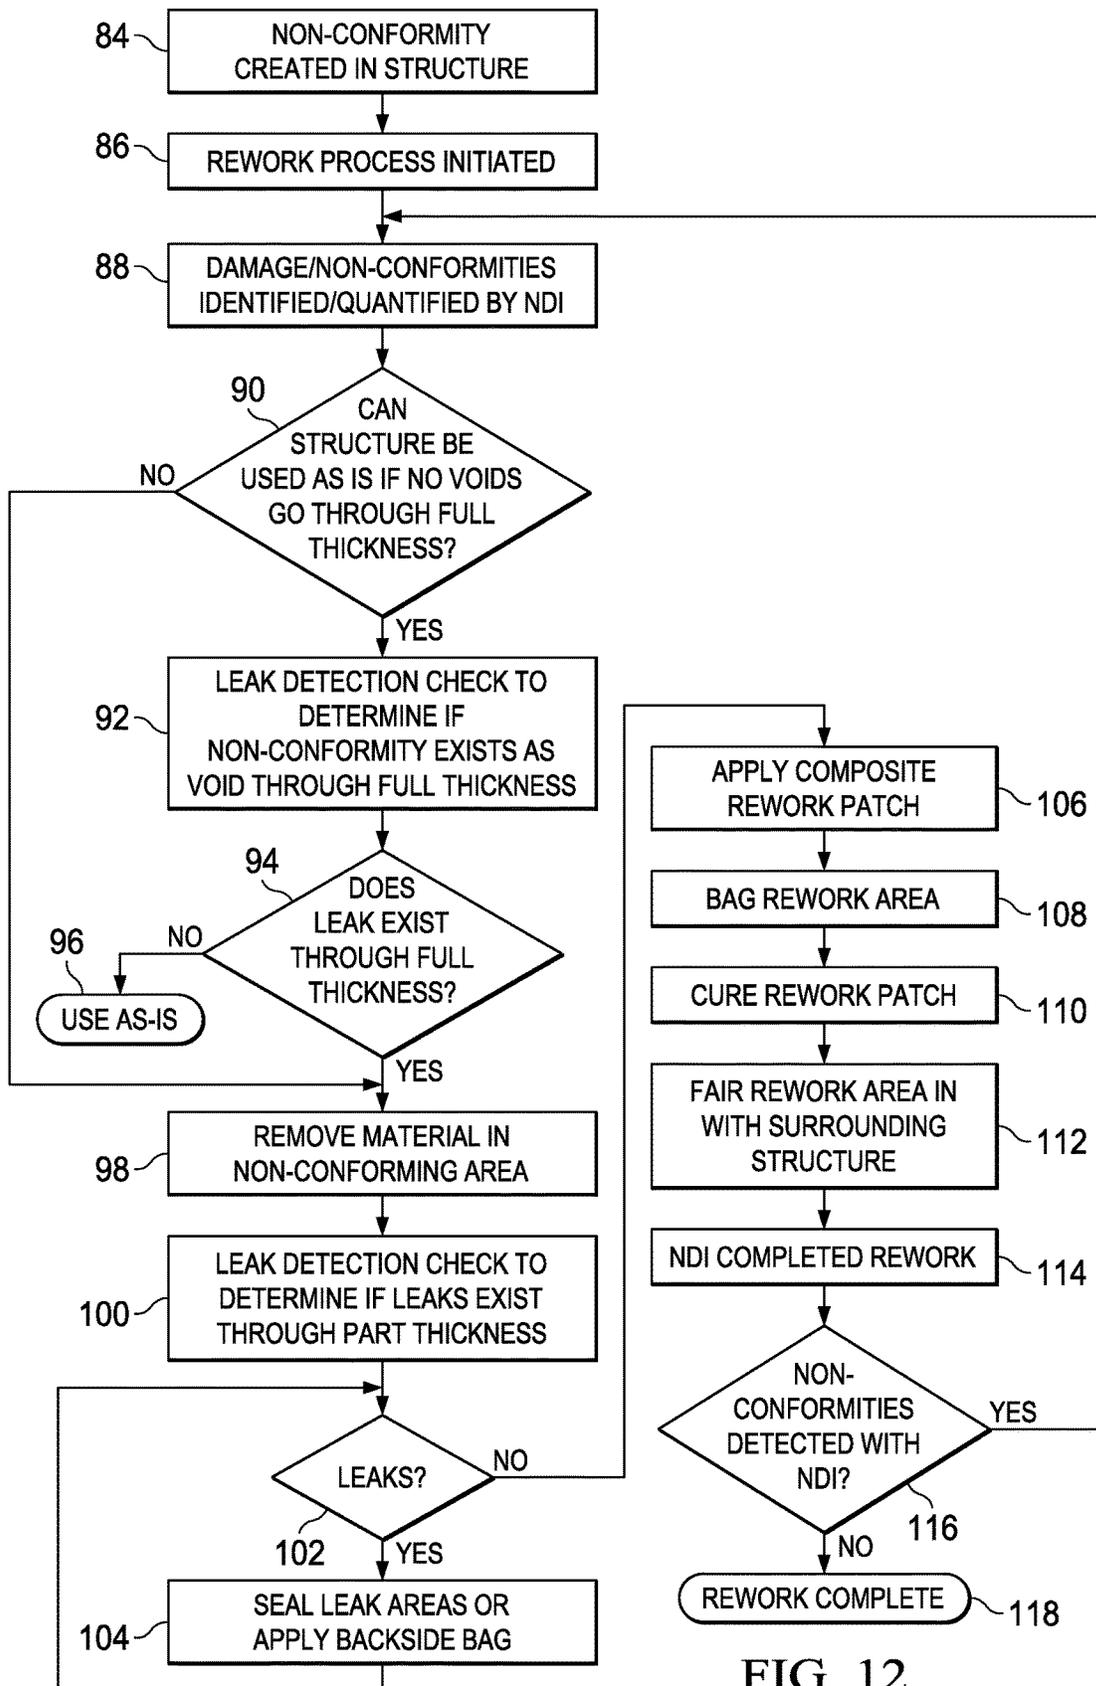
FIG. 12 is an illustration of a flow diagram of a method of leak detection and reworking a composite laminate aircraft skin.
