(10) **Patent No.:** **US 11,559,845 B2**

(54) **METHOD OF REPAIRING A REGION OF A PART INCLUDING A THREADED HOLE**

(71) Applicant: **PRATT & WHITNEY CANADA CORP.**, Longueuil (CA)

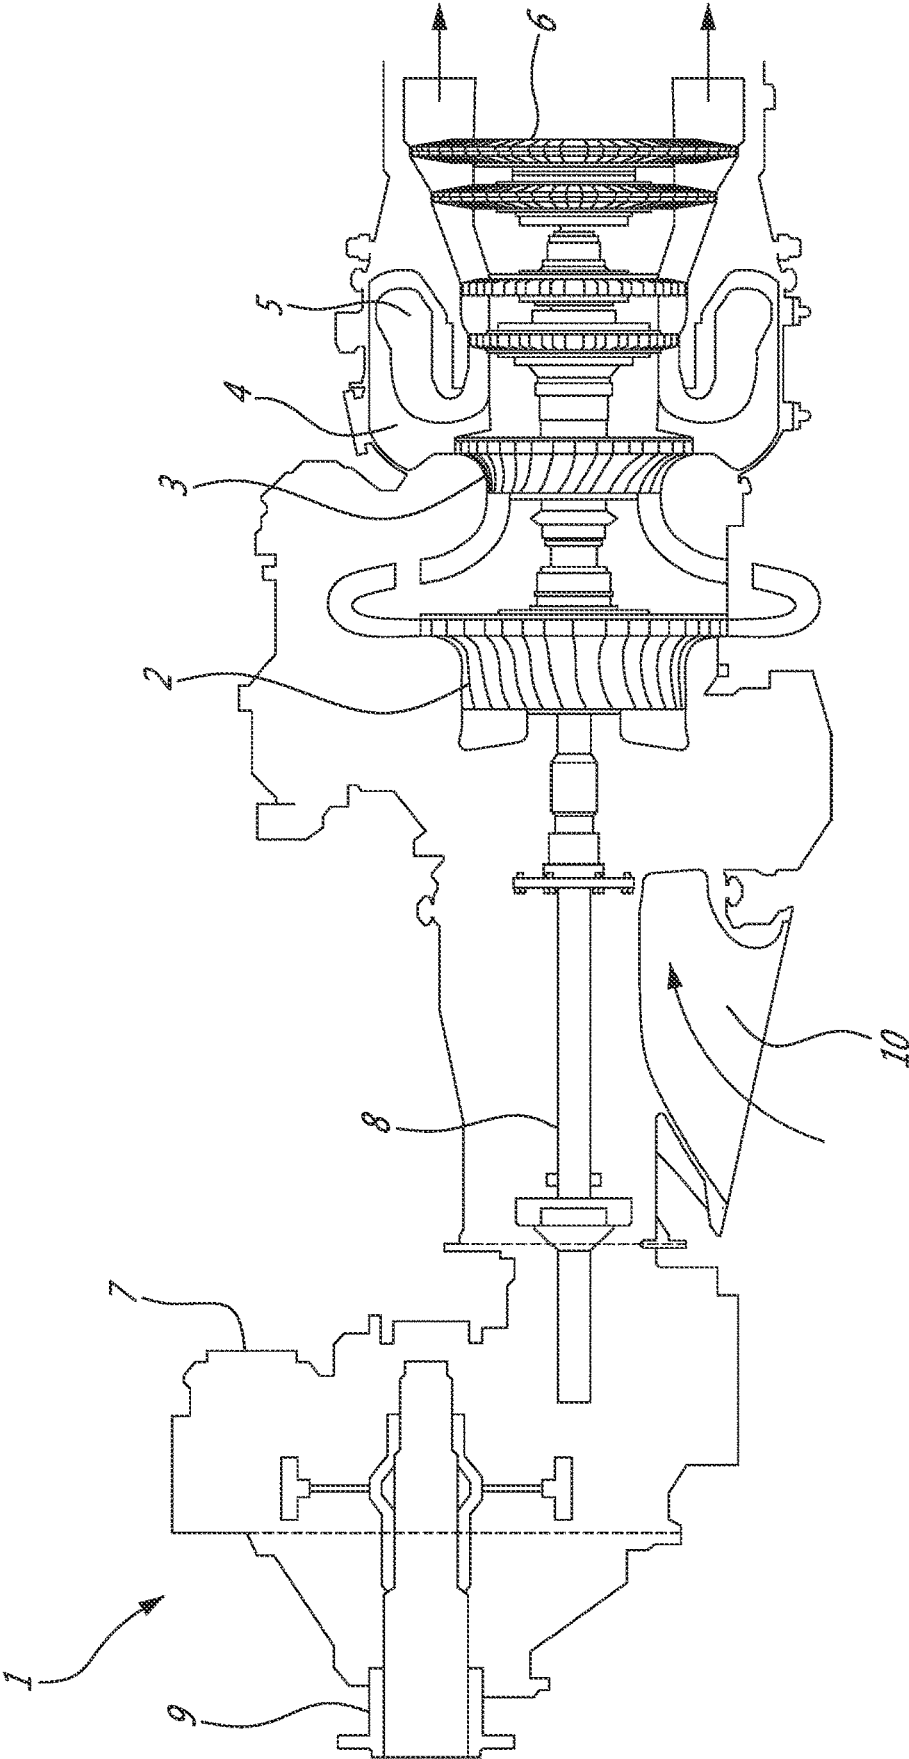
FIG. 1 is a schematic axial cross-sectional view through an exemplary turboprop gas turbine engine with a reduction gearbox between an engine shaft and a propeller shaft;

FIG. 1 shows an axial cross-section through an example turbo-prop gas turbine engine 1. It will be understood that aspects of this disclosure are equally applicable to other types of aircraft engines such as a turboshaft, turbofan, or auxiliary power units. It is also understood that the methods described herein may be used to repair parts made by processes other than casting and also parts that are intended for applications other than gas turbine engines.

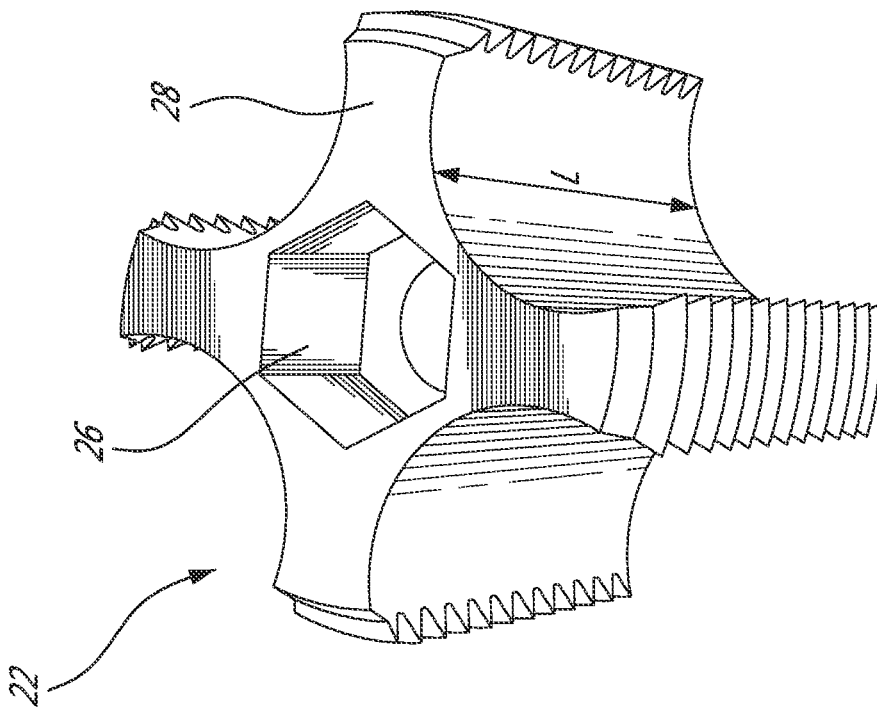
FIG. 4A is a perspective view of an exemplary modified tap that may be used for repairing the defect of FIG. 3;

FIG. 4A depicts a perspective view of modified tap 22 that may be used for repairing defect 20 and FIG. 4B depicts a front view of conventional tap 24 that may be modified to form modified tap 22. Modified tap 22 may be made of tool steel or high-speed steel for example. Modified tap 22 may

Modified tap 22 may include leading end 28 (i.e., tip) of conventional tap 24. Socket 26 may be formed on leading end 28 of modified tap. A shape of socket 26 may be chosen to permit engagement of an end of tool 30 (see FIG. 5). Socket 26 may be formed on leading end 28 of modified tap 22 using computer numerical control (CNC) machining or other suitable material removal process. Socket 26 may extend across a portion of length L of modified tap 22 that is sufficient to allow an end of tool 30 to be received in socket 26 and tool 30 to drive modified tap 22 out of hole 16 and form new threads in the added material when a suitable driving torque is applied to the tool 30.

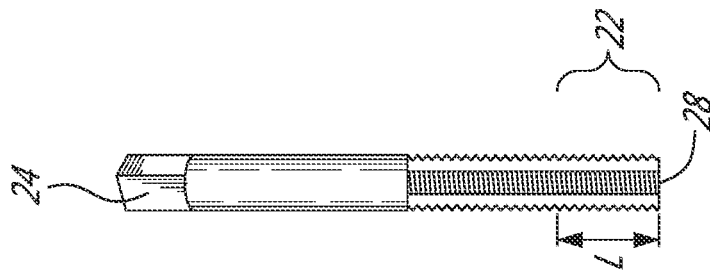
FIG. 4B is a front view of a conventional tap that may be modified to form the modified tap shown in FIG. 4A;

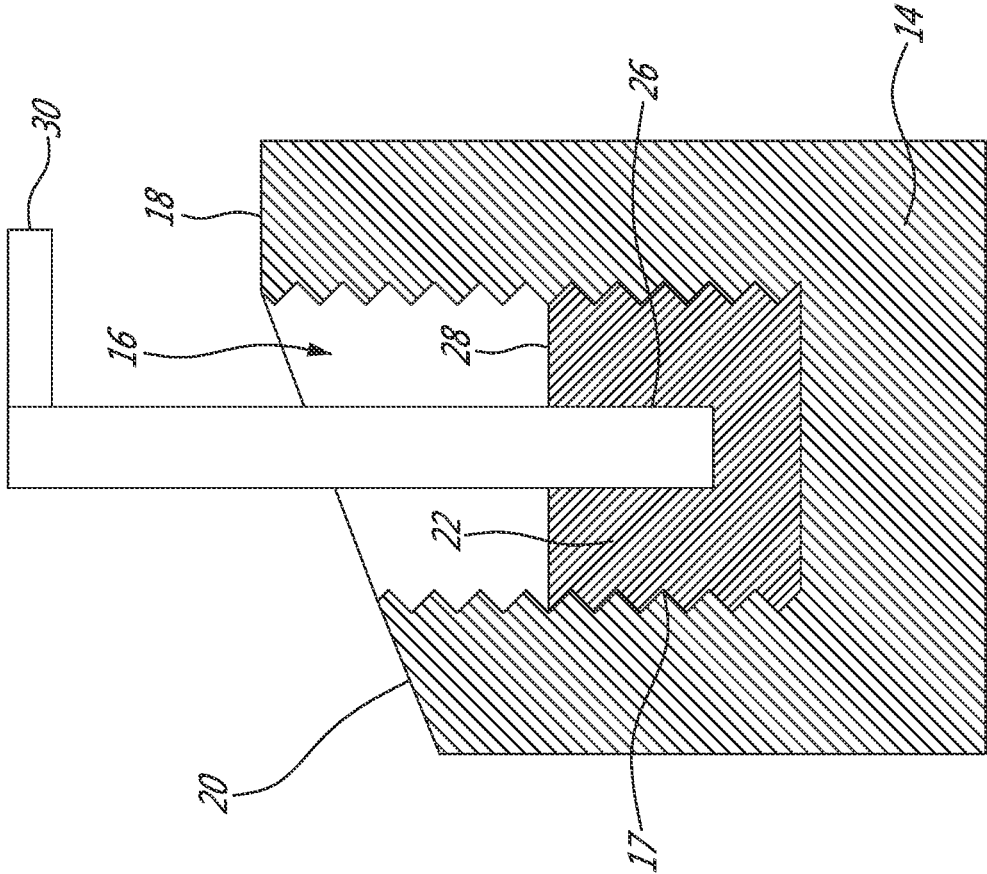
FIG. 5 is a cross-sectional view through the mounting pad of FIG. 2 taken along line 3-3 of FIG. 2 showing the modified tap installed in the hole;

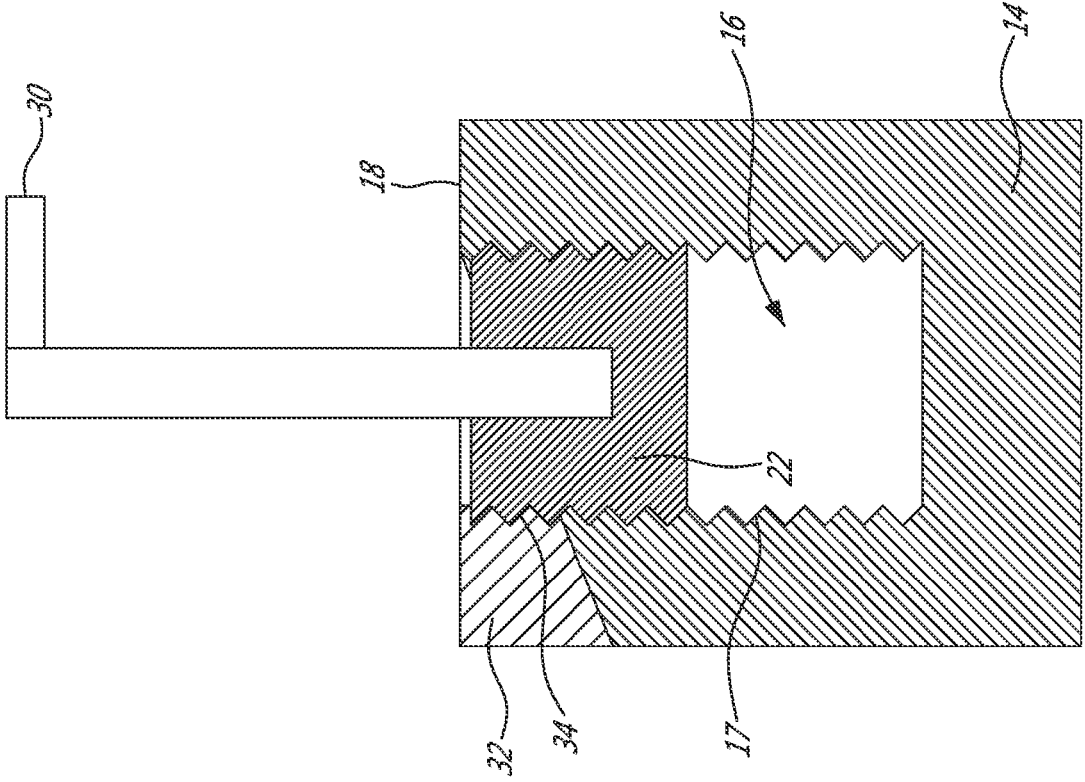
FIG. 7B is a cross-sectional view through the mounting pad of FIG. 2 taken along line 3-3 of FIG. 2 showing the modified tap being used to form threads in the unthreaded extension of the hole;

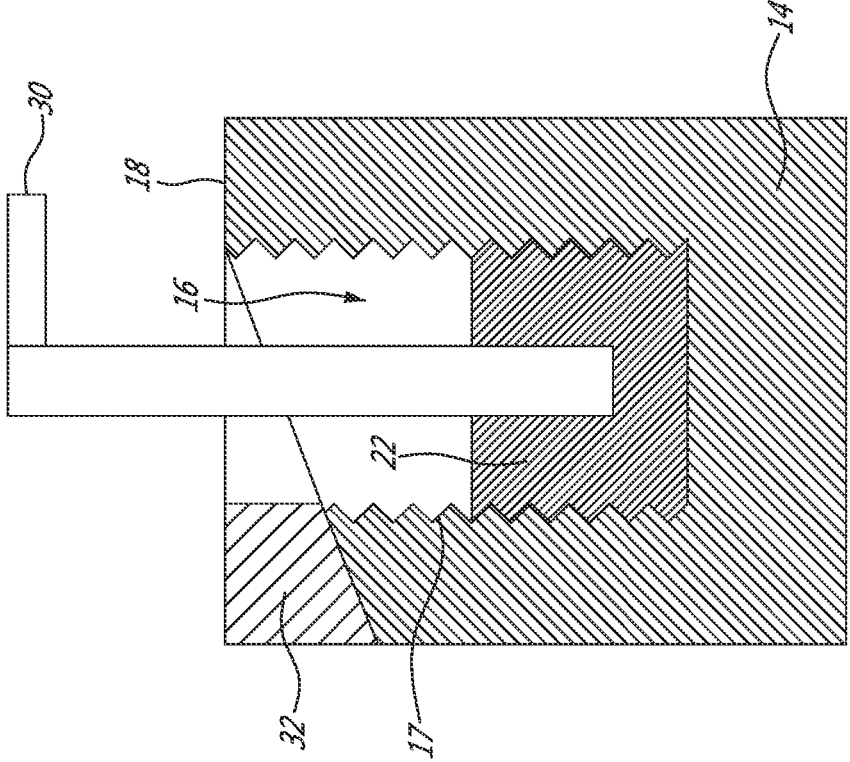
FIG. 7A is a cross-sectional view through the mounting pad of FIG. 2 taken along line 3-3 of FIG. 2 showing the modified tap installed inside the hole and an unthreaded extension of the hole being defined by the new material;

FIG. 7A depicts a cross-sectional view through mounting pad 14 of FIG. 2 taken along line 3-3 of FIG. 2 showing modified tap 22 installed inside hole 16 and an unthreaded extension of hole 16. Material 32 added to mounting pad 14 may have undergone additional machining or grinding after material 32 was added to restore face 18 around the unthreaded extension.

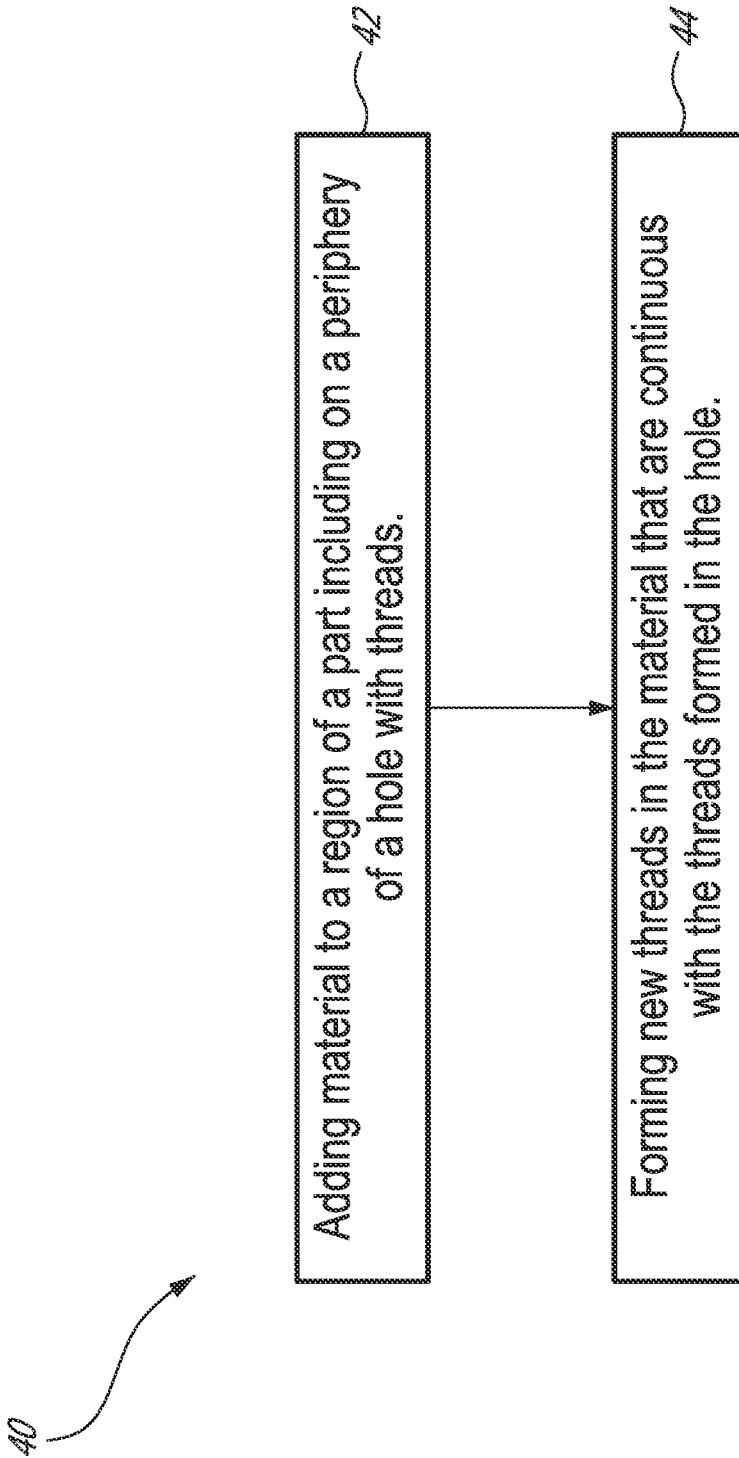
FIG. 8 is a flow chart of an exemplary method for a repairing a region of a part that includes a threaded hole; and
