[54] **TURBINE BLADE REPAIR**

A method of repairing a turbine blade in which damaged material around a lacing wire hole is removed by machining or chemical etching. New metal is then added by welding such that the lacing wire hole is much smaller or completely eliminated and prior to reforming the lacing wire hole, flats may be formed either by the addition or removal of metal in the region of the lacing wire hole so that a lacing wire hole forming drill or machine bit can enter the turbine blade at a surface substantially normal to its direction of travel, thereby minimizing any tendency of the lacing wire hole forming drill or machine bit to snatch or for the blade to vibrate.

TURBINE BLADE REPAIR**DESCRIPTION OF INVENTION**

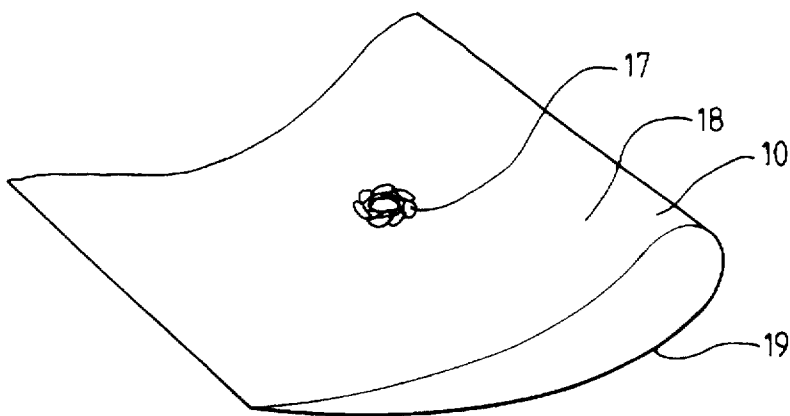
FIG 3

FIG. 3 illustrates the blade of FIG. 1 with the enlarged hole partly filled with weld metal;

blade itself but possibly including other metals alloyed in a manner to provide a durable but long lasting surface is welded to the blade as shown in FIG. 3. It is envisaged that welding of new metal 17 may take place on either side of the blade or possibly both.

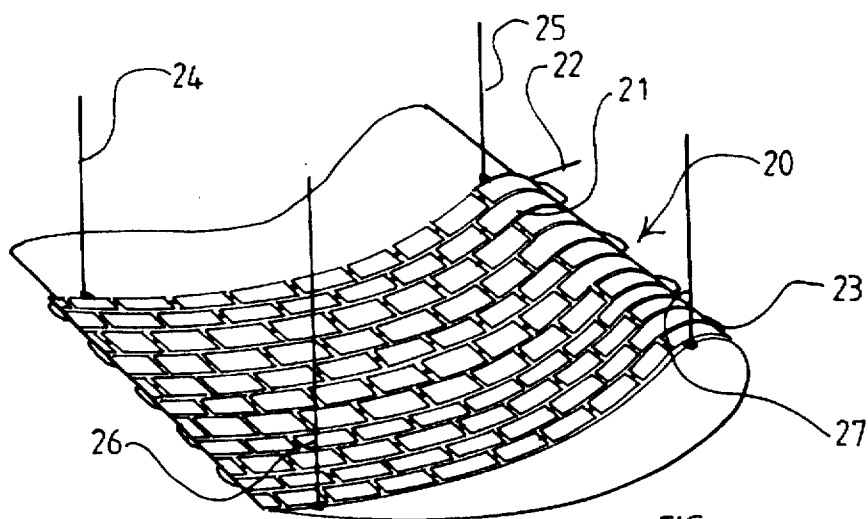
FIG 4

FIG. 4 illustrates part of the blade being subjected to a heat treatment process;

FIG. 4 shows a heating mat generally indicated at 20 comprising a plurality of ceramic beads 21 through which heating elements pass and a controlled current is passed through the heating mat 20 from inlet 22 to outlet 23.

In order to ensure that the blade is heated to the required temperatures, the temperature of the blade during the heating process may be carefully monitored by means of thermocouples shown at 24, 25, 26 and 27. The thermocouples may be placed at other parts of the blade to ensure that those parts of the blade are not adversely affected during the welding to provide weld metal 17 or during the heat treatment processes as shown in FIG. 4.

The new metal 17 may be ground or polished so that the concave surface 18 and convex surface 19 of the blade 10 are returned to their original form and then a heat treatment process may be carried out as shown in FIG. 4 in which the area of the blade surrounding the lacing wire hole is heated to a predetermined temperature for predetermined lengths of time.

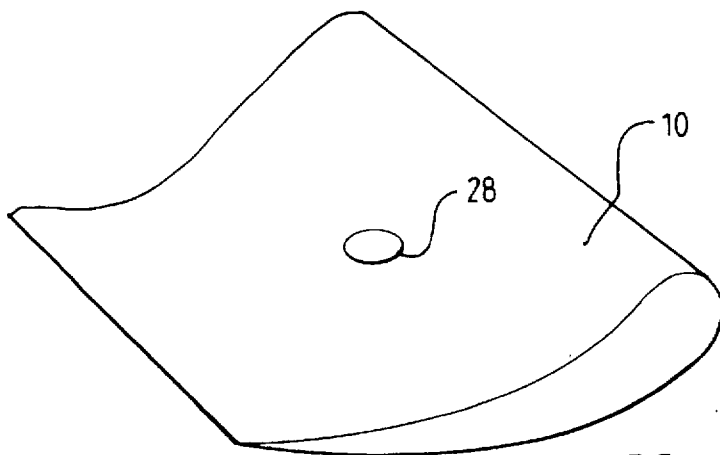
FIG 5

FIG. 5 illustrates the blade with the lacing wire hole re-formed.

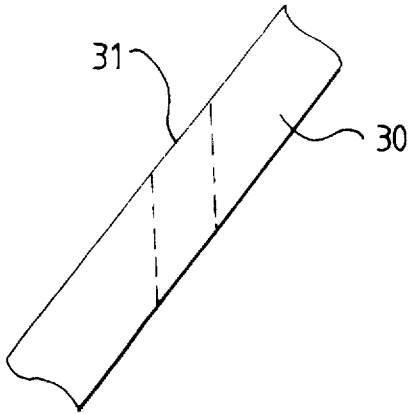
FIG 7

FIG. 7 illustrates the blade shown in FIG. 6 after welding;

Referring now to FIGS. 6 and 7, FIG. 6 shows a turbine blade 30 having a lacing wire hole 31. The lacing wire hole 31 is filled with weld material either completely or partially and excess weld material 32 and 33 is applied to the blade 30 so that when it is required to reform the lacing wire hole 31 the machine bit, for example a drill, can approach a surface 34 that is substantially normal to the direction of travel of the drill during the reforming of the lacing wire hole.

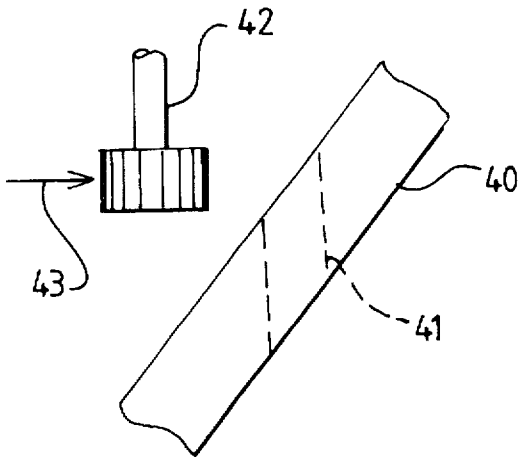
FIG 8

FIG. 8 illustrates a further turbine blade;

An alternative method is shown in FIGS. 8 and 9. A turbine blade 40 in which it is desired to have a lacing wire hole 41 is approached by a machine bit, for example a milling cutter 42 in a direction as shown by arrow 43. A flat 44 is milled into the surface of the turbine blade 40 thus leaving a substantially normal surface 45 which may be approached by a lacing wire hole forming tool such as a drill.

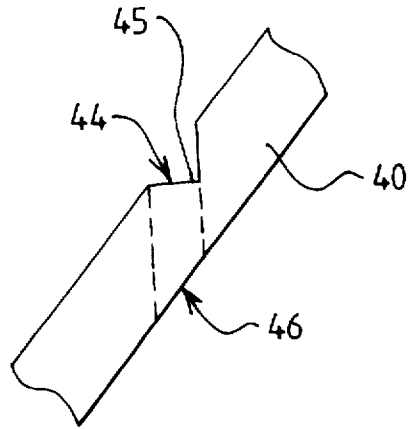
FIG 9

FIG. 9 illustrates the blade shown in FIG. 8 after a flat has been machined.
