United States Patent [19]

[11] Patent Number: 4,776,082

[54] ELECTRIC MOTOR REPAIR

[57] ABSTRACT

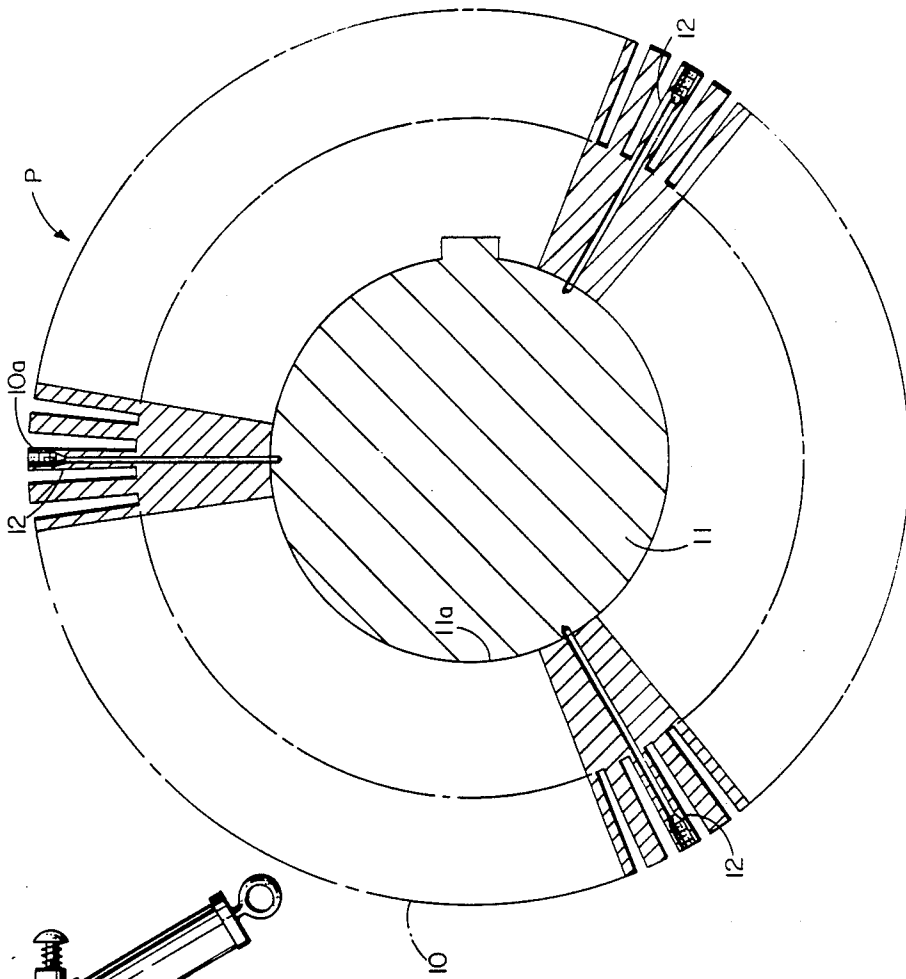
FIG. 1 is a cross-sectional view of a motor armature, exclusive of the armature windings; and

FIG. 1 shows a motor armature 10, on a shaft 11, as seen if looking down axially along the motor shaft. The armature is made up of a number of laminations forming a cylindrical stack. The armature 10 has slots between portions 10a, along its entire perimeter (360° around). In FIG. 1, however, only a portion of the slots, around the armature, are shown for convenience. The slots normally contain the armature windings, but these are not shown, also for convenience. The windings, if shown, would fit within the slots and they would be wound in a configuration that depends upon the desired motor winding parameters. This is well known, of course.

According to the present invention, a bore hole 12 is drilled through the armature, all the way to the shaft. In FIG. 1, three of these holes are shown, separated approximately 120° apart on a common circumferential plane P. The spacing is largely arbitrary. The criteria is adequate access to the shaft and the laminations. Similar holes may be placed axially along the armature, e.g., 1 inch apart, to provide access to the shaft along the entire armature. The holes provide access to the space 11a between the shaft and the armature, and this space, though small, also provides access to the laminations around it.

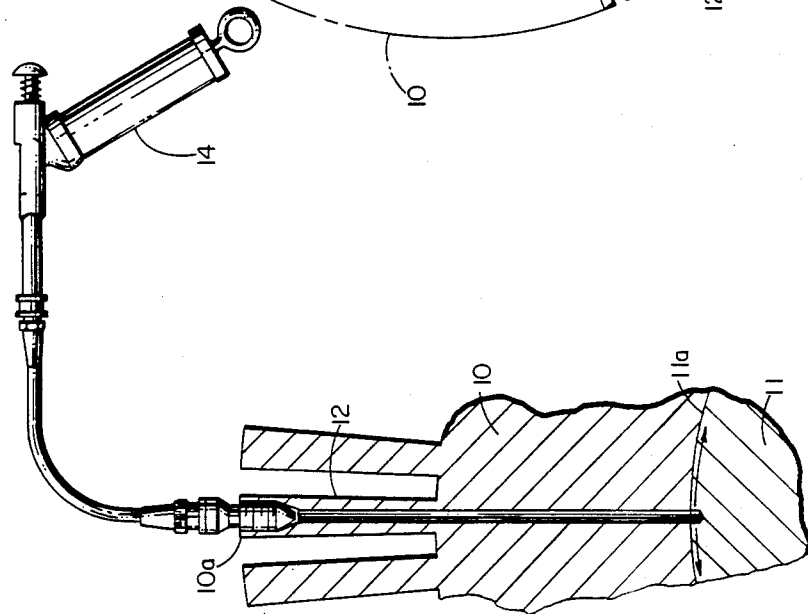
FIG. 2, also an elevational view, but of a portion of the armature, shows a pneumatic tool which is connected to a hole armature.

FIG. 2 shows a small portion of the armature 10. One hole 12 is shown there, and, like the others in FIG. 1, it extends through the armature to the shaft 11. According to the invention, adhesive is inserted under pressure through the hole, preferably using pressure gun 14. The gun is screwed into the outermost portion of the bore hole 12, which is suitably threaded for this purpose. The adhesive is forced into the hole 12, flowing within space area 11a and any void within any immediate laminations. The adhesive is similarly applied through each bore hole 12, and the entire space between the shaft and the armature is filled with adhesive, as a result of the process. Once the adhesive cures, the armature is tightly bonded to the shaft and the laminations are tightly bonded to each other.
