United States Patent [19] Sanchez DETERIORATED EAVEPOST REPAIR APPARATUS FOR HOUSES HAVING SAME Alfredo G. Sanchez, 12361 E. Thunderhead Ranch Rd., Tucson, Ariz. 85747 [21] Appl. No.: 123,556 [22] Filed: Nov. 20, 1987 Int. Cl.⁴ E04G 23/00 U.S. Cl. 52/514; 52/233; 52/745; 52/728 Field of Search 52/311, 313, 233, 514, 52/727, 728, 745 [56] References Cited U.S. PATENT DOCUMENTS 5/1930 Ilson 52/233 1,758,046 Ilson 52/313 1/1932 1,841,127 Kervin 52/728 2,450,345 9/1948

Apparatus and method for repair of deteriorated eaveposts on houses having eaveposts. The apparatus consists of an elongated, tubular body with an end cap and a mounting flange. The apparatus slips over the deteriorated eavepost and attaches to the house with conventional fasteners. The body and end cap of the apparatus are textured to resemble the texture of an intact wooden eavepost and the mounting flange is textured to resemble the texture of the exterior wall of the house.

DETERIORATED EAVEPOST REPAIR APPARATUS FOR HOUSES HAVING SAME

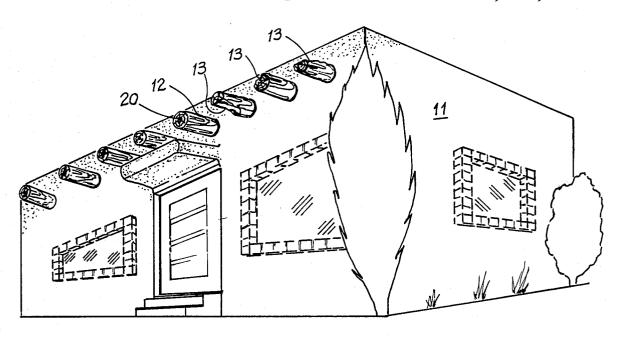
Fig. 1

FIG. 1 is a side elevational view of a home in the southwest style having exposed eaveposts which have 20 deteriorated.

> As seen in FIG. 1, houses in the southwest style 11, have exposed, wooden eaveposts 12, called vigas, which have intact, round, wood ends 20. Exposure to the elements results in cracked, broken, and chipped eaveposts 13.

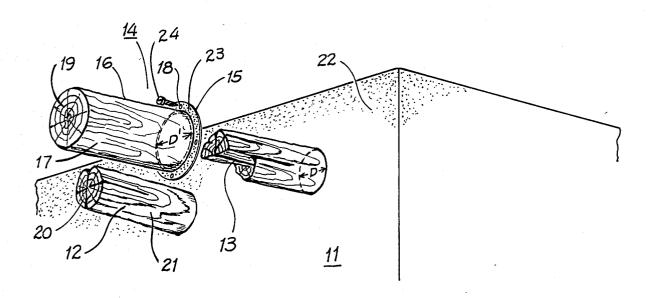
Fig. 2

FIG. 2 is an enlarged perspective view of a deteriorated eavepost and of the repair apparatus of the present

Referring now to the drawings, and more particularly to FIG. 2, there is shown a repair apparatus, generally designated 14, which comprises the preferred em-3,075,358 to A. E. Becker et al. A cap provided with a 30 bodiment of the invention. The apparatus includes an elongated body 16, and end cap 19, and a mounting flange 15.

FIG. 2 shows the preferred embodiment of the invention which provides a method for slipping a repair apparatus 14 over a deteriorated eavepost 13. The repair apparatus 14 consists of an elongated tubular body 16, which has a wood grain appearance 17 resembling that of an intact eavepost 21 and which has a length only nominally longer than that of an intact eavepost 12. The or deteriorated posts and does not produce a cap having 45 interior diameter D' of the tubular body 16 is minimally larger than the exterior diameter D of the eavepost being repaired 13. An end cap 19 is attached to the tubular body 16 and has a wood grain appearance 19 which resembles the appearance of the end of an intact
