**United States Patent** [19]**Amos et al.**[11] **Patent Number:** **5,172,475**[45] **Date of Patent:** **Dec. 22, 1992**[54] **METHOD FOR REPAIRING A ROTOR**[75] **Inventors:** **Dennis R. Amos**, Rock Hill, S.C.;  
**Robert E. Clark**, Orlando, Fla.[73] **Assignee:** **Westinghouse Electric Corp.**,  
Pittsburgh, Pa.[21] **Appl. No.:** **801,137**[22] **Filed:** **Dec. 9, 1991**[51] **Int. Cl.<sup>5</sup>** ..... **B21K 3/04**[52] **U.S. Cl.** ..... **29/889.1; 29/402.08;**  
228/119[58] **Field of Search** ..... 29/889.1, 889, 402.08,  
29/402.13, 402.18; 228/119[56] **References Cited****U.S. PATENT DOCUMENTS**

## METHOD FOR REPAIRING A ROTOR

This invention relates to a method for aligning and joining a plurality of members each having a bore there-through and, more particularly, to a method for repairing a rotor.

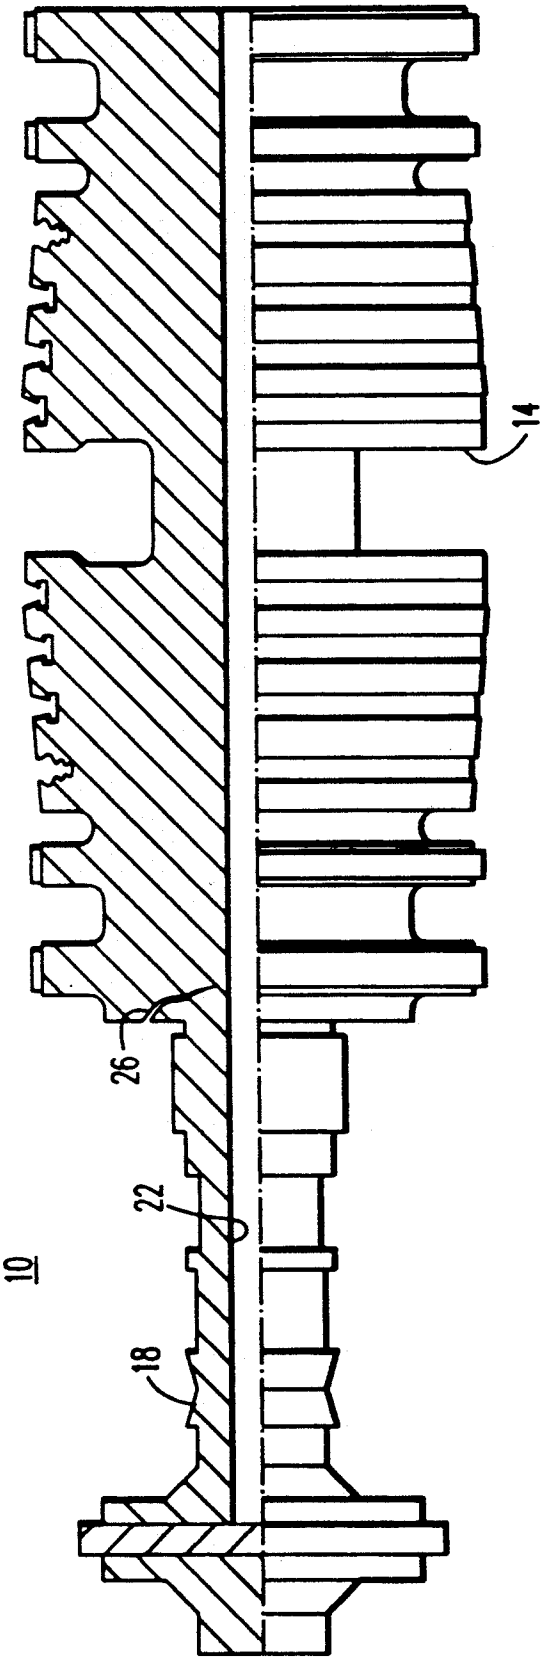
FIG. 1 is a partial cross-sectional view of a rotor having a crack;

Referring to FIGS. 1 and 2, rotor 10 includes a rotor body 14 and a stub end 18. The rotor 10 has a bore 22. A crack 26, by way of example, is positioned between the rotor body 14 and the stub end 18. Initially, the growth of the crack 26 is axial and then the growth of the crack 26 turns inward toward the bore 22.

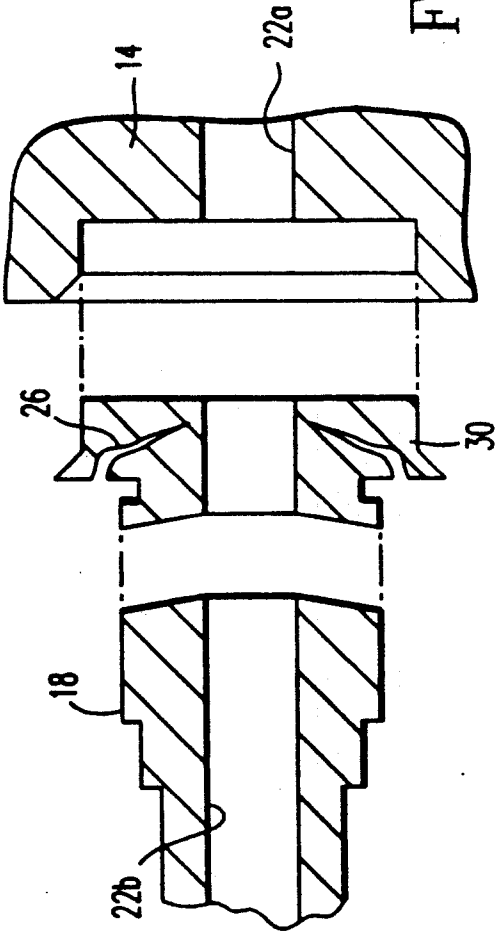
FIG. 2 is a cross-sectional view of the rotor severed into a stub end and a rotor body;

Referring to FIGS. 2 and 3, the portion 30 which was removed from the rotor body 14 is replaced with a weld metal to provide a portion 34. Additional welding may be used to build up enough stock to machine a welding preparation, which is used for providing a surface to weld together the rotor body 14 and the stub end 18. Also, additional weld metal may be used to alter the original design by providing a thicker section and larger diameter portion 34, commonly referred to as upgrading the design, to alleviate fatigue cracking during future operation of the rotor 10.

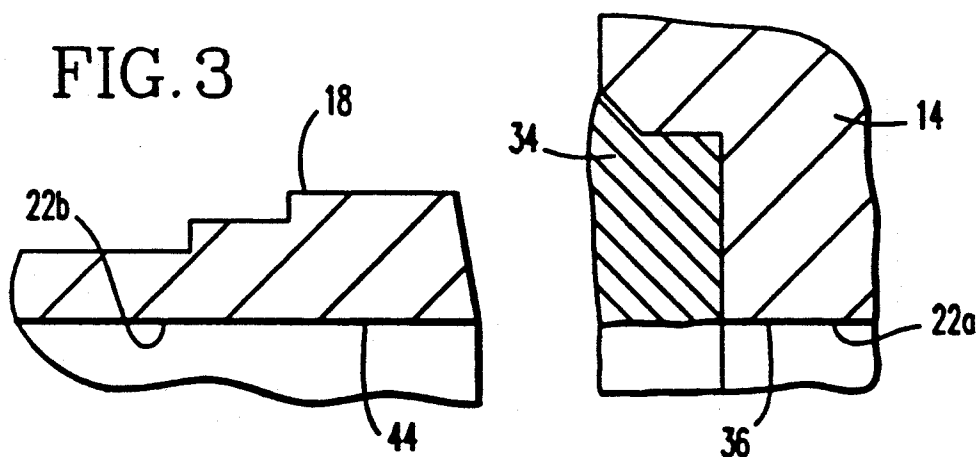
FIG. 4 is a cross-sectional view of the stub end and the rotor body having a built-up portion;

Referring to FIGS. 3 and 4, additional welding is used to deposit weld metal onto a surface 36 positioned adjacent the bore 22a of the rotor body 14 for providing a built-up portion 38. A built-up portion 42 of weld metal is welded onto a surface 44 positioned adjacent the bore 22b of the stub end 18 of the rotor 10. The built-up portions 38 and 42 are positioned within and extend below the original diameter of the bores 22a and 22b.

Referring to FIGS. 4 and 5, the built-up portion 38 and the built-up portion 42 are machined to form a mating connection, such as a spigot-type fit or shiplap, between the rotor body 14 and the stub end 18. As an

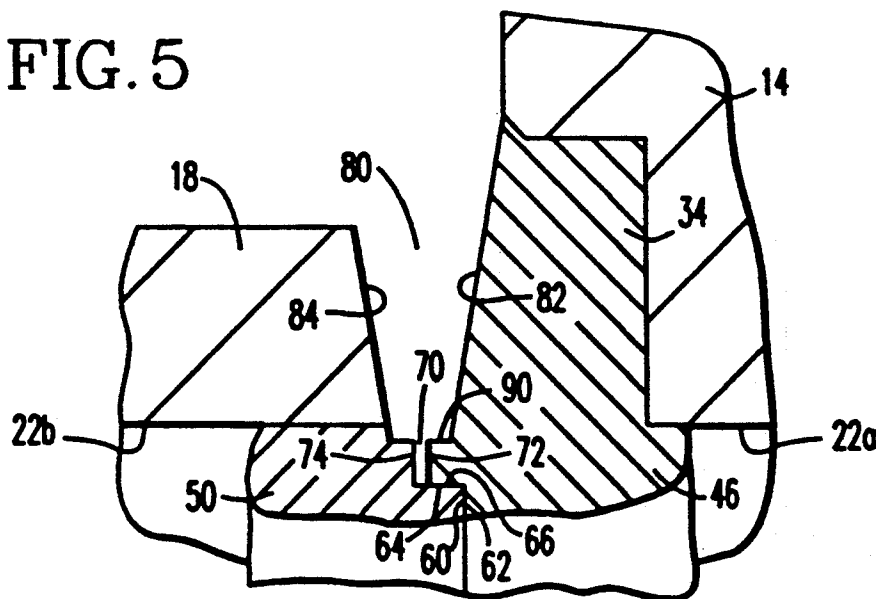
FIG. 6 is a cross-sectional view of weld metal deposited within a welding groove positioned between the stub end and the rotor body;

Referring to FIGS. 5 and 6, after inspecting the alignment to verify the desired concentricity and parallelism of the rotor 10, a weld metal is deposited in the welding narrow groove 80 to form a portion 86, which joins the rotor body 14 and the stub end 18 together. A plurality of weld torches (not shown) may be used to weld the rotor body 14 and the stub end 18 together. Preferably, the weld torches are positioned equidistant from each other around the joint diameter for simultaneously welding the stub end 18 and the rotor body 14 together. The heat input from each arc is substantially the same for each welding torch for preventing distortion in any direction from the rotor body 14 or the stub end 18. The weld torches may move circumferentially around the rotor 10 or the rotor 10 may rotate while the weld torches remain stationary, for welding the circumference of the rotor 10.

Referring to FIGS. 6 and 7, the male spigot 46, the female spigot 50, the root 90, and a portion of the weld metal positioned adjacent to the root 90 and the mating connection is removed, such as by machining, for restoring the diameter of the bore 22 of the rotor 10 to its original diameter. The inside of the rotor 10 is bored along the rotor centerline out to a diameter to a position of clean weld metal, beyond the questionable quality weld located at the root fusion area. The bore surface is nondestructively examined to insure bore surface and sub-surface quality.

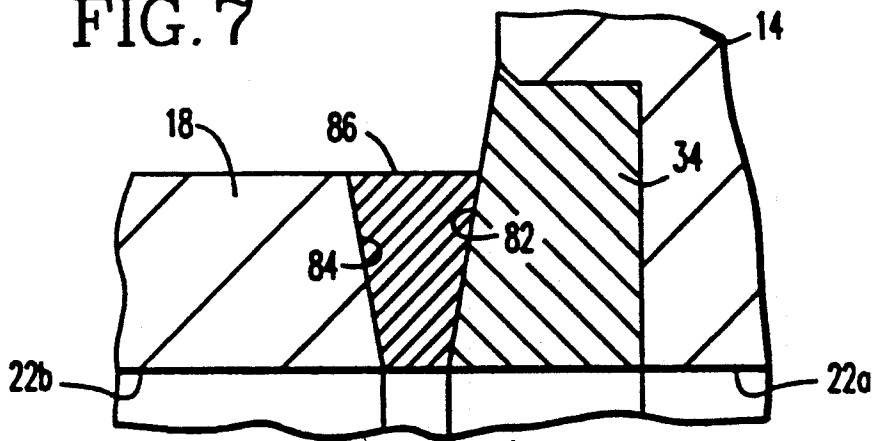
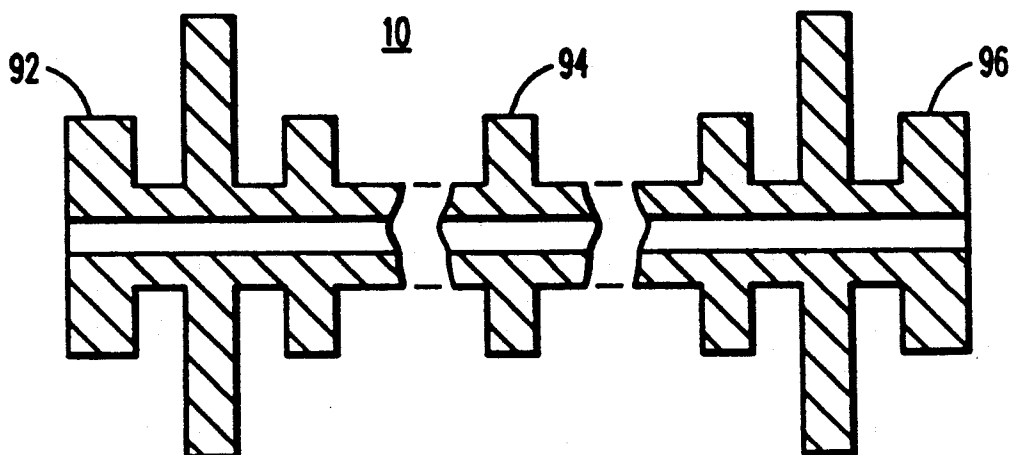
FIG. 8 is a cross-sectional view of the rotor severed at two locations.
