(54) **COMPOSITION AND METHOD FOR SURFACE REPAIR**

A composition and method of repairing damaged concrete and asphalt surfaces includes a two-part polymer resin mixture. To effectuate a repair, the damaged portion is cleaned of debris and loose pieces. The two-part polymer resin mixture is mixed onsite and is applied as a protective overlay over the damaged portion. Once cured, the mixture provides a protective layer over the damaged area.

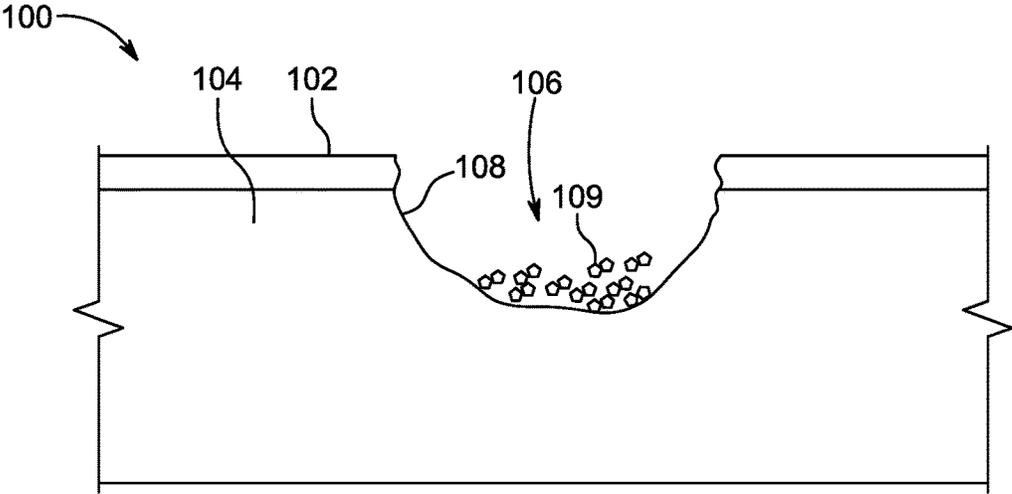
FIG. 1 depicts a pothole in a roadway identified for repair according to an embodiment of the present disclosure;

Referring now to FIG. 1, there is depicted a roadway **100** according to an embodiment of the present disclosure. The roadway **100** may be formed of any suitable material. The roadway **100** may include a surface layer **102** formed on a base material **104** as is known to those of ordinary skill. The surface layer **102** may be formed of any suitable material, including, but not limited to, asphalt or concrete. The base material **104** may be formed of aggregate or some other crushed material, such as crushed stone.

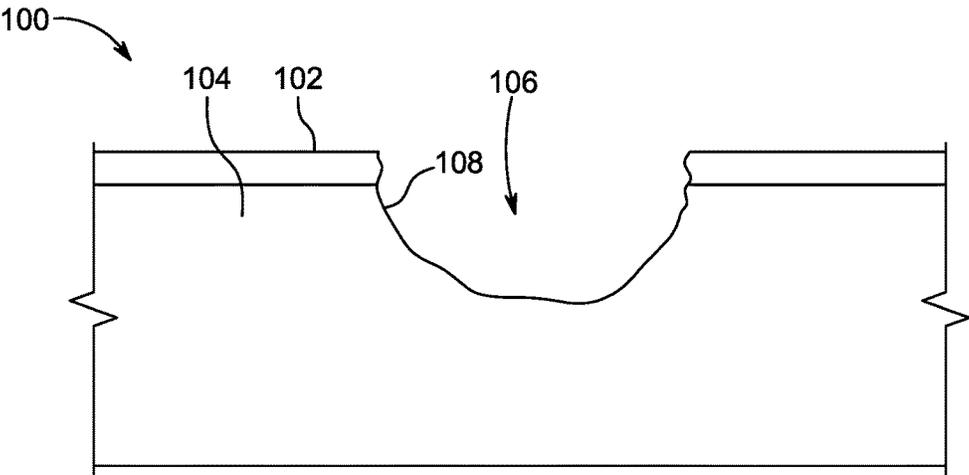
FIG. 2 depicts the pothole in FIG. 1 with the debris removed;

As shown in FIG. 2, where like reference numerals depict like components, the first step in patching the damaged portion **106** is to remove the loose debris to expose the interior surface **108**. This may be done using handheld or powered tools, including shovels.

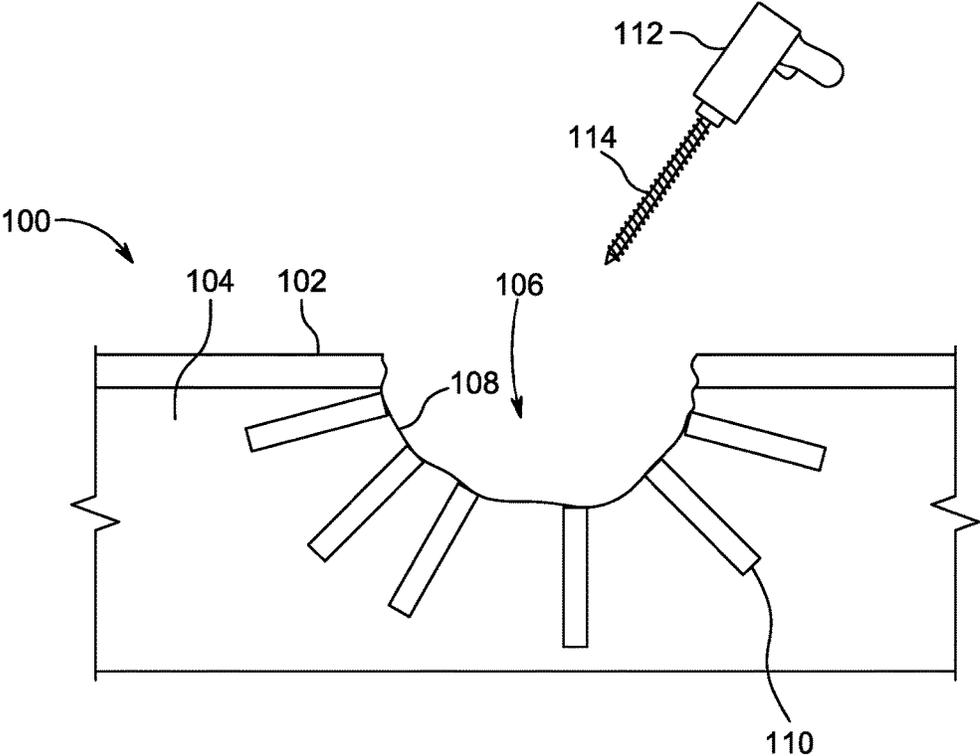
5 FIG. 3 depicts the pothole in FIG. 1 with the boreholes formed in the interior surface;

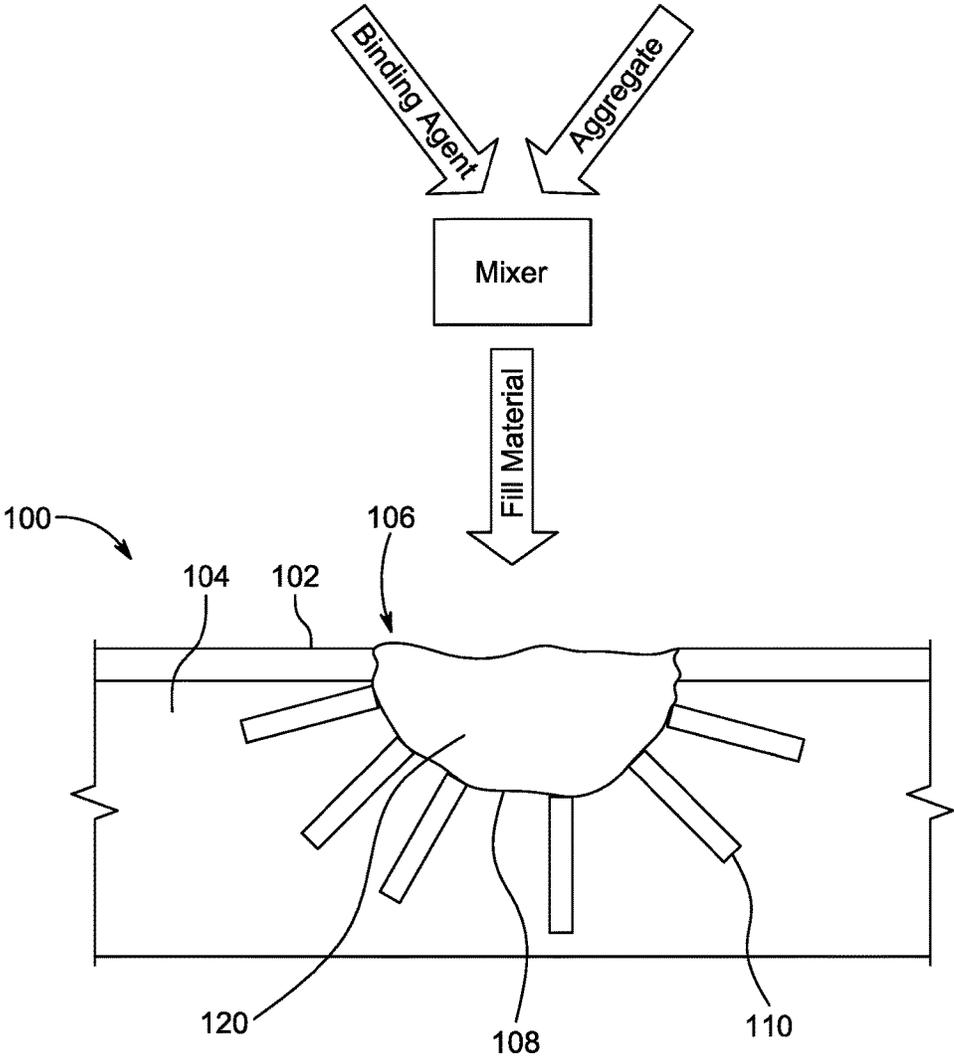
FIG. 4 depicts the pothole in FIG. 1 with the boreholes and pothole filled with a fill material;

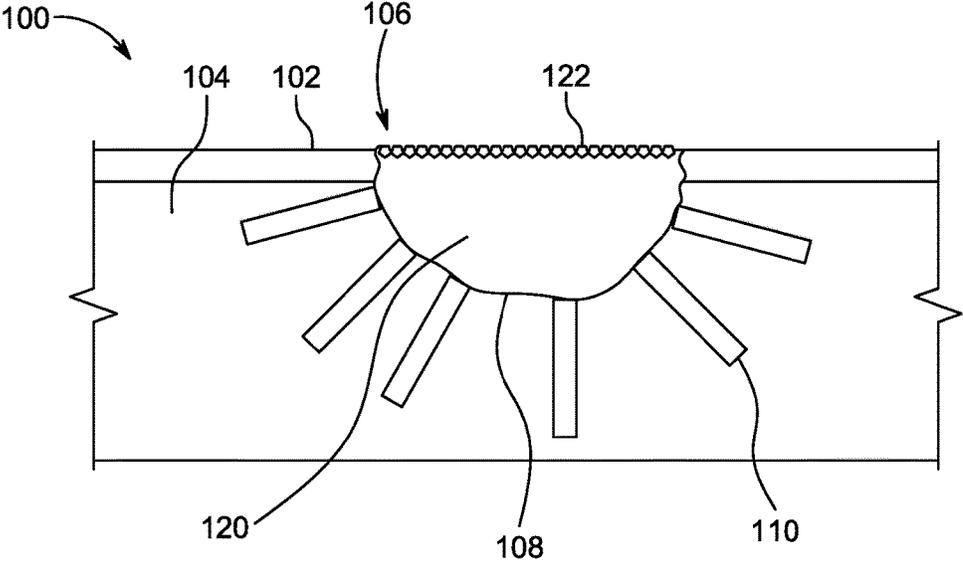
10 FIG. 5 depicts the pothole in FIG. 1 with the fill material and a friction enhancing material;

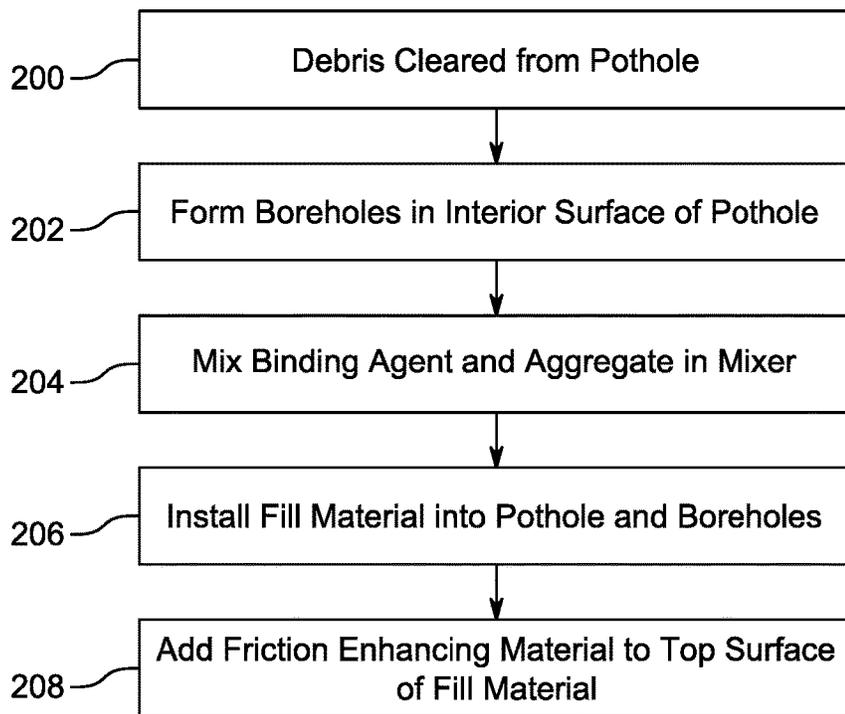
FIG. 6 is a flow chart of a process for repairing a pothole in a roadway according to an embodiment of the present disclosure;

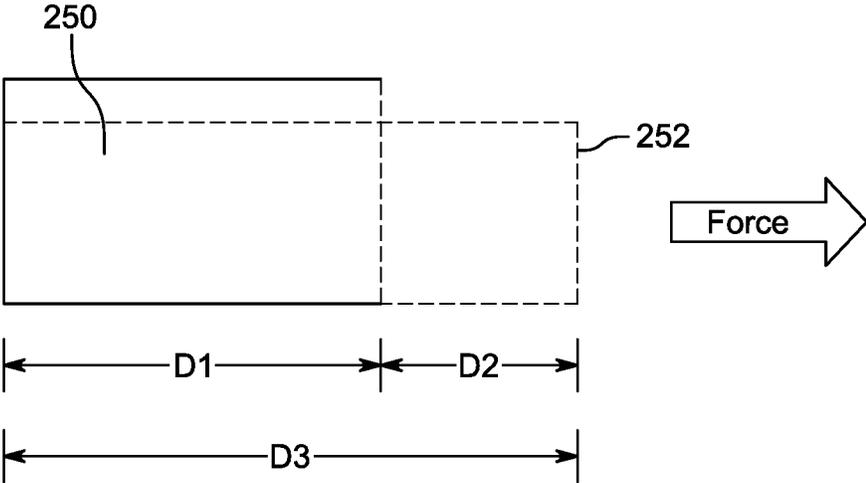
15 FIG. 7 depicts the deformability of the binding agent used in roadway repairs according to an embodiment of the present disclosure;

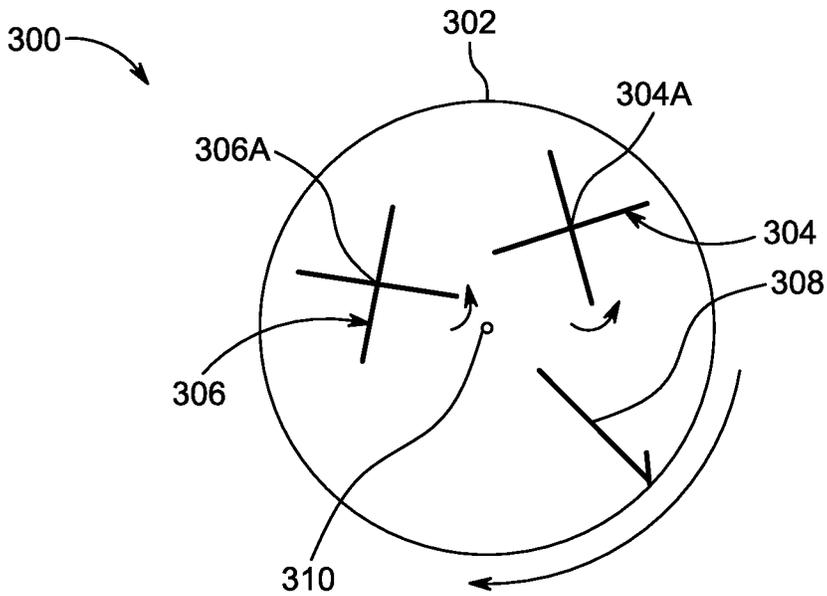
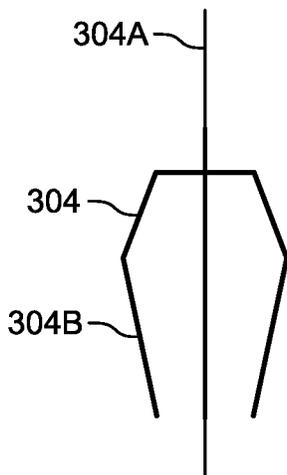
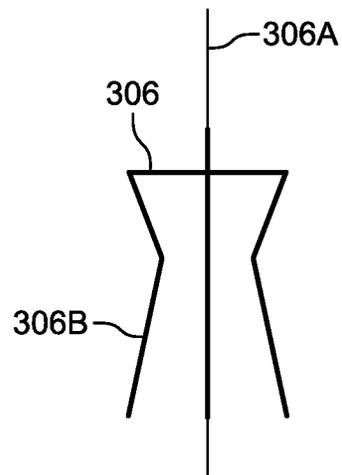
FIGS. 8A-8C depict a mixer for a binding agent and an aggregate according to an embodiment of the present disclosure;

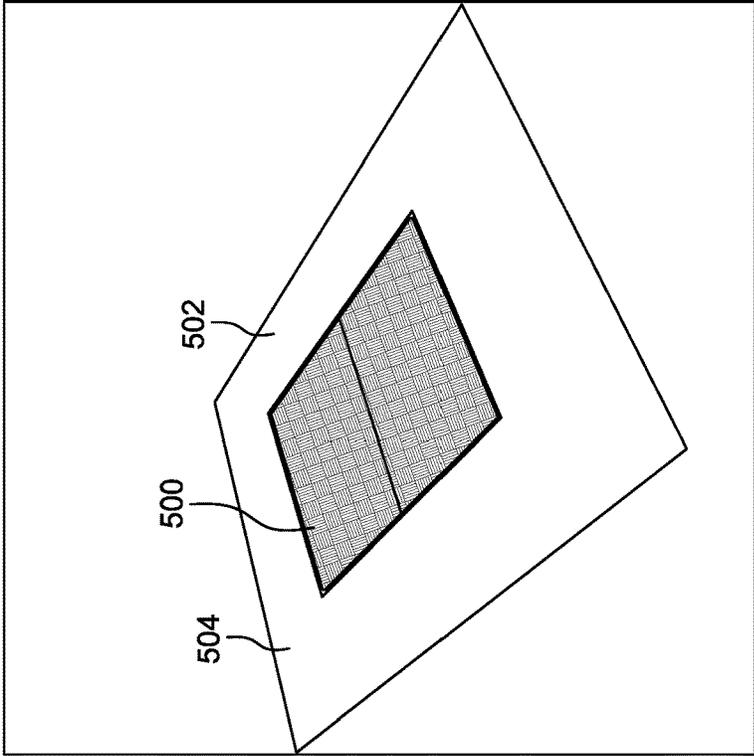
FIG. 10 shows the concrete apron in FIG. 9 after repairs according to an embodiment of the present disclosure;

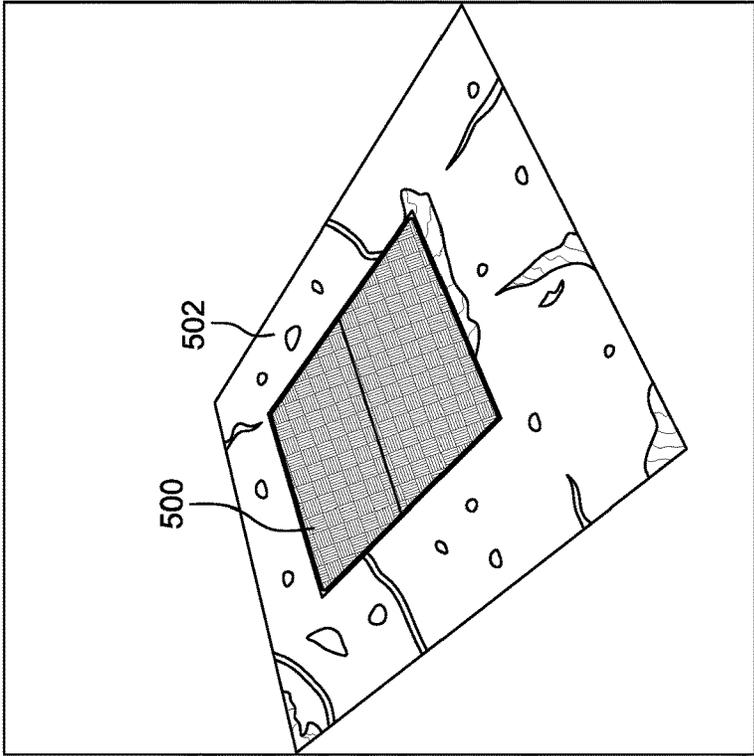
20 FIG. 9 shows a metal cover installed over an access tunnel and having a damaged concrete apron;

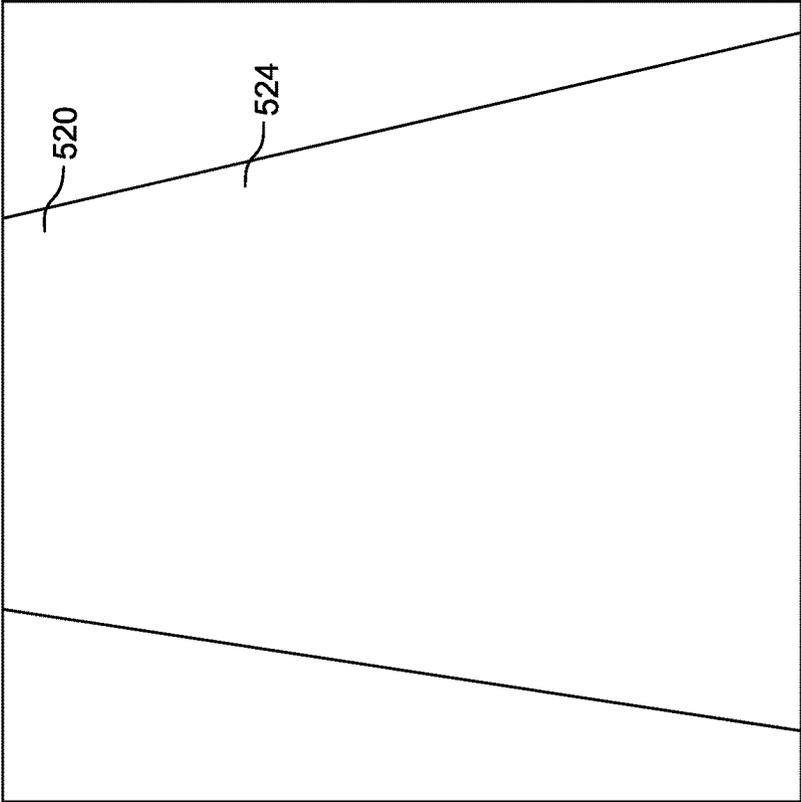
30 FIG. 14 depicts the concrete water trough in FIG. 13 after repairs according to an embodiment of the present disclosure;

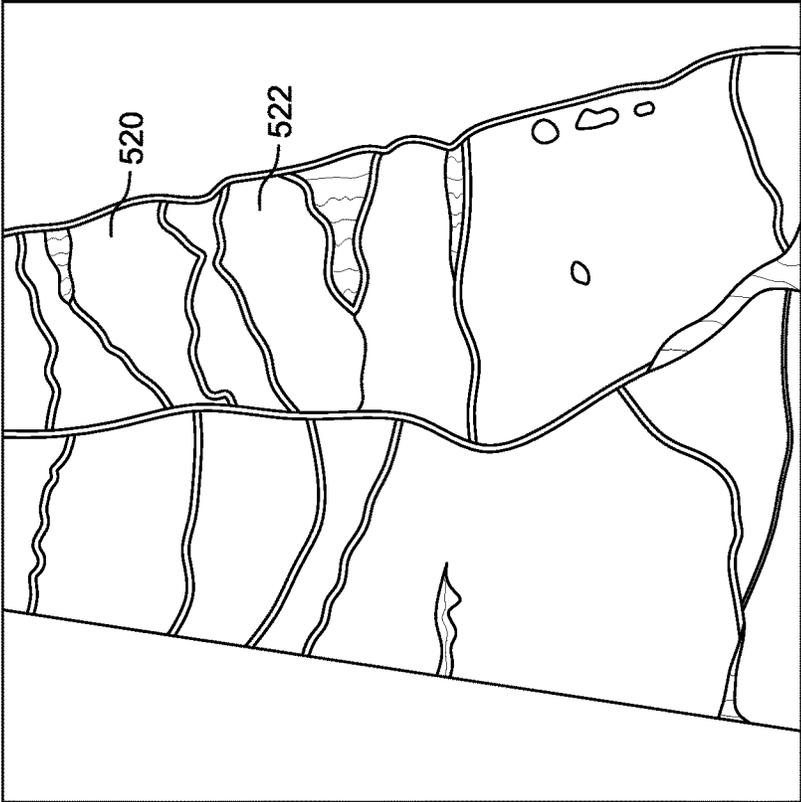
FIG. 13 depicts a damaged concrete water trough formed in a roadway;

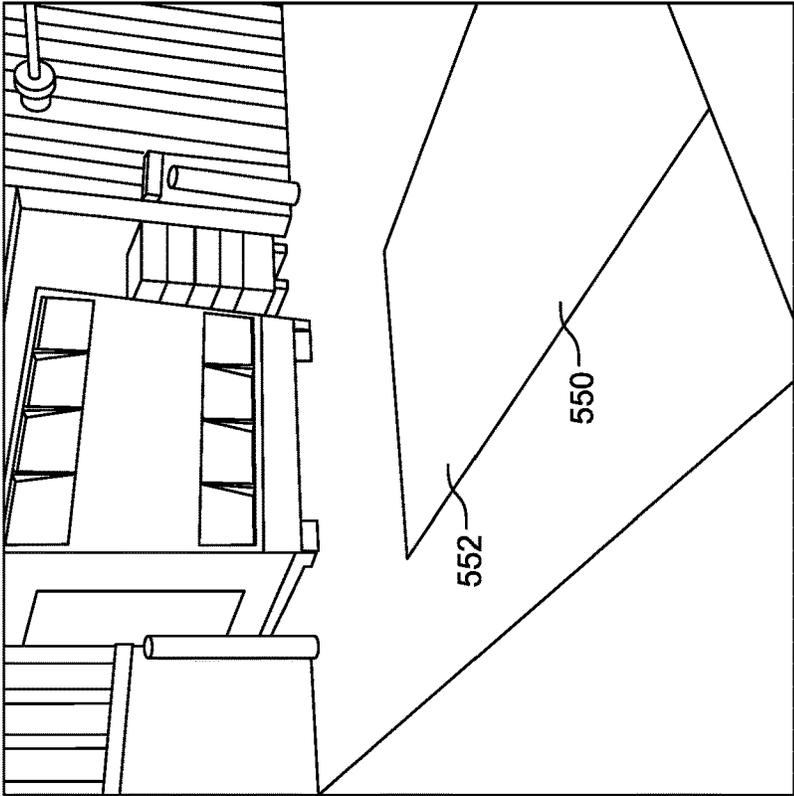
FIG. 20 depicts the surface in FIG. 19 after repairs according to an embodiment of the present disclosure;

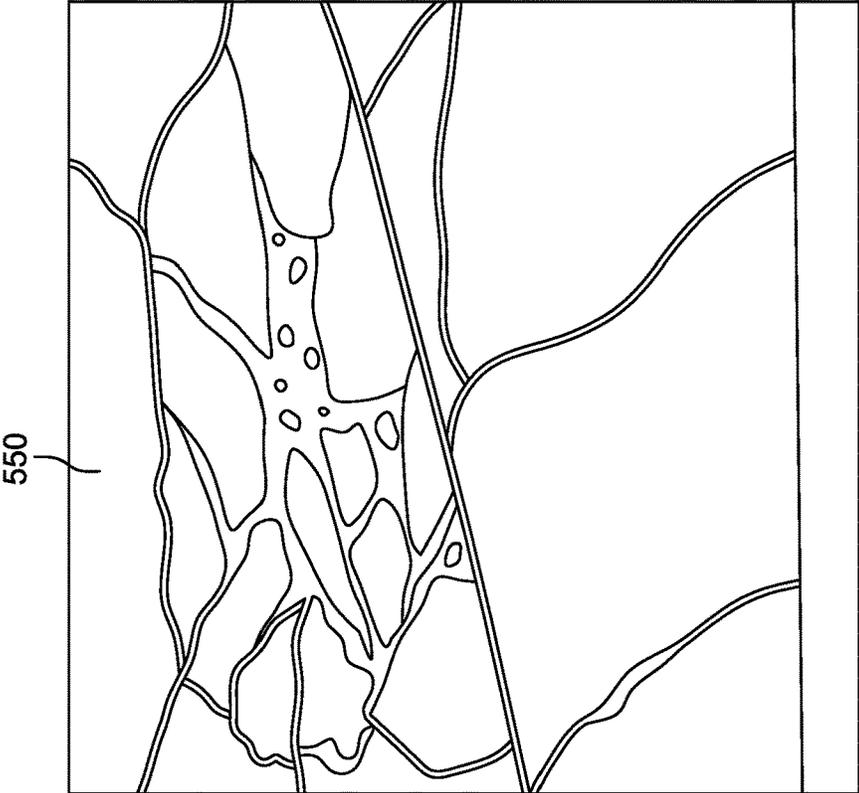
FIG. 19 depicts a damaged surface;

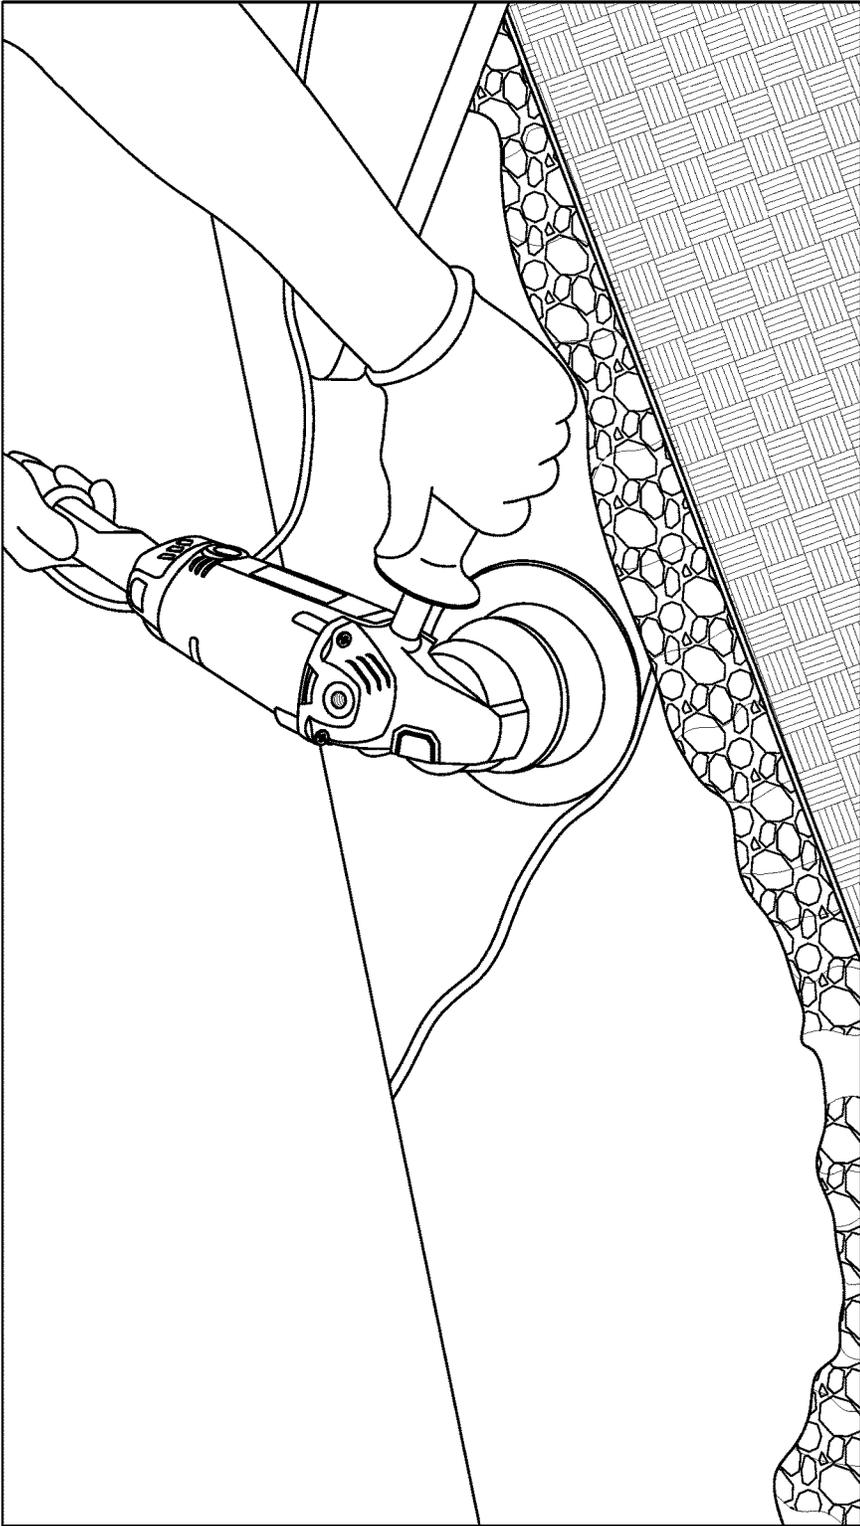
45 FIG. 21 depicts a process for preparing a damaged surface for repair according to an embodiment of the present disclosure;

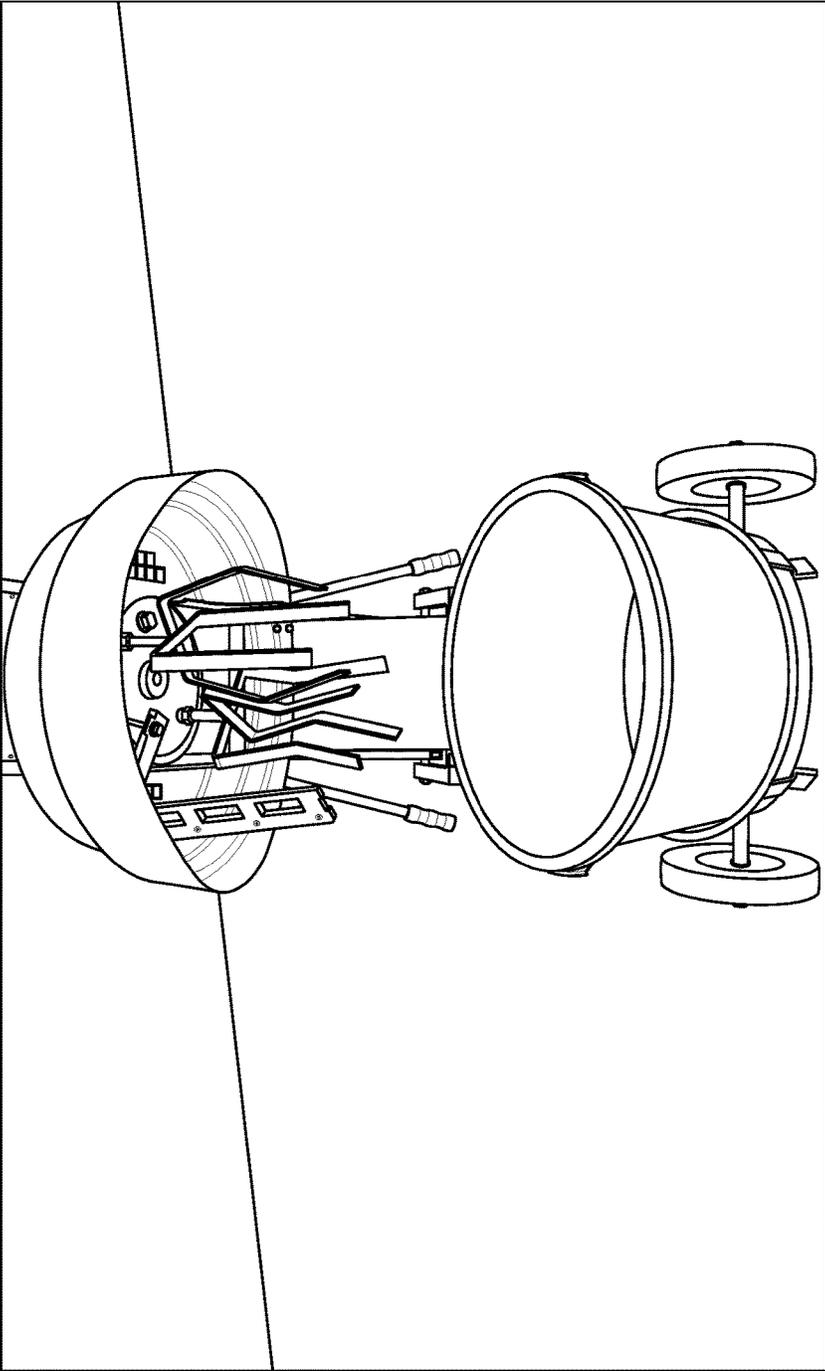
FIG. 22 depicts a mixer for use in mixing resin and aggregate utilized in surface repair according to an embodiment of the present disclosure;

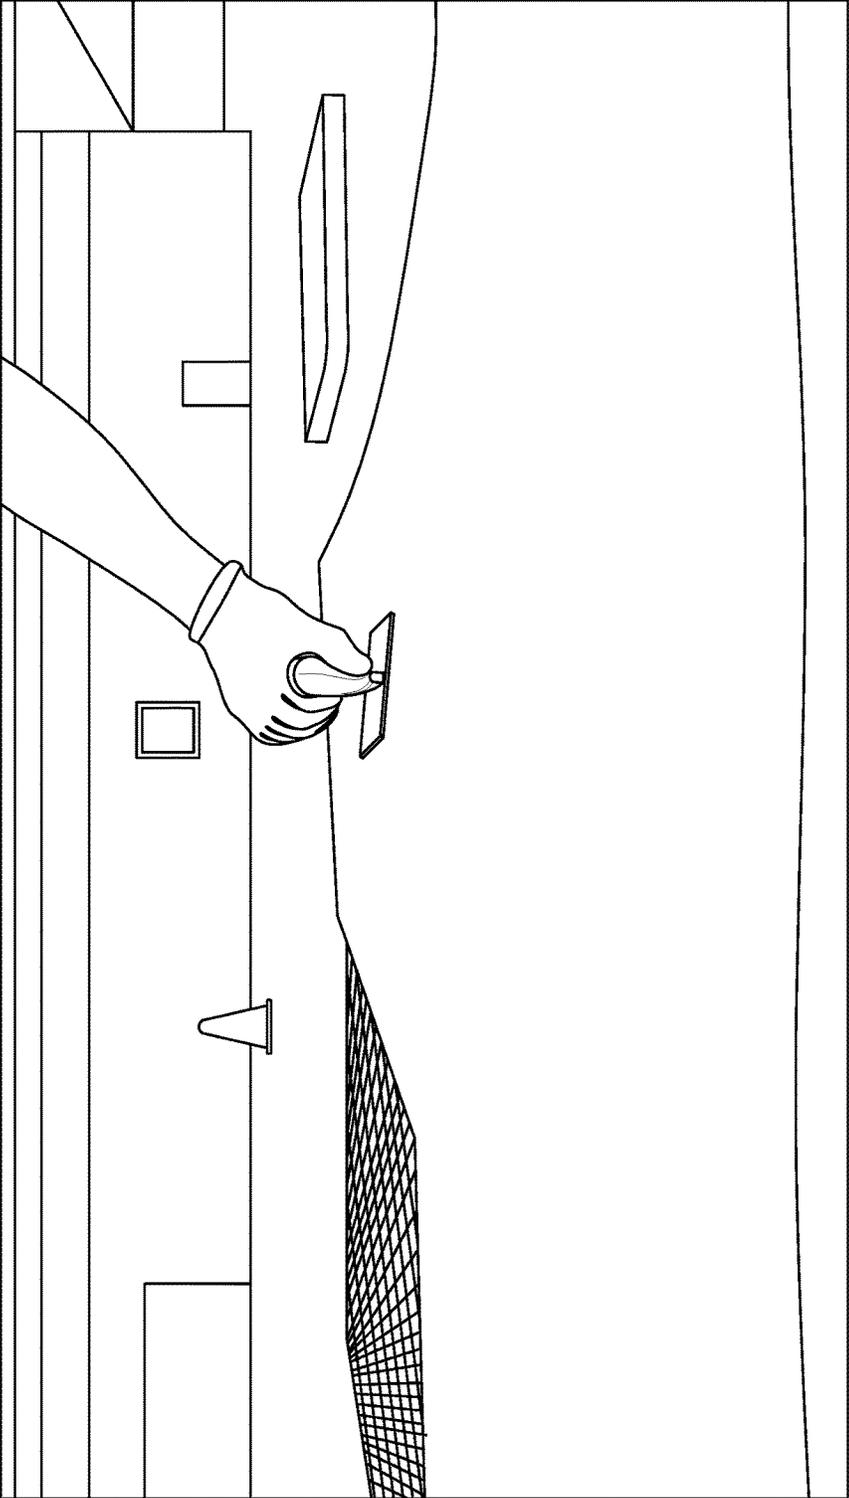
50 FIG. 23 depicts a process for finishing a repair to a damaged surface according to an embodiment of the present disclosure;

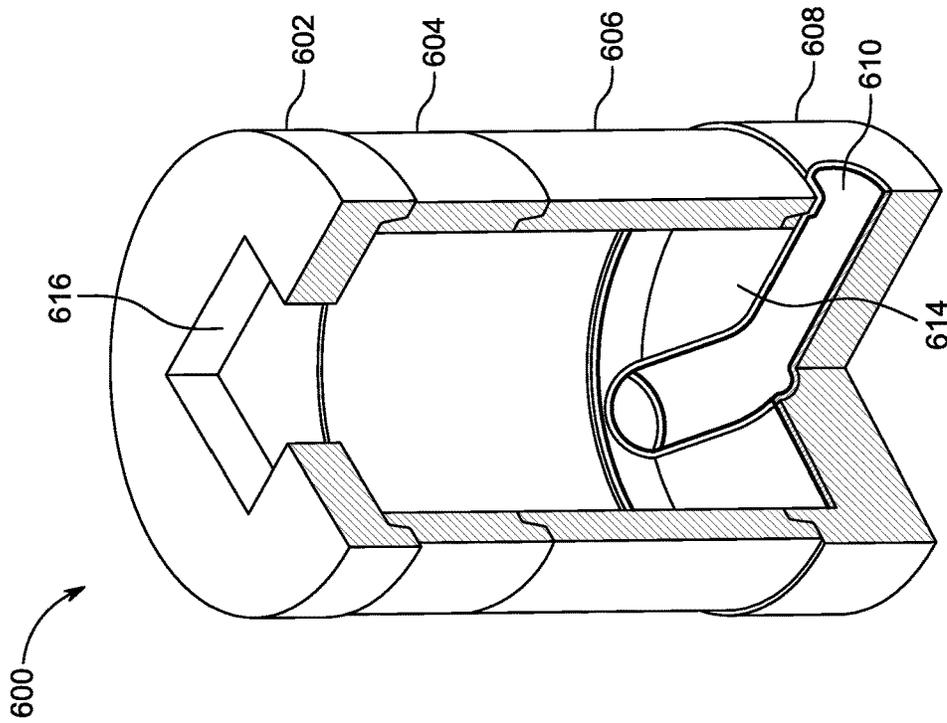
FIG. 24 depicts a manhole assembly having a damaged inner surface; and

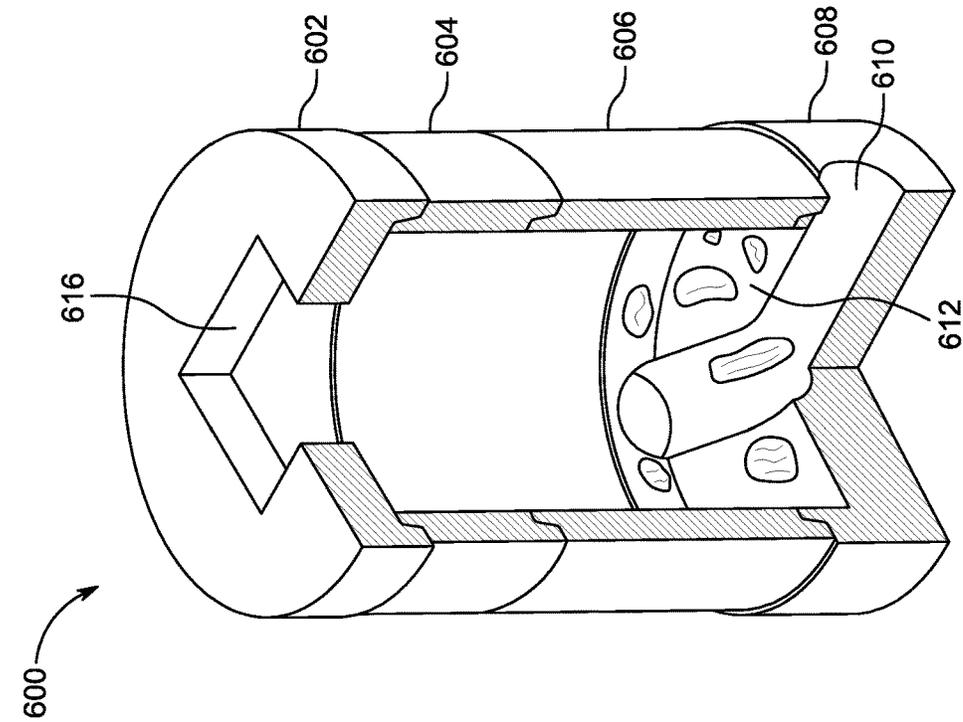
55 FIG. 25 depicts the manhole assembly of FIG. 24 after repairs according to an embodiment of the present disclosure.
