(54) **INTERCHANGEABLE BASE STEEL
STRUCTURE STORAGE ASSEMBLY**

A storage rack assembly includes a base steel structure which is interchangeably connected to the storage rack above. The base steel structure assembly is comprised of structural material with bolted connections which allow for the replacement or changing of damaged material due to accidental forklift contact all while the above storage system stays in place.

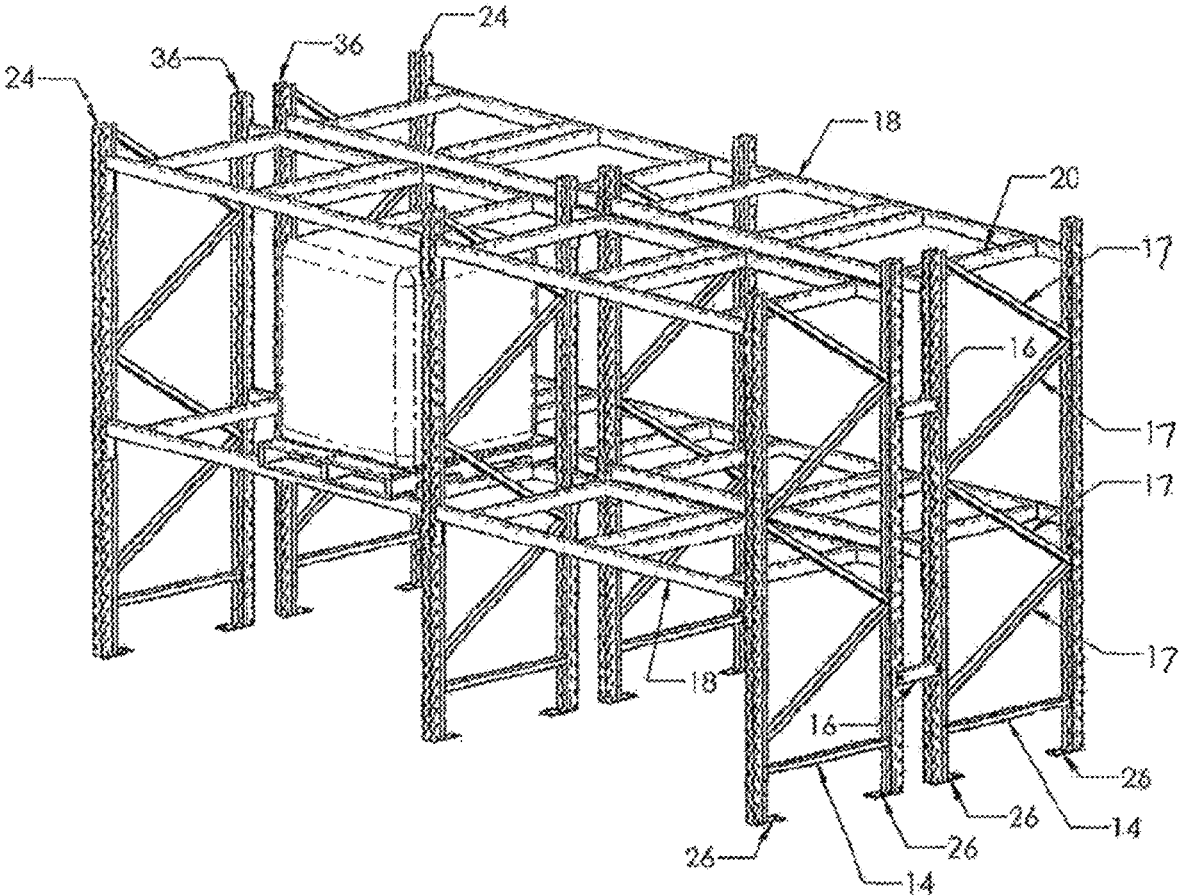
FIG. 1 is a side perspective view of a prior art storage rack;

FIG. 1 shows an example of a prior art storage rack that may be retrofitted to make a rack in accordance with the present invention. A preferred embodiment of the present invention is shown in FIGS. 2-11.

The rack of FIG. 1 has a multitude of forward columns 24, and a multitude of rear columns 36, and horizontal load

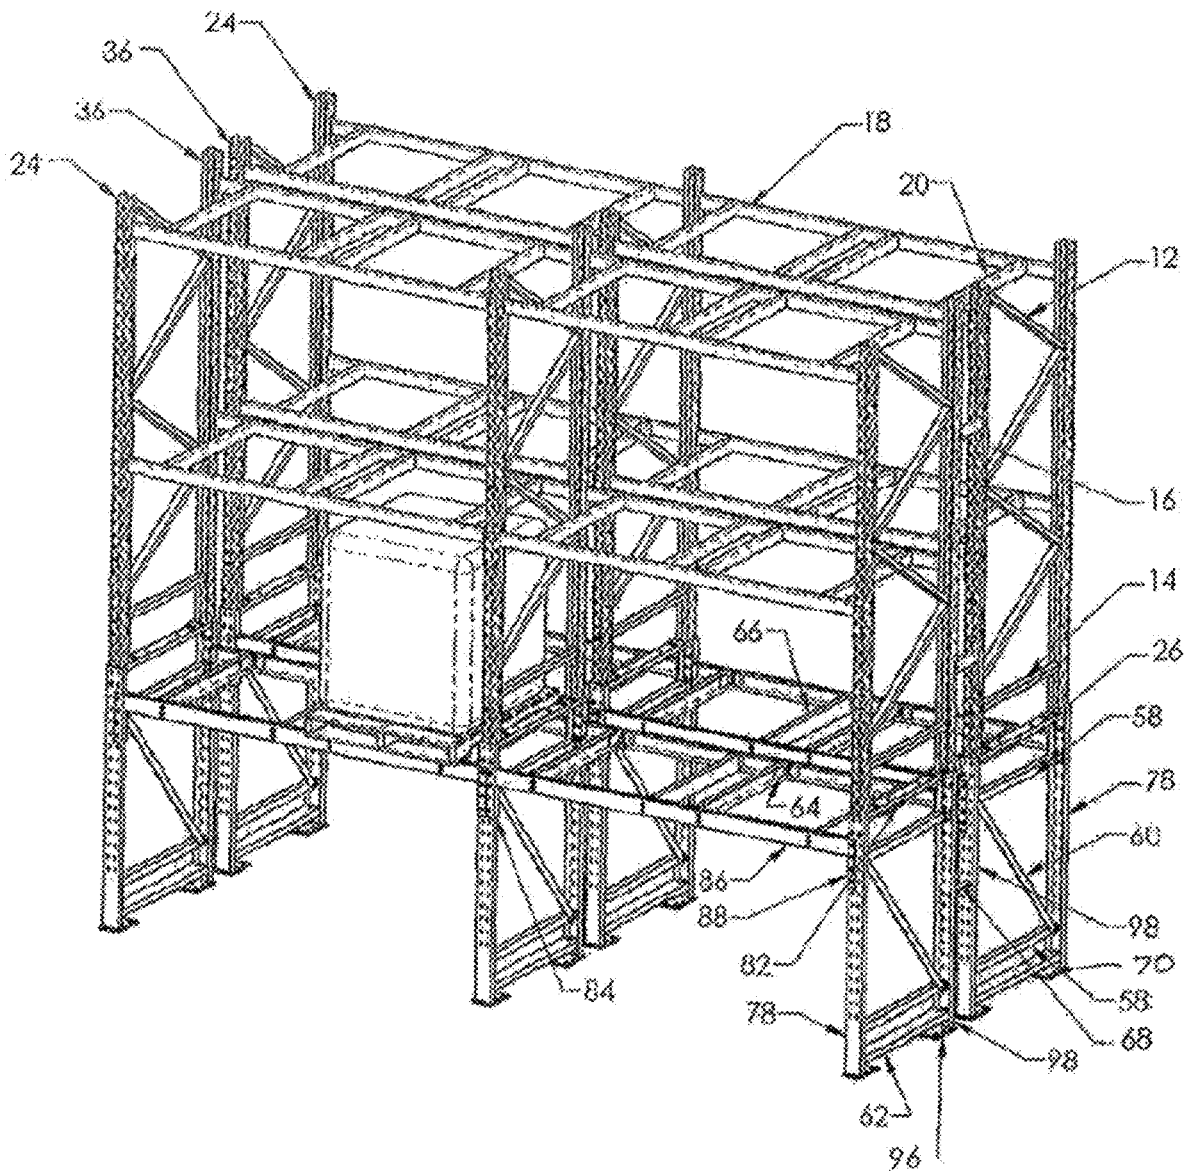
FIG. 2 is a side perspective view of a first embodiment of a storage system made in accordance with the present invention;

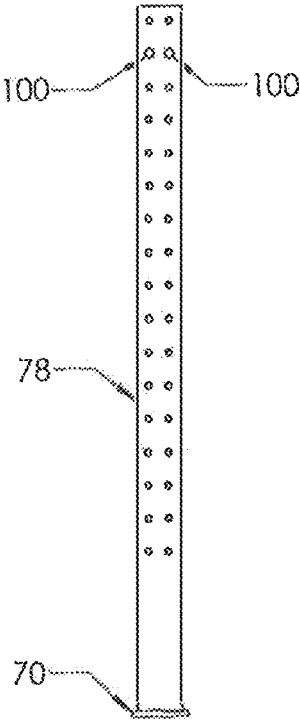
FIG. 3 is a front view of a base portion of the storage system of FIG. 2;

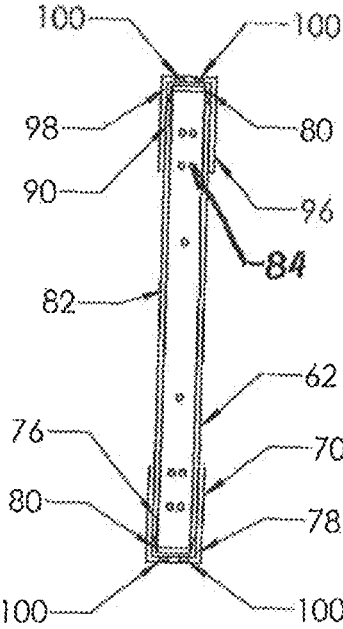
FIG. 4 is a top view of the base portion of the storage system in FIG. 2;

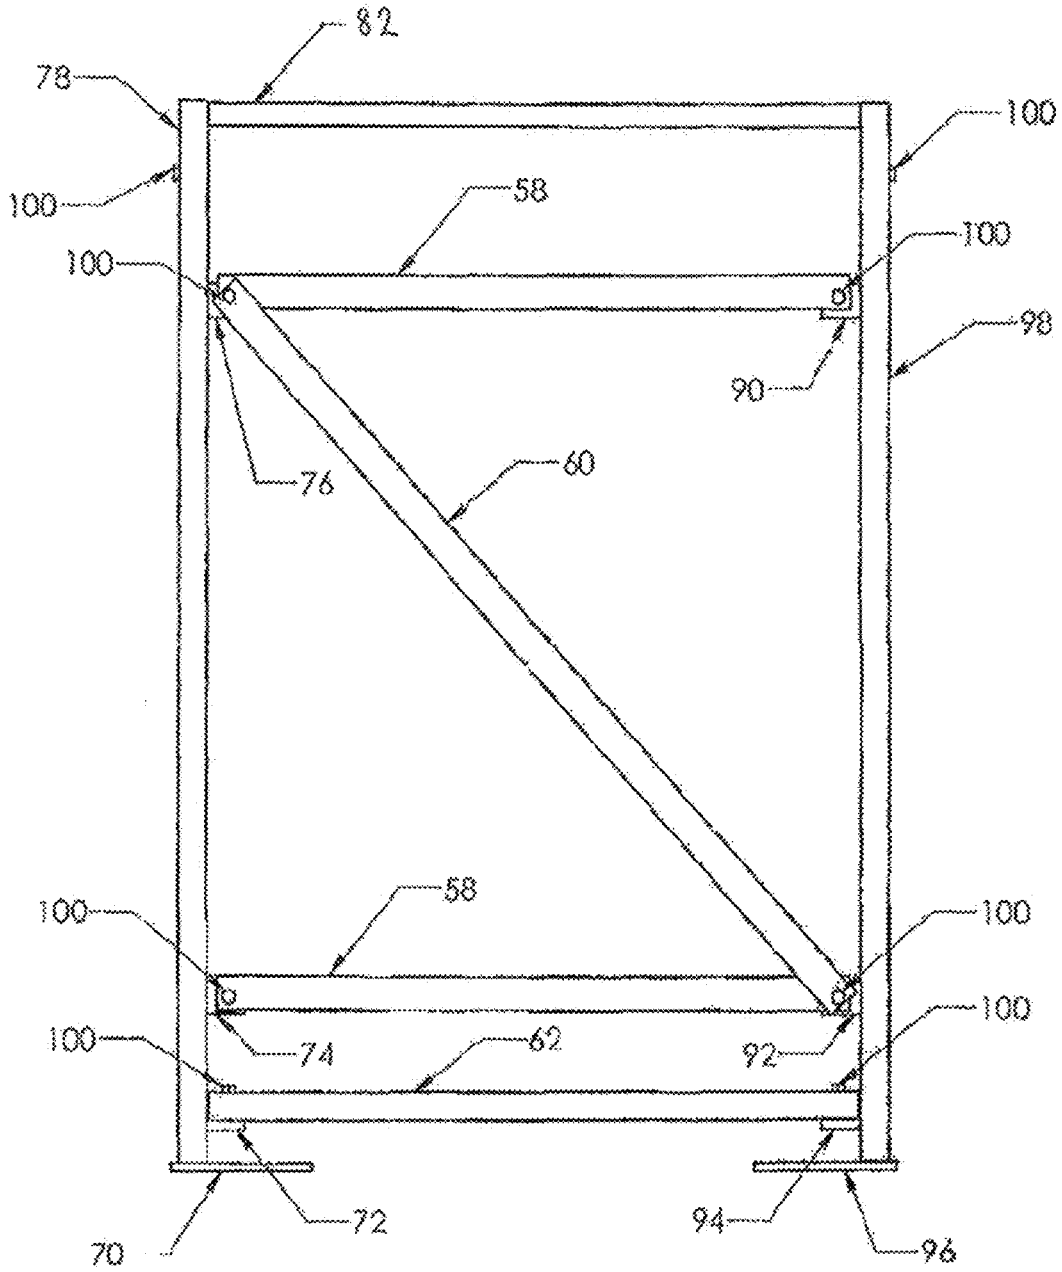
FIG. 5 is a side view of the base portion of the storage system in FIG. 2;

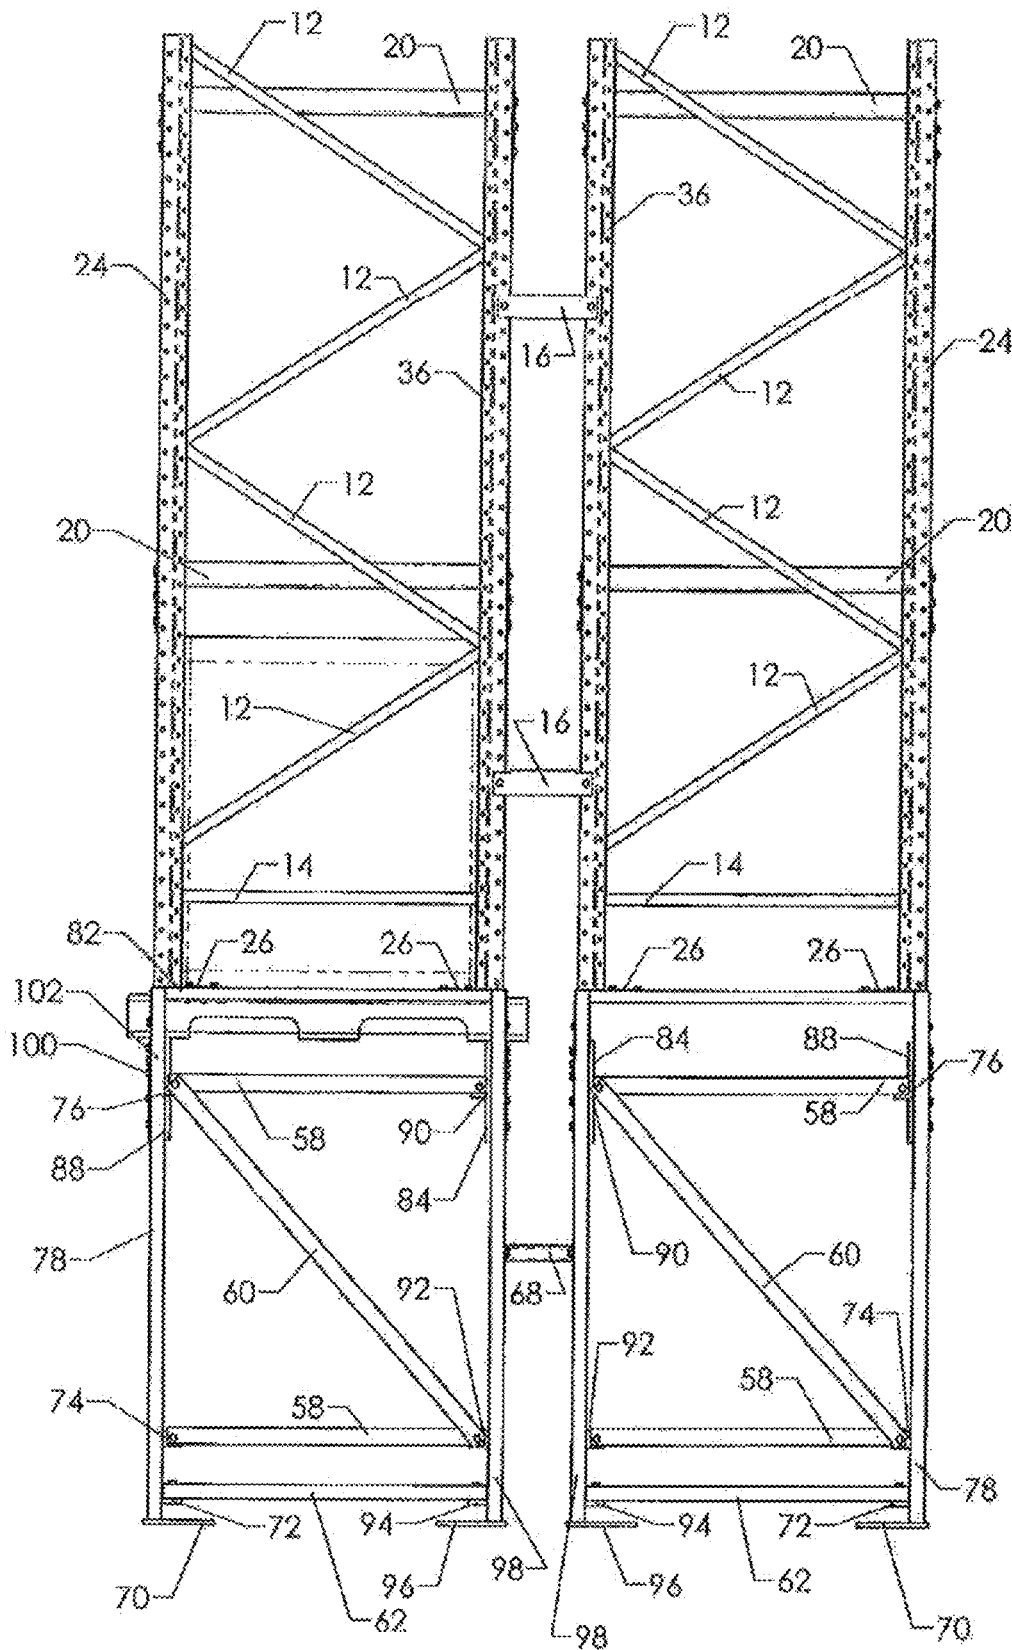
FIG. 6 is a side view of the storage system of FIG. 2;

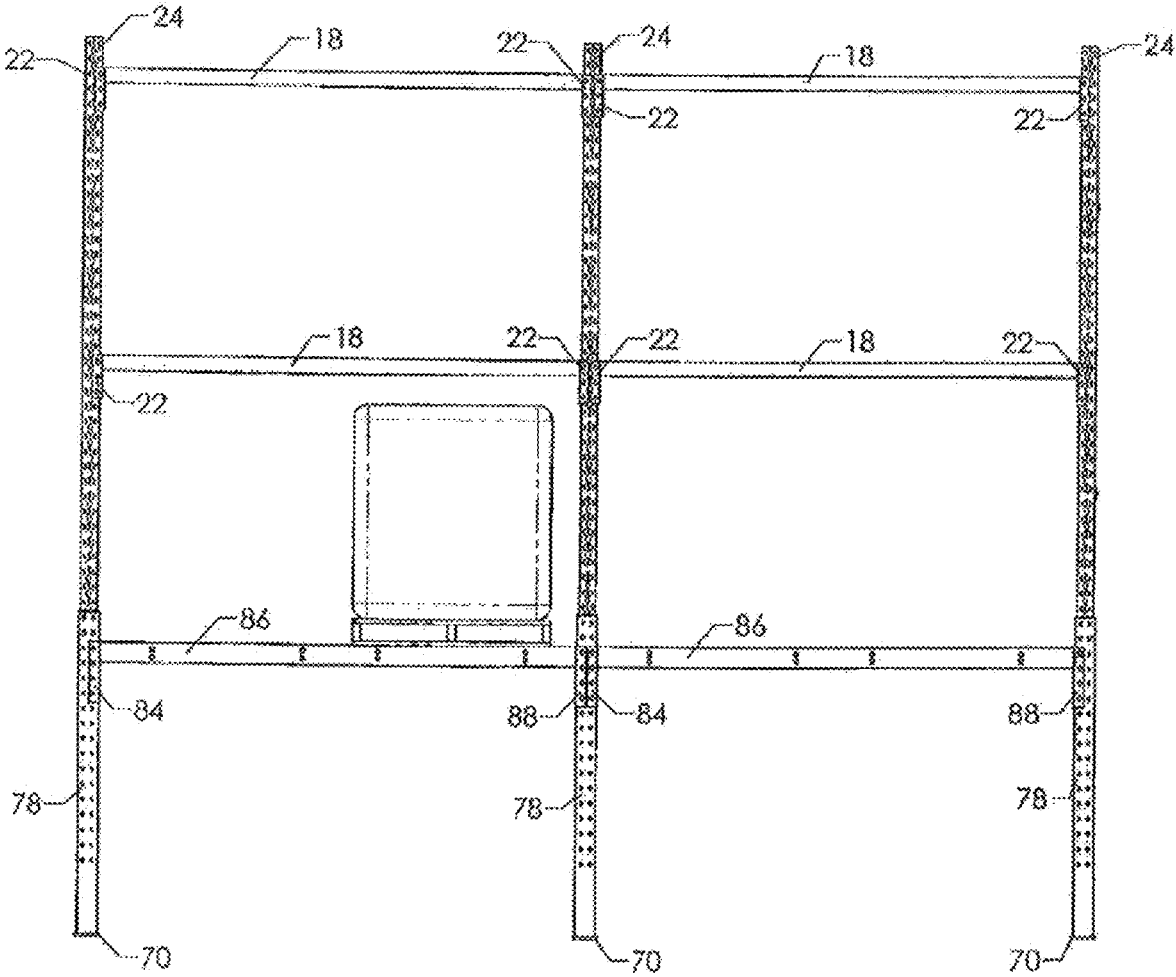
FIG. 7 is a front view of the storage system of FIG. 2;

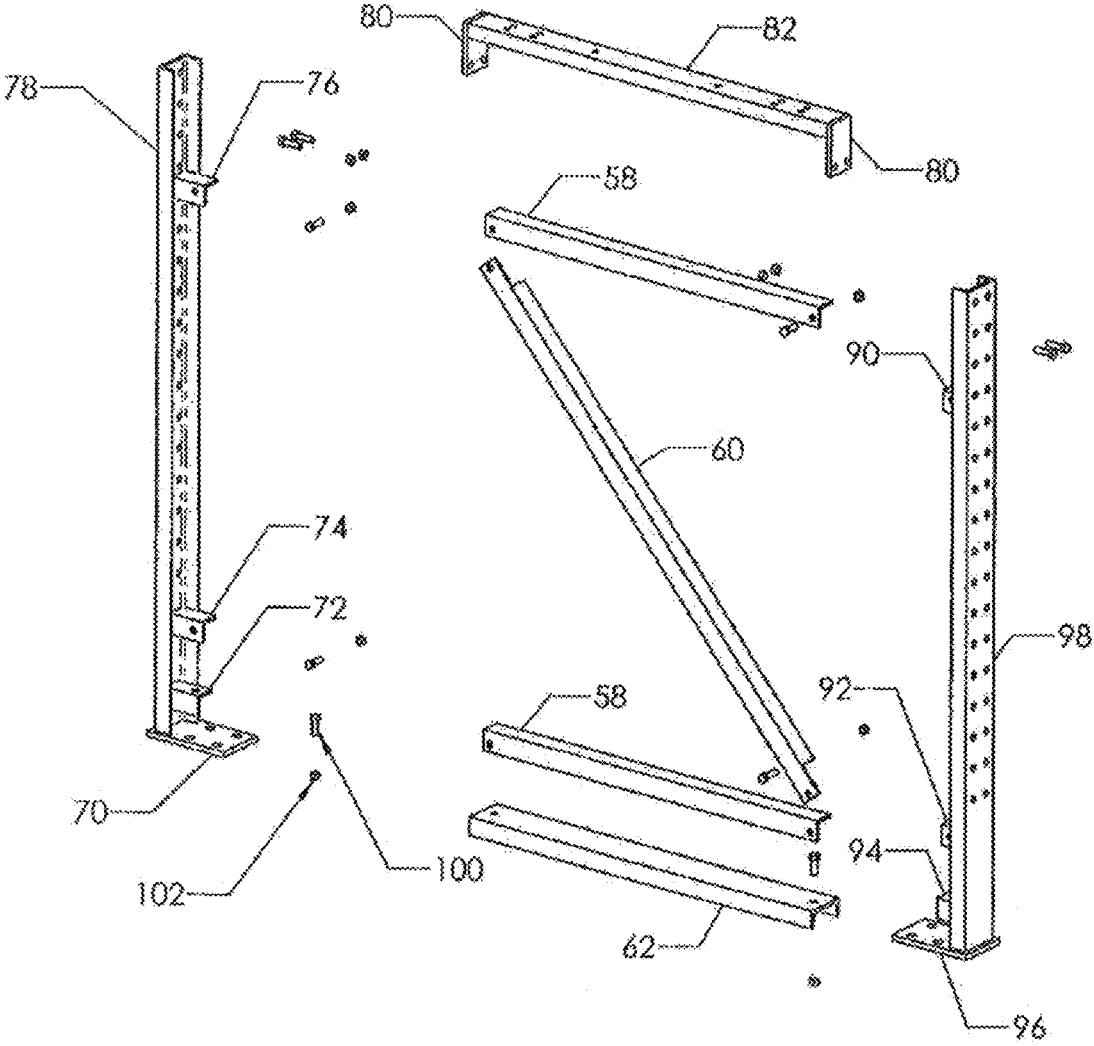
FIG. 8 is a side perspective view of a dismantled base;

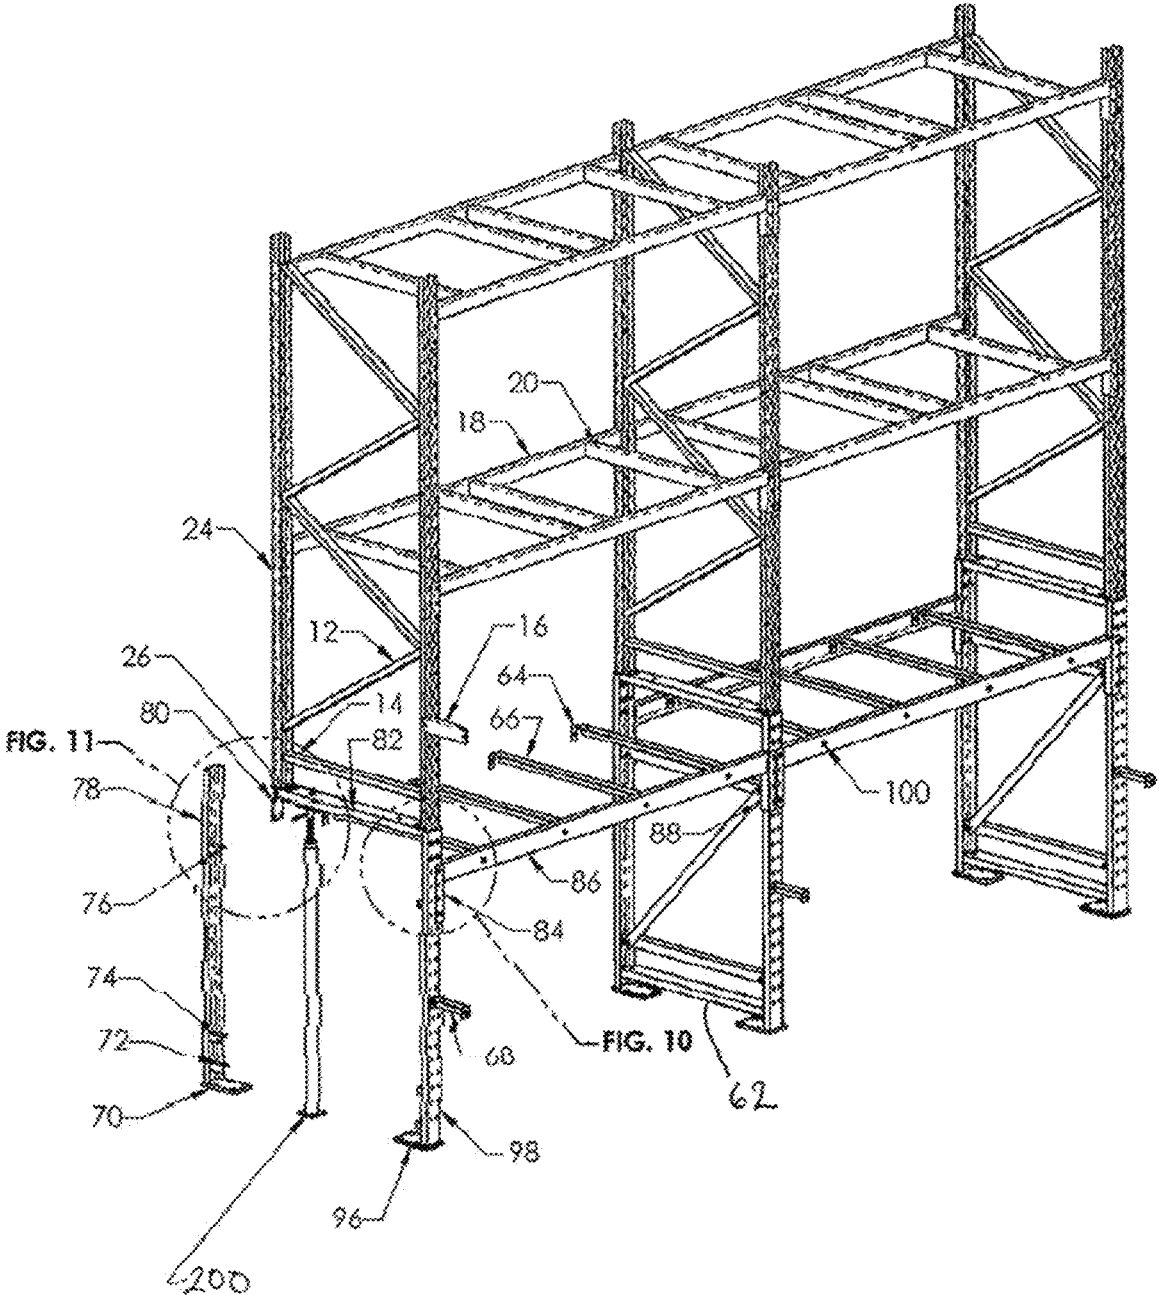
FIG. 9 is a side perspective view of the base being repaired while being supported by the load jack;

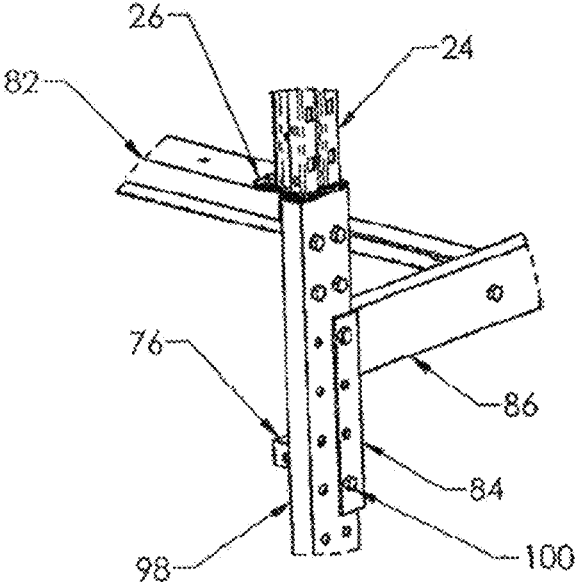
FIG. 10 is an enlarged perspective view of the encircled area 10 in FIG. 9 of the base and above upright connection;

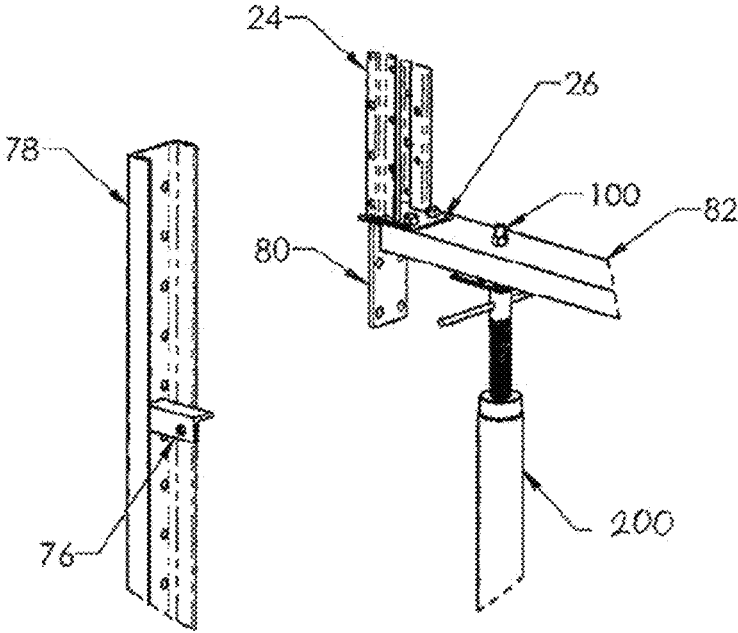
FIG. 11 is an enlarged perspective view of the encircled area 11 in FIG. 9 showing the base and above upright connections as well as a portion of the sub assemblies while under repair;

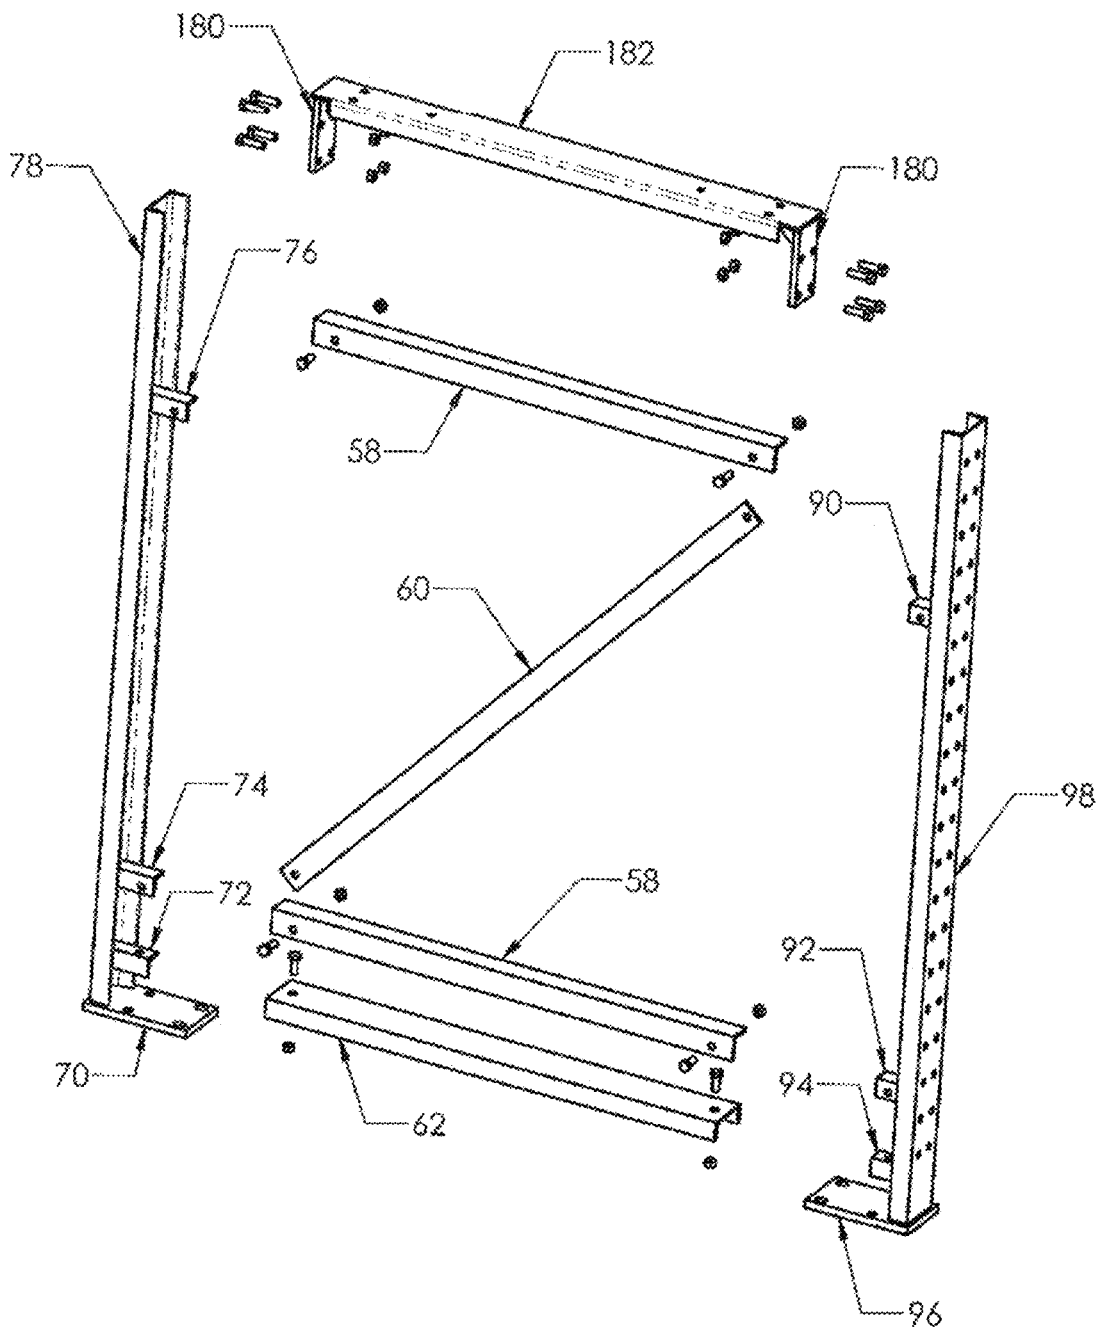
FIG. 12 is a side perspective view of the dismantled base of an alternate embodiment of the storage system; and

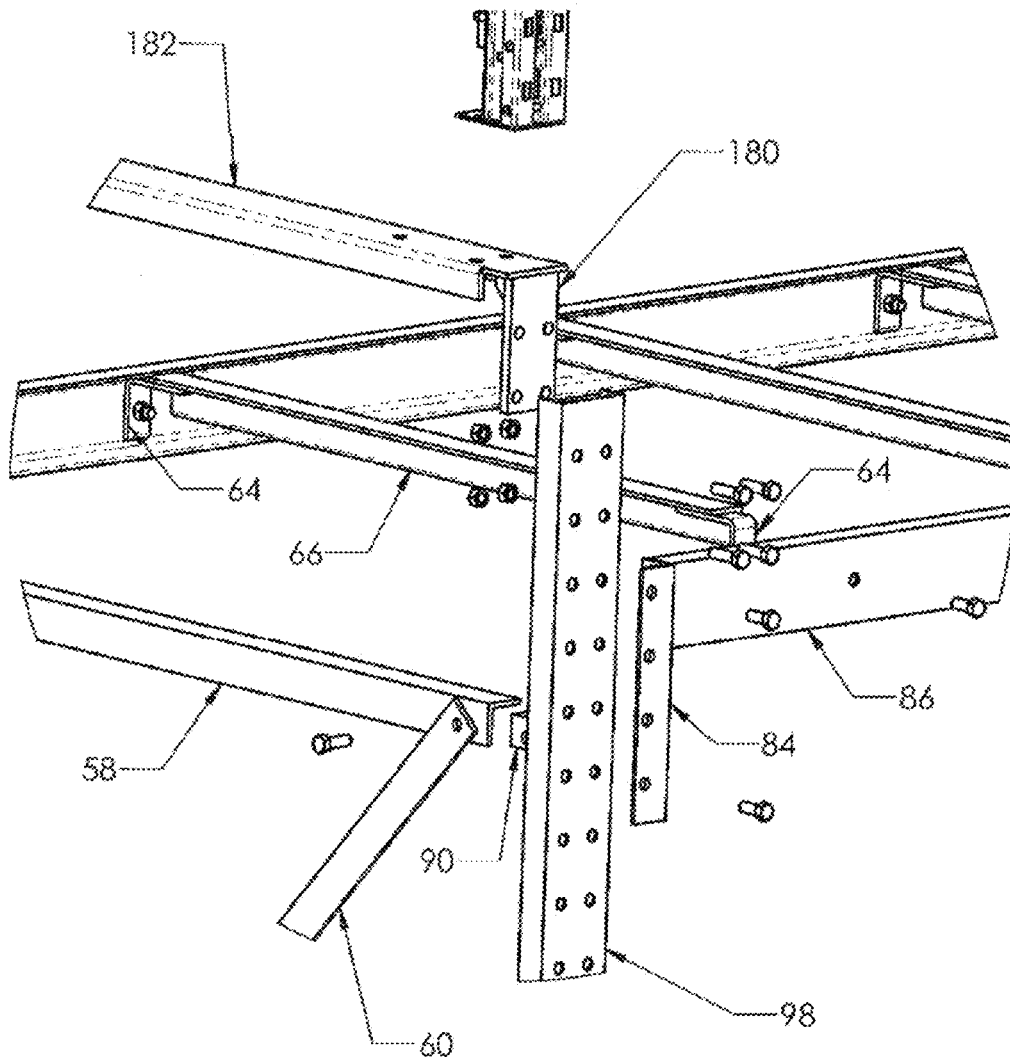
FIG. 13 is an exploded side perspective view of the upper right portion of the base showing an enhanced connection detail.
