(11) **EP 2 161 408 A2**

(54) **Repaired turbine exhaust strut heat shield vanes and repair methods**

(57) A method (50) of repairing a turbine exhaust case strut heat shield vane includes removing (52) a damaged portion of the vane, solution heat treating (54) the vane, attaching (58) a replacement section to the vane, and relieving local stresses (60) in an attachment area between the replacement section and the vane.

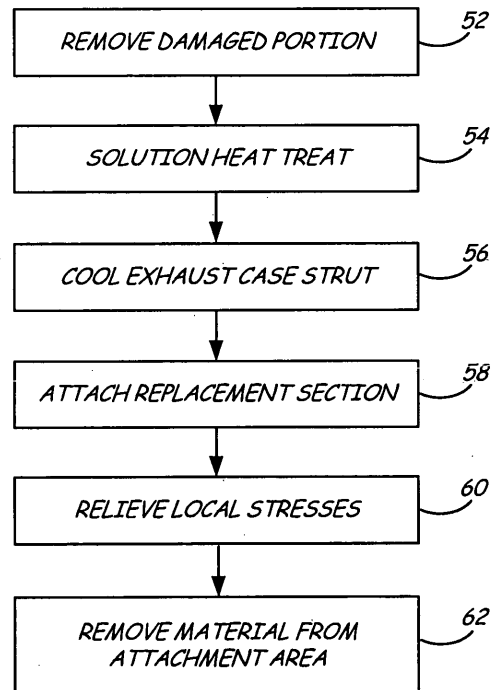
[0010] FIG. 3 is a flow chart of an exemplary embodiment of a method for repairing the turbine exhaust strut heat shield vane shown in FIG. 2.

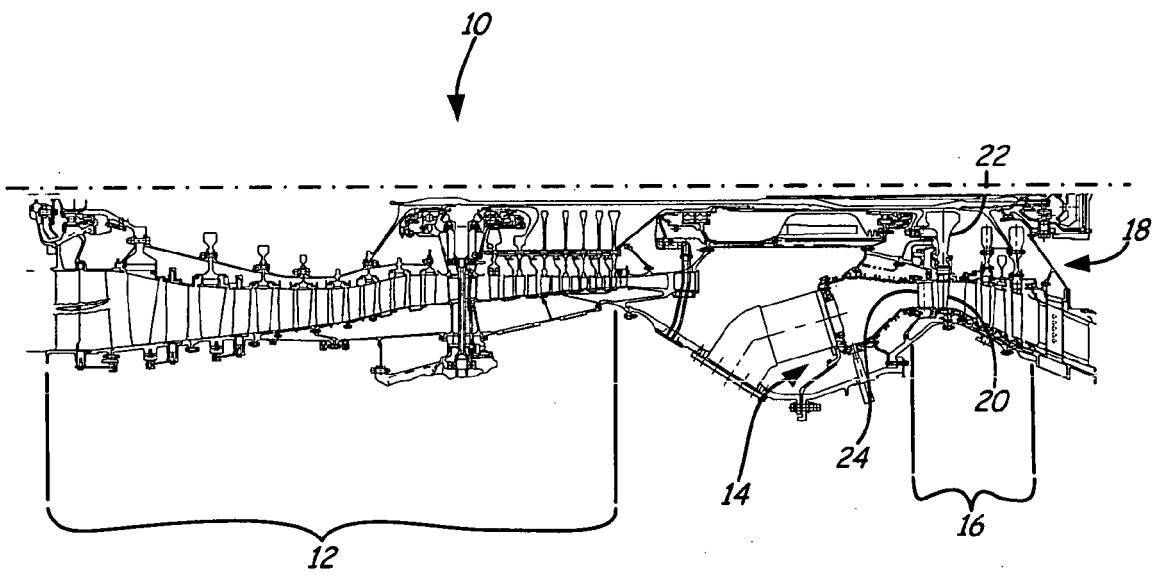
[0008] FIG. 1 is an axial section view of an industrial gas turbine including a turbine exhaust case.

[0012] FIG. 1 is a partial axial section view of industrial gas turbine 10 including compressor 12, combustor 14, turbine section 16, and exhaust case 18. Although the section view of FIG. 1 shows only one combustor 14, turbine 10 will generally include multiple combustors 14 circumferentially distributed around a turbine main shaft (not shown). Turbine section 16 includes a plurality of rotating blades 20 secured to a rotatable rotor disk 22. A plurality of stationary vanes 24 are each alternately positioned upstream of each of the rotating blades 20. The vanes 24 are dimensioned and configured to guide the working gas over the blades 20.

[0014] Exhaust case 18 is positioned downstream of the last row of turbine blades 20 shown in FIG. 1. FIG. 2 is a detail view of exhaust case 18 including a pair of annular rings, such as diffusers 34 and 36, struts 38, and heat shield vanes 40. Diffuser 34 forms the inner wall of the working gas path and diffuser 36 forms the outer wall of the working gas path. Radially extending struts 38 are circumferentially distributed about the engine axis and span the gas path between diffusers 34, 36. Each radially extending strut 38 is surrounded by vane 40. Vanes 40 act both to direct working gas flow through exhaust case 18 and to shield load bearing struts 38 from heat.

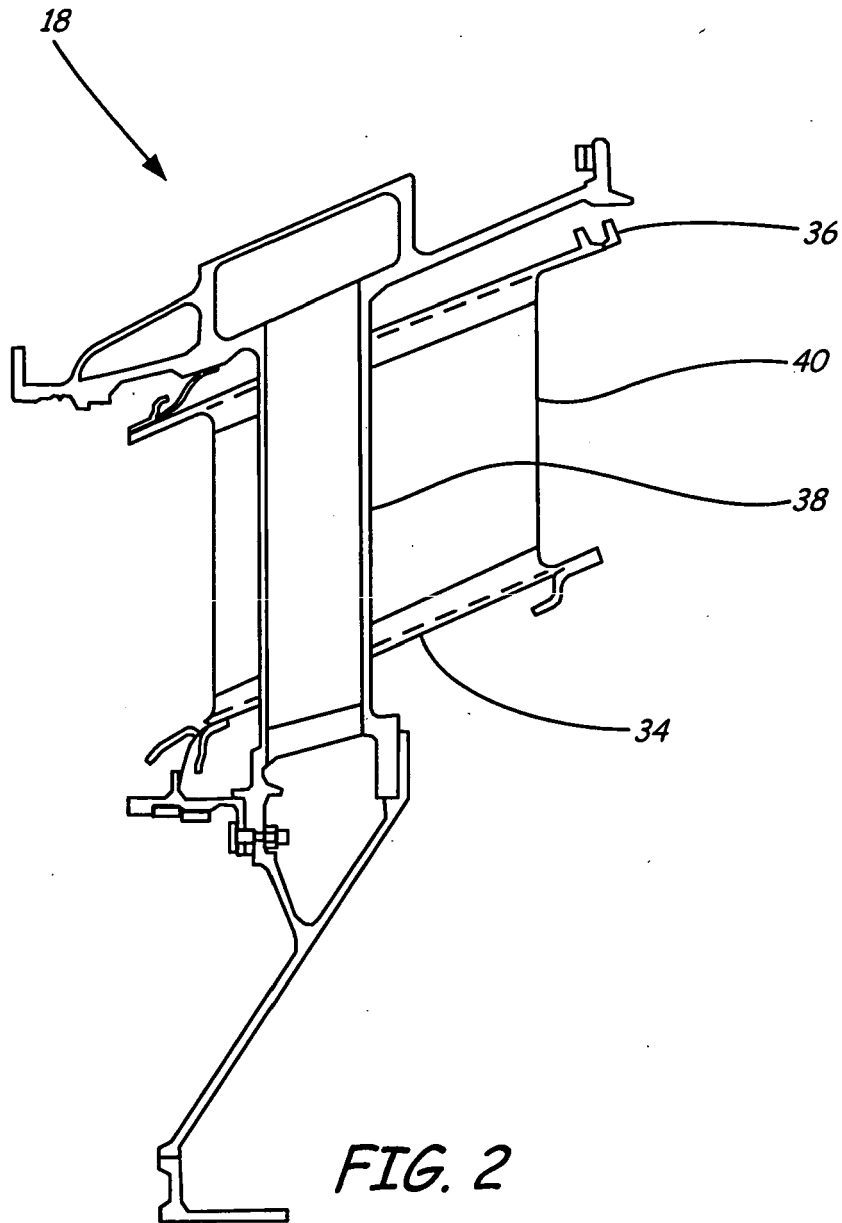
[0009] FIG. 2 is a detail view of the turbine exhaust case including a strut heat shield vane from the turbine of FIG. 1.
