(10) **Patent No.:** US 8,506,159 B2  
(45) **Date of Patent:** Aug. 13, 2013

(54) **METHOD FOR DETECTING DEFECT IN MATERIAL AND SYSTEM FOR THE METHOD**

(73) Assignee: **Nippon Steel & Sumitomo Metal Corporation**, Tokyo (JP)

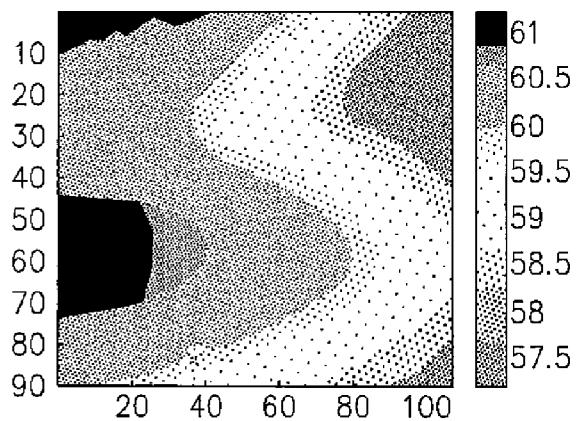
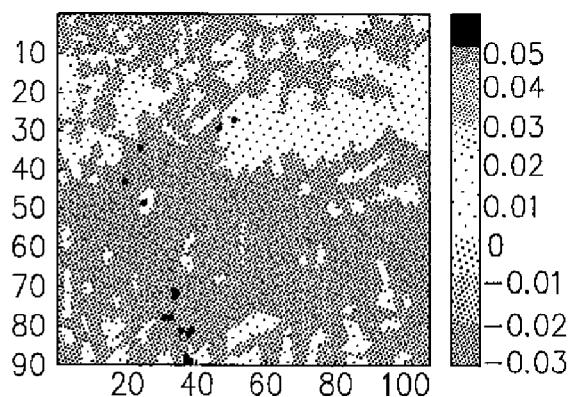
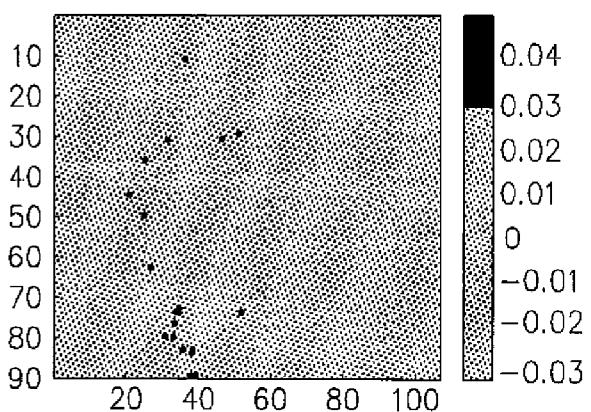
FIG.2A

FIG.2B

FIG.2C

FIGS. 2A, 2B and 2C are schematic diagrams to illustrate an example of the image data processing performed in the image processing part of the detecting device.

An image processing part 302 in the detecting device 3 is for processing the thermal image data input into the inputting part 301 in accordance with a predetermined image data processing procedure. FIGS. 2A, 2B and 2C are schematic diagrams to illustrate an example of the image data processing performed in the image processing part 302 of the detecting device 3. FIG. 2A shows thermal image data input into the inputting part 301. FIG. 2B shows Laplacian-processed thermal image data where the temperature is converted into Laplacian value. FIG. 2C shows a binarized image of the thermal image data of Laplacian value. Laplacian processing is performed in order to reduce a disturbance in the thermal image data (FIG. 2A) provided by temperature irregularity, and also to detect the heat balance taking place at the surface and surface layer of the steel sheet 100 as described later. A surface layer is defined as a part very close to the surface of the material and experientially about one fourth of the thickness region from the surface can be regarded as the surface layer in the case of a 1-2 mm thick steel sheet.

Since the absolute value of Laplacian  $\Delta_{xy}T$  at the position of the defect 101 is detected larger in the inspection area S, it can be said that Laplacian processing can provide the image where the defect 101 is extracted (see the black colored portion in FIG. 2C). Also the type of the defect 101 can be determined based on whether the value of Laplacian  $\Delta_{xy}T$  is positive or negative.

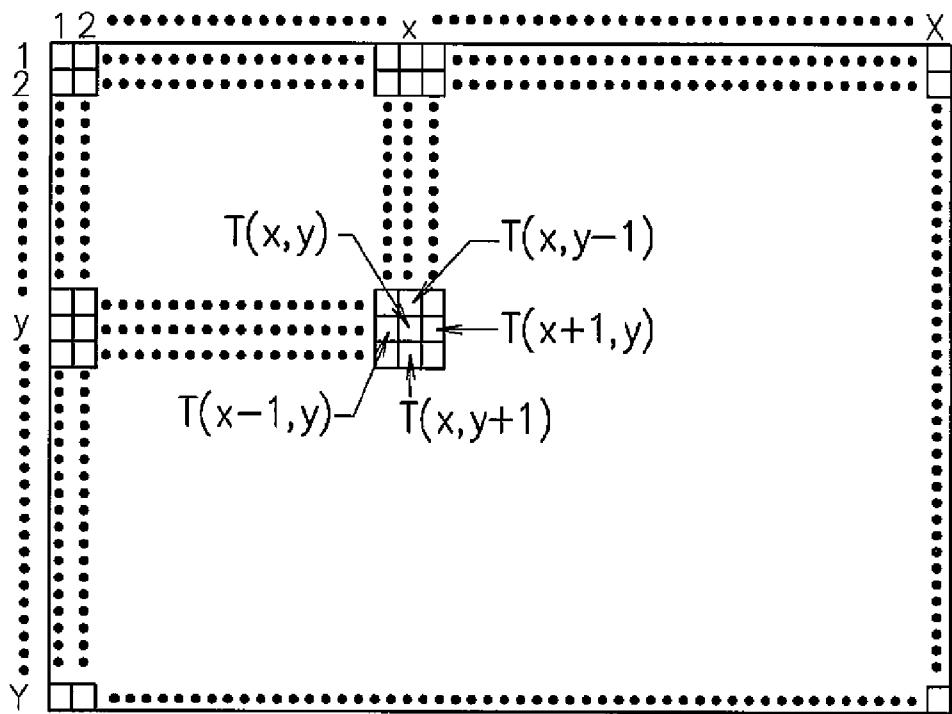
FIG.5

FIG. 5 is an explanatory diagram explaining the relationship between pixels for calculating Laplacian.

A Laplacian  $\Delta_{xy}T$  with respect to a pixel is represented by an expression (1) below. As shown in FIG. 5, the right-hand side of the expression (1) can be calculated using a surface temperature  $T(x, y)$  of the pixel based on thermal image data obtained by the infrared thermography camera and the temperatures of each of the pixels located respectively above, below, right side of and left side of the pixel; i.e.,  $T(x+1, y)$ ,  $T(x, y+1)$ ,  $T(x-1, y)$ ,  $T(x, y-1)$ , where  $h$  is the size of the pixel. In the above, Laplacian is calculated with respect to each single pixel. Laplacian can also be calculated with respect to each block consisting of a plurality of pixels (e.g., 2-pixel by 2-pixel).

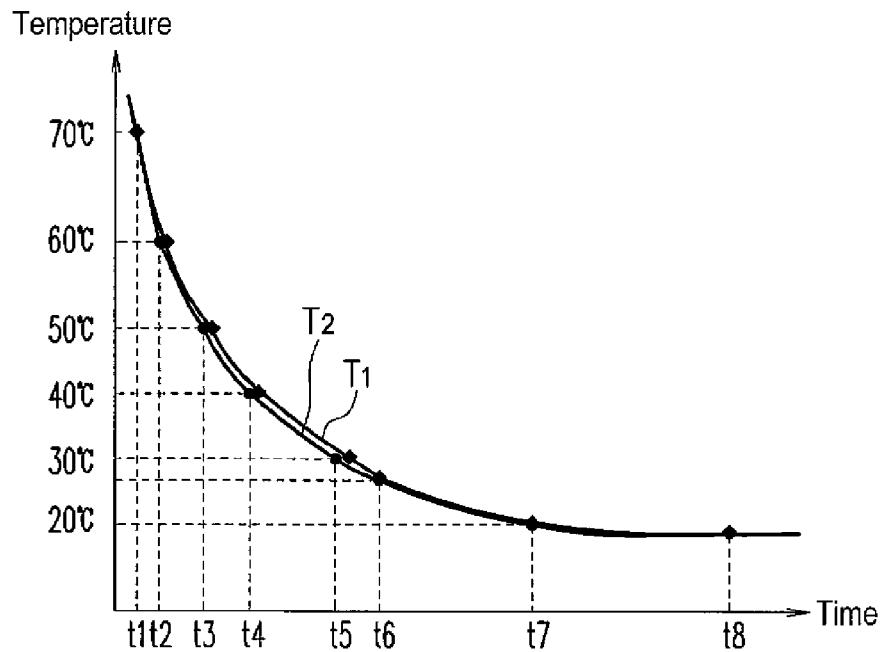
FIG.6A

FIGS. 6A/6B are a graph showing temperature characteristics curves representing surface temperature based on thermal image data in a cooling-down/being-heated-up process obtained by an infrared thermography camera.

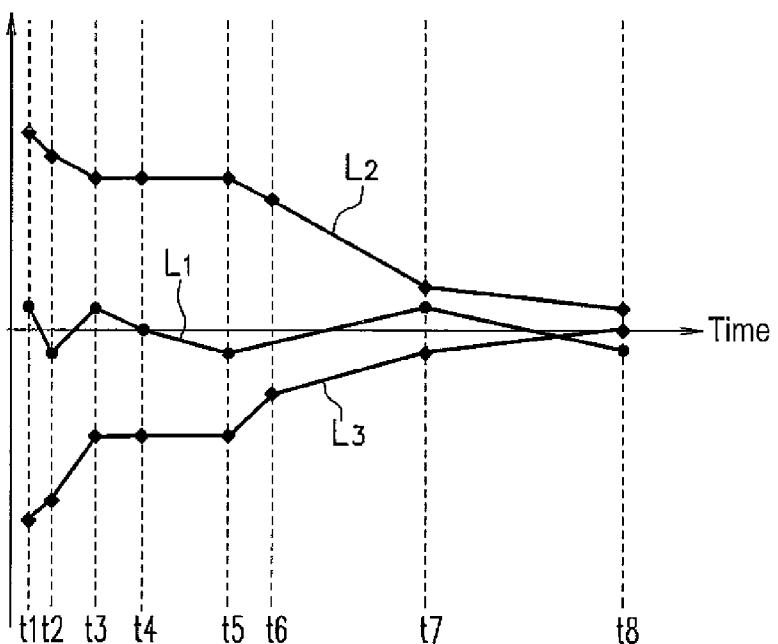
FIG.7A

FIGS. 7A/7B are a graph showing Laplacian corresponding to temperature characteristics curves of FIGS. 6A/6B.

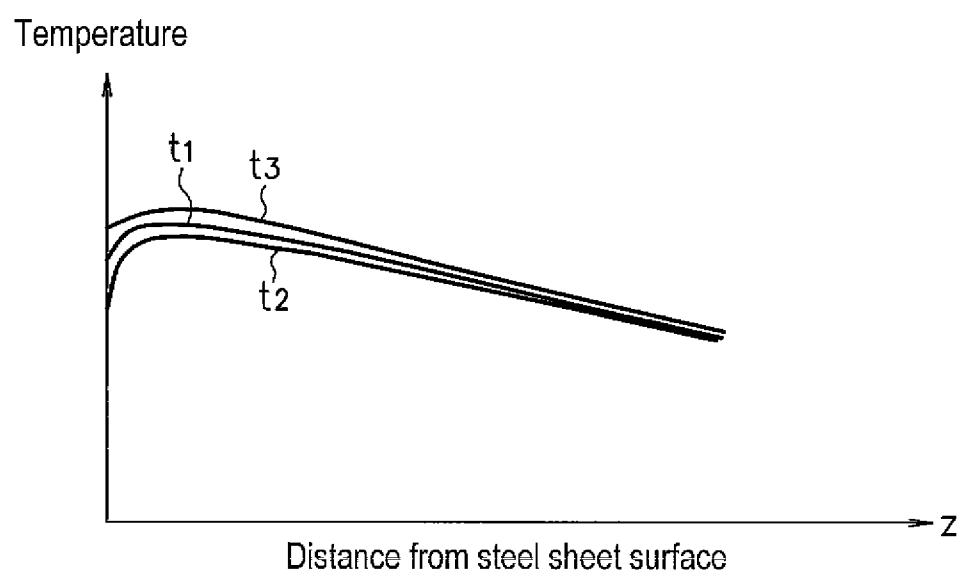
FIG.8

FIG. 8 is a graph showing temperature distribution curves in the surface layer.

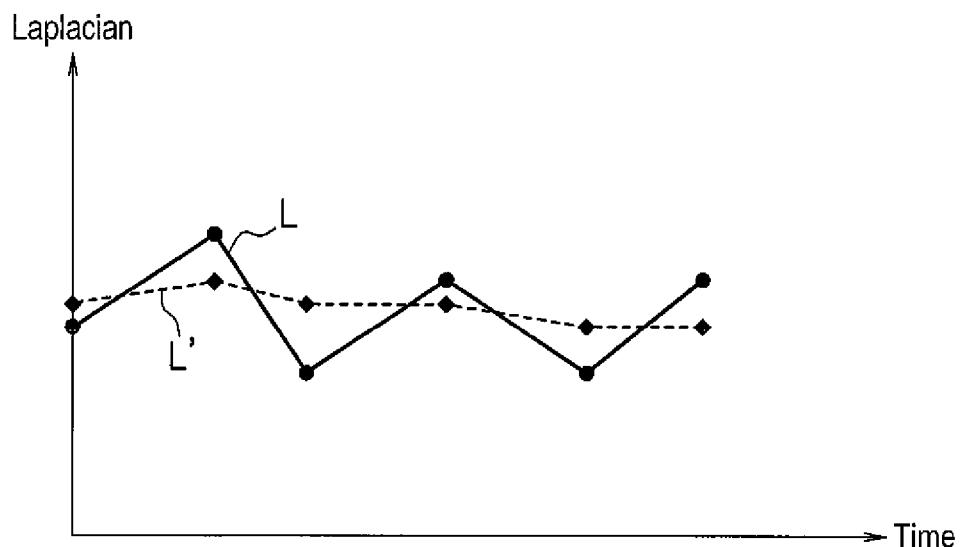
FIG.9

FIG. 9 is a graph showing an effect by Gaussian filtering with respect to thermal image data.

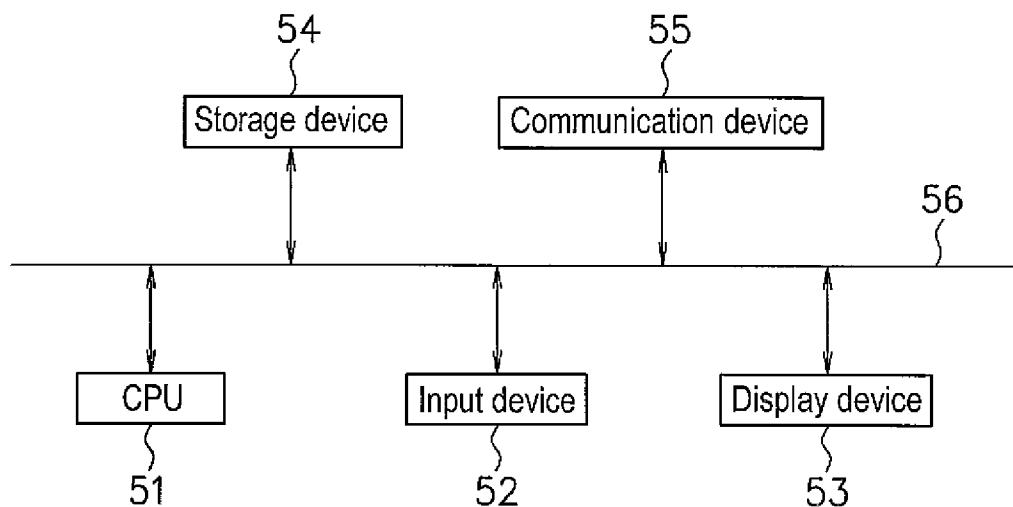
FIG.10

FIG. 10 shows a hardware configuration of a computer system functioning as a detecting device.

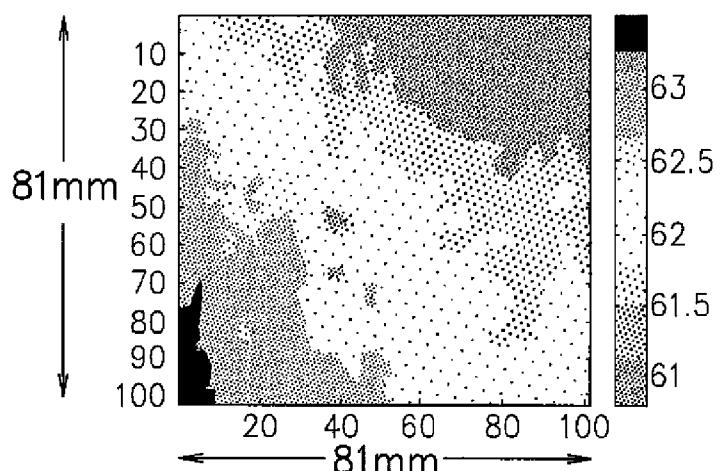
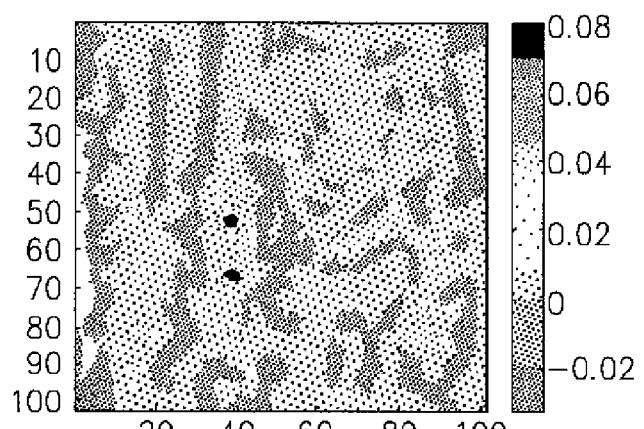
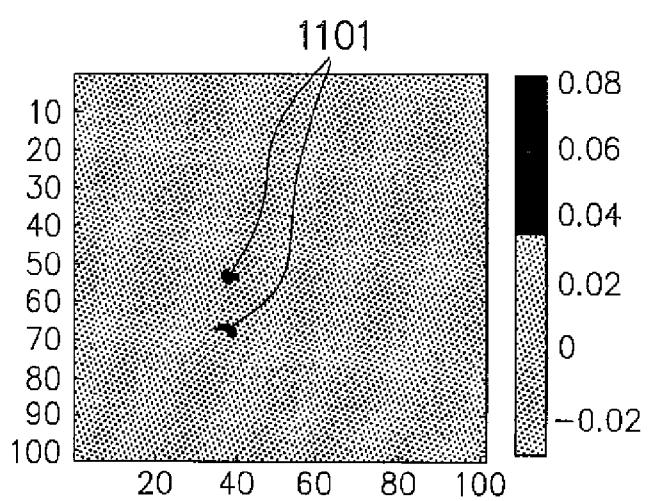
FIG.11A

FIG.11B

FIG.11C

FIGS. 11A, 11B and 11C are an example of an image showing detecting a defect in the cooling down process, wherein the defect is a foreign material or a void located in the surface layer of the steel sheet.

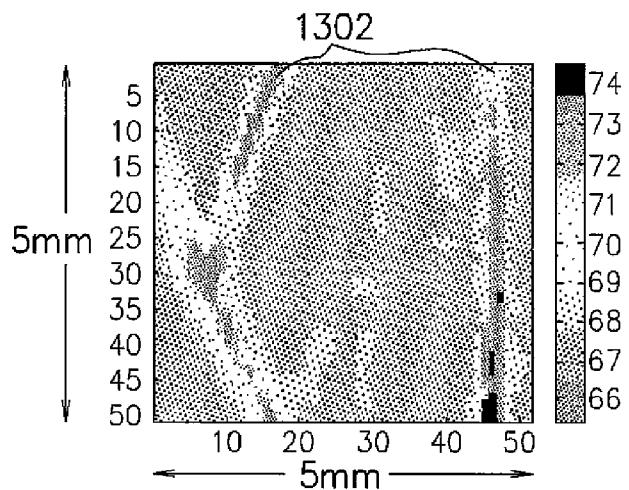
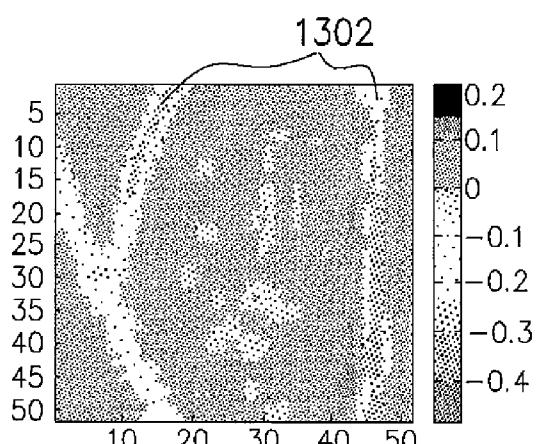
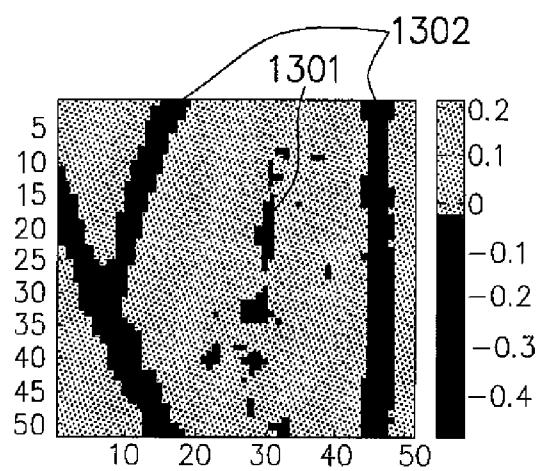
FIG.13A

FIG.13B

FIG.13C

FIGS. 13A, 13B and 13C are an example of an image showing detecting a defect in the cooling down process, wherein the defect is a minute sharp dent located on the surface of the steel sheet.

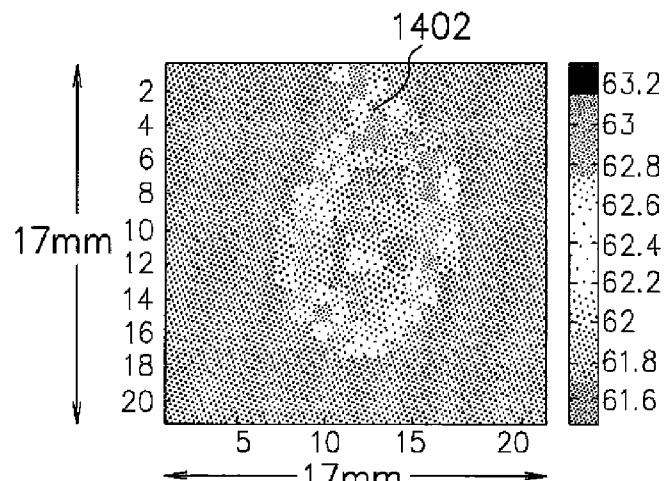
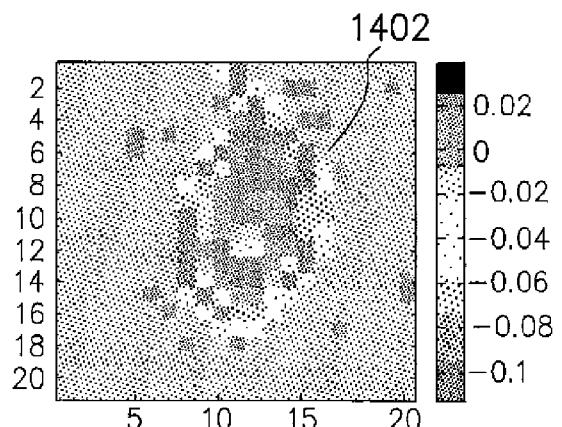
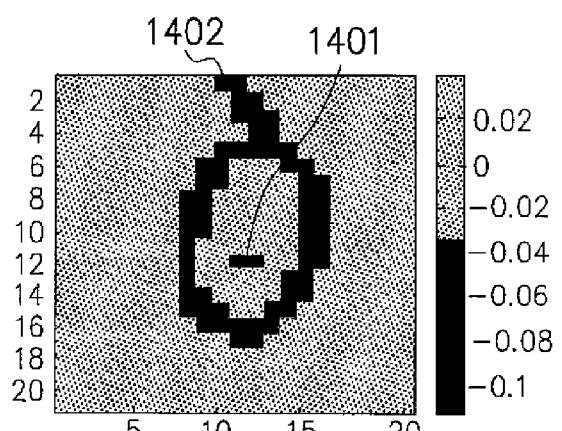
FIG.14A

FIG.14B

FIG.14C

FIGS. 14A, 14B and 14C are an example of an image showing detecting a defect in the cooling down process, wherein the defect is a foreign material attached on the surface of the steel sheet.

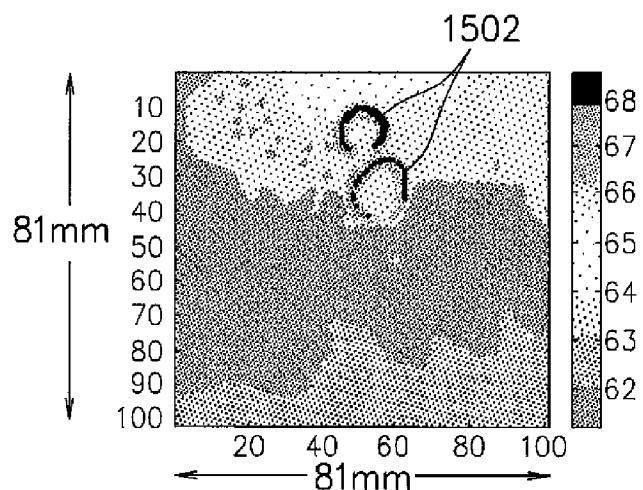
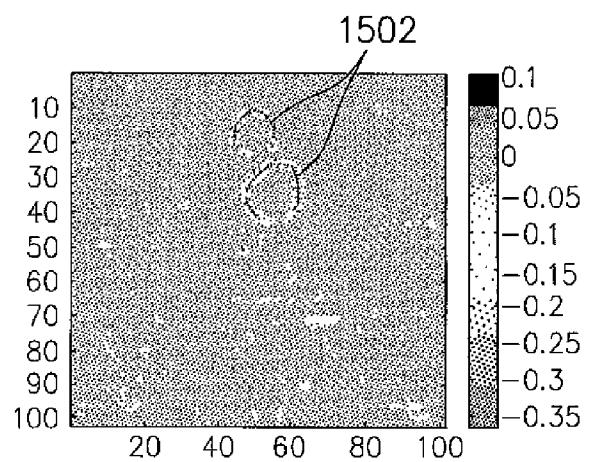
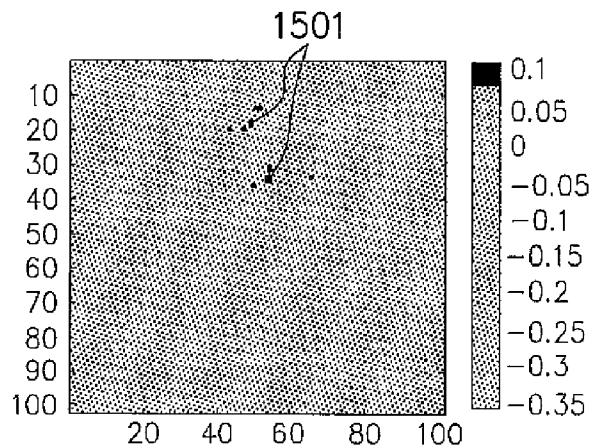
FIG. 15A

FIG. 15B

FIG. 15C

FIGS. 15A, 15B and 15C are an example of an image showing detecting a defect in the cooling down process, wherein the defect is a foreign material in the surface layer of a resin fuel tank for an automobile.

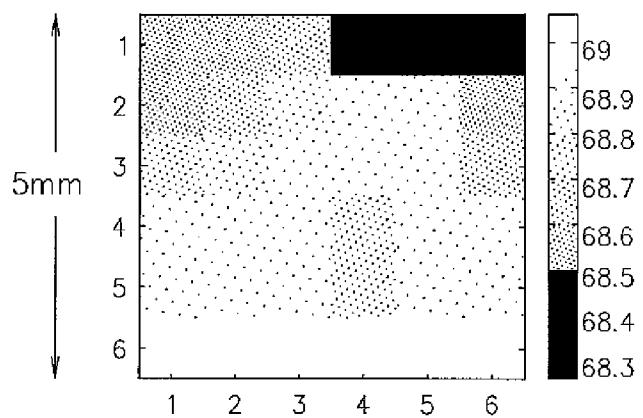
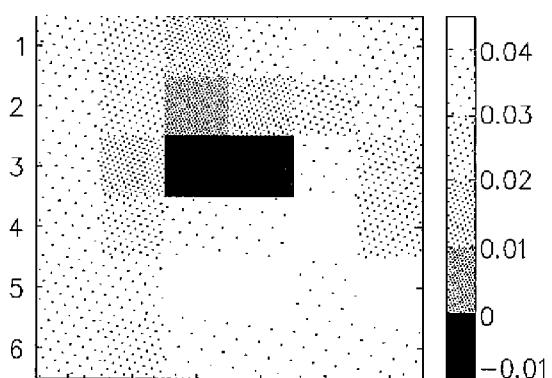
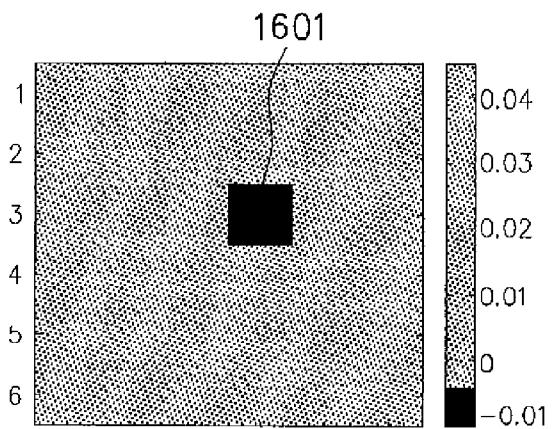
FIG.16A

FIG.16B

FIG.16C

FIGS. 16A, 16B and 16C are an example of an image showing detecting a defect in the heating process, wherein the defect is a minute raised convex portion located on the surface of the steel sheet.

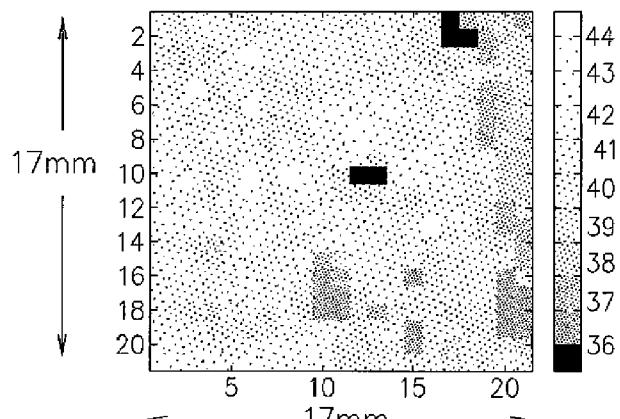
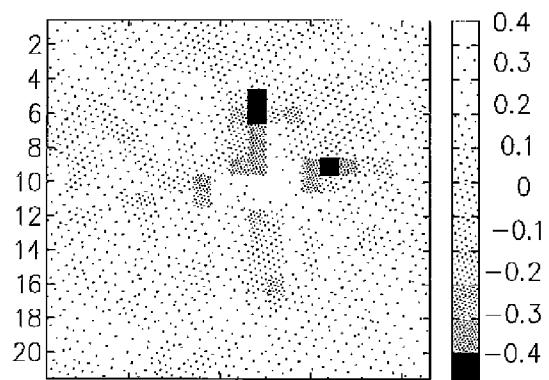
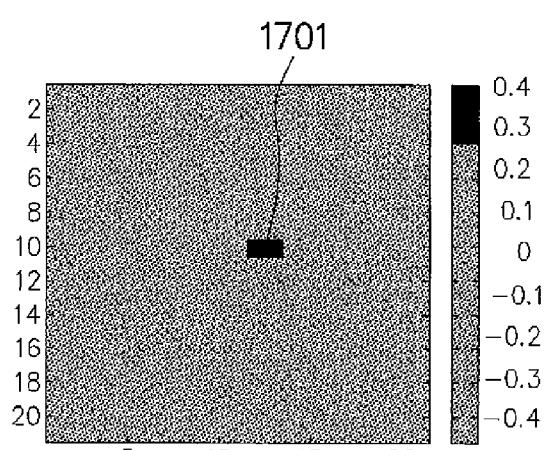
FIG.17A

FIG.17B

FIG.17C

FIGS. 17A, 17B and 17C are an example of an image showing detecting a defect in the heating process, wherein the defect is a minute sharp dent located on the surface of the steel sheet.

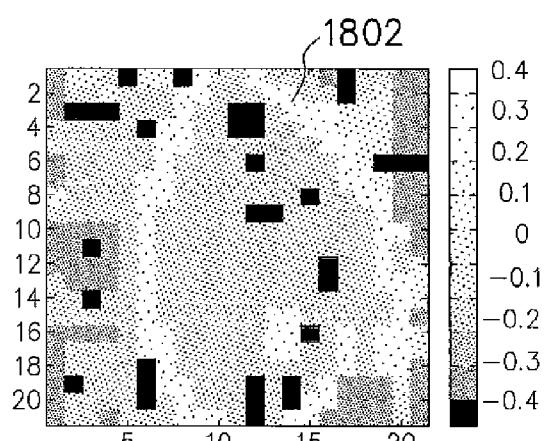
FIG.18A

FIGS. 18A, 18B and 18C are an example of an image showing detecting a defect in the heating process, wherein the defect is a foreign material attached on the surface of the steel sheet.

FIG. 18A is thermal image data taken by the infrared thermography camera, FIG. 18B is a Laplacian processed image of the thermal image data, and FIG. 18C is a binarized image of the Laplacian processed image data. FIGS. 18A, 18B and 18C are schematic diagrams made from an actually obtained image (zoom-up image). FIG. 18C shows the image where defects 1801 (a foreign material attached) are extracted to be clearly viewed. A line pattern 1802 viewed in FIGS. 18A, 18B and 18C is a marking line written on the sample in advance to indicate a portion having the defects after finding the defect by doing a visual check, but not any kind of erroneous detection.

FIG. 18 shows an example where defect detection was made with respect to a steel sheet sample (test piece) having a defect shown as FIG. 3D, i.e., a foreign material attached to the surface of the steel sheet. Thermal image data of the steel sheet sample was taken by an infrared thermography camera while the steel sheet sample was being heated up to about 90° C. The number of pixels of the infrared thermography camera is 256×256, the size of the pixel is 0.8 mm, and the distance between the camera and the steel sheet sample was 60 cm. The angle between the heating direction by the heating device and the steel sheet surface is 60°, and the angle between the optical axis direction of the camera and the steel sheet surface is 90°.

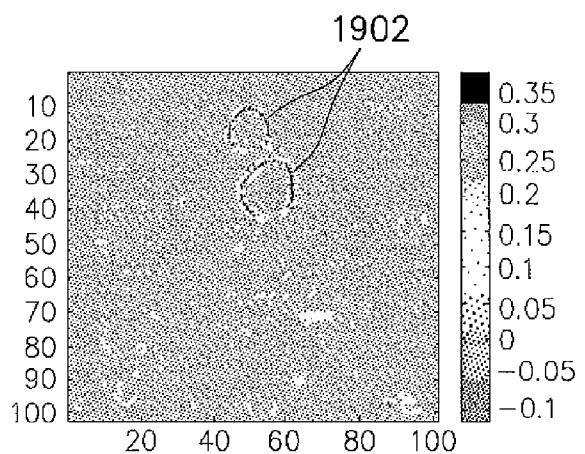
FIG.19A

FIGS. 19A, 19B and 19C are an example of an image showing detecting a defect in the heating process, wherein the defect is a foreign material in the surface layer of a resin fuel tank for an automobile.

This invention can be applied to other types of material. FIG. 19 shows an example where defect detection was made with respect to a sample of a resin fuel tank for an automobile having a foreign material in the surface layer of the tank shell
