(12) United States Patent

US 7,185,955 B2 (10) Patent No.: (45) Date of Patent:

(54)	VISUAL INDICATOR	FOR	PRESSURIZED
	HUR

A tactile and visual indicator is mounted on the hub cap of an axle of a vehicle. The indicator has a deformable face that protrudes away from the hub cap in response to the presence of pressurized air in the space containing the wheel bearings. The position of the deformable face indicates the presence or absence of hub integrity and indication of grease about the wheel bearings.

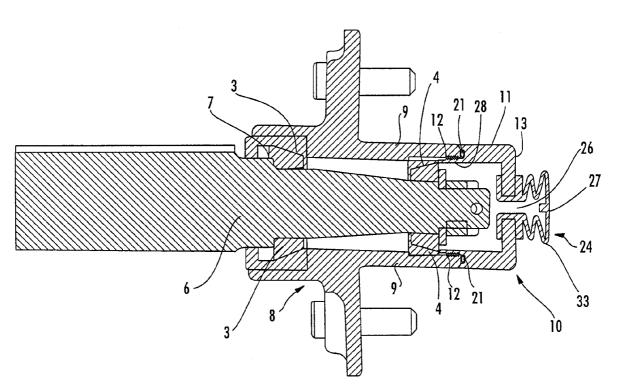
FIG. 1 is a perspective view of a hub cap according to a 60 preferred embodiment of the invention as installed on a trailer wheel hub;

A hub cap 10 according to a preferred embodiment of the invention is shown in FIGS. 1–3. FIG. 1 illustrates the hub cap 10 as installed to the wheel hub 9 of a boat trailer wheel. FIG. 4 is a cross-sectional view of the hub cap 10 as assembled with a hub 9 of an axle and wheel unit 8 for a trailer. The hub 9 is rotatably supported on bearing assemblies 3 and 4 and mounted on an axle 6. A seal 7 adjacent the inner bearing 3 seals the end of the chamber within the hub 9

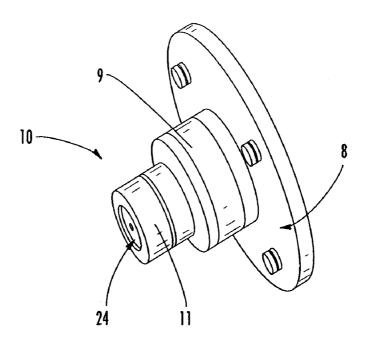
FIG. 2 is a side view of the hub cap of FIG. 1 with deformed valve;

FIG. 3 is a cross-sectional view of the hub cap of FIG. 2; 65

As best seen in FIGS. 2 and 3, the hub cap 10 of the invention includes a cylindrical housing 11, commonly referred to as a dust cap, having a closed first end 13 and an open second end 15. The second end 15 is formed with a flange 12 and an outer annular shoulder 14 which enable the hub cap 10 to be inserted into the outer end of the wheel hub 9 so as to constitute an extension of the wheel hub 9. The flange 12 fits tightly enough within the hub cap 10 so as to create an approximately air tight seal. In the preferred embodiment, the outer end of the wheel hub 9 is sized to allow press fit of the cylindrical housing 11 wherein flange 12 can be sealed with a bonding agent such as LOCKTITE to prevent leakage of air or grease.

The air valve 24, shown in cross section in FIG. 3 is flexible and deformable in response to pressurized air within the wheel hub. As the air pressure increases within the wheel hub, the valve face 33 deforms outwardly. If the air valve 24 is expanded, the integrity of the air trapped within the hub is visually confirmed. If the air valve 24 is flat showing no

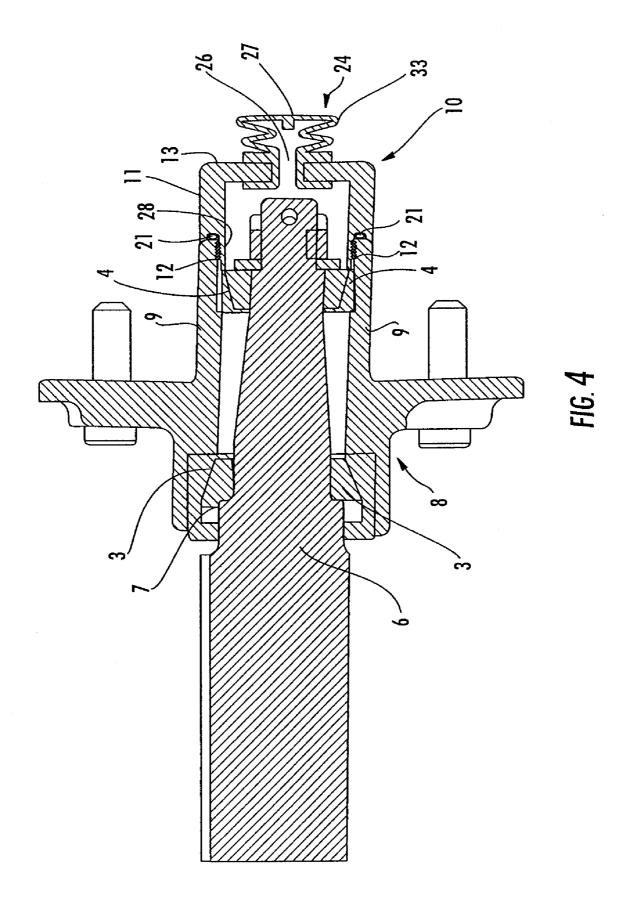
FIG. 4 is a cross-sectional view of the hub cap of FIG. 1 installed on a wheel hub and axle assembly; and

FIG. 4 illustrates a conventional mode of assembly of a wheel hub, the axle 6 is concentrically coupled to bearing assembly 3, the wheel hub 9, and bearing assembly 4, and secured by washer and nut assembly. The hub cap 10 of the invention is attached to the wheel hub 9 in the manner previously described. In order to provide an improved air tight seal at the point of connection of the bearing assembly 3 and the axle 6, the system of the invention can further include the inclusion of a polished sleeve between the bearing assembly 3 and the axle 6 where the seal rides. For instance, should an existing axle be reworked to accommodate the instant invention, the use of a sleeve can be sealingly secured to the axle to provide a smooth surface for the oil seal. The greatest wear problem for the oil seal is the poor surface preparation of the axle that results in premature failure of the oil seal. The use of a sleeve on used axles provides extended oil seal life. In addition, poor manufacturing of an axle can also be rectified by the sleeve.

As shown in FIGS. **4–6**, the air valve **24** may also be formed as a bellows **36**. The bellows may be tubular with circumferential rings **34** spaced along the length of the structure defining interconnected air chambers **39**, **40** and **41**, FIG. **5**. The rings **34** restrict the expansion of the bellows and provide shape to the expanded bellows. The bellows **36** may be designed to expand in a certain sequence relative to the air pressure present in the wheel hub. For example, 5 psi (pounds per square inch) air pressure would inflate one chamber **41** and 10 psi would expand another chamber **40**. In this manner, the air valve would operate as a visual or tactile gauge to indicate a trend and show any remaining air pressure.

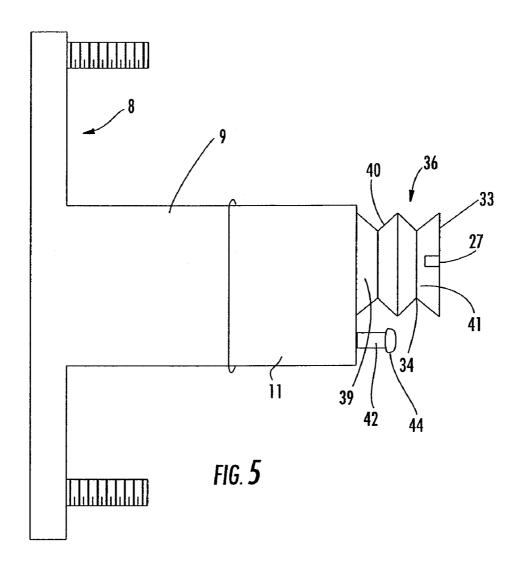
FIG. 5 is a side view of the hub cap of FIG. 4 with the valve deformed; and

FIG. 6 is a cross section of the valve of FIG. 4 and FIG. 5.

As shown in FIG. 5, the closed end of the hub cap housing 11 can optionally include a through bore for receiving the conduit or clindrical metal tube 42, which is fixedly secured 20 therein to provide an air flow coupling between a source of pressurized air and the wheel hub 9. In this alternative embodiment, the conduit 42 is fitted with a conventional inflation valve 43 of any operable construction as would commonly be utilized to inflate automobile tires and the like. As is the conventional construction, a spring-loaded axially disposed post is contained in the valve 43 which is depressed by attachment of an inflation device. The inflation valve 43 is receptive to air from an air compressor, a hand pump, or even an extension hose from a tire valve for use in air insertion. When such a valve is employed, the bellows continues to operate as a visual indicator of the hub integrity. The preferred embodiment of the bellows requires a positive air pressure for expansion to indicate a pressurized condi-
