(12) **United States Patent**
Ducotey, Jr. et al.

(54) **METHOD FOR REPAIRING AN APERTURED GAS TURBINE COMPONENT**

(57) **ABSTRACT**

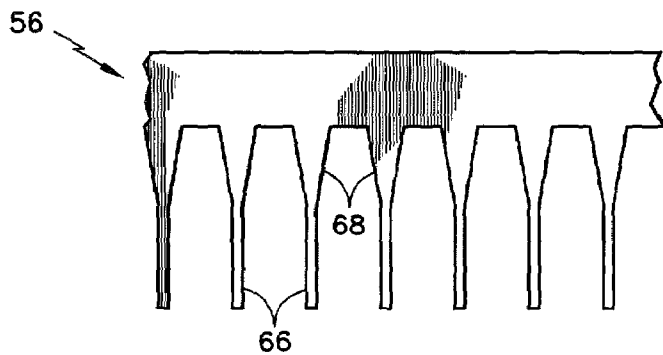
FIG. 7 is a side view of an electrode suitable for use with the repair method of the present invention.

The electrode **56** includes a metering portion **66** and a diffuser portion **68**. The electrode **62** includes a diffuser portion **70**. It is noted that the geometry of the individual electrodes **56**, **62**, specifically the respective portions **66**, **68**, **70**, are preselected to correspond to the required shape of the corresponding diffusion hole **18** to which it is used. In particular, the electrode **56** is chosen to restore the inner diffuser portion **80** and inner metering portion **82** of the respective diffusion hole **18** being repaired in region **48**. Similarly, the electrode **62** is chosen to restore the inner diffuser portion **80** of the respective diffusion hole **18** being repaired in region **50**. This ensures that after the repair is

Referring to FIGS. **5**, **6** and **7**, electrodes **56**, **62** suitable for insertion into an electric discharge machining device are shown. Referring to FIGS. **1**, **4** and **6**, the remanufacture and repair of the diffusion holes **18** in local regions **48**, **50** of vane **10** using electrodes **56**, **62**, respectively, will now be described.

However, in local region **50**, the diffusion holes **18** may be partially or fully clogged, as described earlier, and therefore will need to be reworked to restore the cooling effectiveness of the diffusion hole **18** as well as vane durability. This is accomplished by using the electrode **62** to remove the excessive bond coat material. The electrode **62** may be easily formed by removing a metering portion from an electrode that has a diffuser portion corresponding in shape to the diffuser passage **52**, and more specifically, the inner diffuser portion **80**, of the diffusion hole **18**. This can be accomplished by using a cutting means, for example scissors, to remove the metering portion.
