(12) **United States Patent**  
**Grossklaus, Jr. et al.**

(10) **Patent No.:** **US 6,233,822 B1**  
(45) **Date of Patent:** **\*May 22, 2001**

(54) **REPAIR OF HIGH PRESSURE TURBINE SHROUDS**

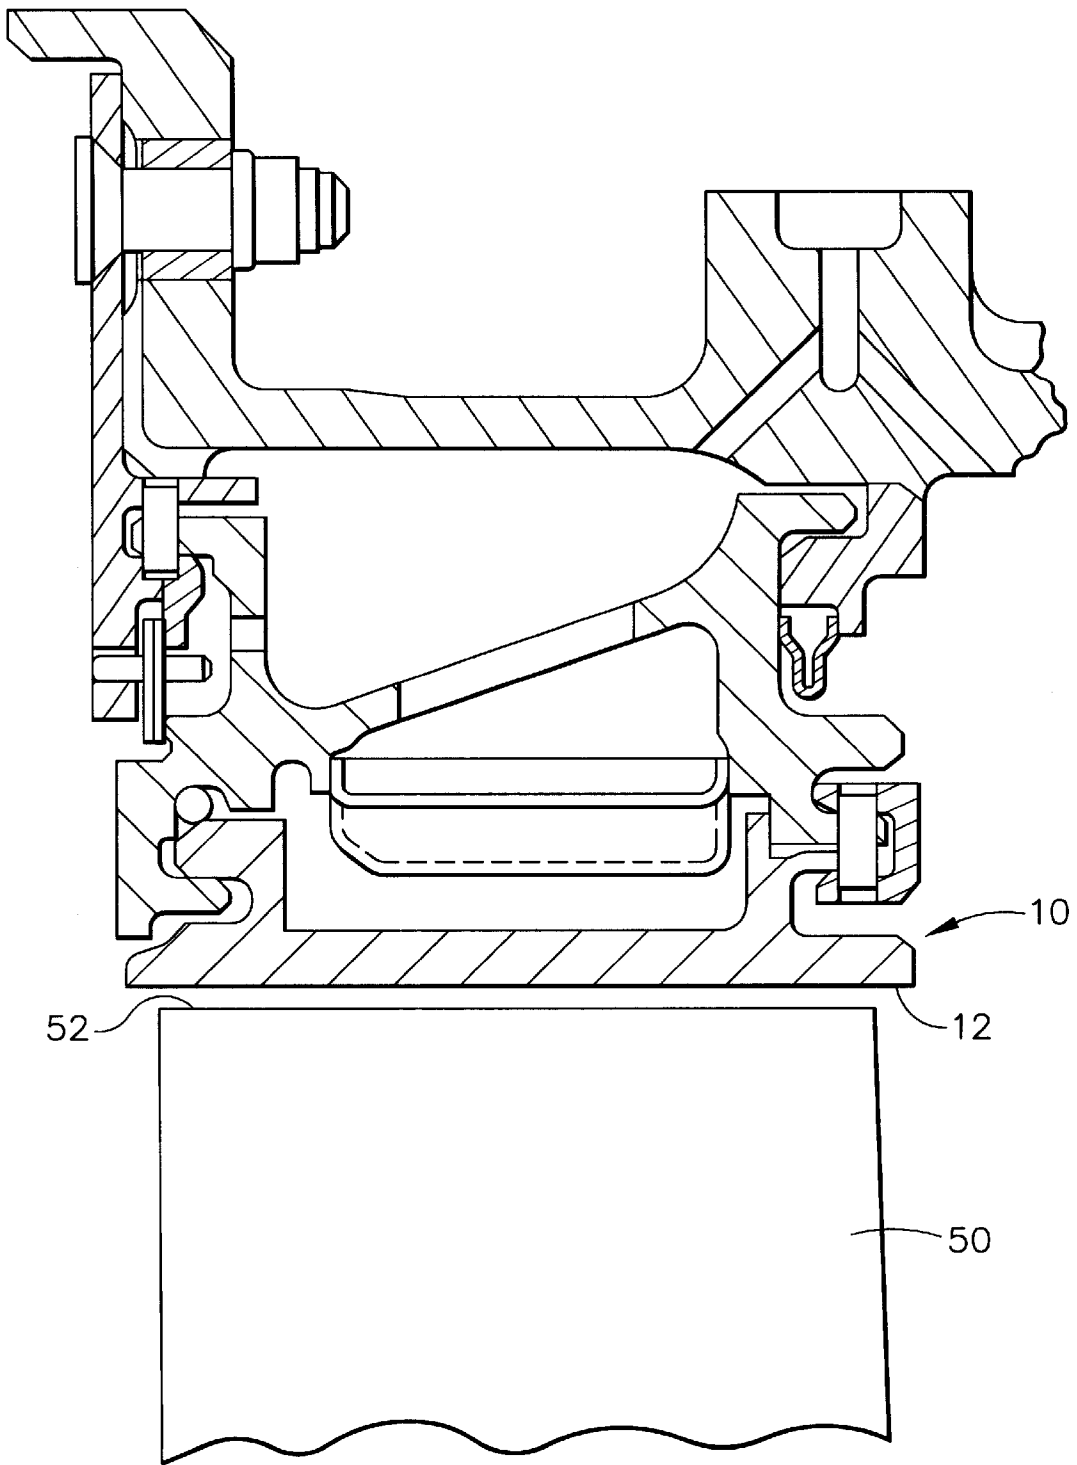
FIG. 1 is a cross-sectional view of a shroud assembly, showing a shroud segment showing the shroud flow path surface adjacent to the tip of a turbine blade, the shroud support, the shroud hanger support and the support case;

FIG. 1 is a cross-sectional of a turbine engine shroud assembly, showing shroud segment 10. In this view, the shroud segment 10 has a flow path surface 12. Also shown for illustration purposes is a turbine blade 50 having a tip 52 immediately adjacent to the flow path surface 12 of the shroud segment. FIG. 2 is a perspective view of shroud segment 10 of FIG. 1. The shroud segment has a fore end 14 and an aft end 16. As shown in FIG. 3, a number of shroud segments having sides 18 are assembled together to form a shroud assembly that has the shape of a cylinder surrounding the turbine blades. As the hot gases of combustion move rapidly from the combustors along the interior of the engine and across the shroud flow path surfaces 12 from the fore end 14 of the shroud segments to the aft end 16 of the shroud segments, the turbine blades are rotated. As can be seen, the tighter the tolerance between the shroud segments and the blades, the more efficient the engine will operate, since smaller volumes of gases will escape across the shroud flow path.

With reference to FIG. 1, turbine blades 50 are designed with tips 52 to cut into the flow path surface 12 of the shroud segments, which generally are comprised of a rub-compliant material. Of course, during the course of engine life, the clearance between the blade 52 and flow path surface 12 will gradually increase just from the operation of the rotating blades against the fixed shroud assemblies at various operating temperatures. Furthermore, as the hot gases of combustion pass along the engine interior across the shroud assembly from the fore rails to the aft rails, mechanical erosion of material from the shroud assemblies will also occur, thus increasing the clearance between the blades and the shroud assembly. Also, the hot gases of combustion contain a number of undesirable by-products which will cause not only oxidation, but also corrosion of the shroud assembly materials. Because the shroud assembly is comprised of a number of shroud segments assembled together to form a ring, as the shroud flow path material is removed, by whatever process described above, a gap develops along the shroud sides 18 between the shroud segments. Eventually, as engine efficiency continues to decrease, the engine must be refurbished to restore the engine parts, including the shroud segments to their original conditions, both dimensionally and materially.
