(10) **Patent No.:** **US 9,127,550 B2**
(45) **Date of Patent:** **Sep. 8, 2015**

(54) **TURBINE SUPERALLOY COMPONENT
DEFECT REPAIR WITH
LOW-TEMPERATURE CURING RESIN**

(73) Assignee: **Siemens Energy, Inc.**, Orlando, FL (US)

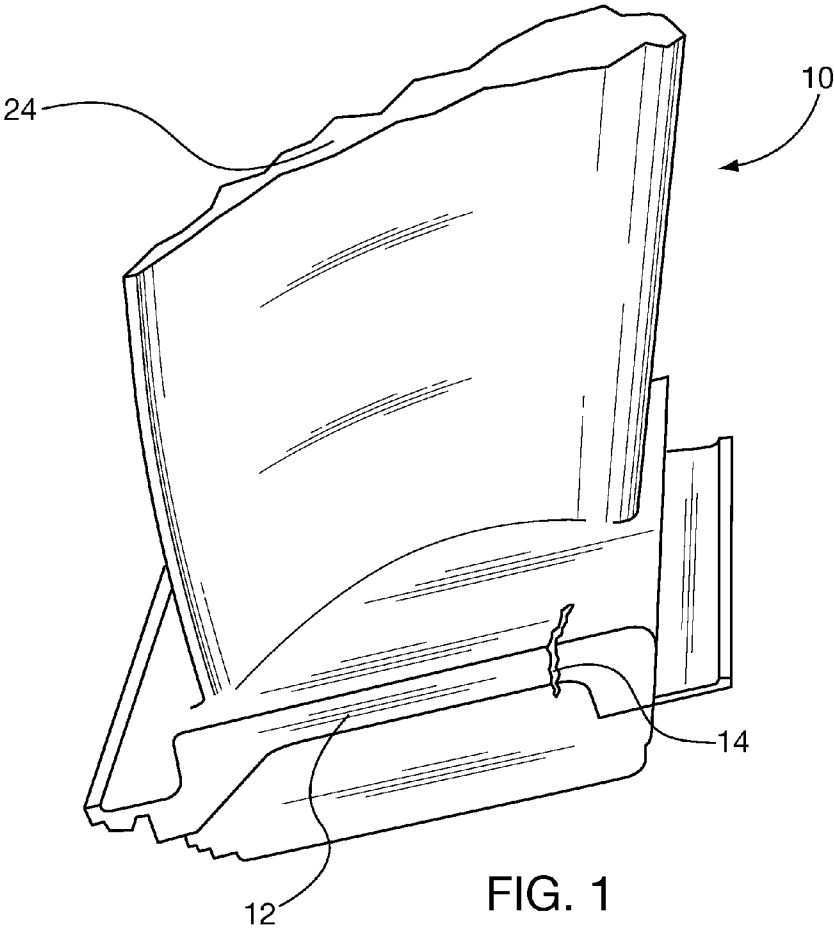
FIG. 1 shows a schematic elevational perspective view of a superalloy turbine blade component having a crack defect void;

FIG. 1 shows a known exemplary thermal barrier coated industrial gas turbine superalloy blade 10 having a blade root substrate 12 with a surface void or defect crack 14 that is a candidate for cosmetic repair, rather than structural repair. The goal of cosmetic repair is to restore a continuous surface in the defect zone within the blade's dimensional specifications. The blade 10 is prepared for repair by stripping existing thermal barrier and other coatings, combustion contamination, etc. by known processes, leaving a clean substrate 12. The crack defect is cleaned, but does not have to be excised from the substrate by grinding or other known metal removal methods, as is customarily done when performing brazing repairs. If the blade 10 has a defect within a previously brazed repair zone, the defect may be repaired with the methods of the present invention without removing the braze material.

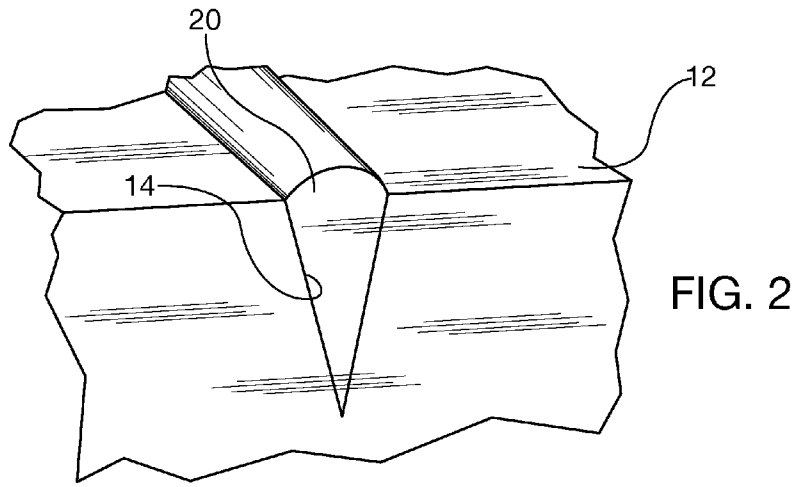
FIG. 2 shows an enlarged perspective view of the turbine blade defect of FIG. 1 filled with resin, in accordance with an embodiment of the present invention;

In FIG. 2, the crack defect 14 within the turbine blade substrate 12 is filled with a hardening resin filler 20, again without the need to remove the crack defect from the substrate. Filler 20 can be applied with hand tools at ambient temperature and intentionally projects, or is "proud" of the substrate surface. After the filler 20 cures, it is ground flush with the substrate as shown in FIG. 3. In this way the filler 20 surface conforms with the surrounding substrate 20 dimensions and restores the repaired blade to dimensional specifications. When applied to the blade substrate 12, the filler 20 is a pliable particle-filled resin putty or two-part epoxy-like

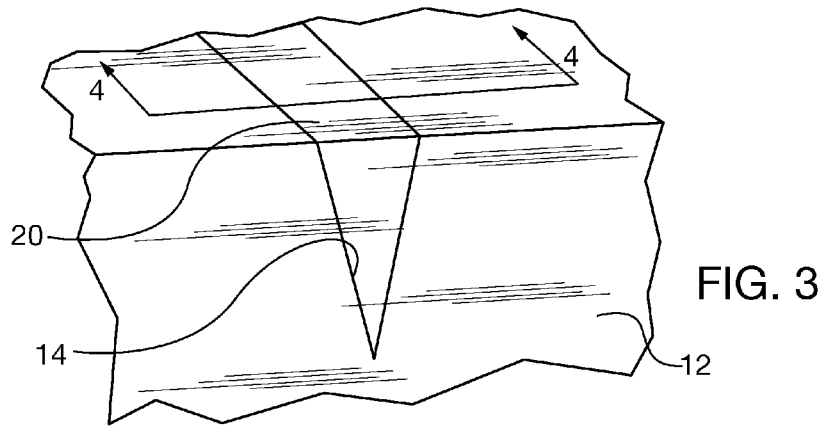
FIG. 3 shows an enlarged view of the turbine blade defect of FIG. 1, where the resin has been ground to conform it to the dimensional profile of the surrounding turbine blade substrate, in accordance with an embodiment of the present invention; and

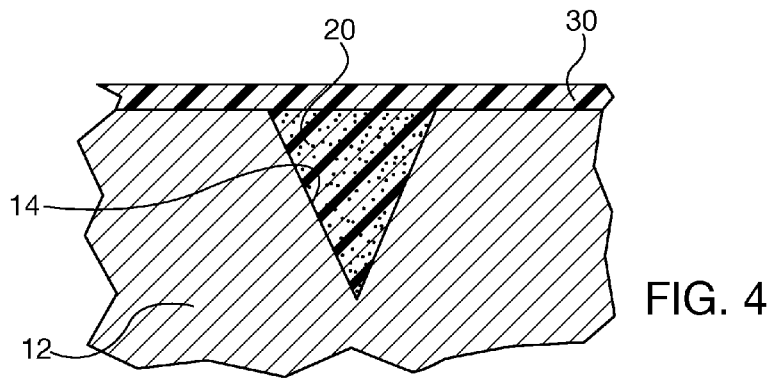
FIG. 4 is an elevational cross-sectional view taken along 4-4 of FIG. 3, showing a thermal barrier coating applied to the substrate and resin.

After filler **20** curing and shaping to conform to the surrounding substrate **12** dimensional specifications the blade **10** or other superalloy component is prepared for application of a metallic bondcoat and thermal barrier coating using presently known methods. For example, the repaired blade **10**, including the now filled defect **14** may be grit blasted prior to application of the bond coating and thermal barrier coating layer. An exemplary repaired turbine blade **10** is shown in FIG. **4**, with a bond coating/thermal barrier coating **30** cov-

ering the substrate **12**, defect **14**, and the cured filler material **20**. The cured filler material **20** may also cover existing braze material on the substrate **12** (not shown) for better adhesion of bond coating and the thermal barrier coating **30**. As previously discussed, braze material often contains elements such as boron, phosphorous and/or silicon that do not promote bond coat or thermal barrier coating adhesion.
