[54] **METHOD OF REPAIRING TURBINE BLADES**

[73] **Assignee:** **Refurbished Turbine Components Limited, Hereford and Worcester, England**

METHOD OF REPAIRING TURBINE BLADES

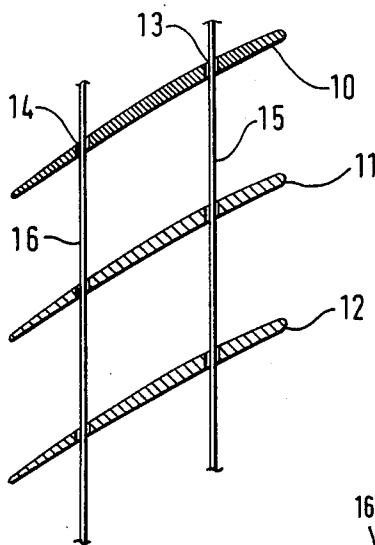
FIG 1

FIG. 1 is a cross-sectional view looking radially inwardly of three turbine blades interconnected by lacing wires;

Referring first to FIGS. 1 and 1A, three turbine blades are shown 10, 11 and 12, each turbine blade having through bores 13 and 14 through which pass respective lacing wires 15 and 16.

The lacing wires 15 and 16 can pass either with clearance through their respective through bores 13 and 14 in the turbine blades, or may be joined to each turbine blade by welding for example.

If the lacing wires pass freely through the through bores 13 and 14 in use of the turbine, the radially outwardly directed centrifugal force on the lacing wires between adjacent turbine blades will cause pressure

contact between the lacing wires and the turbine blades, such pressure contact being sufficient to provide the required restriction of relative movement between adjacent turbine blades.

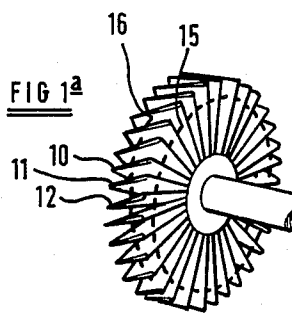
FIG 1a

FIG. 1A is a prespective view of a complete turbine rotor;

FIG. 1A illustrates an example of a rotor from a turbine, the three turbine blades 10, 11 and 12 shown in FIG. 1 being three of a considerable number of blades forming the complete array in the rotor.

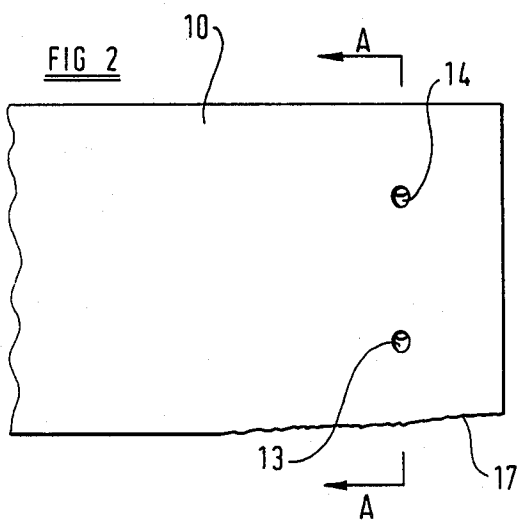
FIG 2

FIG. 2 is a view of an end of an end region of the turbine blade illustrating the area where erosion is most common;

Referring now to FIG. 2, the area of the turbine blade which is most prone to erosion is illustrated, this being the leading edge 17 of the outer end of the turbine blade since it is this part of the blade which "collides" with the steam or particles carried thereby during use of the turbine, and which also has the greatest linear speed being the radially outermost point from the axis of rotation. The leading edge 17 is the edge which is nearest the steam inlet end of the turbine.

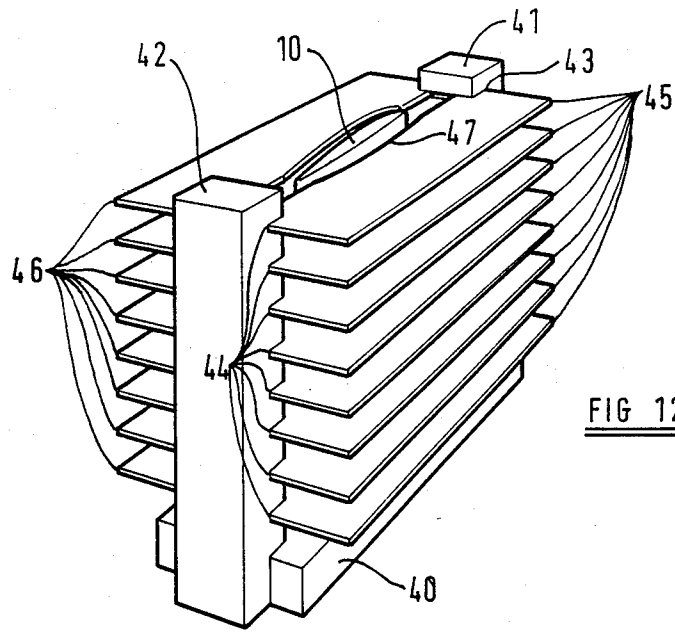
FIG 12

FIG. 12 is a perspective view of a gauge apparatus;

The gauge shown in FIGS. 12 and 13 comprises a base member 40 having a pair of upwardly extending support members 41 and 42, each of the members 41 and 42 being provided with horizontally aligned slots 43 and 44 respectively.

Extending between and located in each pair of horizontally opposed slots 43 and 44 are a pair of gauge members 45 and 46. Each of the gauge members 45 and 46 which comprise metal plates have a cut-out 47 and 48 respectively which corresponds to half the desired cross-sectional profile of the turbine blade 10 at a distance from the base member 40 determined by the distance from the base of the respective horizontally opposed channels 42 and 43.

After the application of such mechanical forces, the blade is subjected to heat treatment, for example as in the oven 60 shown in FIG. 11, and then the form and shape of the blade may be checked by a gauge such as that shown in FIGS. 12 and 13.

In order to check if the turbine blade 10 is of the correct form and shape, it is carefully positioned on the base member 40 and the gauge plates 45 and 46 inserted into their respective channels 42 and 43 and moved into contact with the turbine blade 10. If the gauge plates 45 and 46 do not fit around the turbine blade perfectly, i.e. there is a gap at any position between a gauge plate and the turbine blade, either the form or shape of the blade requires some correction, the form being corrected by imparting a twisting force to the blade as aforesaid, and the shape being corrected by the addition or removal of material by welding or grinding respectively for example.

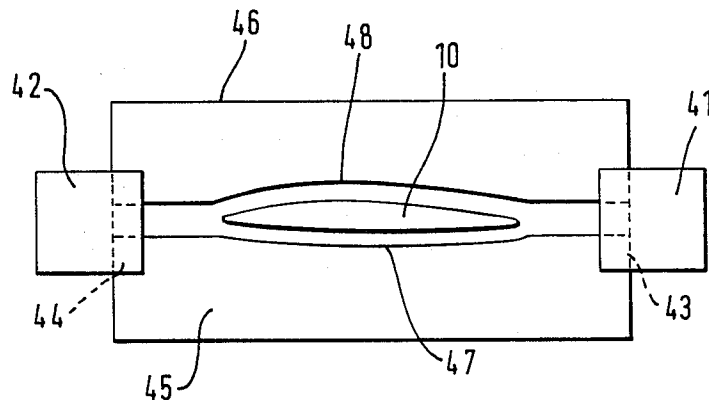
FIG 13

FIG. 13 is a plan view of the gauge apparatus shown in FIG. 12.
