(10) **Patent No.:** **US 8,878,698 B2**

(54) **LIGHTNING STRIKE DETECTION**

(73) Assignee: **The Boeing Company**, Chicago, IL (US)

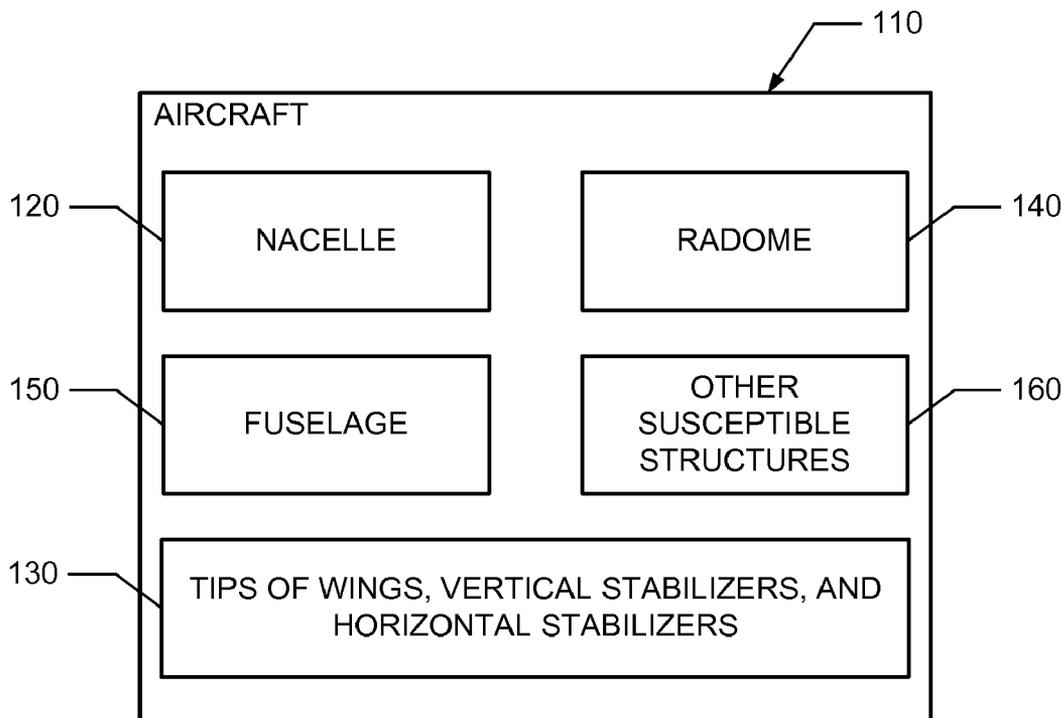
FIG. 1 is an illustration of an aircraft.

Reference is made to FIG. 1, which illustrates an aircraft **110** having a plurality of composite structures. Some composite structures may be made entirely from a composite material such as fiberglass or carbon fiber reinforced plastic (CFRP). Other structures might be a combination of composite materials and metals. For example, a composite structure might include composite material, metal fasteners, electrical bonding jumpers, and metal for lightning strike protection.

Some of the composite structures on the aircraft are more susceptible to lightning strikes than others. On a large commercial aircraft, some of the most susceptible structures include nacelles **120**, tips **130** of wings and vertical and horizontal stabilizers, and radomes **140**. The aircraft's fuselage **150** and other structures **160** might also be highly susceptible.
