(12) **United States Patent**
Lai

(10) **Patent No.:** **US 7,436,466 B2**
(45) **Date of Patent:** **Oct. 14, 2008**

(54) **REPAIRING METHOD OF A THIN FILM
TRANSISTOR ARRAY SUBSTRATE**

(73) Assignee: **Au Optonics Corporation**, Hsinchu
(TW)

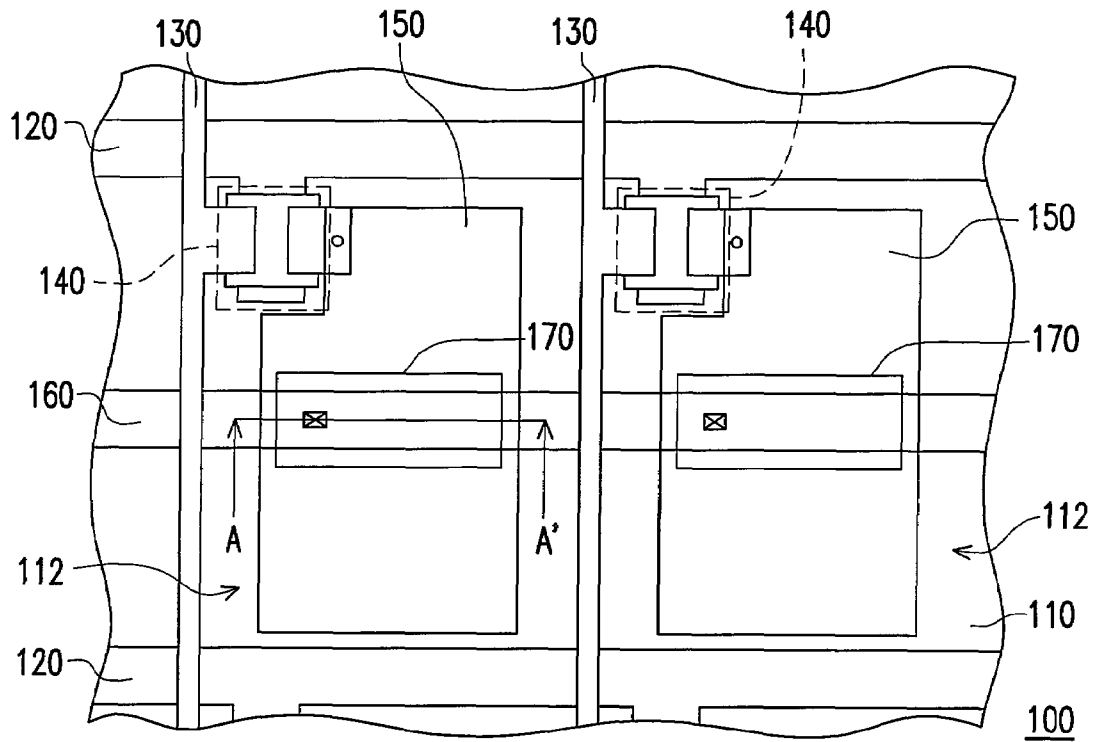
FIG. 1 is a top view of a portion of a conventional thin film transistor array substrate. FIG. 2 is a schematic cross-sectional view along line A-A' of the thin film transistor array substrate in FIG. 1. As shown in FIGS. 1 and 2, a conventional thin film transistor array substrate 100 mainly comprises a

FIG. 1 is a top view of a portion of a conventional thin film transistor array substrate.

substrate 110, a plurality of scan lines 120, a plurality of data lines 130, a plurality of thin film transistors 140, a plurality of pixel electrodes 150, a plurality of common lines 160 (only one is shown) and a plurality of upper electrode 170.

The scan lines 120 and the data lines 130 are disposed over the substrate 110 to define a plurality of pixel areas 112. Each thin film transistor 140 is disposed inside one of the pixel areas 112 and is driven by one of the scan lines 120 and data lines 130. Each pixel electrode 150 is also disposed inside one of the pixel areas 112 and is electrically connected to one of the thin film transistors 140. The common line 160 is disposed over the substrate 110 such that a portion area of the pixel electrode 150 is above one of the common lines 160.

In addition, an upper electrode 170 is disposed between each pixel electrode 150 and one of the common lines 160. Furthermore, a dielectric layer 180 is disposed between the upper electrode 170 and the corresponding common line 160 for isolating the upper electrode 170 and the common line 160. Another dielectric layer 190 is also disposed between the upper electrode 170 and one of the pixel electrodes 150. The dielectric layer 190 has a contact 192 for connecting the upper electrode 170 and the corresponding pixel electrode 150 electrically together.

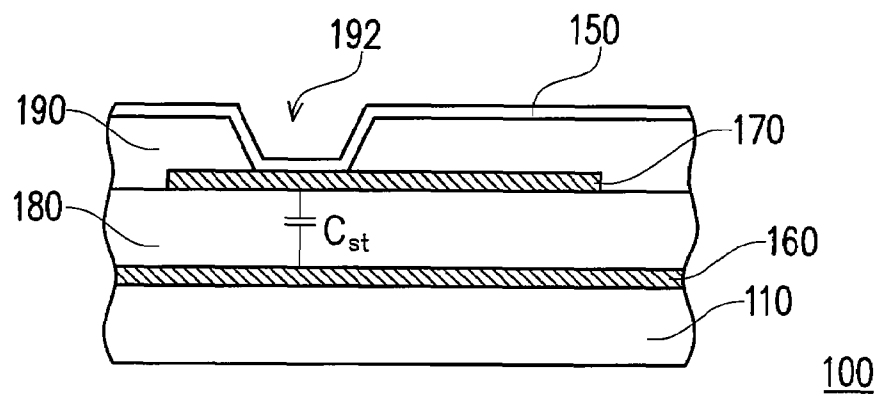
As shown in FIG. 2, the upper electrode 170 and the corresponding common line 160 together form a storage capacitor (Cst) that smooth out the normal operation of various pixels within the thin film transistor liquid crystal display. However, any processing defect or other factors may lead to some particles falling into the dielectric layer 180 or trapped in the defects within the dielectric layer 180 and produce a leaky capacitor. Ultimately, the display quality of the pixel will be compromised.

FIG. 2 is a schematic cross-sectional view along line A-A' of the thin film transistor array substrate in FIG. 1.

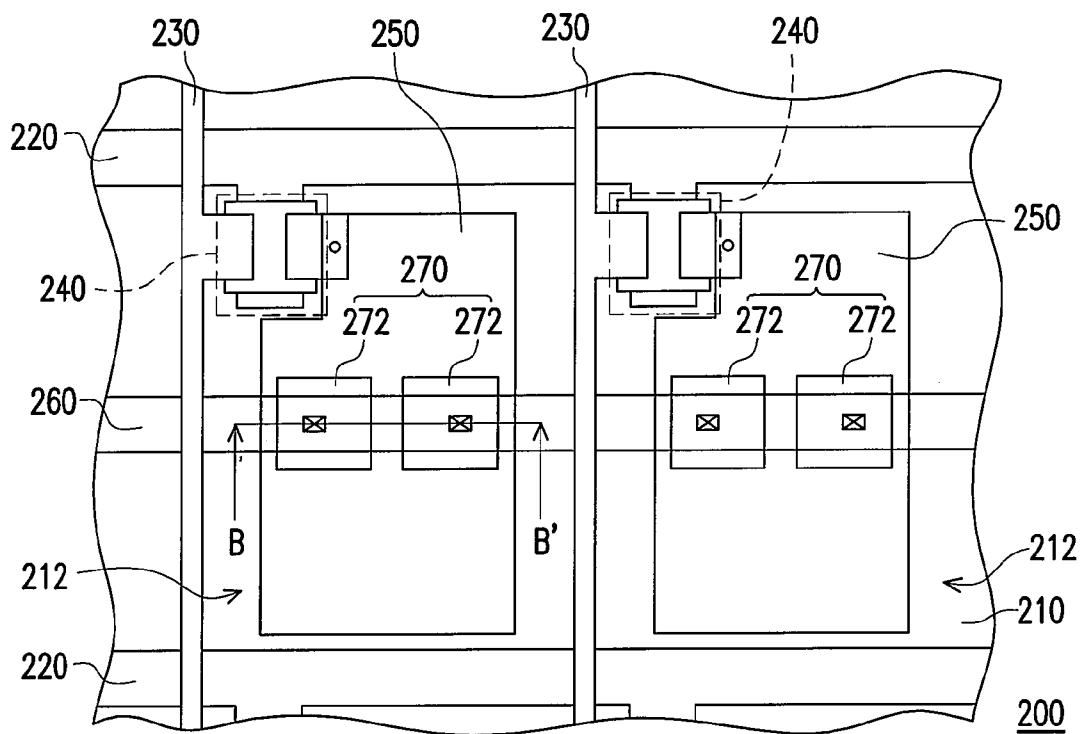
FIG. 3 is a top view of a thin film transistor array substrate according to one preferred embodiment of the present invention.

FIG. 3 is a top view of a thin film transistor array substrate according to one preferred embodiment of the present invention. FIG. 4 is a schematic cross-sectional view along line B-B' of the thin film transistor array substrate in FIG. 3. As shown in FIGS. 3 and 4, the thin film transistor array substrate 200 mainly comprises a substrate 210, a plurality of scan lines 220, a plurality of data lines 230, a plurality of thin film transistor 240, a plurality of pixel electrodes 250, a plurality of common lines 260 (only one is shown) and a patterned upper electrode 270.

The scan lines 220 and the data lines 230 are disposed over the substrate 210 to define a plurality of pixel areas 212. Each thin film transistors 240 is disposed inside one of the pixel areas 212 and driven by one of the scan lines 220 and one of the data lines 230. Each pixel electrode 250 is disposed inside one of the pixel areas 212 and electrically connected to one of the thin film transistors 240. The common line 260 is disposed over the substrate 210 such that a portion area of each pixel electrode 250 is above one of the common lines 260.

The patterned upper electrode 270 is disposed between each pixel electrode 250 and the corresponding common line 260. A dielectric layer 280 is disposed between the patterned upper electrode 270 and the common line 260. Another dielectric layer 290 is disposed between the patterned upper electrode 270 and the pixel electrode 250. It should be noted that the patterned upper electrode 270 comprises a plurality of sub-upper electrodes 272 (only two of them are shown). A portion area of each sub-upper electrode 272 is electrically connected to one of the pixel electrodes 250. For example, a contact 292 is formed in the dielectric layer 290 above each sub-upper electrode 272 so that each sub-upper electrode 272 is electrically connected to one of the pixel electrodes 250. Hence, the sub-upper electrode 272 and one of the common lines 260 together form a storage capacitor (Cst).

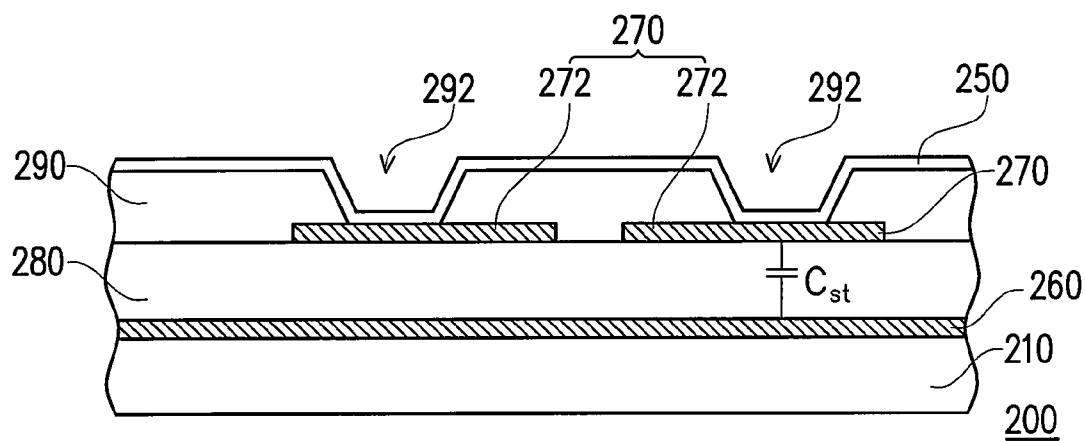
FIG. 4 is a schematic cross-sectional view along line B-B' of the thin film transistor array substrate in FIG. 3.

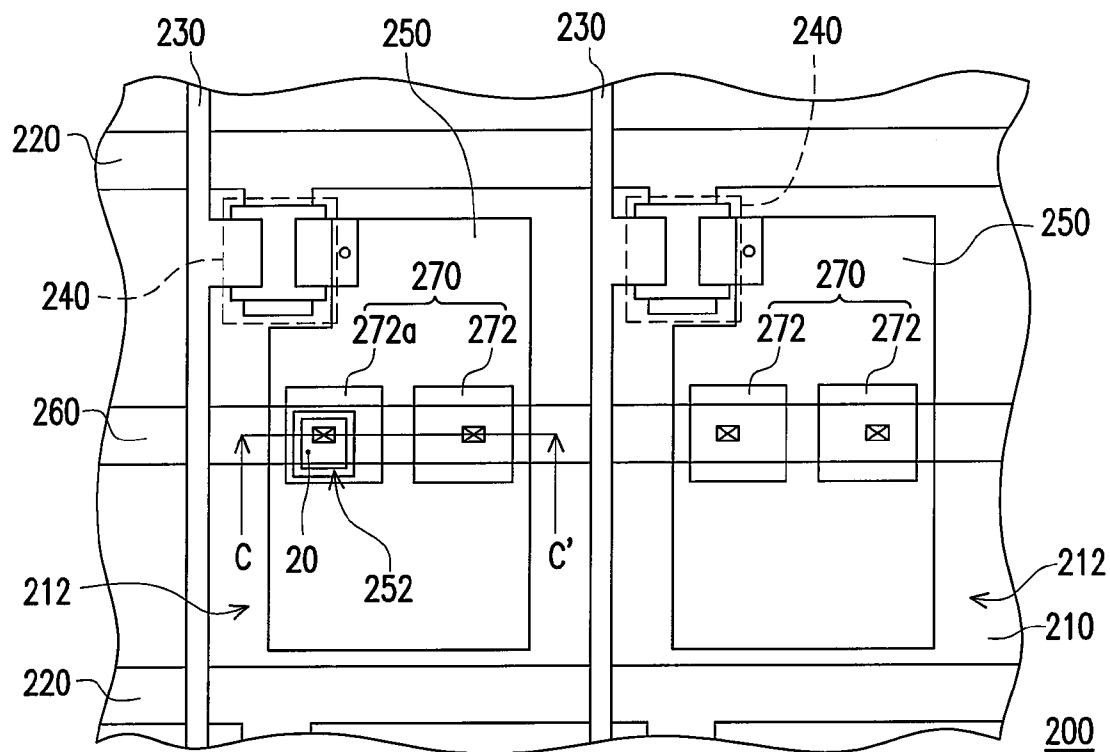
FIG. 5 is a top view of the thin film transistor array substrate in FIG. 3 after performing a laser repairing operation.

FIG. 5 is a top view of the thin film transistor array substrate in FIG. 3 after performing a laser repairing operation. FIG. 6 is a schematic cross-sectional view along C-C' of the thin film transistor array substrate shown in FIG. 5. As shown in FIGS. 5 and 6, if there is a particle (or defect) in the material between one of the sub-upper electrodes 272 and one of the common lines 260, leakage between the sub-upper electrode 272a and the common line 260 may occur. Thus, the pixel may display abnormally and need a repair. The method of repairing the pixel includes removing a portion area of the pixel electrode 250 corresponding to the sub-upper electrode 272a of the defective capacitor so that the sub-upper electrode 272a and the corresponding pixel electrode 250 of the defective capacitor are electrically isolated.

In the present embodiment, a portion area of the pixel electrode 250 above the sub-upper electrode 272a of the corresponding defective capacitor is removed to form an opening 252. The method of removing a portion area of the pixel electrode 250 includes laser ablation, for example. The opening 252 is located around the contact area between the sub-upper electrode 272a and the corresponding pixel electrode 250 of the defective capacitor (that is, around the contact 292). By forming the opening 252, the sub-upper electrode 272a and the corresponding pixel electrode 250 of the defective capacitor are electrically isolated. Since the repair

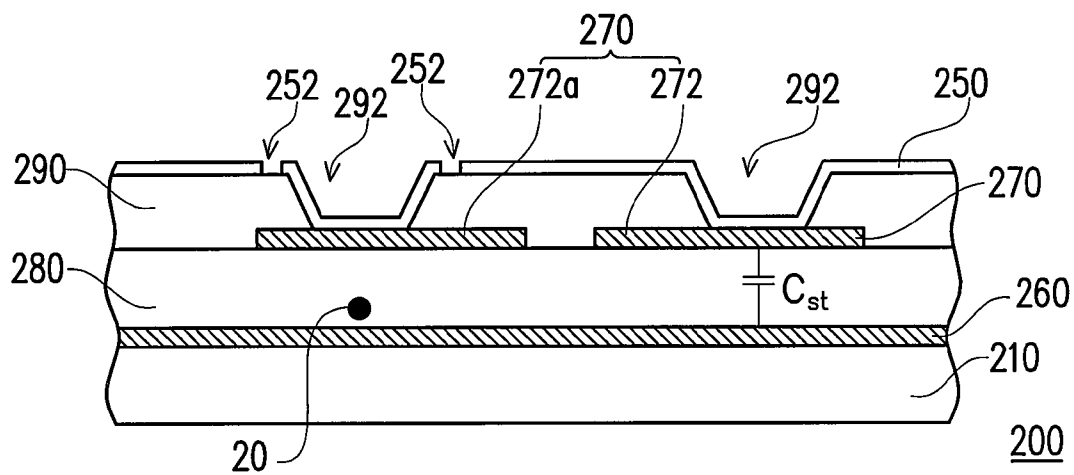
FIG. 6 is a schematic cross-sectional view along C-C' of the thin film transistor array substrate shown in FIG. 5.

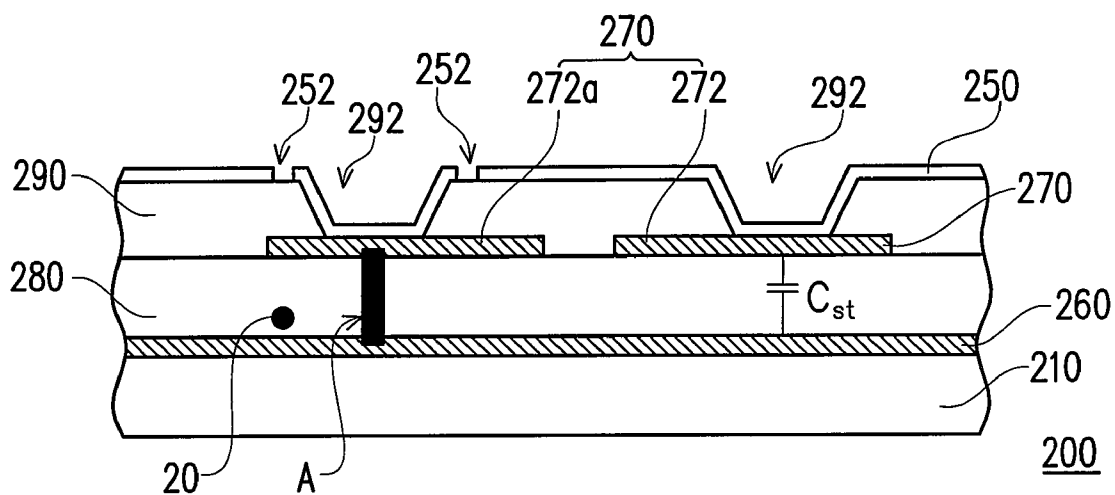
FIG. 7 is a schematic cross-sectional view showing the electrical connection between the common line and the sub-upper electrode in a defective capacitor for repairing a thin film transistor array substrate according to one preferred embodiment of the present invention.

FIG. 7 is a schematic cross-sectional view showing the electrical connection between the common line and the sub-upper electrode in a defective capacitor for repairing a thin film transistor array substrate according to one preferred embodiment of the present invention. After removing a portion area of the pixel electrode 250 corresponding to the sub-upper electrode 272a of the defective capacitor to isolate the sub-upper electrode 272a and the pixel electrode 250 electrically, the sub-upper electrode 272a and the corresponding common line 260 are welded together (labeled A). Hence, the sub-upper electrode 272a and the common line 260 of the defective capacitor are configured at the same potential to prevent any leakage via the particles (or defects). The sub-upper electrode 272a and the corresponding common line 260 are welded together by performing a laser welding process, for example.

In the present invention, the location at which the sub-upper electrode 272a and the corresponding common line 260 of the defective capacitor weld together is underneath the contact 292. However, anyone familiar with the technologies may choose other suitable locations convenient for welding the sub-upper electrode 272a and the corresponding common line 260 of the defective capacitor together.

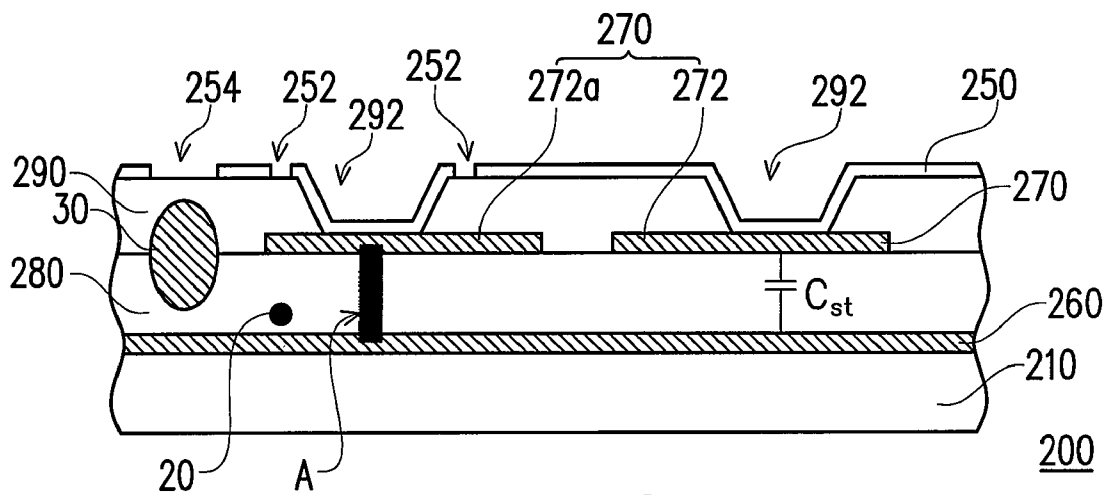
FIG. 8 is a schematic cross-sectional view showing the reparation of a thin film transistor array substrate when a particle is disposed between a pixel electrode and a common line.

FIG. 8 is a schematic cross-sectional view showing the reparation of a thin film transistor array substrate when a particle is disposed between a pixel electrode and a common line. When a particle 30 (or a defect) is formed inside the layers between the pixel electrode and one of the common lines, the repairing method of the present invention also permits the removal of a portion area of the pixel electrode 250 above the particle 30 (or defect). For example, a portion area of the pixel electrode 250 is removed to form an opening 254 that exposes the particle 30 (or defect) using a laser beam.

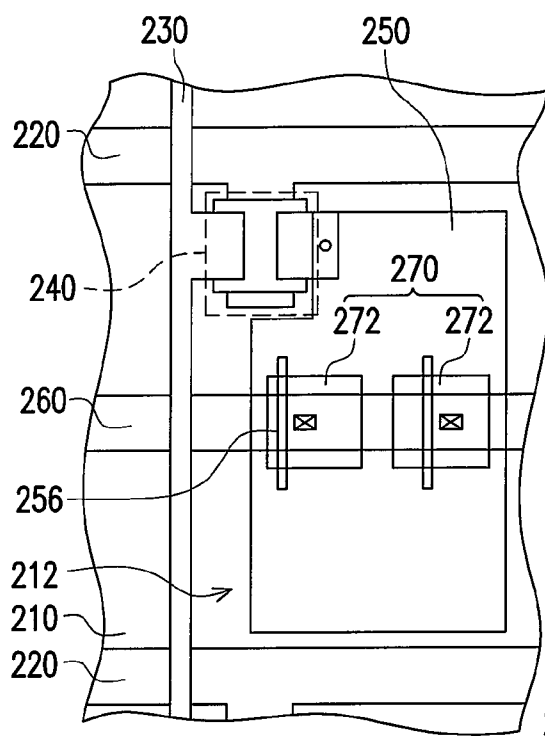
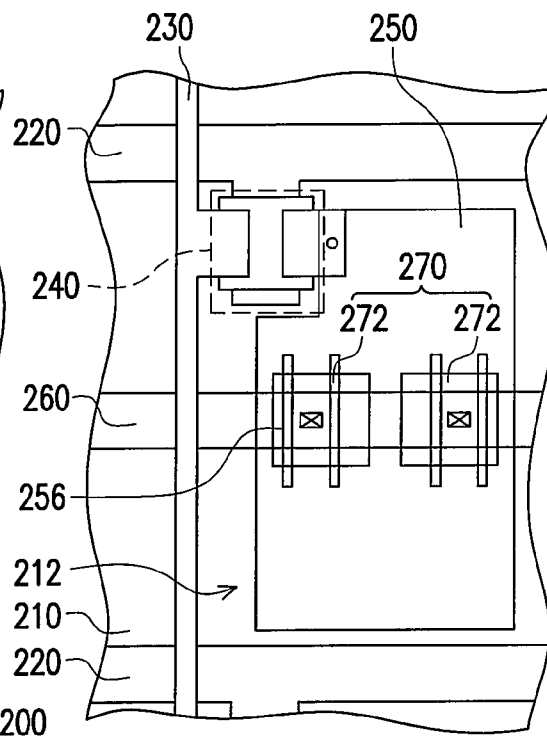
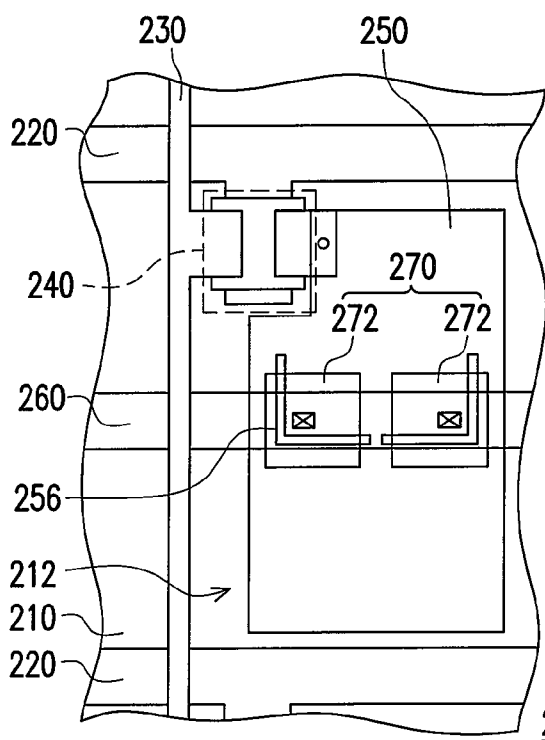
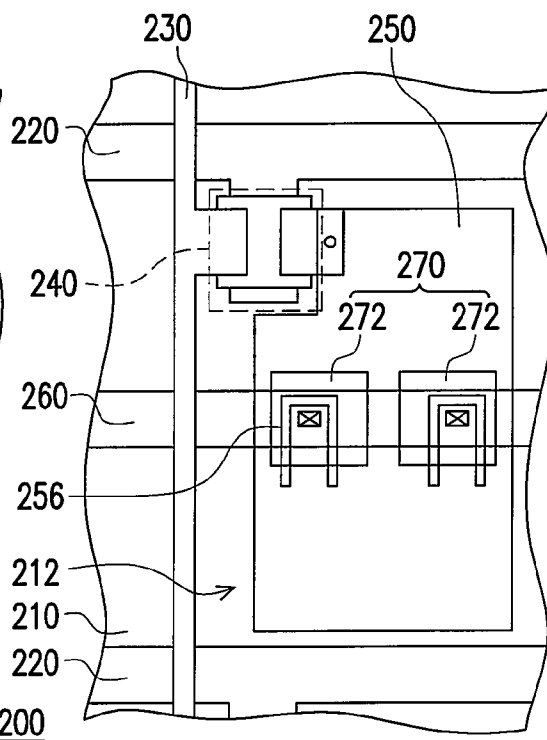
FIGS. 9A through 9D are top views showing different types of thin film transistor array substrates according to another preferred embodiment of the present invention.

FIGS. 9A through 9D are top views showing different types of thin film transistor array substrates according to another preferred embodiment of the present invention. The thin film transistor array substrate of the present embodiment is mostly identical to the one shown in FIG. 3. One major difference is that one or more openings 256 are formed in each pixel electrode 250 when the pixel electrodes 250 are formed. The openings 256 are disposed around the contact region between each sub contact pad 272 and one of the pixel electrodes 250. For example, a straight line opening 256 (shown in FIG. 9A), two straight line openings 256 (shown in FIG. 9B), an L-shaped opening (shown in FIG. 9C) or a U-shaped opening 256 (shown in FIG. 9D) is formed over the pixel electrode 250 corresponding to each sub contact pad 272. With an opening 256 formed over the every pixel electrode 250, a portion area of any one pixel electrode 250 can be readily removed to connect the ends of the opening 256. Hence, an opening similar to the opening 252 that encircles the contact 292 as shown in FIG. 5 can be produced when there is a particle (or defect) between a sub-upper electrode 272 and one of the common lines 260. In the present embodiment, the method of removing a portion area of the pixel electrode 250 includes performing a laser ablation process.

As shown in FIGS. 9A through 9D, a portion area of the opening 256 is disposed above the area occupied by the sub-upper electrode 272 while the remaining portion area of the opening 256 is disposed outside the area occupied by the sub-upper electrode 272. In other words, the openings 256 also cover a region outside the upper electrode 272 to simplify and speed the repairing operation. In addition, anyone familiar with the technology may notice that there is no particular restriction on the dimension of each opening 256.

After removing a portion area of the pixel electrode corresponding to the sub-upper electrode of the defective capacitor, the sub-upper electrode of the defective capacitor and one of the scan lines can be electrically connected by performing a laser welding process. Similarly, if a particle (or defect) is found between the pixel electrode and one of the scan lines, the pixel electrode above the particle (or defect) can be removed using a laser removing method. In addition, the process of fabricating the pixel electrode may include forming one or more openings similar to the ones described in FIGS. **9A** through **9D** to facilitate a laser repair operation.

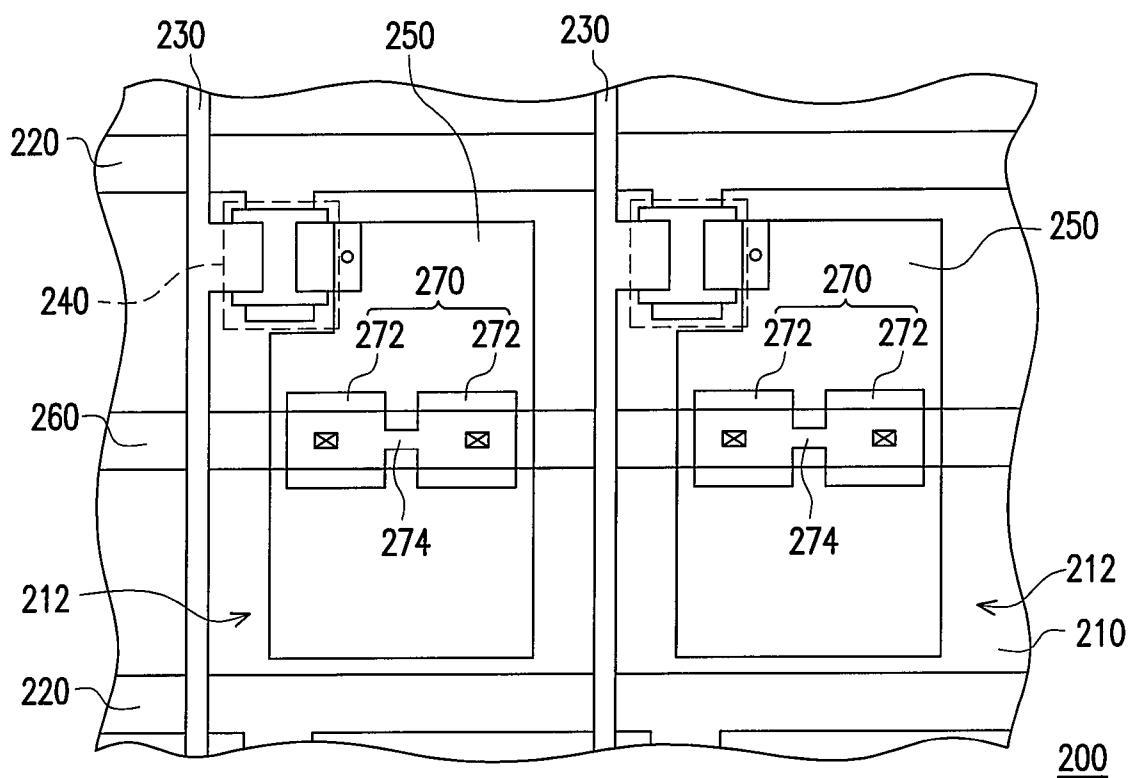
FIG. 10 is a top view of a thin film transistor array substrate according to another preferred embodiment of the present invention.

FIG. 10 is a top view of a thin film transistor array substrate according to another preferred embodiment of the present invention. FIG. 11 is a top view of the thin film transistor array substrate in FIG. 10 after a laser repairing operation. In the present embodiment, the thin film transistor array substrate has a structure mostly similar to the one shown in FIG. 3. One major difference of the present embodiment is that the sub-upper electrodes 272 underneath each pixel electrode 250 are mutually connected through a neck portion 274 that can be severed in a repair operation.

In the presence of a particle 20 (or defect) between one of the sub-upper electrode 270 and one of the common lines 260, a leakage between the sub-upper electrode 272a and the common line 260 may occur. To repair such defect, a portion area of the pixel electrode 250 corresponding to the sub-upper electrode 272a of the defective capacitor is removed. Thereafter, the neck portion 274 connecting with the sub-upper electrode 272a of the defective capacitor 272a is cut so that the sub-upper electrode 272a and the corresponding pixel electrode 250 of the defective capacitor are electrically isolated. In the present embodiment, a portion area of the pixel electrode 250 is removed to form an opening 252. The opening 252 is located around the contact area between the sub-upper electrode 272a and the corresponding pixel electrode 250 of the defective capacitor. Furthermore, the method of removing a portion area of the pixel electrode 250 includes performing a laser ablation and the method of cutting the neck portion 274 includes performing a laser cutting operation. After cutting the neck portion 274 connecting the sub-upper electrode 272a of the defective capacitor, the sub-upper electrode 272a and the corresponding pixel electrode 250 are electrically isolated to achieve the goal of repairing a thin film transistor array substrate.

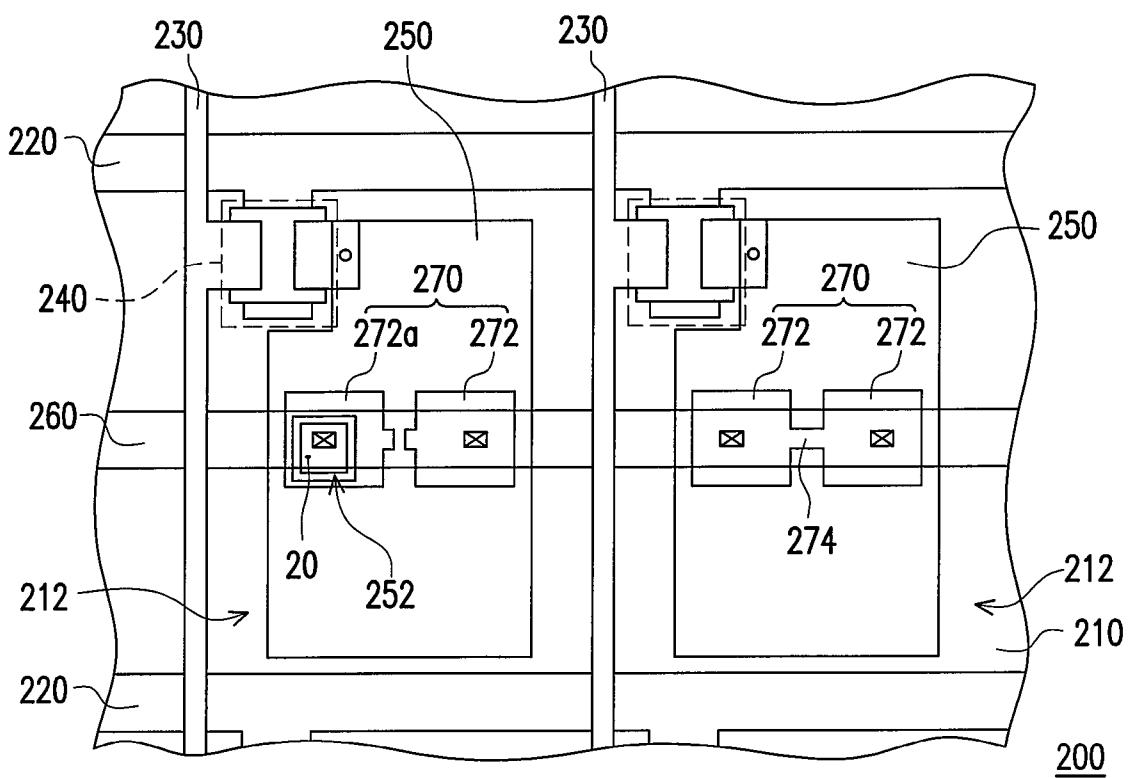
FIG. 11 is a top view of the thin film transistor array substrate in FIG. 10 after a laser repairing operation.

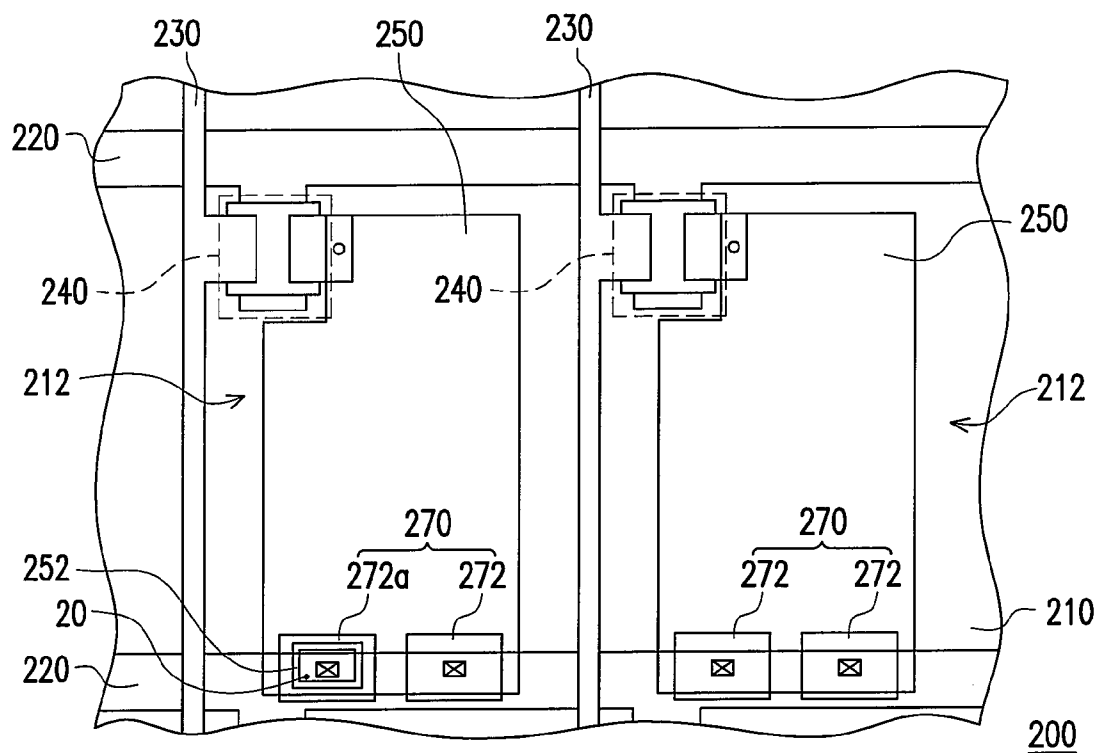
FIG. 12

As shown in FIG. 12, a portion area of each pixel electrode 250 extends into the area above one of the scan lines 220. The patterned upper electrode 270 is disposed between the pixel electrode 250 and the corresponding scan line 220. The patterned upper electrode 270 comprises a plurality of sub-upper electrodes 272. The sub-upper electrode 272 and its underlying scan line 220 together form a storage capacitor inside each pixel.

As shown in FIG. **12**, a portion area of the pixel electrode **250** above the sub-upper electrode **272a** of the corresponding defective capacitor is removed to form an opening **252**. By forming the opening **252** in the pixel electrode **250**, the sub-upper electrode **272a** and the corresponding pixel electrode **250** of the defective capacitor are electrically isolated. The method of removing a portion area of the pixel electrode **250** includes laser ablation, for example.

FIGS. 12 and 13 are top views showing the method of repairing the scan line structure of the storage capacitor inside a thin film transistor array substrate according to the present invention.

FIGS. 12 and 13 are top views showing the method of repairing the scan line structure of the storage capacitor inside a thin film transistor array substrate according to the present invention. As shown in FIGS. 12 and 13, the thin film transistor array substrate has a capacitor on scan line structure (Cst on gate) similar to one shown in FIG. 5.

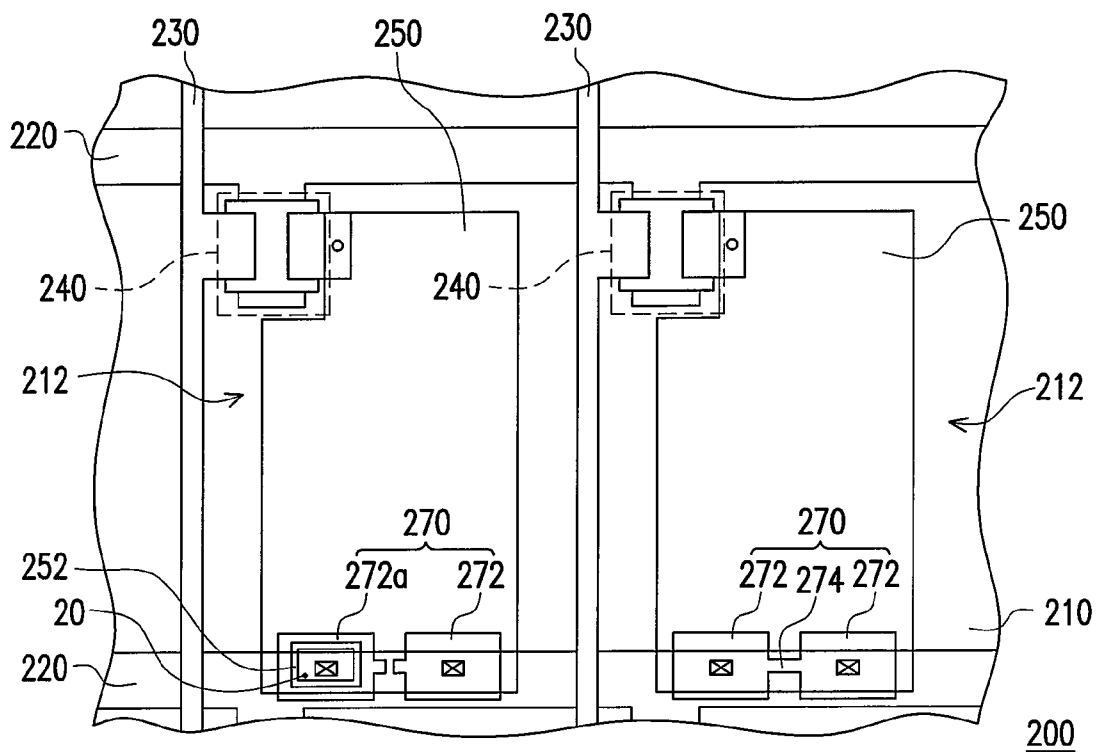
FIG. 13

As shown in FIG. 13, the patterned upper electrode 270 is disposed between each pixel electrode 250 and one of the scan lines 220. The patterned upper electrode 270 comprises a plurality of sub-upper electrodes 272. Furthermore, each sub-upper electrode 272 underneath the pixel electrode 250 has a neck portion 274 connecting with each other. The neck portion 274 serves as a cutting area in a repairing operation.

As shown in FIG. **13**, the repairing method includes removing a portion area of the pixel electrode corresponding to the sub-upper electrode **272a** of the defective capacitor to form an opening **252**. Furthermore, the neck portion **274** connecting with the sub-upper electrode **272a** of the defective capacitor is cut so that the sub-upper electrode **272a** of the defective capacitor and the corresponding pixel electrode **250** are electrically isolated. The method of removing a portion area of the pixel electrode **250** includes a laser ablation process and the method of cutting the neck portion **274** includes a laser cutting operation.

In the presence of a particle (or defect) 20 in the material between one of the sub-upper electrodes 272 and one of the scan lines 220, leakage between the sub-upper electrode 272a and the scan line 220 may occur. Thus, the pixel may display abnormally and need a repair. The method of repairing the pixel includes removing a portion area of the pixel electrode 250 corresponding to the sub-upper electrode 272a of the

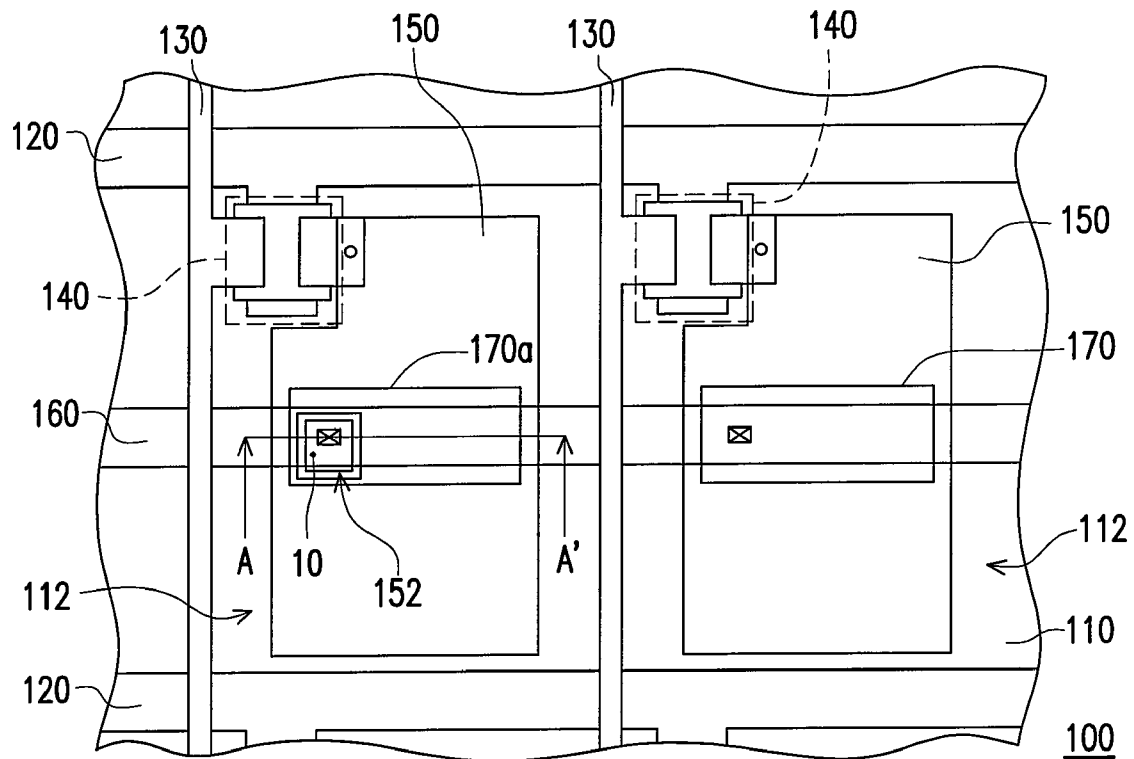
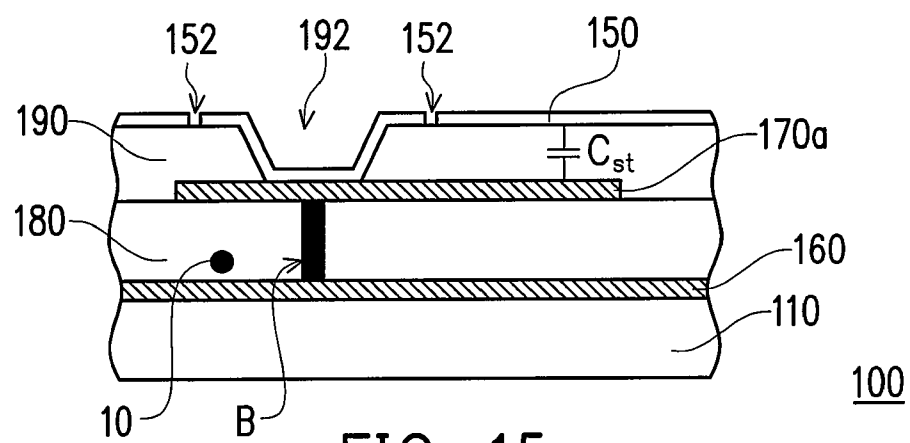
FIGS. 14 and 15 are top view and cross-sectional view showing the configuration after applying the method of the present invention to repair a conventional thin film transistor array substrate.

FIGS. **14** and **15** are top view and cross-sectional view showing the configuration after applying the method of the present invention to repair a conventional thin film transistor array substrate. As shown in FIGS. **14** and **15**, a conventional thin film transistor array substrate **100** has an upper electrode **170** between every pixel electrode **150** and corresponding common line **160**. In the presence of a particle (or defect) **10** between any upper electrode **170** and the corresponding common line **160**, the repairing method of the present invention can be used to rectify the problem. The repairing method of the present embodiment includes removing a portion area of the pixel electrode **150** corresponding to the upper electrode **170a** of the defective capacitor so that the upper electrode **170a** and the pixel electrode **150** of the defective capacitor is electrically isolated. Thereafter, the upper electrode **170a** and the corresponding common line **160** are welded together. Obviously, whether to weld the upper electrode **170a** and the common line **160** of the defective capacitor together can be determined by the amount of leakage in the defective capacitor.

In the present embodiment, a portion area of the pixel electrode **150** above the upper electrode **170a** of the corresponding defective capacitor is removed to form an opening **152**. The method of removing a portion area of the pixel electrode **150** includes laser ablation, for example. The opening **152** is located around the contact area between the upper electrode **170a** and the corresponding pixel electrode **150** of the defective capacitor (that is, around the contact **192**). By forming the opening **152**, the upper electrode **170a** and the

corresponding pixel electrode **150** of the defective capacitor are electrically isolated. Thereafter, the upper electrode **170a** and the corresponding common line **160** are welded together (as shown in label B), for example, by performing a laser welding process, so that the upper electrode **170a** and the common line **160** of the defective capacitor are configured at the same potential.

It should be noted that the thin film transistor array substrate **100** in FIGS. **14** and **15** has capacitor on common line (Cst on common) storage capacitor thereon. However, anyone familiar with the technology can apply the repairing method of the present invention to a substrate having a capacitor on gate (Cst on gate) storage capacitor thereon.

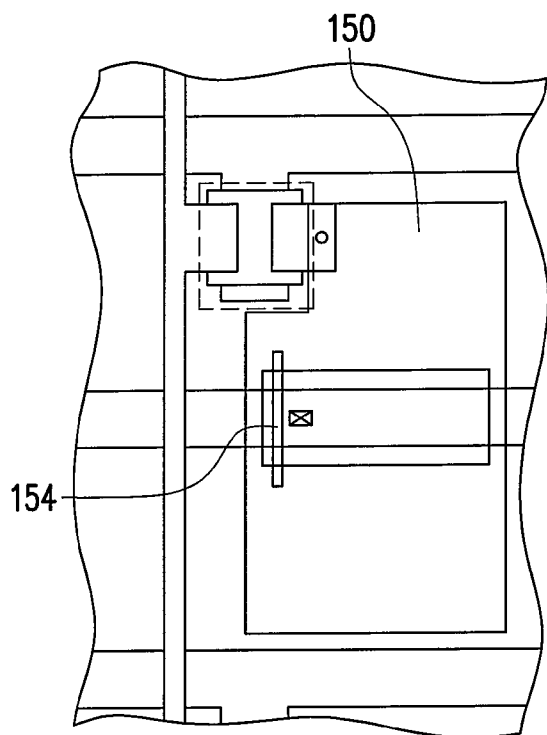
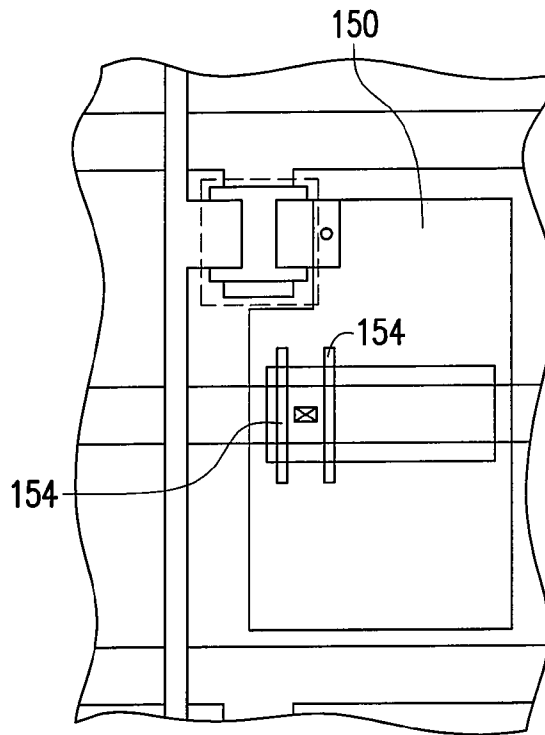
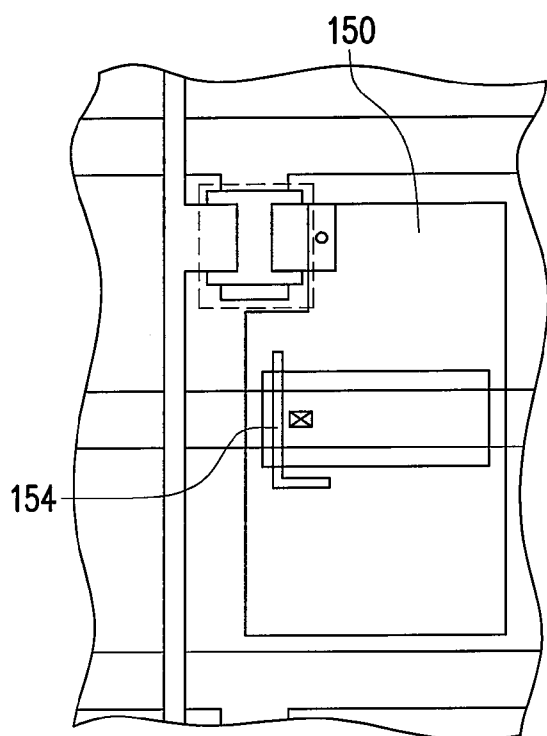
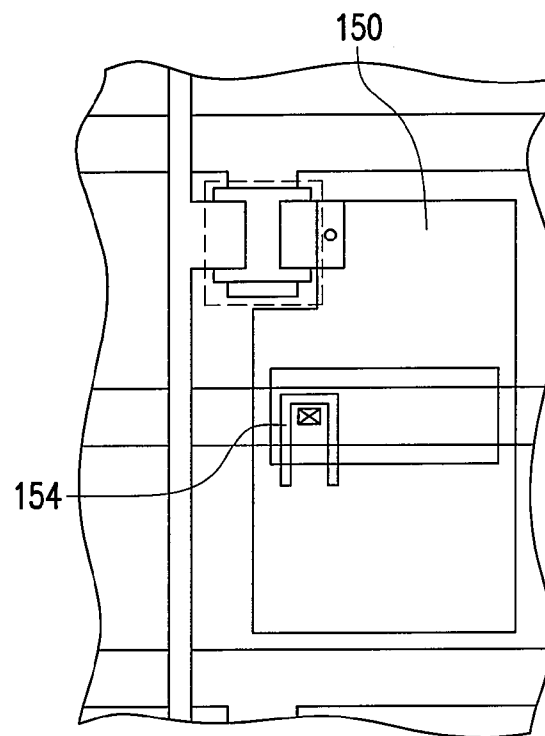
FIGS. 16A through 16D show the types of openings formed on the pixel electrode of a conventional thin film transistor array substrate.

FIGS. **16A** through **16D** show the types of openings formed on the pixel electrode of a conventional thin film transistor array substrate. To simplify and speed up the repairing process, one or more openings **154** are also formed over the thin film transistor array substrate in the process of fabricating the pixel electrode **150**. For example, a straight line opening **154** (as shown in FIG. **16A**), a pair of straight line openings **154** (as shown in FIG. **16B**), an L-shaped opening **154** (as shown in FIG. **16C**) or a U-shaped opening **154** (as shown in FIG. **16D**) are formed over the pixel electrode **150**. Since the openings **154** are similar to the openings disclosed in FIGS. **9A** through **9D**, detailed description is omitted.

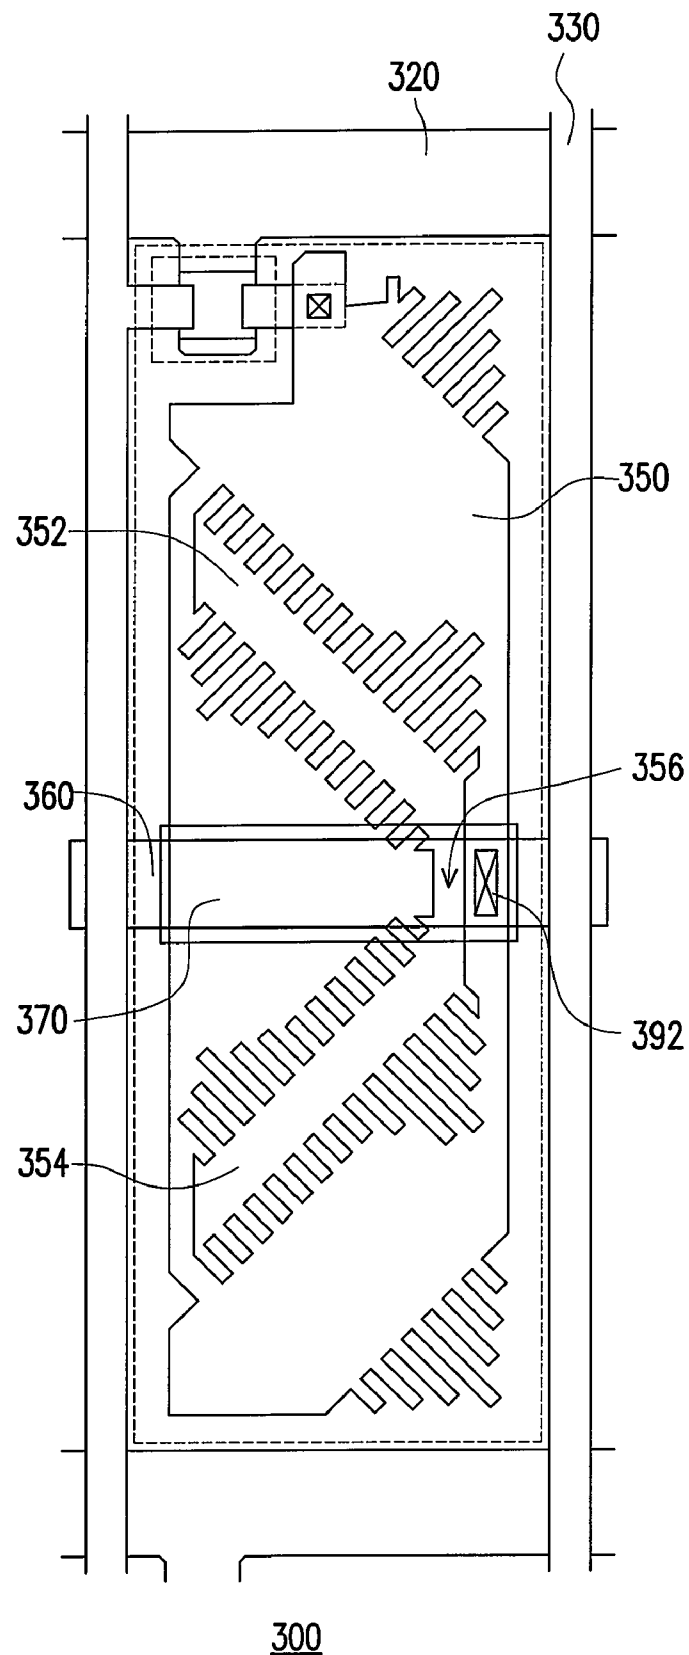
FIG. 17 is a top view showing a thin film transistor array substrate applied to a multi-domain vertical alignment liquid crystal display (MVA-LCD) according to yet another preferred embodiment of the present invention.

FIG. **17** is a top view showing a thin film transistor array substrate applied to a multi-domain vertical alignment liquid crystal display (MVA-LCD) according to yet another preferred embodiment of the present invention. The thin film transistor array substrate **300** in the present embodiment has a structure very similar to the thin film transistor array substrate disclosed in FIG. **1**. Hence, only the dissimilar portions are described in the following.

The thin film transistor array substrate **300** has at least a first slit **352** and at last a second slit **354** disposed over each pixel electrode **350**. The first slit **352** extends in a direction different from the second slit **354** and the direction of exten-

sion of the first and the second slit **352**, **354** are different from the scan line **320**, the data line **330** or the common line **360**. In addition, a first slit **352** and one of the second slits **354** are connected together through a connecting area **356** when the first slits **352** and the second slits **354** are formed. The electrical contact area (the contact **392**) between the upper electrode **370** and the corresponding pixel electrode **350** are adjacent to the connecting area **356** between the first and the second slit. Furthermore, the upper electrode **370** and the corresponding common line **360** are coupled to form a capacitor.

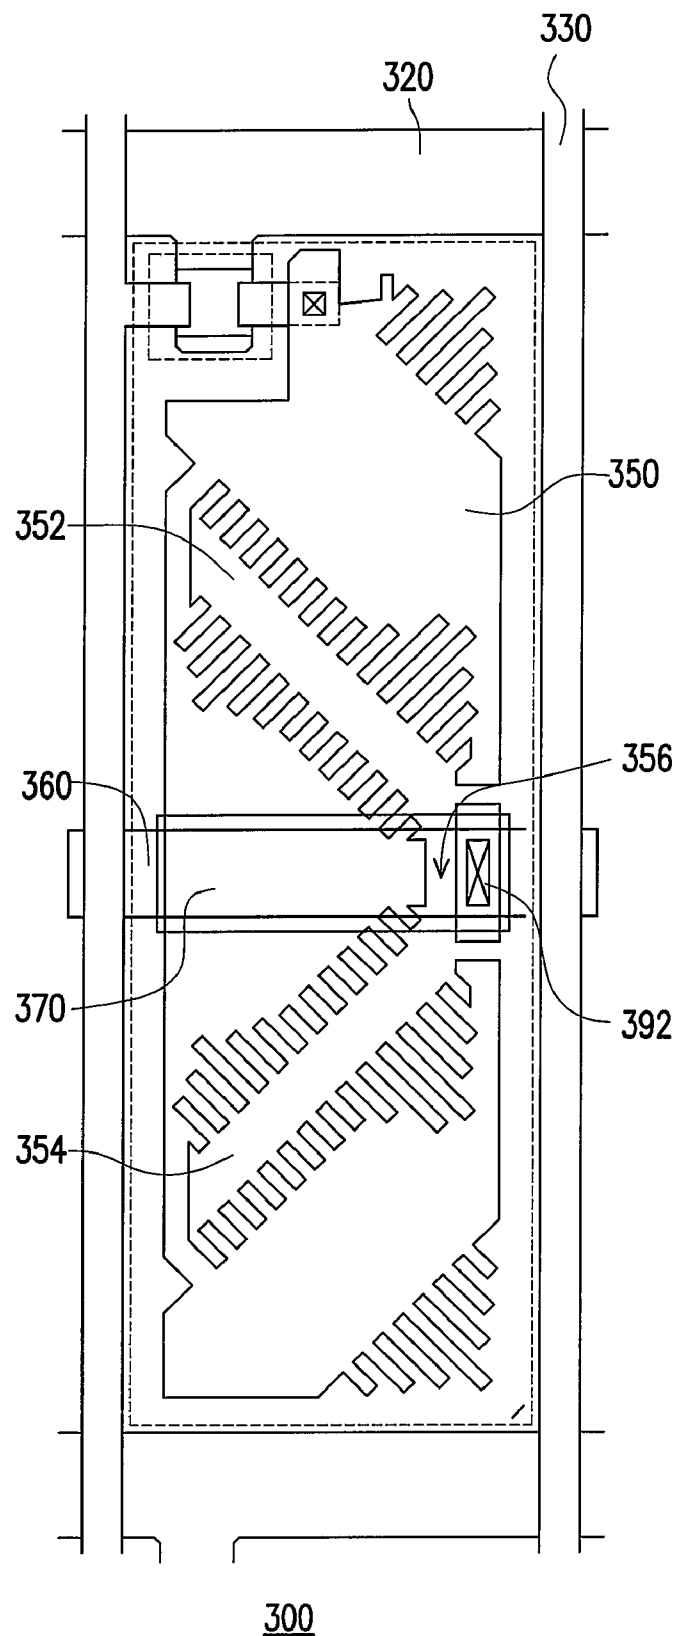
FIG. 18 is a top view of the thin film transistor array substrate of the MVA-LCD in FIG. 17 repaired according to the method of the present invention.

It should be noted a repair is required when a particle or defect is formed between the upper electrode **370** and one of the common lines **360** so that the upper electrode **370** and the common line **360** together form a defective capacitor. FIG. **18** is a top view of the thin film transistor array substrate of the MVA-LCD in FIG. **17** repaired according to the method of the present invention. The repairing method includes removing a portion area of the pixel electrode **350** corresponding to the upper electrode of the defective capacitor. In the present embodiment, the portion area of the pixel electrode **350** to be removed is the area around the electrical contact (the contact **392**) between the upper electrode **370** and the corresponding pixel electrode **350**. Thus, the upper electrode **370** of the defective capacitor and the corresponding pixel electrode **350** are electrically isolated. In other words, by removing a small portion of the pixel electrode **350** (a small area around contact **392**) covering the upper electrode **370**, the upper electrode **370** and the corresponding pixel electrode **350** of the defective capacitor are electrically isolated. Since only a small portion of the pixel electrode **350** covering the upper electrode **370** is removed in the present embodiment, a large capacitance can be maintained after the repair operation.

Thereafter, the upper electrode **370** and the corresponding common line **360** of the defective capacitor are welded together so that the upper electrode **370** and the corresponding common line **360** of the defective capacitor are at the same potential. Obviously, whether to weld the upper electrode **370** and the common line **360** of the defective capacitor together can be determined by the amount of leakage in the defective capacitor.
