(10) **Patent No.:** **US 10,954,102 B2**

(54) **DIAGNOSTIC STEP FOR A PASSENGER CONVEYOR**

(71) Applicant: **OTIS ELEVATOR COMPANY,**  
Farmington, CT (US)

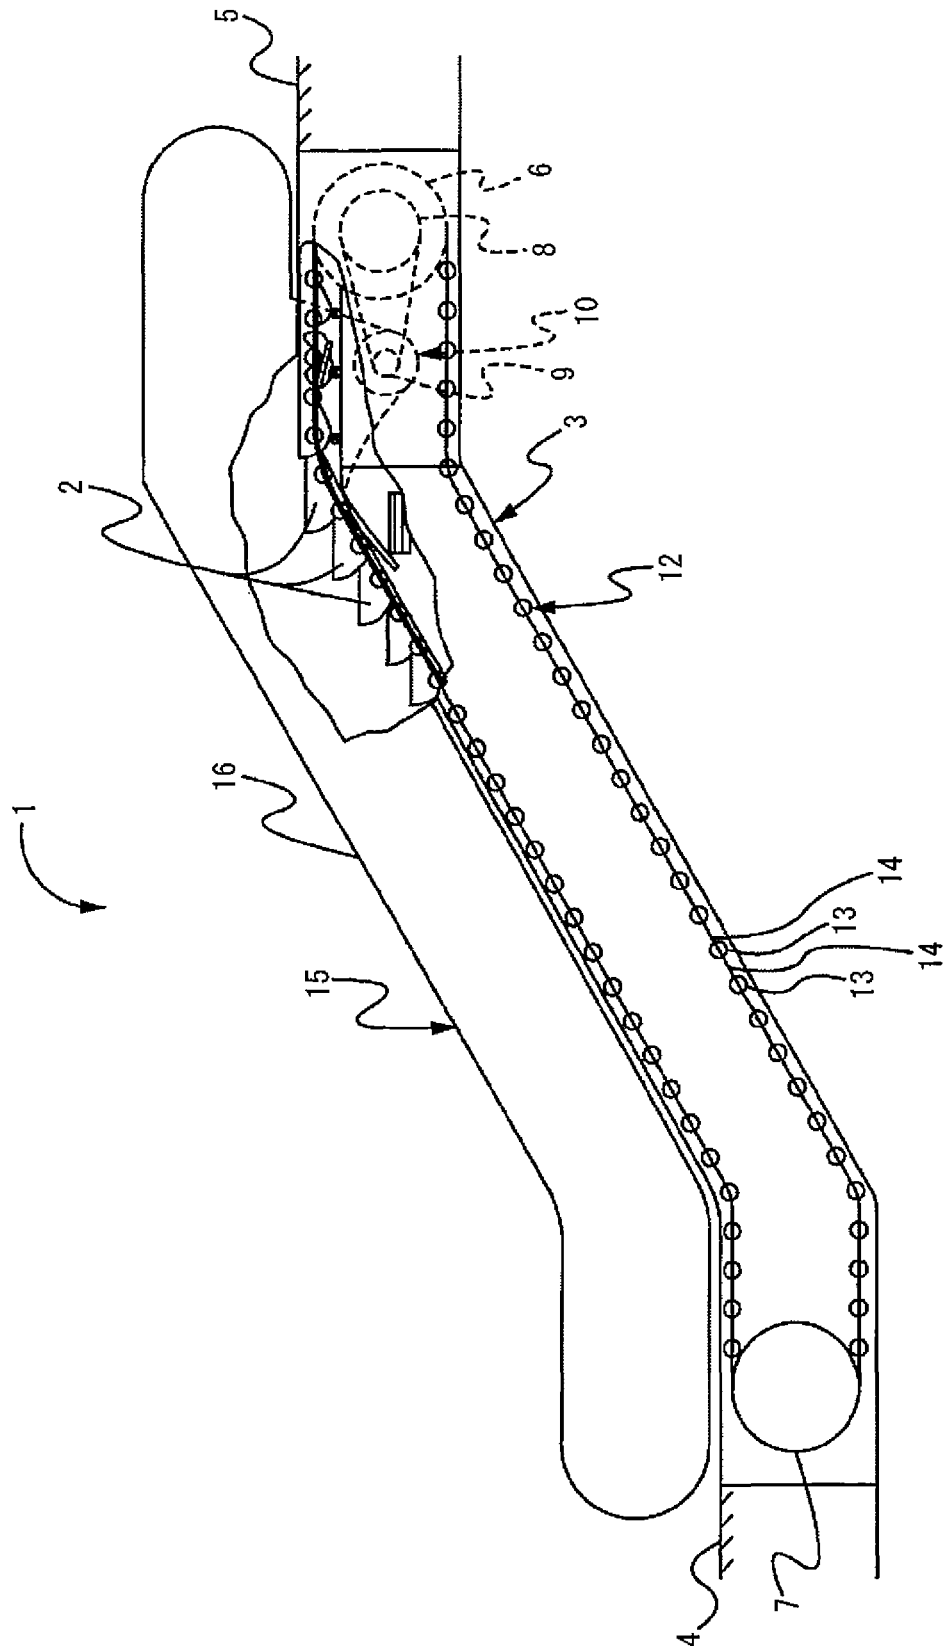
Fig. 1

FIG. 1 is a cross-sectional diagram of an escalator.

FIG. 1 schematically shows a passenger conveyor 1 in which the diagnostic device of the present invention may be used. In this example, the passenger conveyor 1 is an escalator including a plurality of escalator steps 2 that travel around a loop for carrying passengers between landings at different levels within a building.

The example passenger conveyor 1 of FIG. 1 comprises a truss 3 installed between a lower landing 4 and an upper landing 5. A first sprocket wheel 6 is rotatably supported at an upper end of the truss 3 and a second sprocket wheel 7 is rotatably supported at a lower end of the truss 3. A drive system (not shown) rotates the first sprocket wheel 6 as well as a handrail drive sprocket 8. The handrail drive sprocket 8 is coupled to a pulley 9 which forms part of a handrail drive system 10.

The escalator steps 2 are coupled to a step chain 12 which may include a plurality of rollers 13 connected by a plurality of links 14. The step chain 12 and the escalator steps 2 are driven by the drive system via the first sprocket wheel 6. A typical step chain 12 includes a pair of parallel endless loops on both lateral sides of the escalator steps 2. The loops are connected together by transverse axles (not shown) that pass between and help support the escalator steps 2. Thus, while only a single loop is illustrated in FIG. 1, it will be understood that the escalator includes dual loops, and each step chain 12 is driven around respective sprocket wheels 6, 7 positioned in the interior space of the truss 3 on each lateral side thereof.

An endless handrail 15 passes around a balustrade assembly 16. While only a single handrail 15 is illustrated in FIG. 1, it will be understood that a pair of endless handrails 15 are supported on a respective balustrade assembly 16 on both lateral sides of the escalator steps 2 and are each driven by a respective handrail drive system 10 positioned in the interior space of the truss 3 on each lateral side thereof.

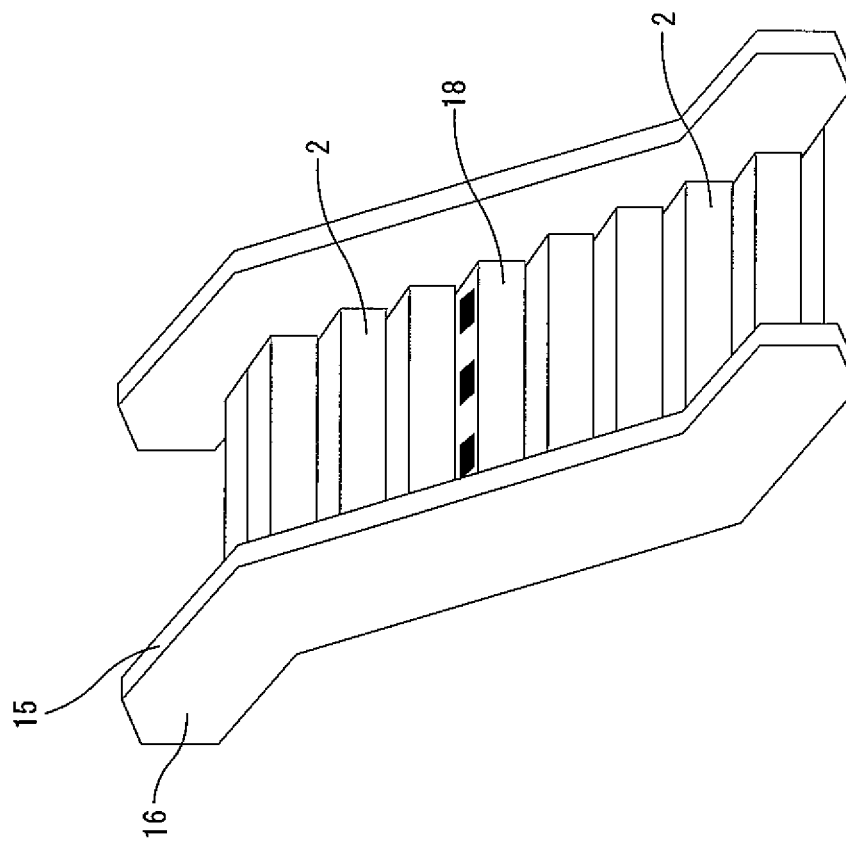
Fig. 2

FIG. 2 is a schematic view of an escalator with the diagnostic step of the present invention installed thereon.

FIG. 2 shows an example diagnostic device 18 of the present invention in the form of a step. The diagnostic step 18 may be simply installed on the escalator during maintenance or repair by removing a single escalator step 2 and attaching the diagnostic step 18 in place of the removed escalator step 2.

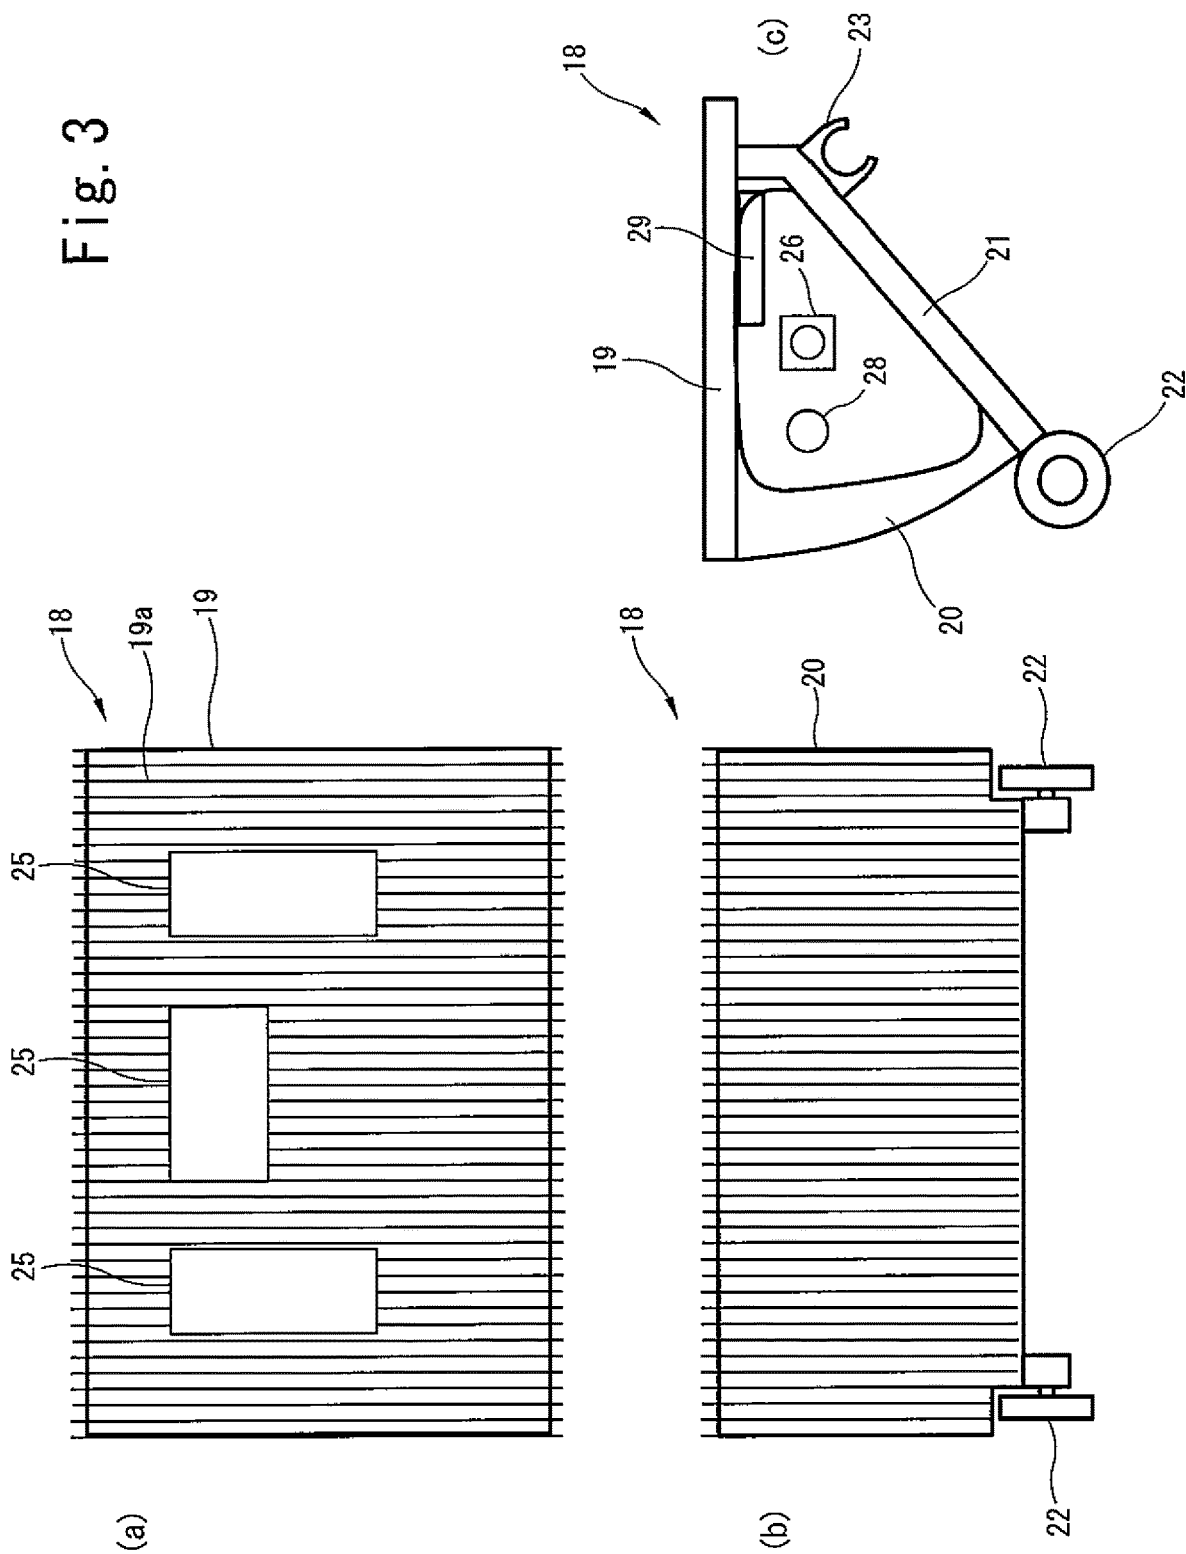
Fig. 3

FIG. 3(a) is a plan view, FIG. 3(b) is a front view and FIG. 3(c) is a side view of the diagnostic step of FIG. 2.

As shown in FIG. 3, the diagnostic step 18 may have a configuration which resembles escalator step 2 and includes a tread portion 19 joined to a riser portion 20 and step arms 21 (only one shown in FIG. 3) connecting the tread portion 19 to the riser portion 20 as known in the art. The step arms 21 are connected to each other by an axle 24 (FIG. 4) and may each comprise rollers 22 on one end for riding on a rail and support members 23 on the other end for engaging a transverse axle such that the diagnostic step 18 may be

driven around the loop together with the escalator steps 2 when it is installed on the escalator. FIG. 3(a) shows a plan view, FIG. 3(b) shows a front view and FIG. 3(c) shows a side view of the diagnostic step 18.

The outer surface 19a of the tread portion 19 corresponds to the surface of escalator step 2 which receives the foot of a passenger and faces generally upward during the advance path. The tread portion 19 includes at least one maintenance window 25 (three in this example) for access to the inner side of the diagnostic step 18.

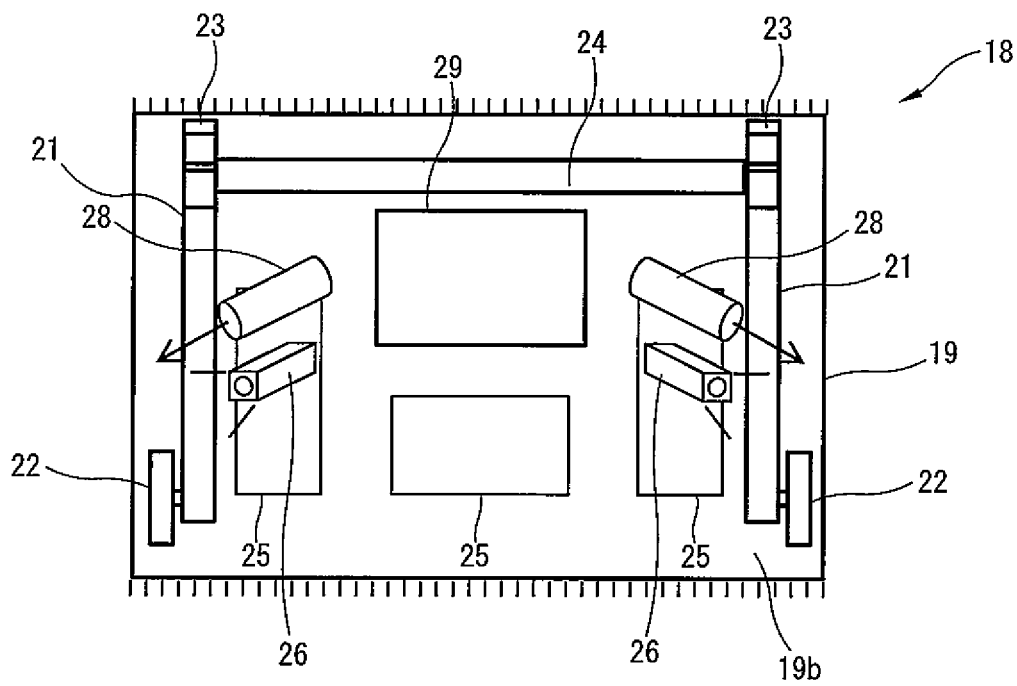
Fig. 4

FIG. 4 is a bottom view of the diagnostic step of FIG. 2.

The diagnostic step 18 includes at least one camera 26, at least one directional microphone 28 and an analyzer unit 29 in the space defined by the tread portion 19, riser portion 20 and step arms 21. In the embodiment shown in FIG. 4, the diagnostic step 18 includes two cameras 26 and two microphones 28. Each camera 26 may be attached to the inner surface 19b of the tread portion 19 such as by brackets and may be adjustable to shoot different directions. Each camera 26 may include a LED light. In this embodiment, one camera is adjusted to shoot one or a plurality of components positioned on one lateral side (ex. the left-hand side of FIG. 2) and one camera is adjusted to shoot one or a plurality of components positioned on the other lateral side (ex. the right-hand side of FIG. 2) of the interior space of the truss 3. The directional microphones 28 may also be attached to the inner surface 19b of the tread portion 19 such as by brackets and may be adjustable to point to different directions. In this embodiment, one microphone 28 is adjusted to point to one or a plurality of components on the right-hand side and one microphone 28 is adjusted to point to one or a plurality of components positioned on the left-hand side of the interior space of the truss 3.

In this way, the cameras 26 and the microphones 28 may collect images or sounds of components positioned on the left-hand side and on the right-hand side separately. Such components may include components such as the handrail drive system 10 or sprocket wheels 6, 7. The cameras 26 and the microphones 28 may be adjusted through the maintenance windows 25 after installing the diagnostic step 18 onto the escalator.

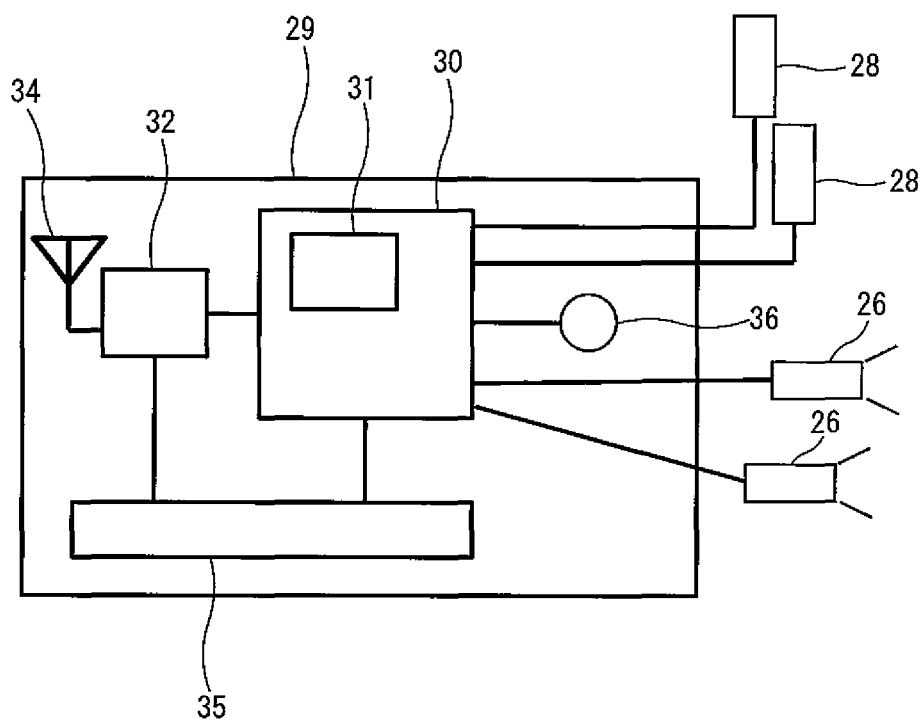
Fig. 5

FIG. 5 is a detailed view of the analyzer unit of FIG. 4.

The analyzer unit 29 may be attached to the inner surface 19b of the tread portion 19. A detailed view of the analyzer unit 29 is shown in FIG. 5. The analyzer unit 29 may comprise a printed-circuit board 30 including a memory 31, a wireless network interface device 32 such as a 3G modem, WiFi interface etc. including an antenna 34 and a battery 35 for providing power to all of the components included in the diagnostic step 18. The directional microphones 28 and cameras 26 are connected to the printed-circuit board 30 to provide sound data and image data. An acceleration sensor 36 may also be connected to the printed-circuit board to provide acceleration data. The printed-circuit board 29 receives the analog data or digital data from the cameras 26, microphones 28 and sensor 36, converts analog data to digital data as necessary and stores such data in the memory 31. The sound data and image data are synchronized. The printed-circuit board 29 may further analyze such data. Data and analyzed results may be provided to a wireless network 38 (FIGS. 7 to 9) via the wireless network interface device 32.

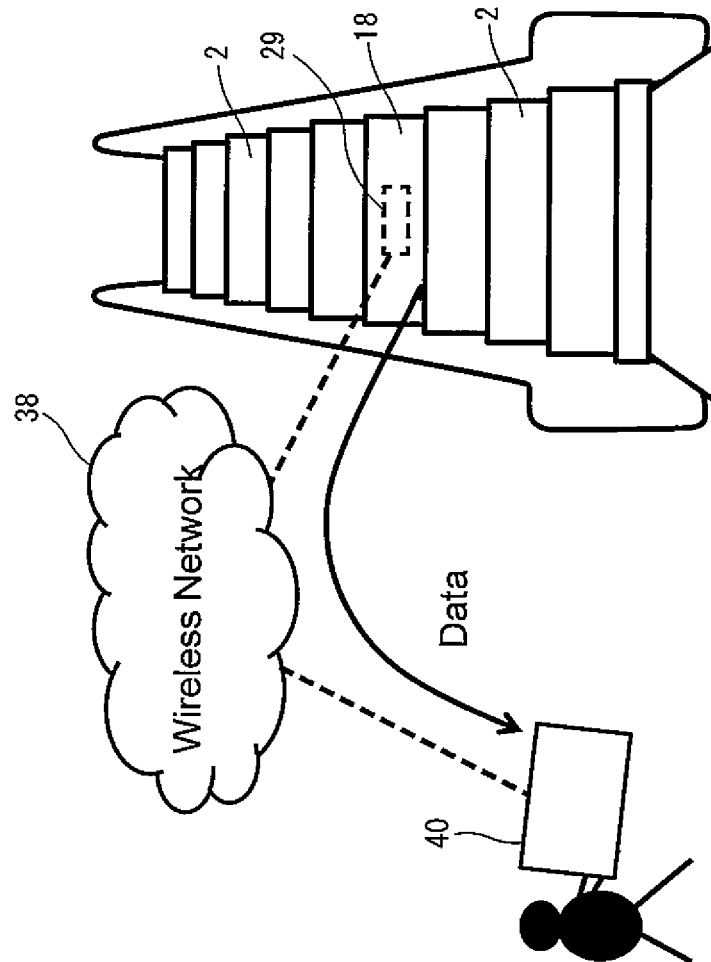
Fig. 7

FIG. 7 is a schematic view of a wireless network connecting the analyzer unit and a personal computer.

With reference to FIG. 7, data may be transmitted to a personal computer 40 which may be in the form of a tablet, smart phone etc. via the wireless network 38. A service engineer may listen to the sounds emanating from the left-hand side of the truss 3 while viewing the corresponding image of the components positioned on the left-hand side of the truss 3 causing the sounds. The sounds and image may be switched to the right-hand side after checking the left-hand side. This allows the service engineer to easily find out which components, components positioned on the left-hand side or components positioned on the right-hand side, are causing abnormal sounds, in spite of sound reverberations inside the truss 3 and also allows the service engineer to visually check the components causing the abnormal sounds at the same time. This greatly shortens the time to determine the cause of failure or malfunctions associated with the escalator and does not require stopping the escalator and gaining access to the space beneath the escalator steps 2.

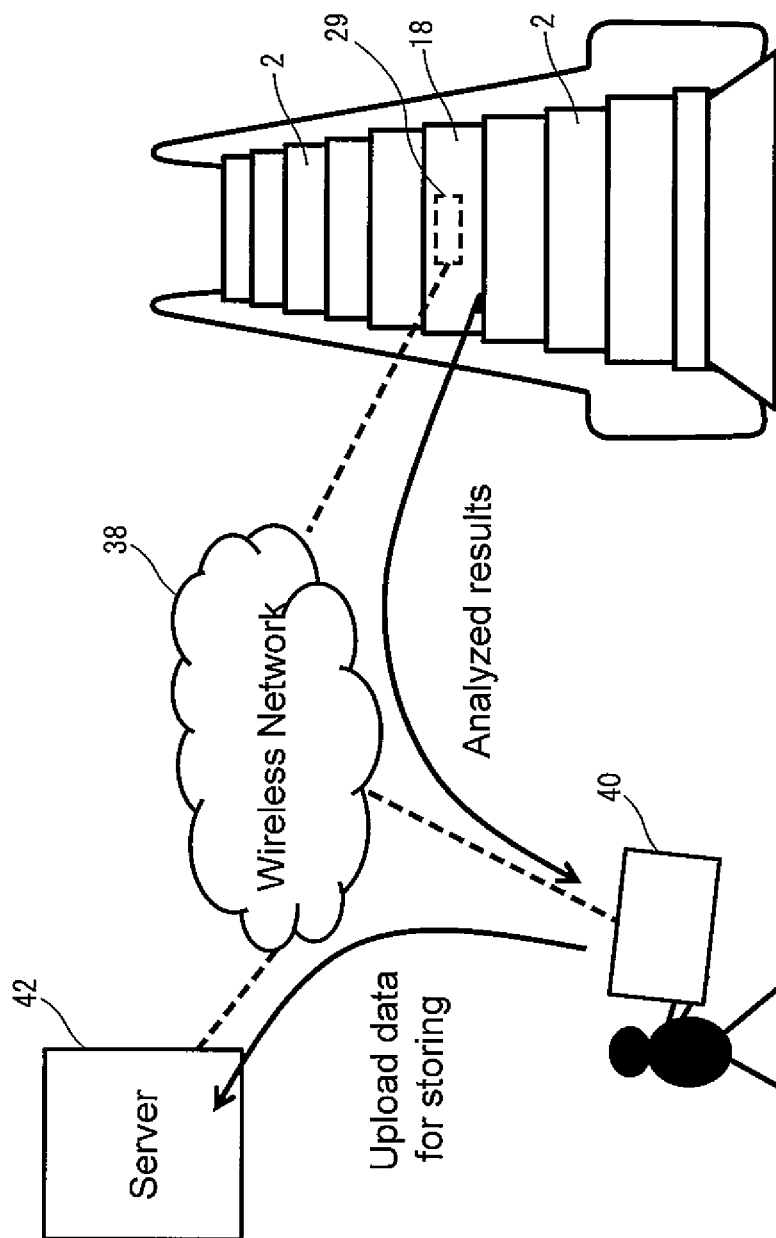
Fig. 8

FIG. 8 is a schematic view of a wireless network connecting the analyzer unit, a personal computer and a server.

FIG. 8 shows another embodiment in which the analyzer unit 29 analyzes data from the microphone 28, camera 26 and/or sensor 36 and the analyzed results are transmitted to the personal computer 40 of the service engineer. The analyzed results may include the detection of abnormal sounds with corresponding images and may allow the service engineer to immediately determine the cause of failure or malfunctions associated with the escalator. The service engineer may upload such results to a server 42 for storage. The server 42 may be remote from the site and the stored data may be used for preventive maintenance. This process is carried out via a wireless network 38.

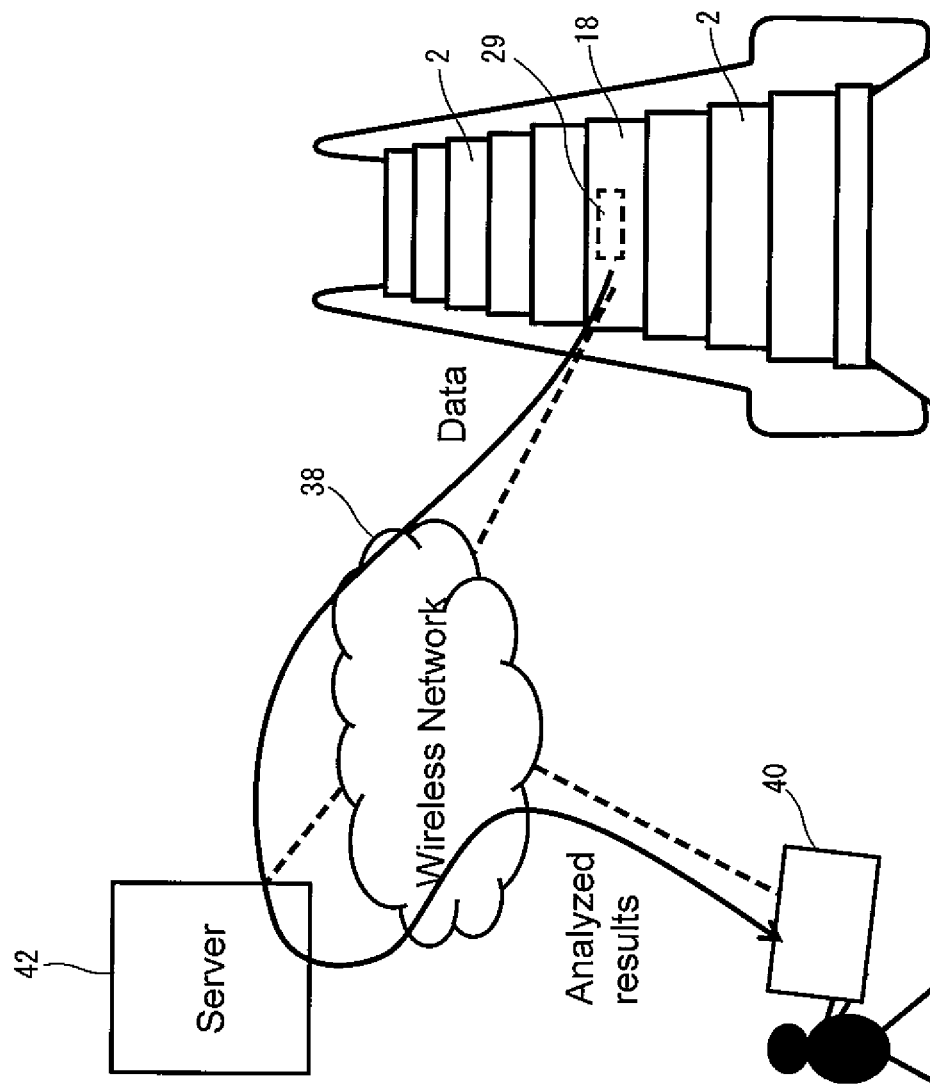
Fig. 9

FIG. 9 is a schematic view of another example wireless network connecting the analyzer unit, a personal computer and a server.

FIG. 9 shows a further embodiment in which data and/or analyzed data is transmitted to a server 42. The server 42 may be remote from the site. The data is stored and may be further analyzed in the server 42. The stored data may be used for preventive maintenance. The server 42 may provide the further analyzed results to the personal computer 40 of the service engineer. This process is also carried out via a wireless network 38.
