[54] **ULTRASONIC EXAMINATION OF REACTOR PRESSURE VESSEL TOP GUIDE**

[73] Assignee: General Electric Company, San Jose, Calif.

[57] **ABSTRACT**

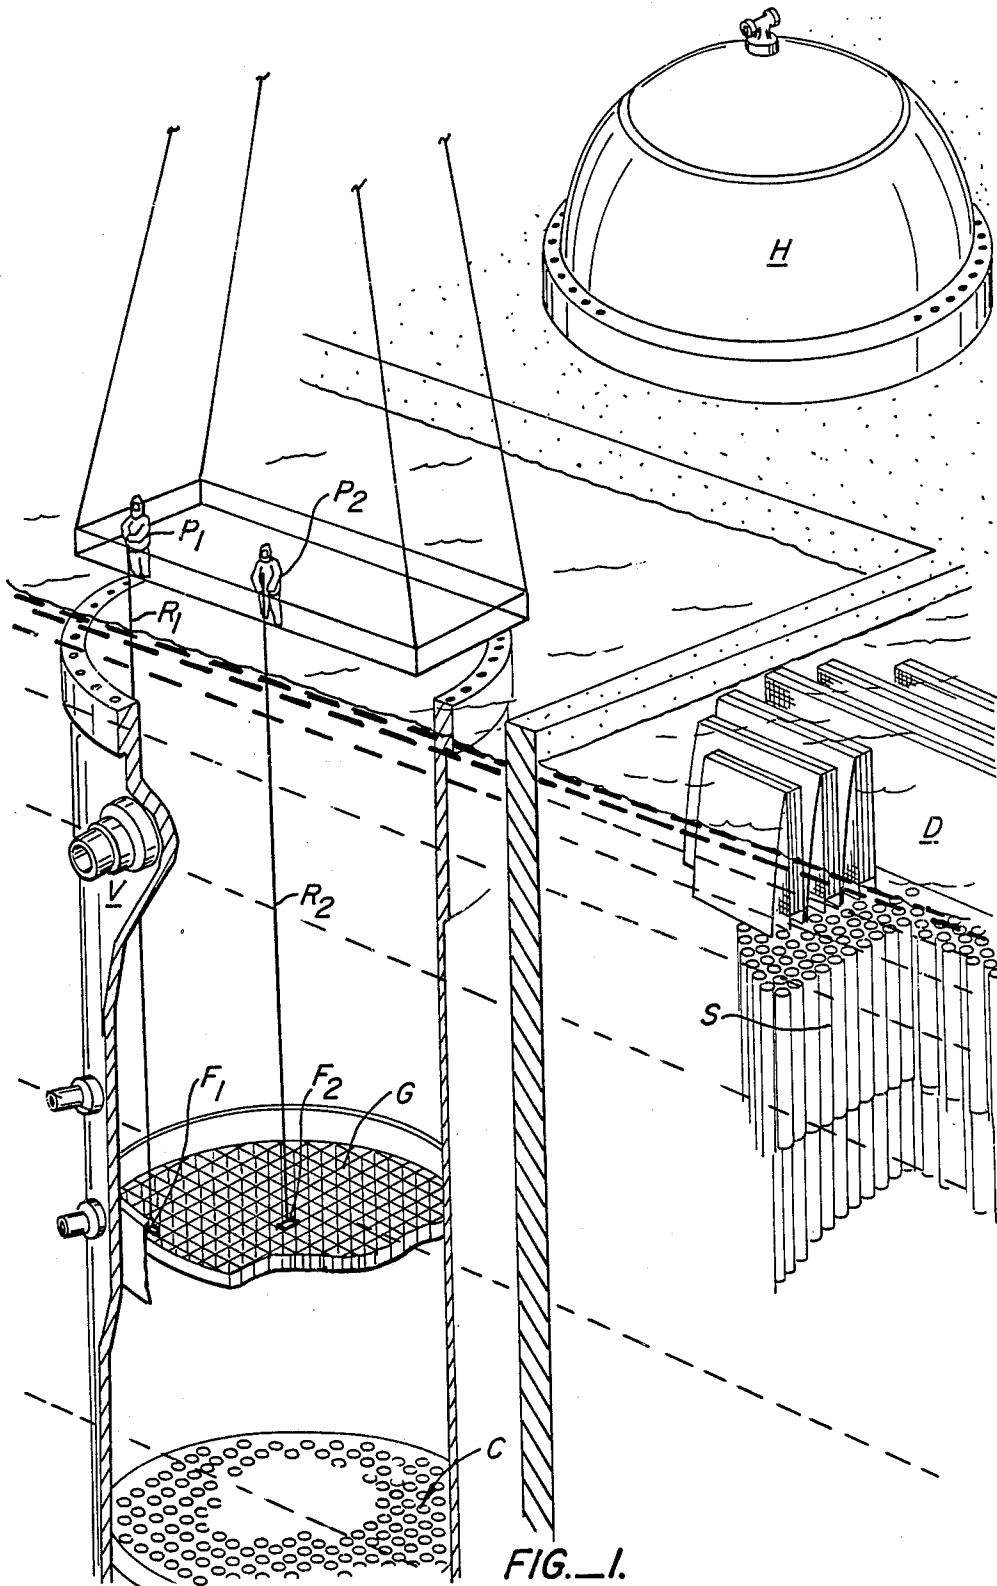
FIG. 2 is a plan view of the top guide of FIG. 1 illustrating a pattern of removal of the fuel assemblies for the disclosed ultrasound testing of the top guide;

Referring to FIG. 2, a plan view of the top guide G is illustrated within the reactor vessel V. Top guide G is shown to be a lattice-like structure of intersecting bars. These bars typically overlie a core plate C (see FIG. 1) and define discrete cells 20. As is well known in the prior art, the cells 20 each brace the tops of four fuel assemblies. The cells 20 of the top guide G hold the fuel assemblies at their upward end remote from the core plate C which supports the weight of the fuel assemblies. The function of the top guide G is at least two fold in nature.

Secondly, the top guide G maintains the fuel assemblies with their sides parallel to one another and spaced apart from one another. This enables among other things, the control rods to penetrate the cruciformed shaped interstices between four fuel assemblies. Such a configuration of four fuel assemblies A maintained by the top guide assembly is shown at cell 20' in FIG. 2.

In order for a test of this invention to be conducted, it is preferred that each cell 20 have the fuel assemblies A removed. This prevents protrusion of the fuel channels of the fuel assembly from interfering with the test procedures herein set forth. The area of fuel assembly removal is shown in heavy solid lines. It will be understood that fuel assemblies on both sides of the portion of the top guide G designated by the heavy lines are removed.

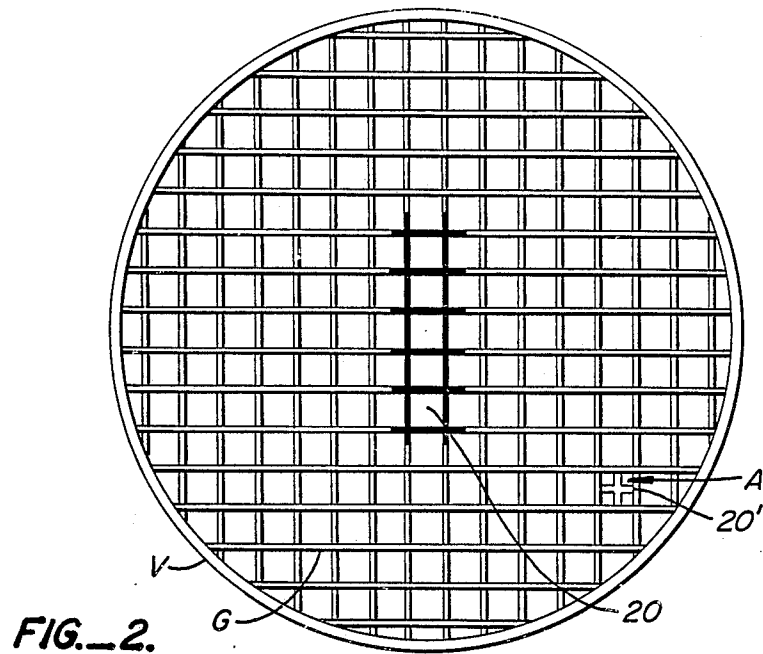
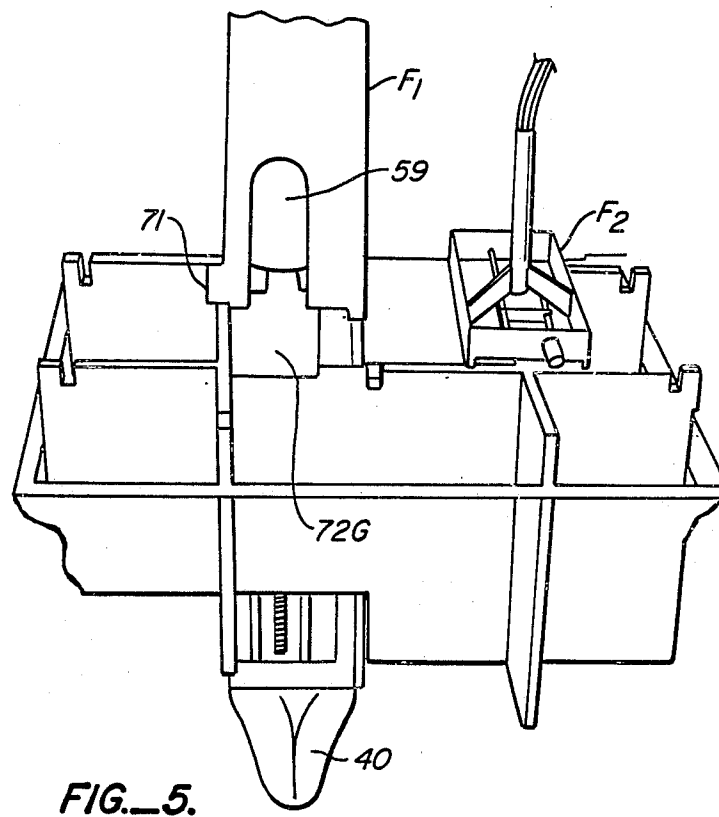
FIG. 3B.

FIG. 3B is a plan view of the vertically sweeping carriage illustrating the carriage and the 70° angle of incidence of ultrasound to and from the bar;

Referring to FIG. 3B, carriage 60 is illustrated in plan with its two faces 61, 62. Each of the faces 61, 62 have paired transducers. These transducers are 63 and 65 on face 61 and 64 and 66 on face 62.

Transducer 63 sends a signal at 70° away from face 61 towards the corner defined by the intersection of the faces 61, 62. Transducer 65 adjacent the corner of faces 61, 62 sends an acoustical signal horizontally at 70° away from the corner defined by faces 61, 62. The acoustical signals of transducers 64, 66 on face 62 are correspondingly angularly incident towards and away from the swept cell corner.

The purpose of these opposed angularly incident signals may readily be understood. Specifically, the transducers 63, 65 will pass immediately over the bar that they are interrogating. In such passage, the acoustical signals must be given an angle of incidence wherein penetration of the bar with the acoustical signal and detection of the returned acoustical signal is assured. By the specific orientation herein disclosed, thorough checking of a bar at the corner of a discrete cell in guide G is assured; one transducer interrogates to the corner, the remaining transducer interrogates away from the corner; as can be seen, vertical sweep across the entire width of the bar by the transducers thoroughly interrogates the full width of the bars forming the corner with horizontal ultrasound to detect vertical cracking.

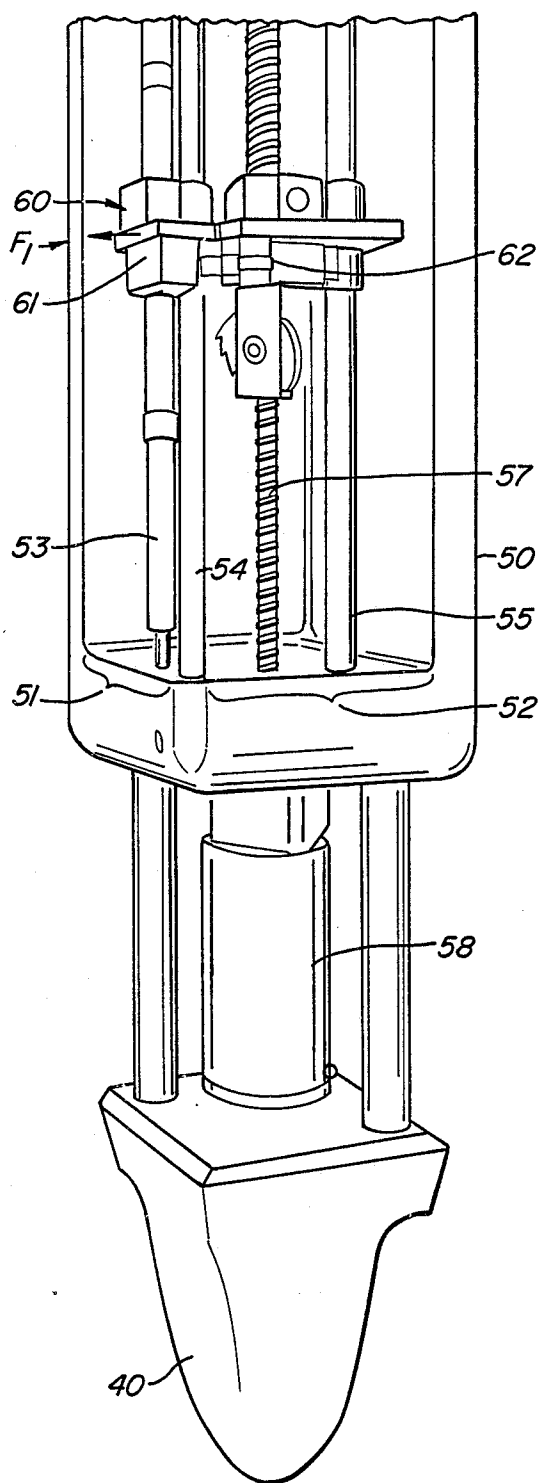
FIG. 3C.

FIG. 3A and 3C are respective small and enlarged perspective views of a fuel channel sectioned top guide ultrasound test frame for vertically sweeping from a cell corner sound transducers, with the sound transducers emanating angularly incident horizontal ultrasound waves for the detection of vertically aligned cracking;

Referring to FIG. 3A, frame F1 includes a nose piece 40 having the shape of a finder and a main body 50 having the approximate section of a fuel channel of a typical fuel assembly. A carriage 60 is shown mounted for vertical excursion along two respective open and therefore exposed sides 51, 52 of frame F1. The carriage rides on three bars 53, 54, and 55. The carriage is propelled by a ball screw (imbedded in the carriage 60 and therefore not shown) following a rotating threaded shaft 57. Rotation of shaft 57 is monitored at shaft encoder 58 and caused by motor 59 at the top of the assembly. Conventional rotation of motor 59 and tracking

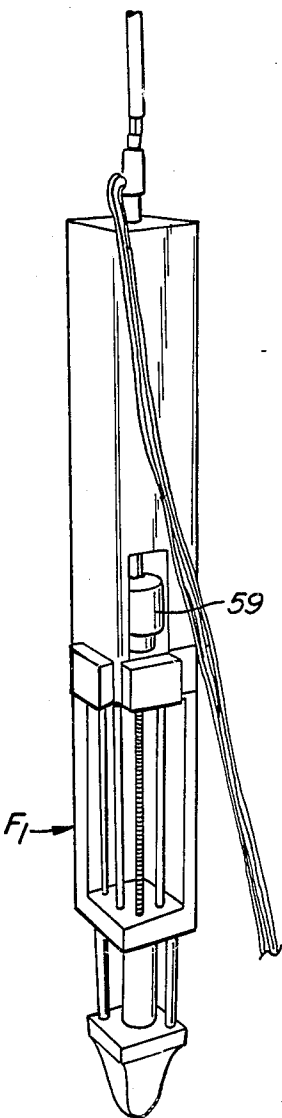
FIG. 3A.

of rotation at shaft encoder 58 enables precise positioning of the carriage 60 to be known.

Carriage 60 includes a carriage face 61 parallel to open side 51 and a second carriage face 62 parallel to open side 52. Faces 51, 52 each confront a bar at the corner of a cell in a top guide.

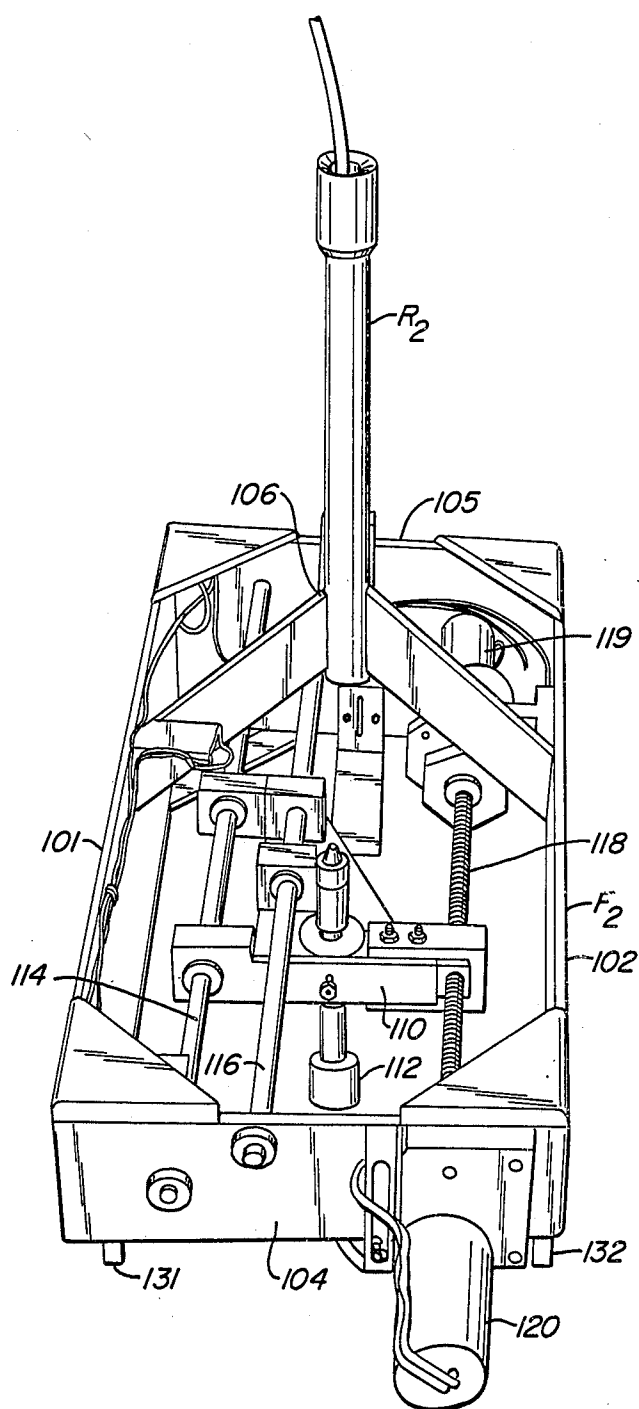
FIG. 4.

FIG. 4 is a perspective view of a cradle assembly for horizontally sweeping along a top side edge of a bar at the upward portion of the lattice of the top guide, the acoustical transducer interrogating the bar with vertical signals for the presence of horizontal tracks; and,

Referring to FIG. 4, frame F2 is illustrated. It includes longitudinal sides 101, 102 and ends 104, 105. These sides and ends form a rigid frame structure connected at a yoke 106 to rod R2. Paired rods 114, 116 form points of support for the excursion of a carriage 110. Carriage 110 has mounted there below an ultrasound transducer 112. Carriage 110 is driven by a threaded shaft 118 at a ball screw imbedded within the

carriage 110 (not shown). Motor 119 causes shaft 118 to rotate. A shaft encoder 120 determines the precise position of the carriage 110.

Feet 131, 132 rest upon a bar parallel to section 104 of the rotor. A forward foot from bar 105 (obscured in the view here shown) preferably rests on the bar tested at a portion within the next cell on top guide G.

Turning to FIG. 5, placement of the frame F2 is illustrated. Referring back to FIG. 4 it will be understood that transducer 112 undergoes excursion the length of the frame. The single transducer 112 interrogates with vertical ultrasound waves a bar for horizontal cracking. Thus the fixtures set forth in Figs. 3A and 3B and FIG. 4 are capable of remotely interrogating the lattice of top guide G for horizontal and vertical cracking.
