(12) Patent Application Publication (10) Pub. No.: US 2009/0291204 A1 Meredith et al.

(54) DEVICE AND METHOD FOR REPAIRING MORTAR JOINTS BETWEEN CHIMNEY TILES

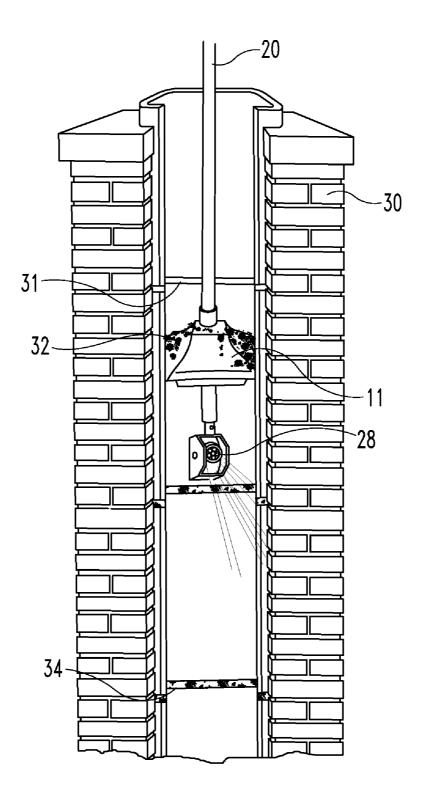
Fig. 1

[0008] FIG. 1 shows a perspective view of the inventive tool being used for the inventive method, according to one embodiment.

[0043] Referring now to the drawings, FIG. 1 shows a perspective view of the inventive tool being used for the inventive method, according to one embodiment. Plunger assembly 11 is positioned in chimney by using rod 20 to push the plunger assembly and camera 28 into the chimney. Repair material 32, which may be mortar or another chimney-repair material, has been provided on plunger assembly 11 so that the plunger may push the material into chimney joints 31. A repaired joint 34 results.

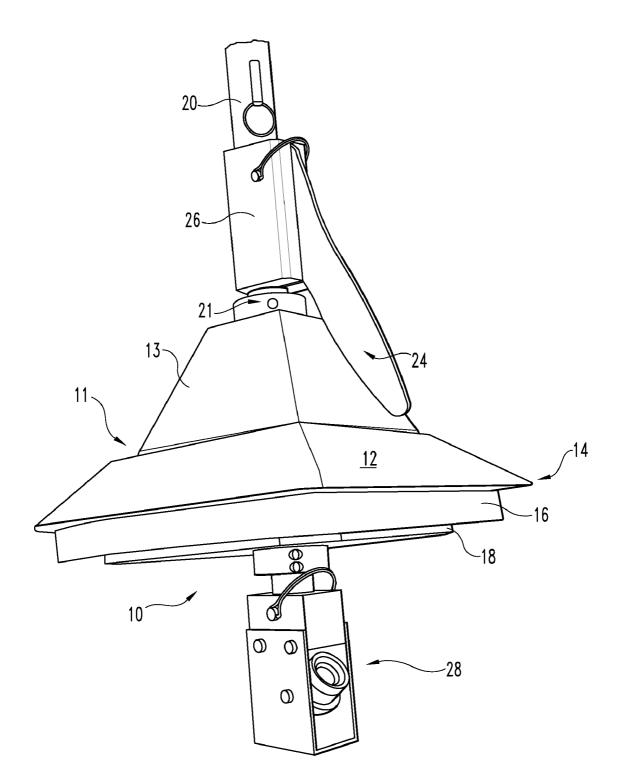
Fig. 2

[0009] FIG. 2 shows a perspective view of the inventive tool, according to one embodiment.

[0044] FIG. 2 shows a perspective view of the inventive tool, according to one embodiment. Plunger/camera assembly 10 includes a plunger assembly 11 that is sized to be slightly larger than the interior of a chimney flue to be treated. Plunger assembly 11 has a plunger blade 12 that slopes to a rim 14 to direct mortar or another repair material to the flue

surface when mortar is dropped onto the plunger from above. Plunger blade support plate 16 lends rigidity and support to plunger blade 12.

[0045] Plunger assembly 11 is mounted on rod 20 which extends both above and below the assembly. As indicated above, a sleeve may be provided to facilitate rotation of the rod through plunger 10 without turning the plunger.

[0046] A spreader paddle 24 is mounted to rod 20. Spreader paddle 24 is fixed to rod 20 such that rotation of rod 20 additionally rotates spreader paddle 24.

[0047] A camera 28 is provided on rod 20 below plunger 11. The camera may be in a fixed orientation (although generally rotatable), or it may be capable of being maneuvered to view higher or lower when desired. Camera 28 is also preferably fixed to rod 20 such that rotation of rod 20 rotates camera 28.

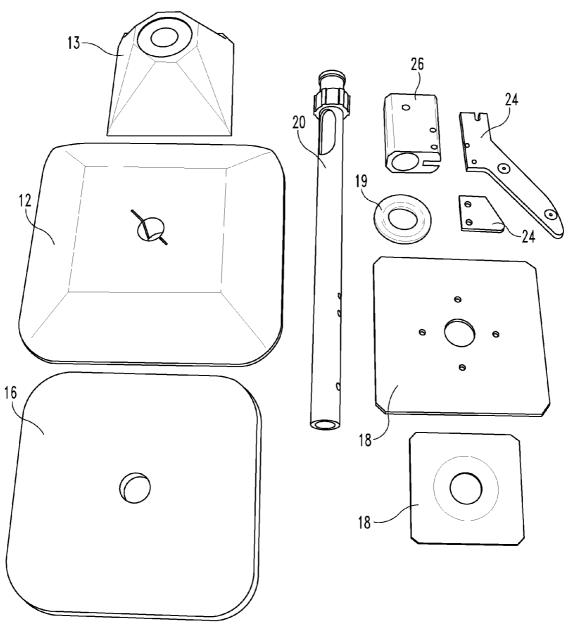
Fig. 3

[0010] FIG. 3 shows the components of the plunger assembly of the inventive tool, according to one embodiment.

[0048] FIG. 3 shows the components of the plunger assembly of the inventive tool, according to one embodiment. Plunger head 13, plunger blade 14, plunger blade support plate 16, spreader head 26, spreader paddle 24, retainer ring 19, and retainer plates 18 are shown, as is rod 20.

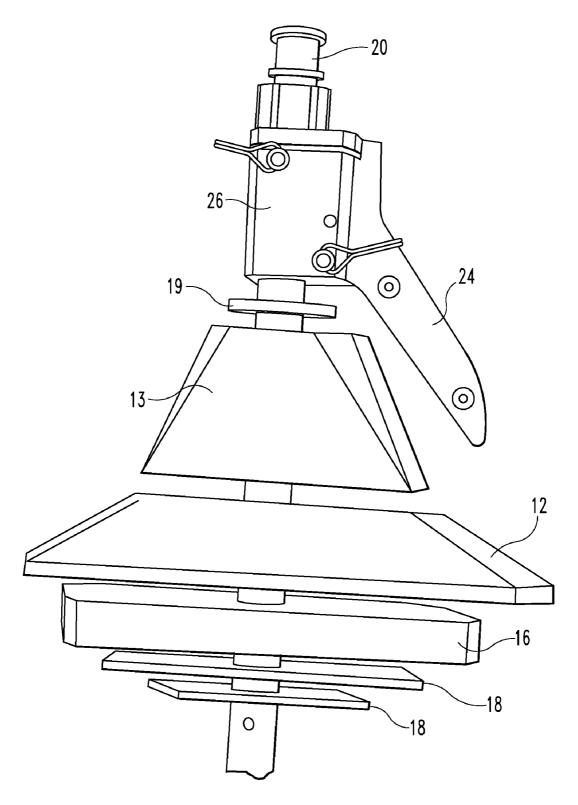
Fig. 4

[0011] FIG. 4 shows a semi-exploded view of the plunger assembly of the inventive tool, according to one embodiment. [0012] FIG. 5 shows a perspective view of the inventive tool, according to one embodiment.

[0049] FIG. 4 shows a semi-exploded view of the plunger assembly of the inventive tool, according to one embodiment. Spreader head 26 holds spreader paddle 24 on rod 20 such that rotation of the rod correspondingly rotates the spreader paddle. Retainer ring 19 and retainer plates 18 hold plunger head 13, plunger blade 14, and plunger blade support plate 16 in place on the rod. A lock nut or locking screw 21 may be used to hold the pieces in place. A sleeve (not illustrated) may be used to isolate the plunger assembly so that rotation of the rod does not result in rotation of the plunger assembly.

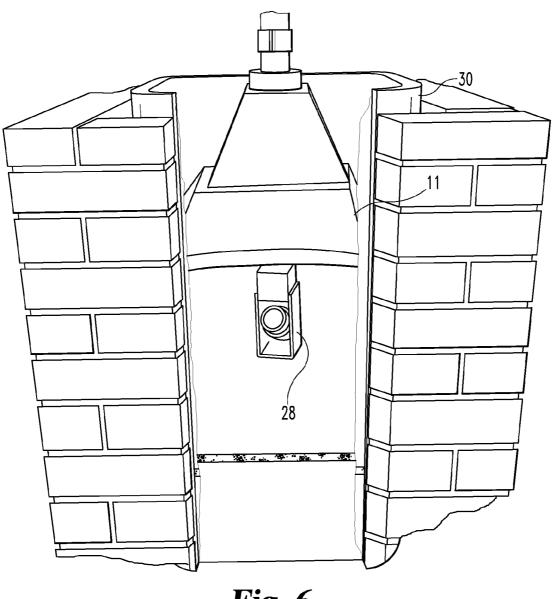
Fig. 6

[0013] FIG. 6 shows a perspective view of the inventive tool in a chimney (in partial section), according to one embodiment.

[0051] FIG. 6 shows a perspective view of the inventive tool in a chimney (shown in partial section, with the front part of the chimney cut away), according to one embodiment. Plunger assembly 11 is positioned so as to receive mortar from above and to be pulled upward to push mortar into joint 30.

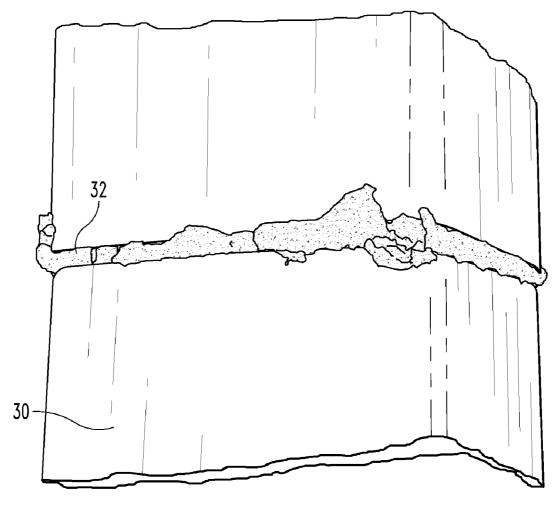
Fig. 7

[0014] FIG. 7 shows an exterior view of a chimney joint filled with mortar after being repaired by the inventive tool according to the inventive method, according to one embodiment

[0052] FIG. 7 shows an exterior view of a chimney joint filled with mortar after being repaired by the inventive tool according to the inventive method. Mortar or other repair material 32 fills the joint in the repaired chimney 30.
