US009404374B2

(54) **TRUNNION HOLE REPAIR UTILIZING INTERFERENCE FIT INSERTS**

(73) Assignee: **United Technologies Corporation**,  
Hartford, CT (US)

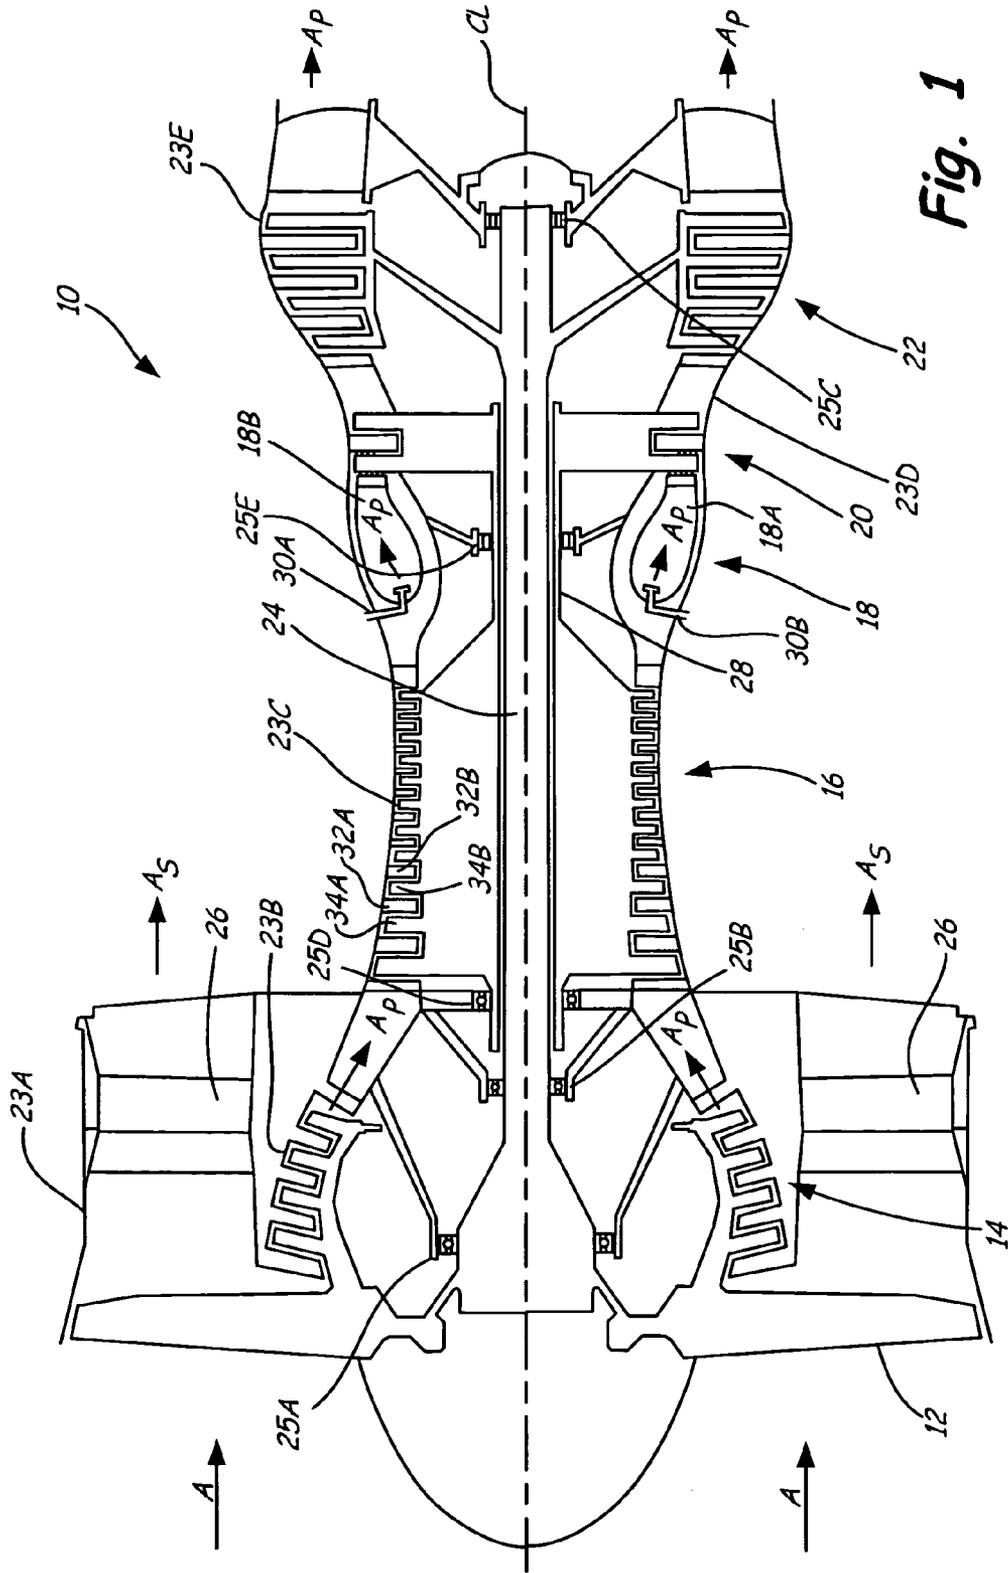
Fig. 1

FIG. 1 shows a schematic of a gas turbine engine in which the shrink-fit variable vane hole inserts of the present invention are used.

FIG. 1 shows gas turbine engine 10, in which shrink-fit variable vane hole inserts can be used. Gas turbine engine 10

comprises a dual-spool turbofan engine having variable stator vanes for which the advantages of the hole inserts are particularly well illustrated. Gas turbine engine 10 comprises fan 12, low pressure compressor (LPC) 14, high pressure compressor (HPC) 16, combustor section 18, high pressure turbine (HPT) 20 and low pressure turbine (LPT) 22, which are each concentrically disposed around longitudinal engine centerline CL. Fan 12 is enclosed at its outer diameter within fan case 23A. Likewise, the other engine components are correspondingly enclosed at their outer diameters within various engine casings, including LPC case 23B, HPC case 23C, HPT case 23D and LPT case 23E such that an air flow path is formed around centerline CL.

Inlet air A enters engine 10 and it is divided into streams of primary air  $A_p$  and secondary air  $A_s$  after it passes through fan 12. Fan 12 is rotated by low pressure turbine 22 through shaft 24 to accelerate secondary air  $A_s$  (also known as bypass air) through exit guide vanes 26, thereby producing a major portion of the thrust output of engine 10. Shaft 24 is supported within engine 10 at ball bearing 25A, ball bearing 25B and roller bearing 25C. Primary air  $A_p$  (also known as gas path air) is directed first into low pressure compressor (LPC) 14 and then into high pressure compressor (HPC) 16. LPC 14 and HPC 16 work together to incrementally step up the pressure of primary air  $A_p$ . HPC 16 is rotated by HPT 20 through shaft 28 to provide compressed air to combustor section 18. Shaft 28 is supported within engine 10 at ball bearing 25D and roller bearing 25E. The compressed air is delivered to combustors 18A and 18B, along with fuel through injectors 30A and 30B, such that a combustion process can be carried out to produce the high energy gases necessary to turn turbines 20 and 22. Primary air  $A_p$  continues through gas turbine engine 10 whereby it is typically passed through an exhaust nozzle to further produce thrust.

In order to expand the performance range of engine 10, variable stator vanes are used in high pressure compressor 16. For example, HPC 16 comprises variable vanes 32A and 32B, which are stationary and extend radially inward from fan case 23C. Blades 34A and 34B, which rotate with HPC 16 on shaft 28, are positioned adjacent vanes 32A and 32B. Vanes 32A and 32B form part of an array of vane stages arranged circumferentially around the engine centerline between HPC case 23C and an inner diameter vane shroud. Blades 34A and 34B sequentially push primary air  $A_p$  past vanes 32A and 32B within HPC 16 to increase the pressure of primary air  $A_p$ . Vanes 32A and 32B rotate about their radial axis to adjust the incidence of the air  $A_p$  onto subsequent blades, including blade 34B, during different operation modes, or speeds, of engine 10. In order to ensure optimal operation of engine 10, it is preferable that vanes 32A and 32B are able to rotate freely about their axis within HPC case 23C and the inner diameter vane shroud.

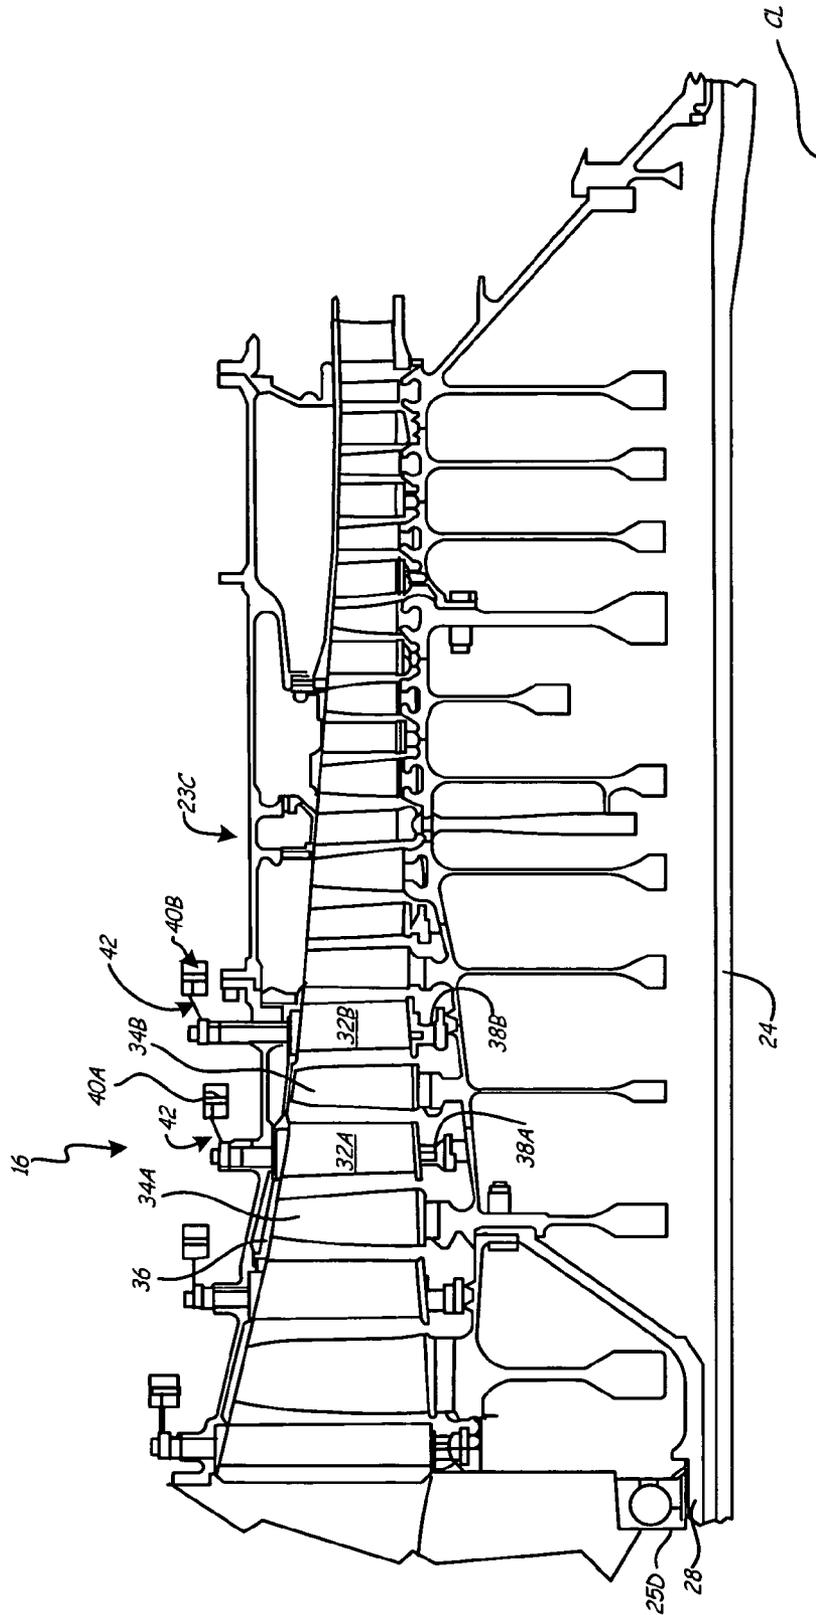
Fig. 2

FIG. 2 shows a high pressure compressor section of the gas turbine engine of FIG. 1 showing the interaction between variable stator vanes and a high pressure compressor (HPC) front case.

FIG. 2 shows the sequential arrangement of the various stages of high pressure compressor 16 about centerline CL of gas turbine engine 10. For the embodiment of engine 10 shown, HPC 16 is divided into stages S5 through S15, with LPC 14 of FIG. 1 comprising stages S1 through S4. Vanes 32A and 32B and blades 34A and 34B comprise stages S6 and S7 of HPC 16, respectively. The variable vanes rotate between HPC case 23C and a plurality of inner diameter vane shrouds. Specifically, vanes 32A and 32B rotate between HPC outer shroud 36, which is a component of case 23C, and HPC inner shrouds 38A and 38B, respectively. In order to rotate vanes 32A and 32B within outer shroud 36, vanes 32A and 32B are connected to sync rings 40A and 40B, respectively, through a plurality of sync arms 42. Sync rings 40A and 40B are connected to, for example, a hydraulic actuator to adjust the pitch

of vanes 32A and 32B such that airflow through HPC 16 is optimized for different operating levels of engine 10. In order that vanes 32A and 32B rotate freely within outer shroud 36 and inner shrouds 38A and 38B, vanes 32A and 32B include inner and outer diameter trunnions.

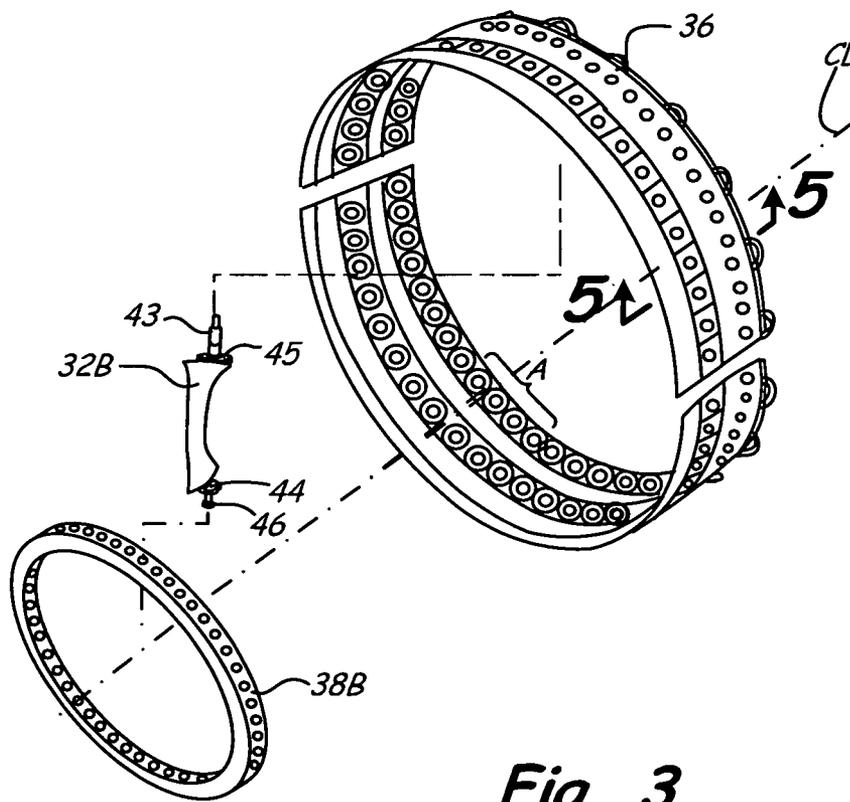
Fig. 3

FIG. 3 shows a perspective view of the HPC front case of FIG. 2.

FIG. 3 shows an exploded view of variable vane 32B positioned between outer vane shroud 36 and inner vane shroud 38B. Outer vane shroud 36 and inner vane shroud 38B are positioned concentrically around engine centerline CL at the inner and outer diameters of vane 32B, respectively. Vane shroud 36 comprises a conically shaped body that surrounds stages S6 and S7 of HPC 16, including vanes 32A and 32B and blades 34A and 34B. Vane shroud 36 typically comprises a split-ring construction wherein it is divided into upper and lower halves.

Vane 32B includes outer trunnion 43 and inner trunnion 44 that rotate within variable vane counterbored holes. Using sync ring 40B and sync arms 42 as shown in FIG. 2, vane 32B is rotatable about trunnions 43 and 44 within the counterbored holes in outer vane shroud 36 and inner vane shroud 38B. Additionally, trunnions may include additional features for assisting in true rotation of the variable vanes. For example, vane 32B includes outer diameter hub 45 and inner diameter hub 46 that rotate within the counterbores surrounding the counterbored trunnion holes and help to keep vanes 32B properly aligned. Vane 32A is configured similarly to vane 32B.

As engine 10 progresses into its lifecycle, the counterbores become damaged or worn from use and weather, thus impeding the free rotation of trunnions 43 and 44 within the counterbores, and hubs 45 and 46 against the counterbores. Impediments to the rotation of vanes 32A and 32B can lead to misalignment of the vane pitch along the flow path of engine 10 resulting in sub-optimal operation of HPC 16 and engine 10. Typically, the counterbores begin to show wear after one engine overhaul cycle, with extensive damage appearing typically after 2-3 engine overhaul cycles. In lieu of replacing expensive engine components, such as outer vane shroud 36, after they have worn beyond practical use, the present invention provides a system and method for repairing counterbored holes, principally for variable vanes. Particularly, the repair system and method includes a shrink-fit counterbored hole insert, which can be included in new engine components or can be retrofit into engine components as a fix to damage already sustained. Although hereinafter the invention is described with respect to repairing vane bottom counterbores at the outer diameter end of a high pressure compressor, the repairs can be made to both inner diameter and outer diameter vane shrouds. The repair is particularly well suited to HPC cases, but can also be used for LPC variable vane cases or in any other application using variable vanes.

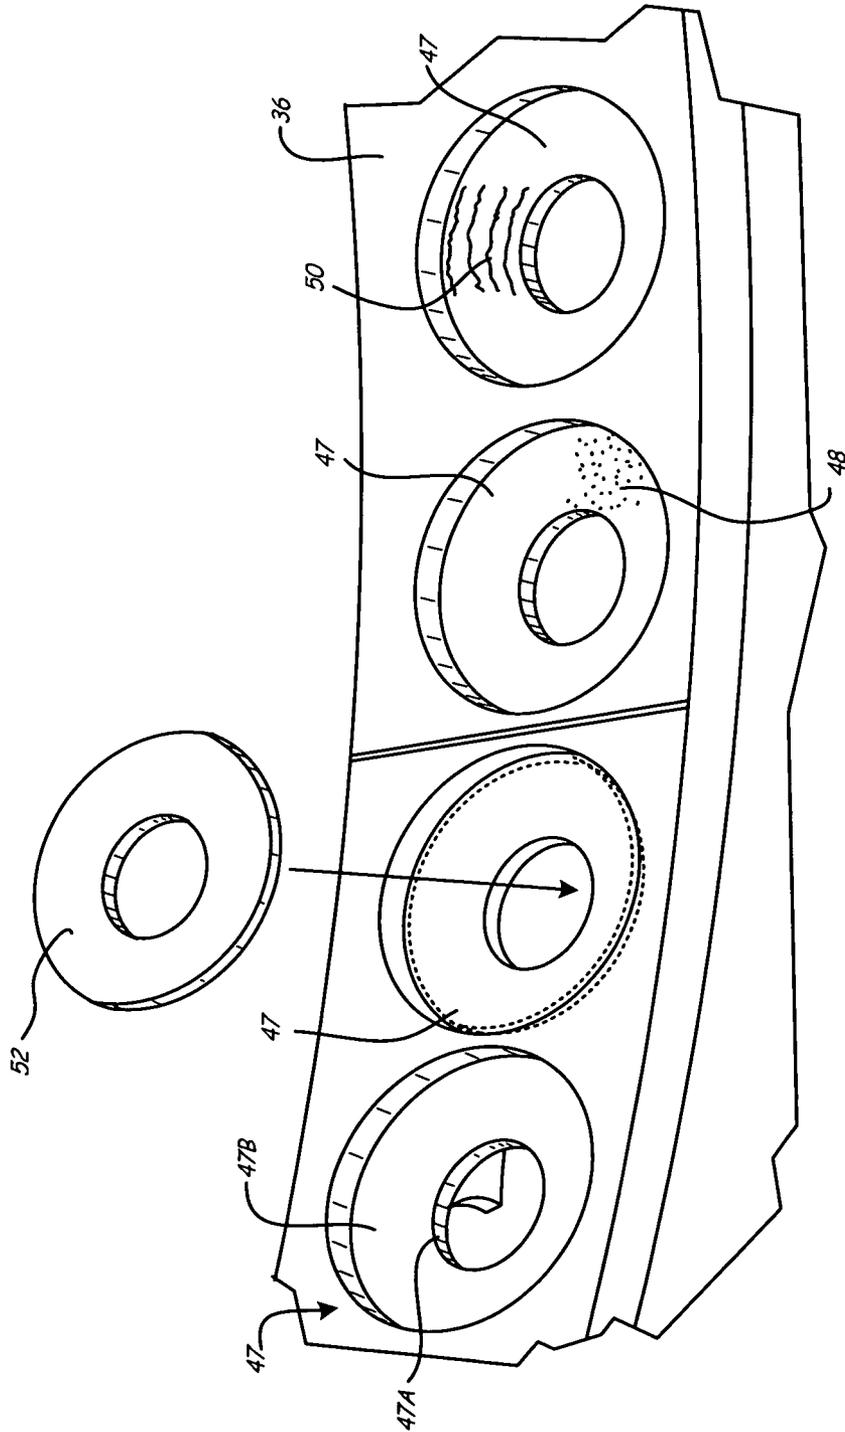
Fig. 4

FIG. 4 shows a perspective view of variable vane counterbores in the HPC front case of FIG. 3.

FIG. 4 shows breakout portion A of FIG. 3, showing a perspective view of vane bottom counterbored holes 47, in outer vane shroud 36. Outer vane shroud 36 includes counterbored holes 47 that each receives an outer diameter trunnion from a variable vane, such as trunnion 43 from vane 32B. Counterbored holes 47 comprise hole 47A, which is surrounded by counterbore 47B. Counterbored holes 47 are machined to original design dimensions, free of any pitting, wear or corrosion. However, due to various sources, vane counterbored holes 47 become damaged such that rotation of hub 45 and trunnion 43 is hampered. For example, counterbored holes 47 develop corrosion 48 that arises from harsh operating conditions of engine 10. Corrosion 48 includes pitting or other structural deficiencies of the base material comprising vane shroud 36, which is typically a steel alloy such as an Austenitic steel or another iron-based alloy that

builds up oxide layers leading to corrosion. Corrosion 48 arises from the extreme temperatures at which engine 10 operates and other external factors such as salt-rich operational environments. Counterbored holes 47 also develop scoring 50 that arises from routine rotation of trunnion 43 and hub 45 within counterbored holes 47. Corrosion 48 and scoring 50 prevent free rotation of hub 45 on the surface of the counterbore into which they are inserted. As such counterbored holes 47 are provided with shrink-fit insert 52. Counterbored holes 47 are over-bored such that any damage is removed from the base material of shroud 36. Subsequently, shrink-fit insert 52, having dimensions corresponding to that of the removed over-bore plus nominal additional material, is inserted into counterbored holes 47 to restore shroud 36 to original specifications.

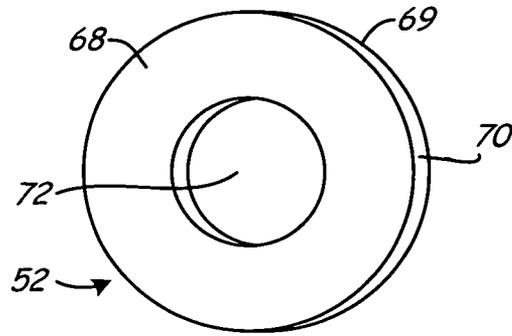
**Fig. 6A**

FIG. 6A shows a perspective view of a shrink-fit variable vane hole insert.

FIG. 6A shows a perspective view of shrink-fit insert 52, which is constructed such that counterbored hole 54B can be

milled out, or over-bored, to remove the corrosion or damage to counterbored hole 54B. Shrink-fit insert 52 includes top surface 68, bottom surface 69, side wall 70 and aperture 72. Top surface 68 and bottom surface 69 are illustrated as being generally parallel creating a uniform thickness of shrink-fit insert 52.

Shrink-fit insert 52 may be comprised of any material suitable for withstanding the thermal and mechanical stresses associated with shroud 36 during operation of engine 10. In various embodiments, shrink-fit insert 52 is made from a metallic alloy or from an engineered plastic. Any suitable alloy can be used, however, alloys matching that of shroud 36 are particularly suitable. For example, Austenitic stainless steels, such as 300 series stainless; or nickel materials, such as the Inconel family, would also be suitable materials. Polyetheretherketone (PEEK) materials, such as Sustatec® PEEK as is commercially available from Sustaplast, L.P., Edgewood, N.Y.; or PTFE-based materials, such as Rulon® 945 as is commercially available from St. Gobain Performance Plastics, Valley Forge, Pa. are examples of suitable engineered plastics. Rulon® 957, also available from St. Gobain, is another suitable material. For any material selected desirable properties include heat resistance, low friction and strength. Additionally, corrosion resistant material may be selected to reduce recurrence of corrosion damage. Low-friction materials may be selected such that the variable vanes are better able to rotate. Specifically, the material for shrink-fit insert 52 may be selected to have a lower coefficient of friction than that of the material comprising shroud 36. It is preferable that materials be able to sustain temperatures upwards of 315° C. (600° F.), preferably up to about 371° C. (700° F.), which are temperatures commonly reached around HPC 16. It is also desirable to match the thermal expansion rate of the material of shrink-fit insert 52 with that of the material comprising shroud 36. The qualities for shroud 36 can be selected to match design needs depending on performance parameters of engine 10.

Shrink-fit insert 52 may be created by cutting a pre-sized washer from a sheet of material. The washer may be fabricated utilizing a waterjet cut, laser cut, die cut, or similar process. Multiple washers may be cut from one sheet of material, and the same sheet of material may contain shrink-fit inserts with varying outer diameters to cover wide tolerances on trunnion hole inner diameters. In an alternate embodiment, a custom fit shrink-fit insert may be created from a piece of material by machining, grinding, stoning, sanding or similar process. The shrink-fit insert is specifically sized based on the amount of material removed from shroud 36 to have a desired diameter and thickness or geometry.

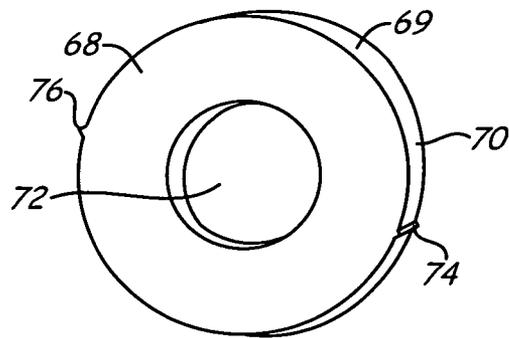
**Fig. 6B**

FIG. 6B shows a perspective view of an alternate embodiment of a shrink-fit variable vane hole insert.

In an alternate embodiment illustrated in FIG. 6B, top surface 68 and bottom surface 69 are nonparallel such that wall 70 has a sloping shape that varies around the edge perimeter of shrink-fit insert 52 and inner wall that creates aperture 72. Wall 70 also has two tangs 74 and 76 that may be used to retain shrink-fit insert 52 in place against shroud 36.

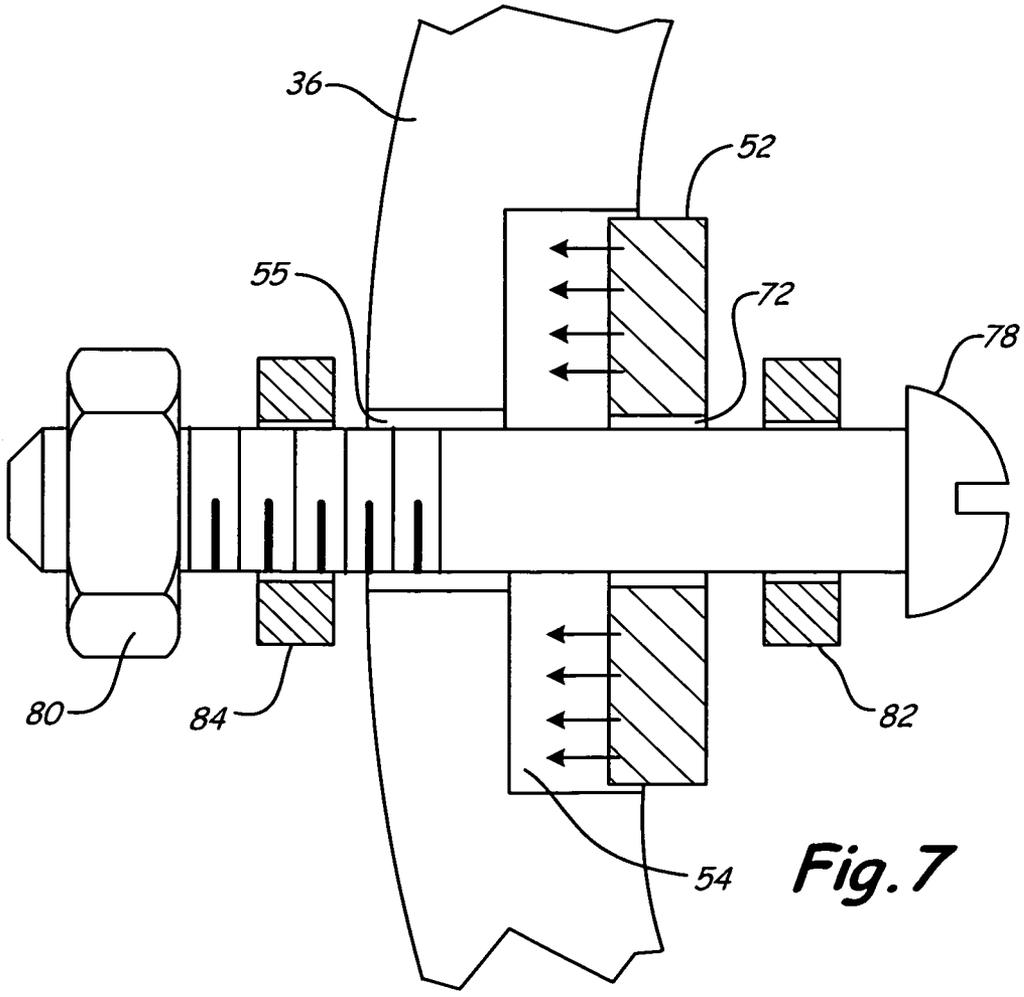
**Fig. 7**

FIG. 7 shows a close-up view of a shrink-fit variable vane hole insert and a variable vane counterbore.

FIG. 7 shows a cross sectional view of shrink-fit insert 52 being installed into counterbored hole 54 of outer diameter vane shroud 36. Counterbored hole 54 is machined into shroud 36 such that it is made to specification as is required by design parameters. As described above, counterbored hole 54 undergoes corrosion and wear such that shroud 36 becomes damaged. The damage associated with the corrosion or wear extends into the base material of shroud 36 a particular depth. As such, counterbored hole 54 is machined out, or over-bored, a particular depth to remove the damaged base material. However, it is not enough to simply remove the damaged material, as any material removal of shroud 36 permits slop in

the rotation of vane 32B, which affects the efficiency of HPC 16. A uniform amount of material is removed from counterbored hole 54 such that it can be readily replaced to restore shroud 36 to its original design dimensions. Shrink-fit insert 52 is inserted into the over-bored counterbored hole 54 to restore shroud 36 and counterbored hole 54 to their original dimensions. Thus, shrink-fit insert 52 is made to dimensions that are nominally larger than the amount of material removed from counterbored hole 54 in removing the damaged base material.

Shrink-fit insert 52 is secured to shroud 36 through an interference or press fit. Shrink-fit insert 52 is sized to be slightly larger in its outer diameter than counterbored hole 54 inner diameter. For example, the outer diameter of shrink-fit insert 52 should be about 0.050 mm to 0.075 mm larger than the inner diameter of counterbored hole 54. To facilitate assembly, shrink-fit insert 52 may be supercooled to shrink its dimensions. In one embodiment, shrink-fit insert 52 is placed in liquid nitrogen, which provides the supercooling. After shrink-fit insert 52 is supercooled, it is installed in counterbored hole 54 on shroud 36. As illustrated in FIG. 7, the installation may be assisted through application of additional pressure. Fastener 78, such as a bolt or machine screw, is inserted through aperture 72 of shrink-fit insert 52 and trunnion hole 55 of shroud 36. A nut 80 may then be used to tighten the fastener 78 and seat shrink-fit insert 52 in place, along with washers 82 and 84. Shrink-fit insert 52 may then be allowed to warm, thus increasing in size to create the interference fit. Fastener 78, nut 80, and washers 82 and 84 may then be removed, and vane 32 may be reinstalled. In an alternate embodiment, shrink-fit insert 52 may be installed with the use of a mechanical press. Utilizing an insert held in place with an interference fit is preferable to the prior art as no subsequent machining steps are required once shrink-fit insert 52 is seated within shroud 36.

Utilizing a shrink-fit insert 52 allows for an easy method of repair of shroud 36. First, damage to shroud 36 is assessed. The damage is removed by machining or similar material removal process, making sure that the least amount of material (depthwise) possible is removed. Counterbored hole 54 is then measured to obtain its diameter, and shrink-fit insert 52 is selected based on this measurement. In one embodiment, a shrinkage fit washer of proper outer diameter and thickness is pulled from existing stock, with the outer diameter being larger than the diameter of counterbored hole 54. In another embodiment, shrink-fit insert 52 is custom created to contain the proper outer diameter and geometry. Shrink-fit insert 52 is supercooled to reduce the outer diameter so that it can be placed where material has been removed from counterbored hole 54. Shrink-fit insert 52 is placed in position and allowed to expand to secure itself within shroud 36. Placing the shrink-fit insert 52 can be done by manual insertion, or with assistance of tools such as a press or mallet.
