(11) **EP 2 020 274 A1**

(71) Applicant: **United Technologies Corporation**  
**Hartford, CT 06101 (US)**

(54) **Apparatus and method for repairing airfoil tips**

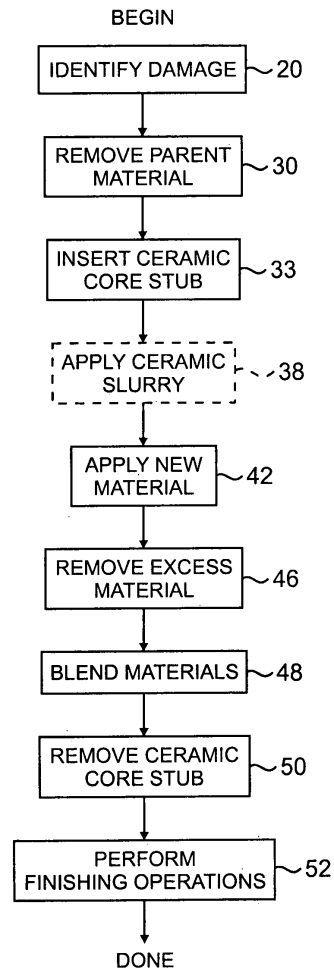
**FIG. 1**

(57) A method of repairing an airfoil (22) for a gas turbine engine includes removing a damaged portion of the airfoil (27) at a radially outward tip (26) of the airfoil, securing temporarily a portion of a ceramic core stub (34) within an internal cavity of the airfoil, applying new metallic material (44) to the airfoil covering an exposed portion of the ceramic core stub (34), machining the airfoil (22) to remove an excess portion of the new metallic material (44), and removing the ceramic core stub (34) from the internal cavity (28) of the airfoil.

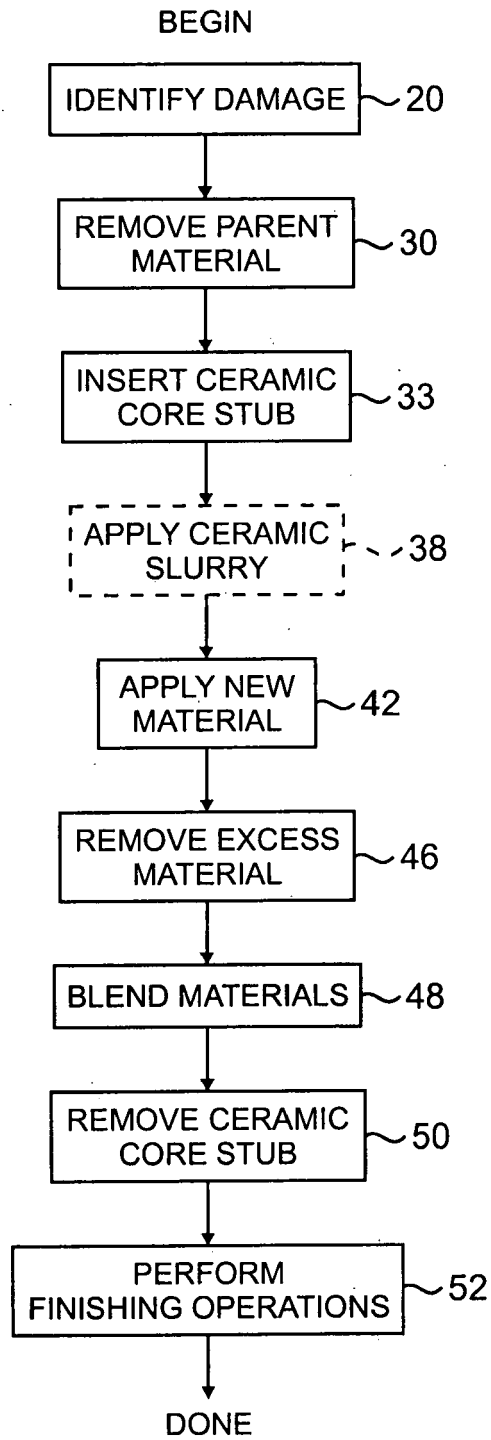
**FIG. 1**

FIG. 1 is a flow chart that illustrates a repair method according to the present invention.

**[0009]** FIG. 1 is a flow chart that illustrates an embodiment of the inventive repair method. Details of the repair process will be described with reference to FIGS. 2-8. As shown in FIG. 1, an initial step is to identify damage to a tip region of a selected airfoil (step 20). The tip region is located at a radially outward portion of the airfoil when installed in an engine.

**[0011]** As shown in FIG. 1, the next step is to remove parent material at the tip region 26 of the airfoil 22 (step 30). As shown in FIG. 2, the parent material is removed beyond a cut line 32. The amount of parent material removed, that is, the location of the cut line 32, can vary as dictated by the amount of damage identified. Moreover, in some situations, the cut line 32 can be located at a standardized location that is radially inward of the damage to the tip region 26. In any case, removal of parent material at step 30 exposes the core 28 at the tip region 26 (and newly establishes a tip region 26A).

cure a ceramic core stub to the core 28 (step 33). The term "ceramic core stub" refers to a ceramic structure that resembles a portion of a structure that displaces molten material when originally casting the blade 24 to define the core 28. The ceramic core stub is a preformed structure that is inserted into the exposed core 28 of the airfoil 22 and secured there. The ceramic core stub has a shape that corresponds to a desired configuration of the core 28, and includes any internal features (e.g., trip strips) formed along the core 28.

**[0015]** Next, as shown in FIG. 1, new material is applied to the airfoil 22 at the tip region 26A (step 42). FIG. 5 is a side view of a portion of the airfoil 22, showing new material 44 applied to the parent material of the airfoil 22 at the tip region 26A according to step 42. The new material 44 covers the ceramic core stub 34, effectively trapping it within the core 28 of the airfoil 22. The new material 44 forms a metallurgical bond with the parent material, and can be applied and built-up by a known welding technique, such as laser clad welding, tungsten inert gas (TIG) welding, or other suitable techniques. Typically, the new material 44 is applied to dimensions that are somewhat greater than the original airfoil 22 (i.e., greater than the blueprint specifications for the airfoil 22). The new material 44 can have a composition that is identical or similar to the composition of the parent material of the airfoil 22. Alternatively, the new material 44 can comprise an alloy that is more easily welded than the parent material of the airfoil 22. In some applications, it may be possible to use more easily weldable materials for the new material 44 when operational stresses are suitably low at the tip region 26A.

**[0017]** Next, as shown in FIG. 1, the new material 44 and the parent material of the airfoil 22 are blended (step 48). These machining and blending steps provide the airfoil 22 with a desired final contour, for instance, returning it to original (i.e., blueprint) dimensions, and reduce or eliminate any discontinuities at the joint where the new material 44 and the parent material of the airfoil 22 meet. FIG. 7 is a side view of a portion of the airfoil 22 after blending (step 48). At this stage during the repair process, the airfoil 22 has been restored to the desired final contour. However, the ceramic core stub 34 remains inside the core 28 of the airfoil 22.

**[0018]** Next, as shown in FIG. 1, the ceramic core stub 34 is removed from the core 28 of the airfoil 22 using a known autoclave process (step 50). During this step, the ceramic core stub 34 is broken up and drawn out of the airfoil 22 in a manner similar to that performed during original fabrication and prior to use. For example, the autoclave process can involve the use of Potassium Hydroxide, heat, pressure and agitation to break up and remove ceramic material of the ceramic core stub 34. Similar autoclave processes are used to remove the ceramic core from hollow investment castings (see, e.g., commonly-assigned U.S. Pat. No. 5,778,963, which is hereby incorporated in full by reference).

**[0019]** Lastly, as shown in FIG. 1, any desired finishing operations are performed (step 52). Examples of such finishing processes include heat treatments, the reapplication of coatings, and other known processes.

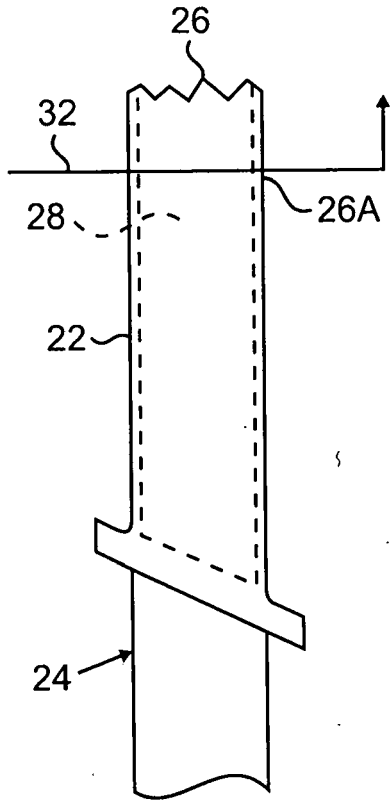
**FIG. 2**

FIG. 2 is a side view of a damaged airfoil for a gas turbine engine.

**[0010]** FIG. 2 is a side view of a damaged airfoil 22 of a turbine blade 24 that has previously been in use in a gas turbine engine. The airfoil 22 includes a tip region 26 and a core 28. The airfoil 22 is formed of a metallic parent material, for example, a nickel- or cobalt-based superalloy, or titanium and alloys thereof. The term "parent material" refers to material of the airfoil 22 that has previously been in service, and can include original material as well as other material added during previous repairs. The core 28 provides at least one internal cooling passageway through the airfoil 22. The core 28 is illustrated as a monolithic void defined within the airfoil 22. However, it should be recognized that the illustrated embodiment is provided merely by way of example, and those skilled in the art will recognize that the core 28 can include any number of internal passageways having any shape or arrangement to allow cooling fluid to flow through the airfoil 22. Moreover, the core 28 can include internal features such as trip strips or other structures.

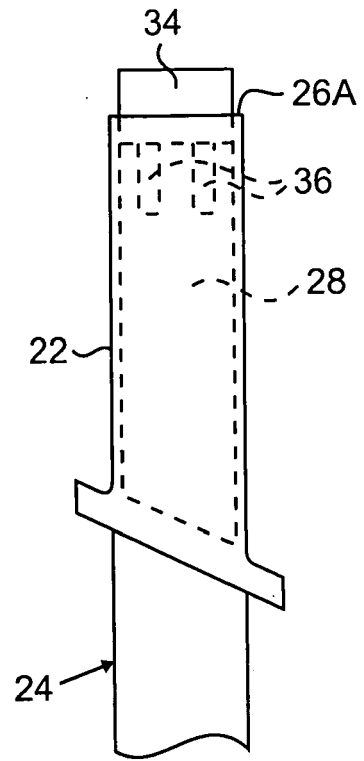
**FIG. 3**

FIG. 3 is a side view of the airfoil as a repair process is being performed.

**[0013]** FIG. 3 is a side view of the blade 24 with a ceramic core stub 34 partially inserted into the core 28 of the airfoil 22. A portion of the ceramic core stub 34 generally protrudes from the core 28, radially outward from the location of the cut line 32 (see FIG. 2). In order to suitably secure the ceramic core stub, the ceramic core stub 34 can be provided with one or more radially inwardly extending stumps 36 that are positioned to extend into the core 28.

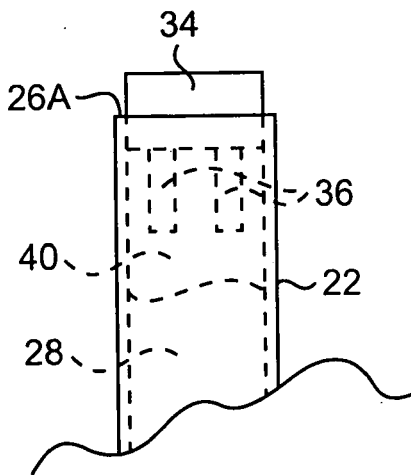
**FIG. 4**

**[0014]** Optionally, a ceramic slurry can be applied inside the core 28 of the airfoil 22 to adhere to the ceramic core stub 34 and better secure the ceramic core stub 34 to the core 28 (step 38). FIG. 4 is a side view of a portion of the airfoil 22 with a ceramic slurry 40 applied inside the core 28 to secure the ceramic core stub 34. The provision of the optional stumps 36 can enhance the effectiveness of the ceramic slurry 40 in securing the ceramic core stub 34 to the airfoil 22. Once the ceramic slurry 40 is applied, it can be hardened as desired. The hardened ceramic slurry 40 adhered to the ceramic core stub 34 can be considered to be a single structure for simplicity, and therefore the ceramic core stub 34, the stumps 36 and the ceramic slurry 40 are hereinafter collectively referred to as simply the ceramic core stub 34.

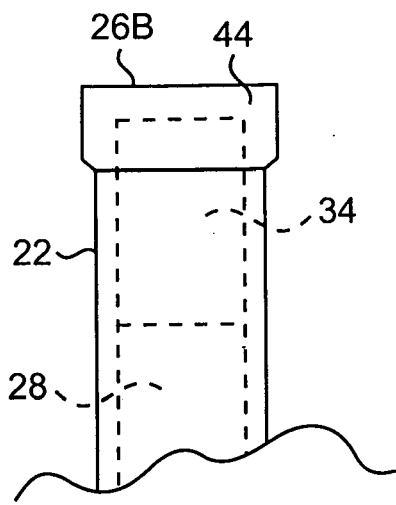
**FIG. 6**

terial 44, if any such excess new material 44 exists (step 46). FIG. 6 is a side view of a portion of the airfoil 22 after new material 44 is machined at a newly established tip region 26B to bring the airfoil 22 to a desired final spanwise dimension.

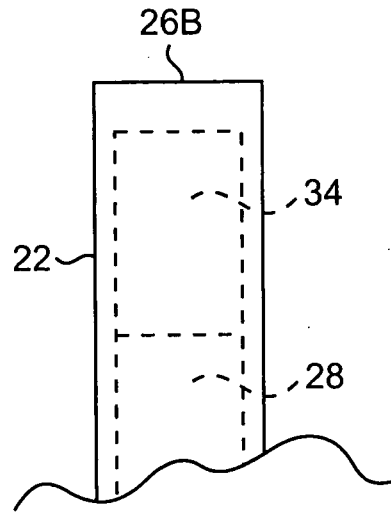
**FIG. 7**

FIGS. 4-7 are side views of a tip portion of the airfoil at various stages during the repair process.

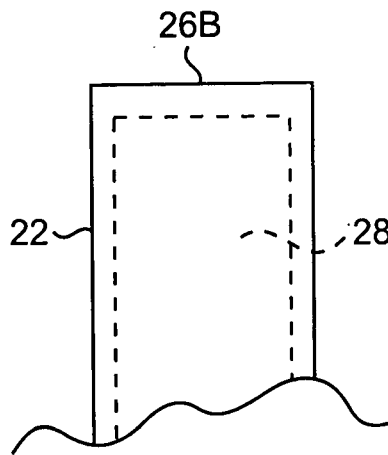
**FIG. 8**

FIG. 8 is a side view of a tip portion of the airfoil upon completion of the repair process.

**[0020]** FIG. 8 is a side view of a portion of the airfoil 22 upon completion of the repair process of the present invention. The airfoil 22 is provided with a final contour, the ceramic core stub 34 has been removed such that the core 28 is open to permit cooling fluid to flow there-through, and all finishing process have been performed.
