[54] METHOD AND APPARATUS FOR DETECTING LEAKS AND OTHER DEFECTS ON SEWERS AND THE LIKE CHANNELS

METHOD AND APPARATUS FOR DETECTING LEAKS AND OTHER DEFECTS ON SEWERS AND THE LIKE CHANNELS

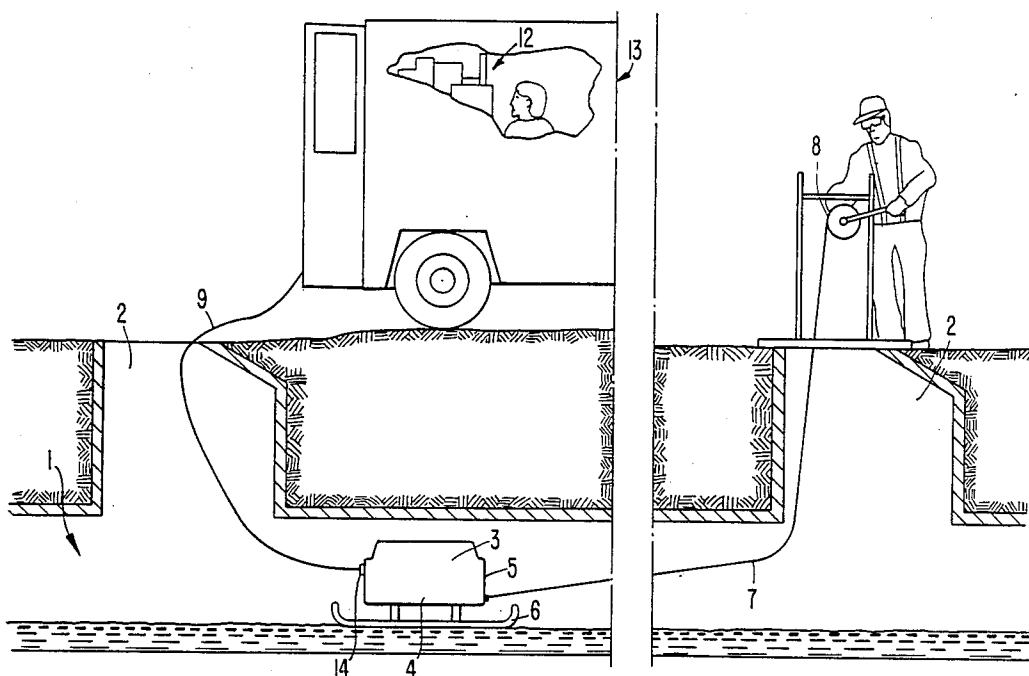
FIG. 1.

FIG. 1 is a highly schematic view, partly in section, illustrating the inspection method and apparatus of the invention.

With reference to FIG. 1 a sewer with waste water is designated 1 and manhole wells are designated 2.

An IR scanning device 3 is mounted inside a waterproof protecting shell 4 with a window 5 and carried by a sledge 6. A pulling wire 7 coupled to a winch 8 is attached to the sledge and a communication cable 9 rolled off and on a reel 10 with a metering device 11, FIG. 2, connects the scanning unit 3 with a central unit 12 housed inside a van 13.

The physical environment inside sewers is, for obvious reasons, hostile to the thermographic equipment, which has, thus, to be encapsulated. This is carried out by enclosing it in the watertight sledge and using special leakproof connectors 14, e.g. of so called military type, and a rugged protective lens. The cable, which is dragged through the sewer must also be of a waterproof quality.

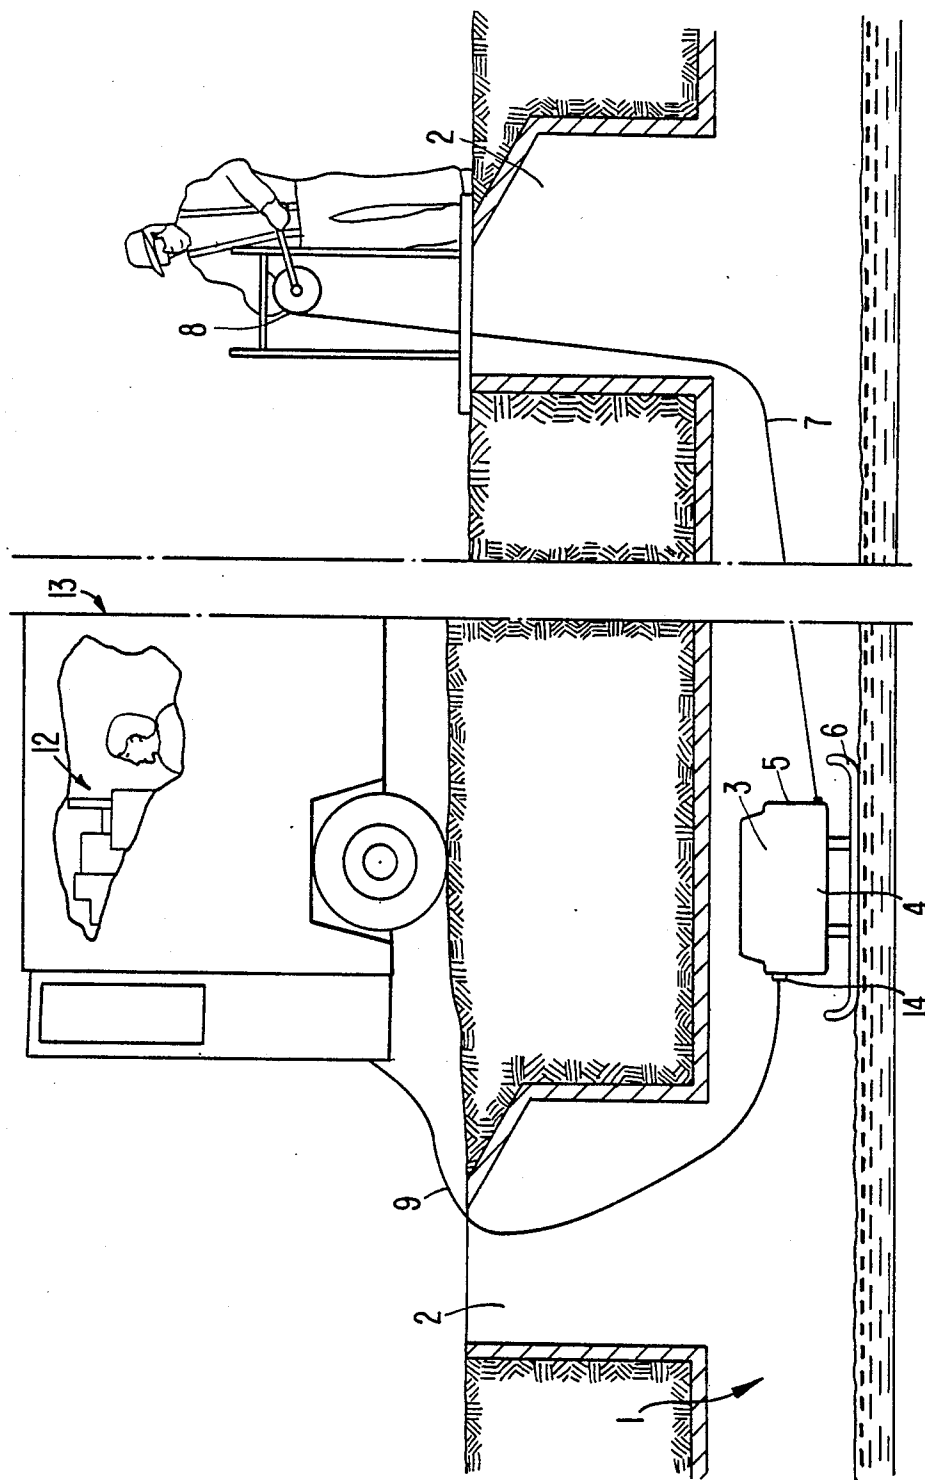
FIG. 2 is a diagram illustrating the arrangement of the electronic system,

In FIG. 2, the part to the left the double dash-dotted line indicates the scanner unit 3 inside the sewer and the part to the right of same dash-dotted line the so called central unit designated 12 in FIG. 1.

The scanner 3 is enclosed by the water and moist proof shell 4 and the cable 9 is connected to the said unit

by a connector 14. Inside the van 13 is found the cable reel 10 with its metering device 11 adapted to count the length of cable reeled off (or on). The cable 9 is via a connector box 15 connected to a display unit 16 in turn via a two way cable connection 17 connected to a video tape recorder VTR 18. The metering device 11 is connected, via cable 19, to an interface, an image data terminal (IDT) 20, cooperating over a BCD unit 21 with another IDT 22—both IDTs having so called C videos 23 and 24 respectively.

The cable 25 connects the IDT 20 with a discon 26 and a monitor 27 and with the display unit 16.

In a modified embodiment, the IR sensing device is combined with a TV camera and an appropriate light source indicated in dashed lines in FIG. 2. Such TV camera is also connected with the central unit, which is equipped with a display means, such as 16', for the TV image and furthermore with an electronic apparatus for displaying the IR image on top of the TV image or vice versa to form a combined image. Such a combined IR and TV image is more easily read by the operator and gives both the leak indicating temperature image and a visual picture of the location and shape of the damage or leak. The IR camera and the TV camera might of course be used one at a time but the best result is attained if they are used simultaneously.

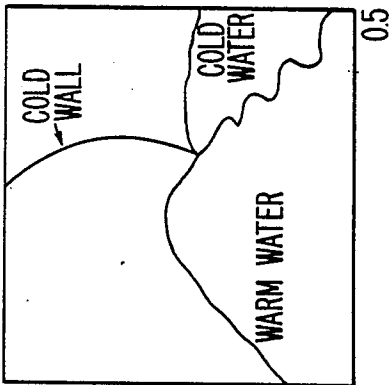
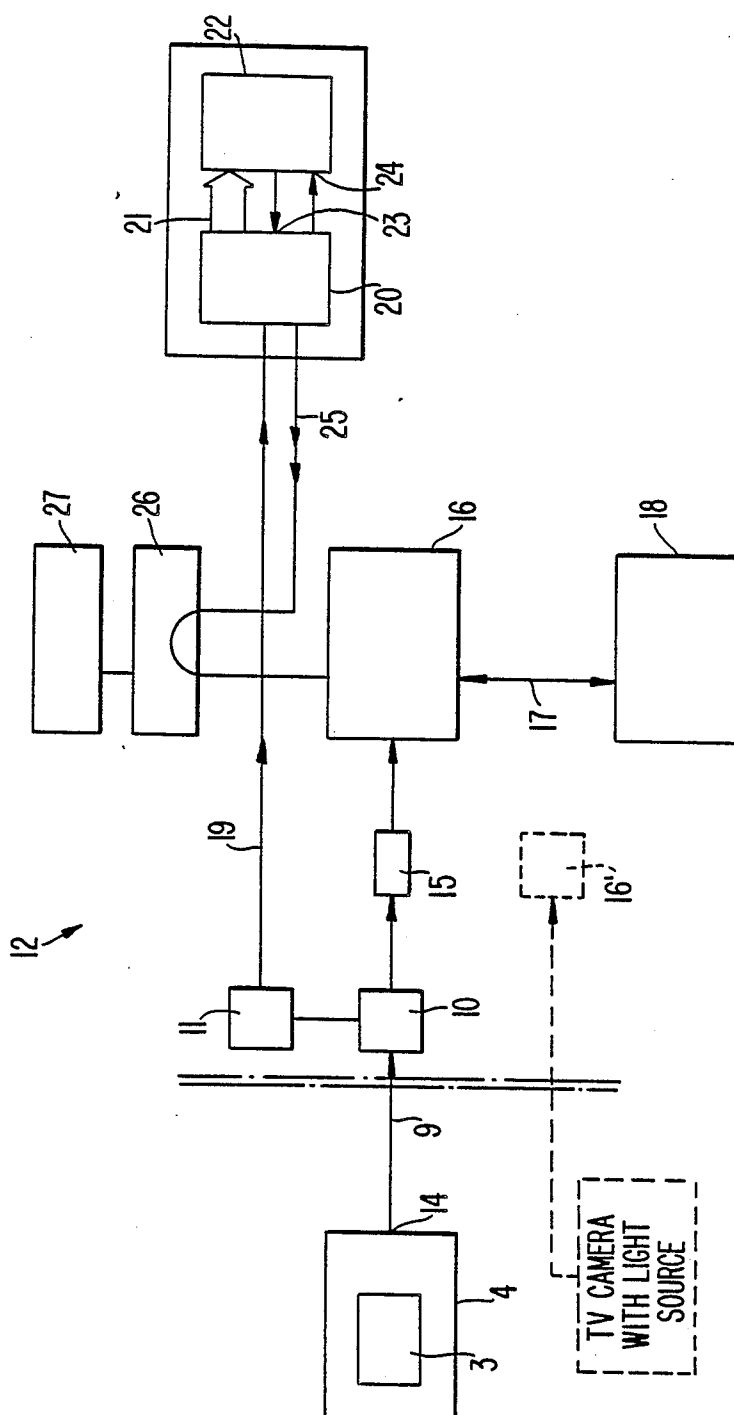
FIG. 3.

FIGS. 3 and 3a illustrate two flows of water joining at a manhole, the left flow warm and the right flow cold. The wall of the sewer is cold.

The thermograms shown on FIGS. 3-6 are results from an inspection of a sewer 100 meters in length and chosen at random and show detection of some examples of faults.

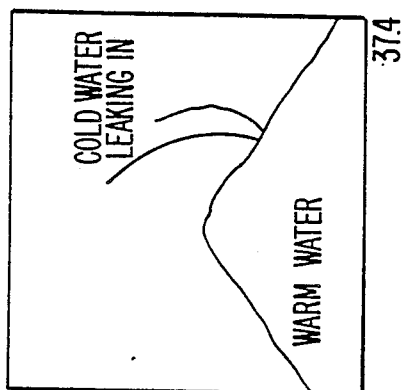
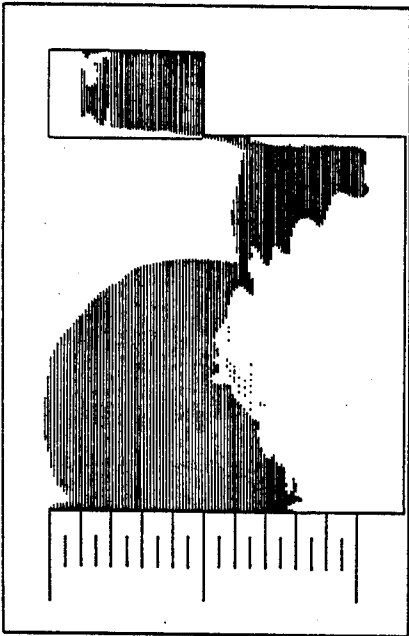
FIG. 4.

FIGS. 4 and 4a show an area including a joint and a finger-like light area (dark in the actual thermogram but shown light for clarity of illustration) indicates colder surface water leaking in.

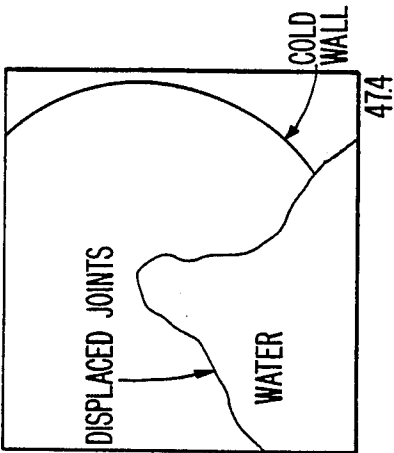
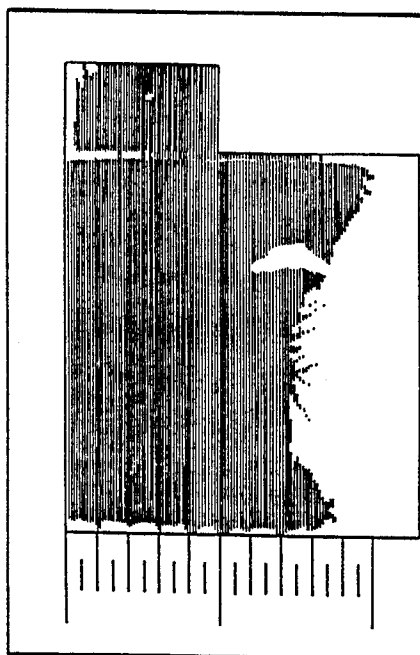
FIG. 5.

FIGS. 5 and 5a show the influence of cold water surrounding and penetrating a displaced joint. Colder surface water seeps in along the joint.

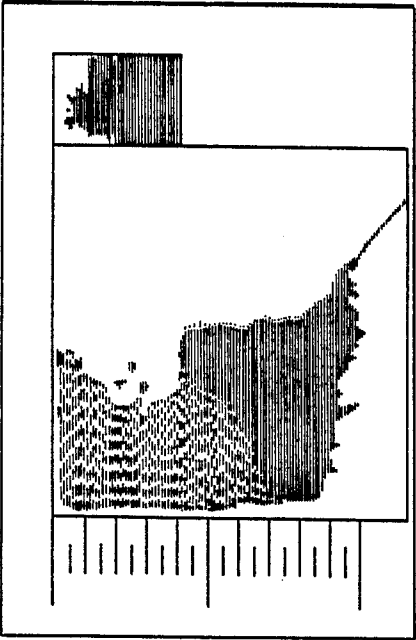
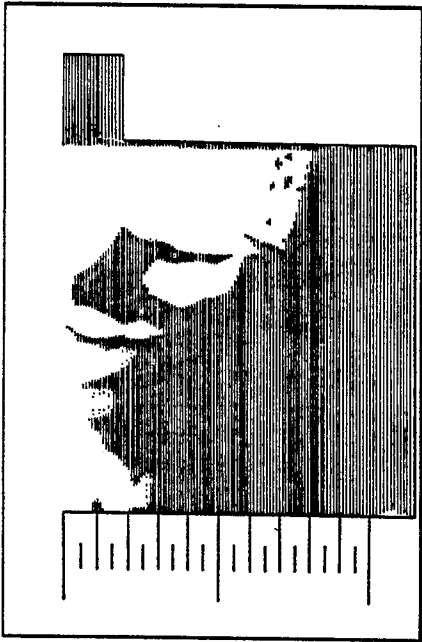
FIG. 6.

FIGS. 6 and 6a illustrate how roots have penetrated the sewer wall but not yet to an extent causing leakage. The roots taking water from the contents of the sewer are warmer than the wall behind kept cooler by the surrounding filling material.
