(12) **EUROPEAN PATENT APPLICATION**

(54) **Rotor repair method and rotor repair apparatus**

(57) A to-be-repaired damaged part, which occurs in a rotor (1), is removed and shaped by machining or grinding (S1). The shaped surface, from which the to-be-repaired damaged part is removed in the step (S1), is roughened by a blasting process (S2). A coating is formed on the surface, which is roughened in the step

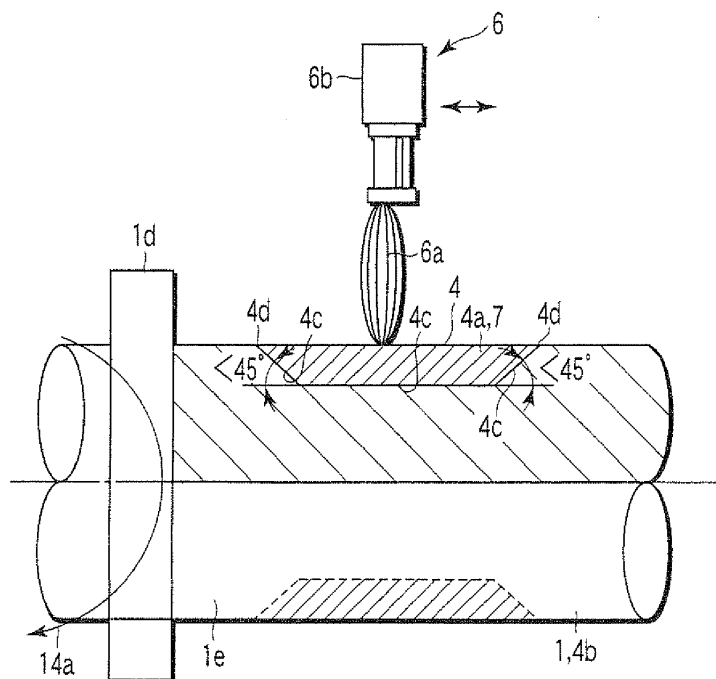
**FIG. 2**

FIG. 2 is a structural view showing a state in which a damaged part of a rotor is repaired by a high-velocity flame spray step illustrated in FIG. 1;

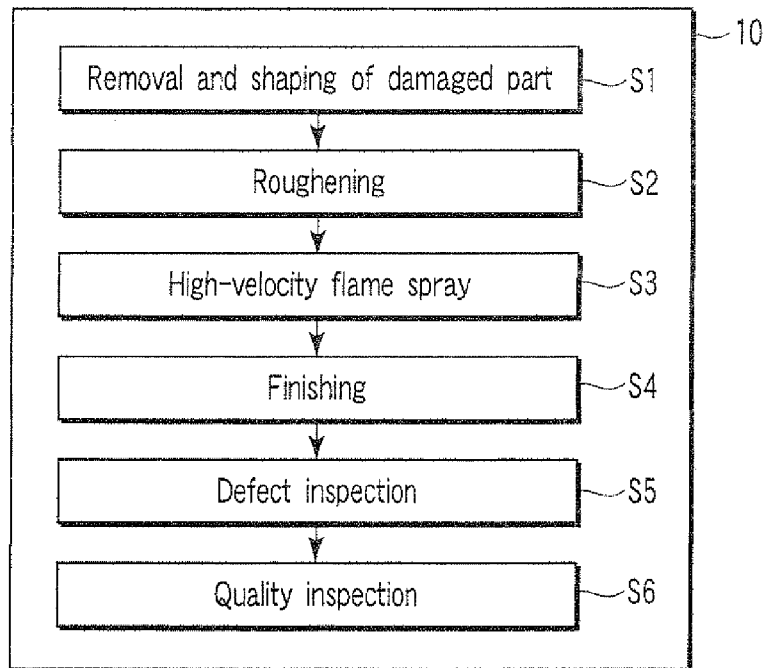
FIG. 1 is a flow chart illustrating a rotor repair method by high-velocity flame spray according to the present invention;

**[0021]** FIG. 1 is a flow chart illustrating a rotor repair method 10 according to a first embodiment of the present invention. This method will be described below in detail.

**[0022]** In a first step S1, for example, a repair worker finds, by visual observation, a damaged part, which is to be repaired, in the journal 1e of the rotor 1. The damaged part is completely removed and shaped by machining or grinding, as will be described later.

**[0023]** Subsequently, in a second step S2, the shaped surface, from which the to-be-repaired damaged part is removed in the first step S1, is roughened by a blasting process using a blasting material and process conditions (to be described later).

**[0026]** In a fifth step S5, a defect inspection is performed to check presence/absence of a defect.

**[0027]** In a sixth step S6, a dimensional/quality inspection is performed for the part repaired in the fifth step S5.

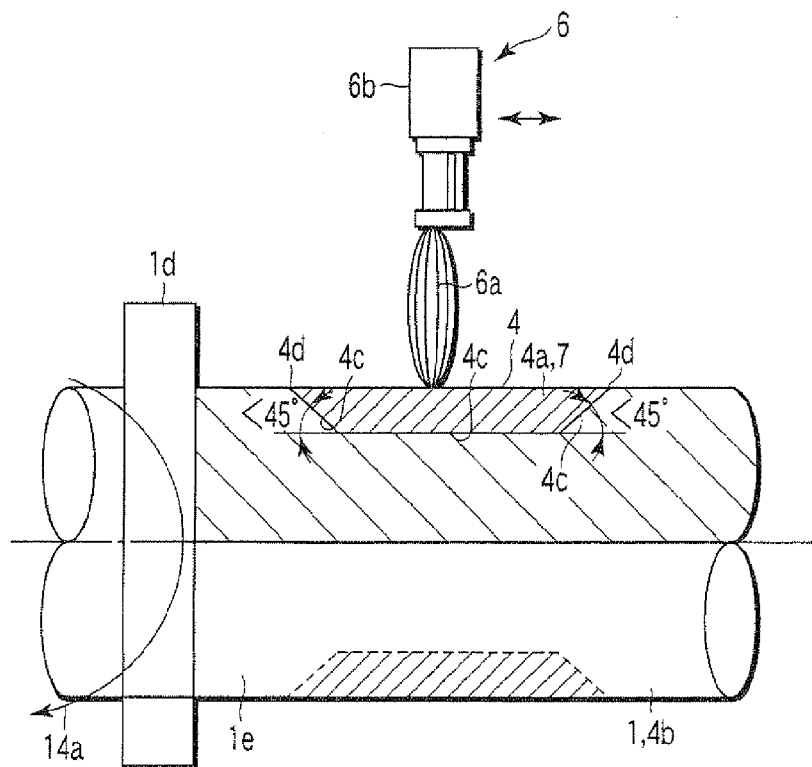
**[0040]** FIG. 2 illustrates the high-velocity flame spray in the third step S3 in FIG. 1. FIG. 2 shows the state in which the damaged part 4 of the rotor 1, which is rotatably supported by the journal bearing 3 shown in FIG. 7 or a thrust bearing (not shown), is repaired by using a high-velocity flame spray apparatus 6, which is described below. The high-velocity flame spray apparatus 6 includes a spray gun 6b which is capable of adjusting the velocity of a flame 6a at 600 m/sec to 3000 m/sec, and the velocity of particles at 500 m/sec to 2000 m/sec.

**[0030]** In the first step S1, when the to-be-repaired damaged part of the journal 1e is removed and shaped, the damaged part is removed, for example, in an isosceles-trapezoidal shape, as shown in a cross-sectional view of FIG. 2. Specifically, each of both axial end portions, that is, a boundary plane 4c between a to-be-removed damaged portion 4a and a non-damaged portion 4b, is shaped so as to have a bottom surface portion and an inclined surface portion. The bottom surface portion is formed parallel to the rotational axis. The inclined surface portion (sloping portion) 4d is formed at each of both end portions of the bottom surface portion, at an angle of 45° or less (excluding 0°) to an extension line including the bottom surface portion.

**[0041]** The conditions for the high-velocity flame spray in the third step S3 are as follows. For instance, a spray apparatus 6 which is manufactured by TUFA (model No. JP5000) is used. The base material of the rotor is

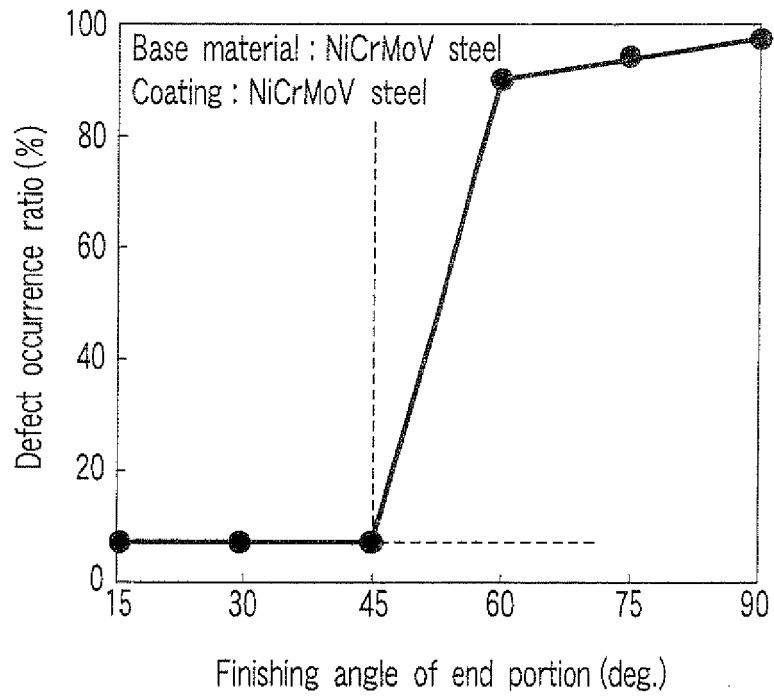
FIG. 3A shows an experimental result which indicates a defect occurrence ratio at a boundary plane at a time when a coating is formed by the high-velocity flame spray step for repairing the damaged part, as illustrated in FIG. 1;

**[0043]** Specifically, FIG. 3A shows the defect occurrence ratio of the boundary plane 4c at the time when the coating is formed by the high-velocity flame spray apparatus 6 (i.e. the defect occurrence ratio at 5 measurement points on the corner portion of repaired part 9). On the other hand, FIG. 3B is a cross-sectional view of the boundary plane 4c in the case where the finishing angle of the corner portion at the boundary plane between the to-be-removed damaged portion 4a of the damaged part 4 and the non-damaged portion 4b is set to be greater than 45°. In this case, a defect occurs at the corner portion (indicated by arrows).

**[0045]** As is clearly understood from FIG. 3, if the corner portion of the repaired part 9 is formed to have the inclined surface with the angle of 45° or less (excluding 0°) or the arcuate surface, the defect occurrence ratio is decreased to 10% or less, and a defect will hardly occur. Thus, the defect occurrence ratio can be reduced, the close contact of the spray coating can be improved, and the reliability of repair by thermal spray can be enhanced.

**[0046]** By contrast, if the angle of the inclined surface of the corner portion is set to be greater than 45°, the defect occurrence ratio increases to 80% or more, and a considerable number of defects will occur at the corner portion.

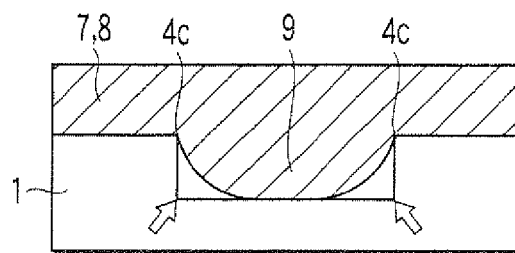
FIG. 3B is a cross-sectional view of a boundary plane in a case where the finishing angle of a corner portion at the boundary plane between a to-be-removed damaged portion and a non-damaged portion of the rotor is set to be greater than 45° in the method illustrated in FIG. 1;

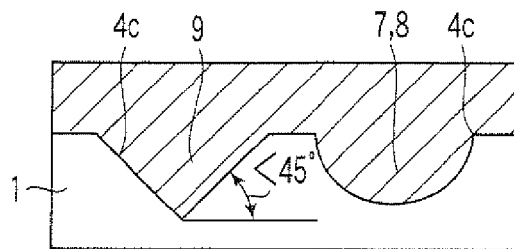
FIG. 3C is a cross-sectional view of a boundary plane in a case where the angle (i.e. the finishing angle of a corner portion) of an inclined surface of a grooved part at both ends of the boundary plane between a to-be-removed damaged portion and a non-damaged portion of the rotor is set to be 45° or less (excluding 0°) in the method illustrated in FIG. 1;

**[0044]** FIG. 3C is a cross-sectional view of the boundary plane 4c in the case where the angle (i.e. the finishing angle of the corner portion) of the inclined surface 4d of the grooved part at both ends of the boundary plane 4c between the to-be-removed damaged portion 4a of the damaged part and the non-damaged portion 4b is set to be 45° or less (excluding 0°). In this case, no defect occurs at the corner portion. In FIG. 3B and FIG. 3C, numeral 7 denotes a spray material that is sprayed at the to-be-removed portion 4a, numeral 8 denotes the sprayed coating, and numeral 9 denotes the repaired part.

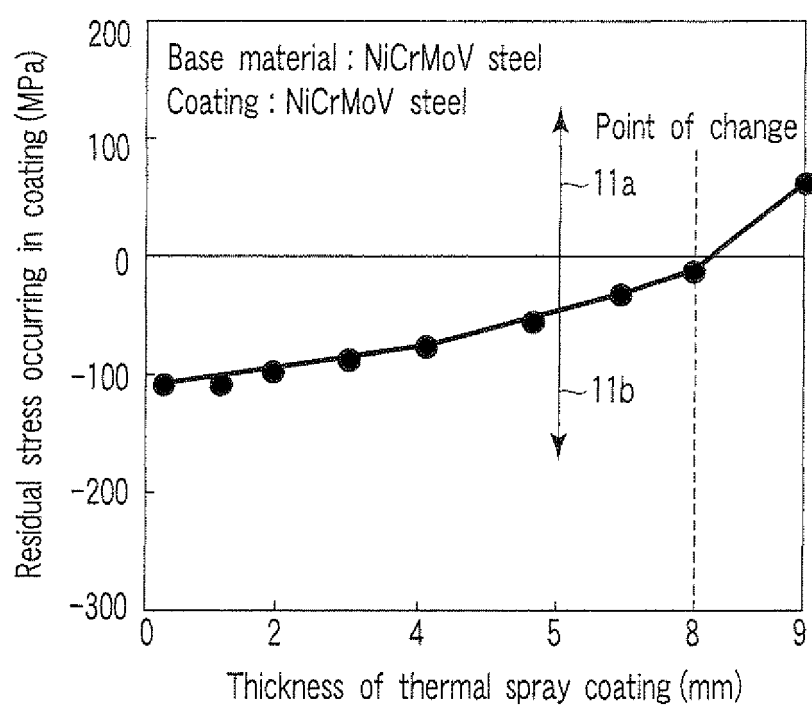
FIG. 4

**[0050]** As regards the thickness of the coating at the time of repair, as shown in the X-ray residual stress measurement result in FIG. 4, the coating has a compressive residual stress 11b up to 8.0 mm. At 8.0 mm or more, the residual stress 11 of the coating changes to a tensile residual stress 11a. It is understood that on the tensile stress side, peeling or cracking of the coating occurs, and the thick film cannot be formed. In the current situation, the maximum thickness is 8.0 mm, and the thick film can be formed in this range.

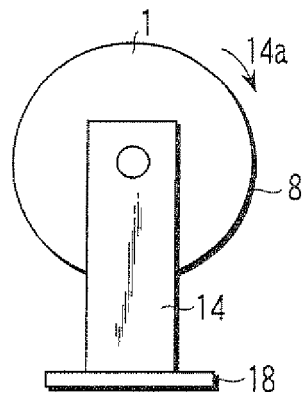
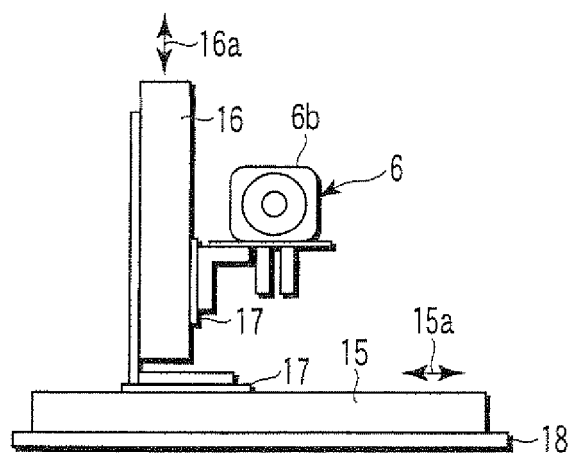
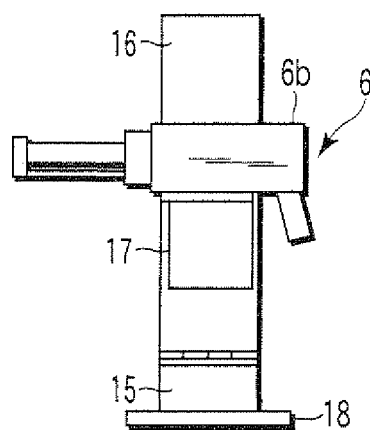
FIG. 5A is a front view showing the state in which the rotor is repaired by the high-velocity flame spray coating according to the invention at an on-site generation plant;

**[0051]** FIG. 5 is a view for describing a second embodiment of the present invention. The repair method 10 for the rotor 1 by the high-velocity spray apparatus 6 in the third step S3 is implemented at one of the location of a generation plant on the site (a turbine generator including a rotor to be repaired) and the location of a repair factory, or at the location where these are disposed together. FIG. 5A is a front view, FIG. 5B is a left side view of FIG. 5A, and FIG. 5C is a right side view of FIG. 5A. The structure shown comprises a rotor 1 to be repaired at the site; a rotor driving unit 14; a high-velocity flame spray

**[0058]** FIG. 5 shows repair equipment which is substituted for the factory-installed spraying robot when the spray coating 8 is formed for repair. When repair is conducted, the spray gun 6b is fixed to the spray gun driving units 15 and 16 which can arbitrarily move the spray gun 6b in the horizontal direction 15a and vertical direction 16a relative to the rotational axis of the rotor 1.

**[0060]** In this case, the equipment used is configured to include a spray gun movement table 17 which moves the spray gun 6b in the horizontal direction 15a and vertical direction 16a relative to the rotational axis of the rotor 1, and configured to be able to control the spray gun movement speed with a pitch of 0.1 mm/sec. Moreover, while the rotor 1 is being rotated in a direction of arrow 14a shown in FIG. 5A, the spray gun 6b is moved in the horizontal direction 15a to perform repair by thermal spray.

**[0062]** At the time of thermal spray repair, the spray gun 6b is moved in the horizontal direction 15a while the rotor 1 is being rotated (arrow 14a). This aims at uniformly forming the spray coating 8 on the outer peripheral surface of the rotor 1.

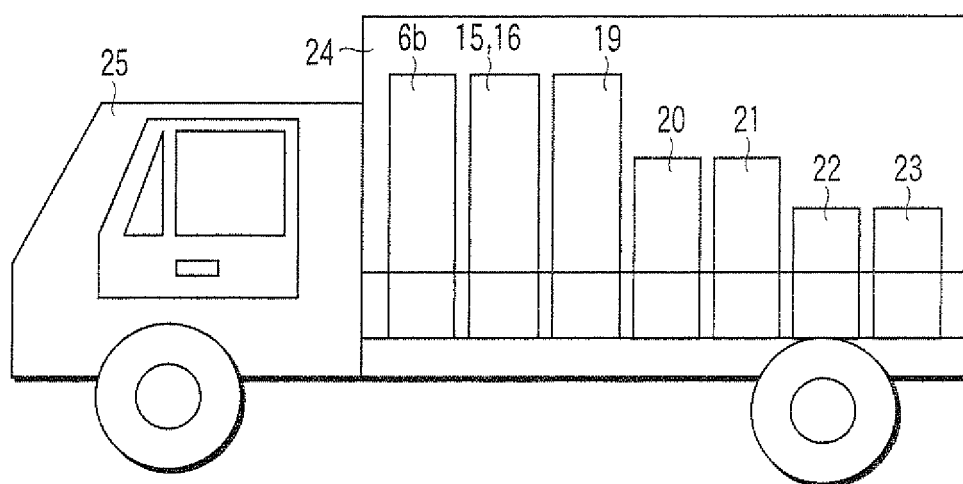
FIG. 6 is a schematic view showing the state in which a thermal spray repair system according to another embodiment of the invention, which is configured for repair of an on-site generation plant, is mounted on a movable vehicle;

[0066] FIG. 6 shows a third embodiment of the invention which relates to repair at the one-site generation plant. A thermal spray repair system 24, which comprises a spray gun 6b, spray gun driving units 15 and 16, a simplified sound-proof chamber 19, a cooling water chamber 20, a dust collecting unit 21, a generator 22 and a blasting unit 23, is mounted on a movable vehicle 25, so that repair 10 may be performed on the site with ease.

[0067] By simply transporting the thermal spray repair system 24 mounted on the vehicle 10, it becomes unnecessary to consume a great deal of labor in arranging for traffic means or transporting means both at domestic areas with inconvenient transportation means and at foreign countries. Repair work for the on-site generation plant can be conducted within a short time period.

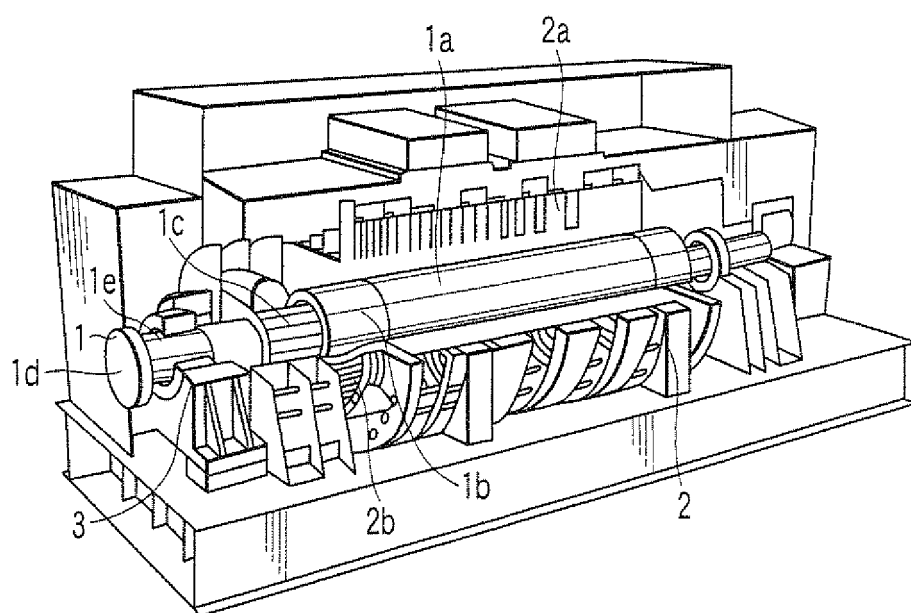
**[0002]** FIG. 7 is a schematic view showing the structure of a conventional turbine generator. The turbine generator generally comprises a stator 2, a rotor 1, and a journal bearing 3 that rotatably supports the rotor 1.

**[0003]** The stator 2 comprises a stator core 2a and a stator coil 2b that is inserted in slots formed in the stator core 2a.

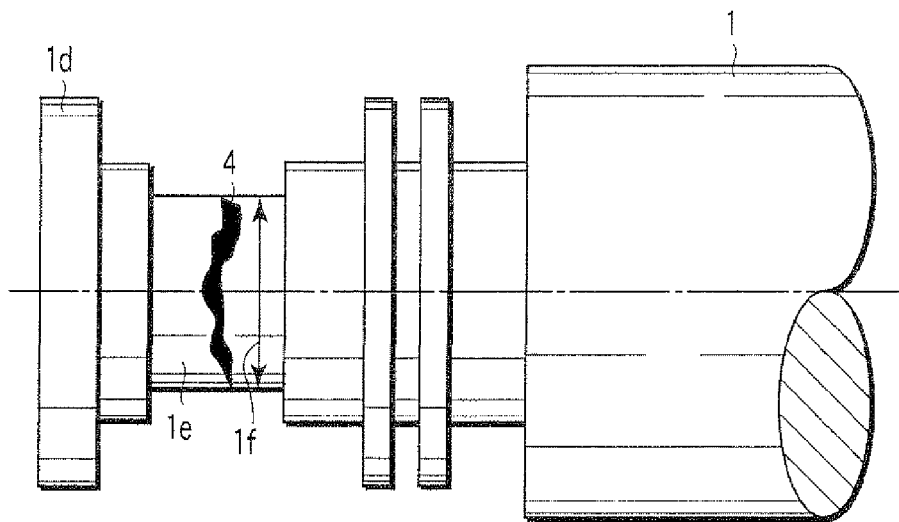
**[0006]** For example, as shown in FIG. 8A, a damaged part 4 may occur in the journal 1e of rotor 1, which is rotatably supported by the journal bearing 3 (not shown), due to foreign matter, abnormality in driving and the life of parts.

FIG. 8A is a schematic view showing a damaged part occurring in a rotor journal which is supported by a conventional journal bearing;

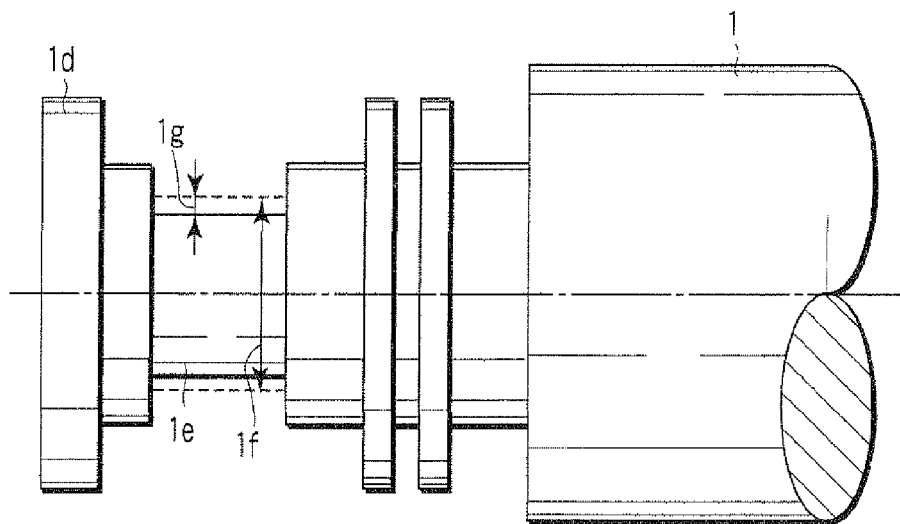
**[0007]** In this case, in order to remove the damaged part 4 in the journal 1e, the diameter 1f of the rotor (rotor diameter) is reduced by a dimension 1g by machining, etc., as shown in FIG. 8B.

FIG. 8B is a schematic view showing the state in which the damaged part occurring in the rotor journal, which is supported by the conventional journal bearing, is removed;

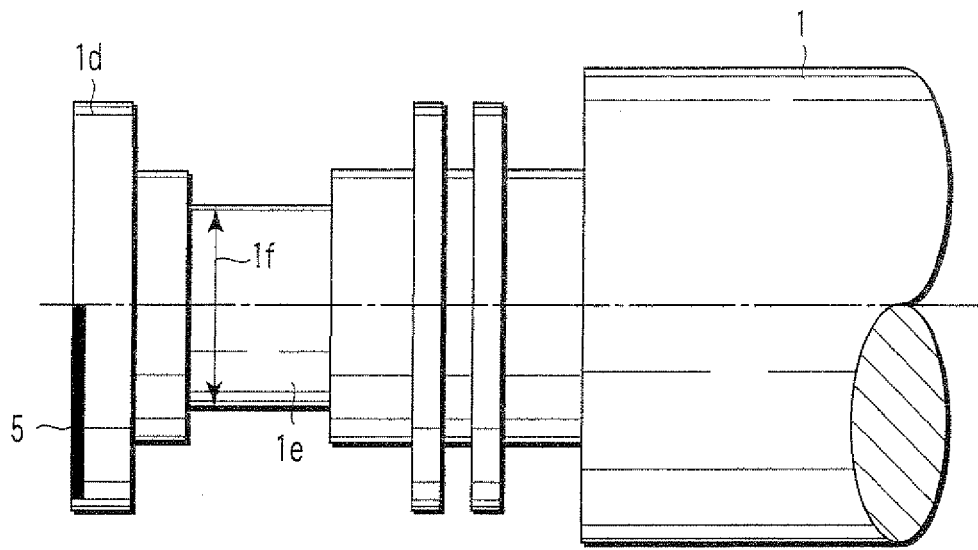
FIG. 9A

**[0009]** In addition, as shown in FIG. 9A, when an erroneously machined part 5 occurs in a machining process step in the manufacture of the rotor 1, design alteration or the like is performed each time such part 5 occurs, and the abnormality of the erroneously machined part 5 is eliminated by machining, etc., as shown in FIG. 9B. This may cause a decrease in performance or reliability of an apparatus using the rotor.

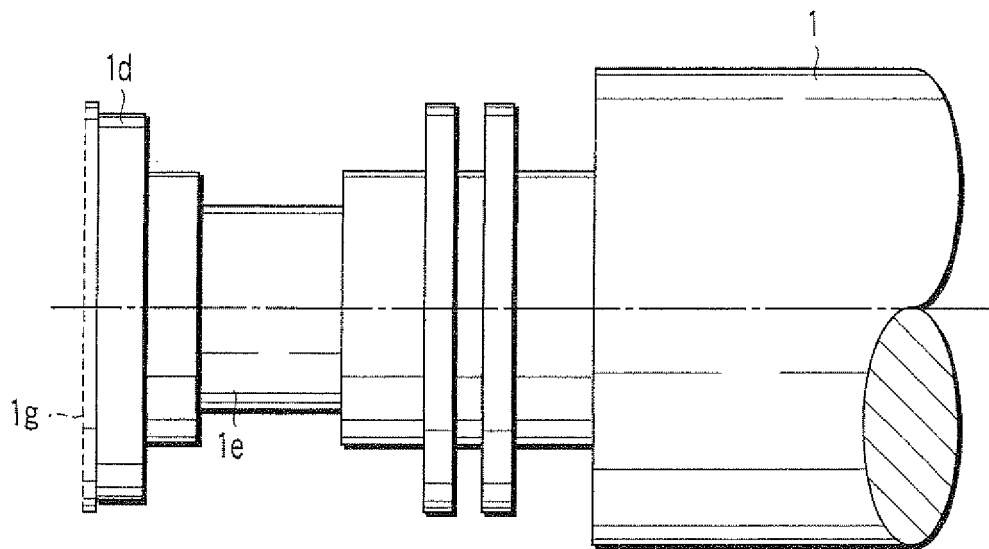
FIG. 9B is a schematic view showing the state in which an erroneously machined part has occurred in a machining process step at the time of manufacturing a conventional rotor.
