(10) **Patent No.:** **US 11,421,780 B2**  
(45) **Date of Patent:** **Aug. 23, 2022**

(54) **READING INTERNAL TEMPERATURE OF  
CONTINUOUSLY VARIABLE  
TRANSMISSIONS**

(71) Applicant: **High Performance Harry's Inc.,**  
Albany, MN (US)

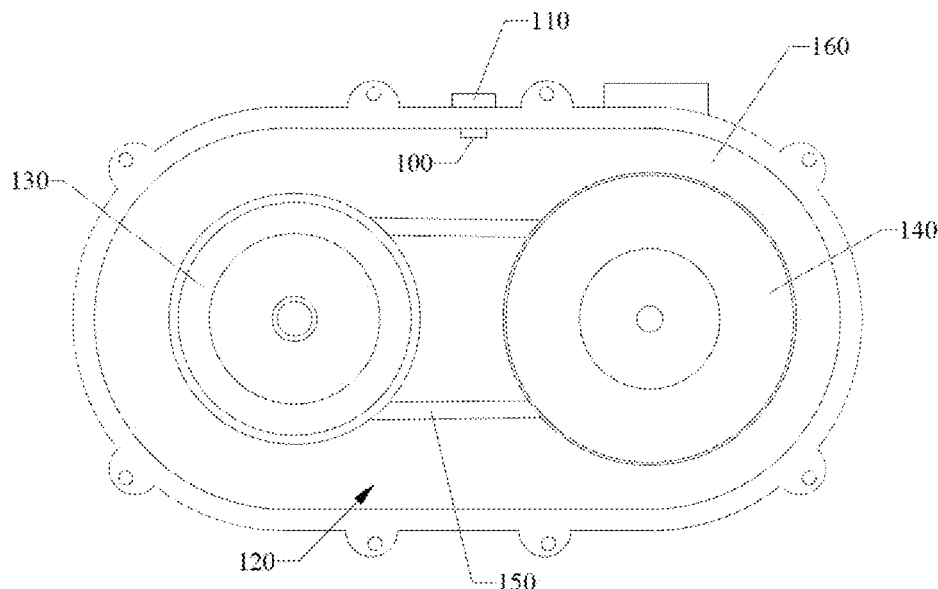
A system and method are presented that measure the temperature of a component in a continuously variable transmission (CVT) system. An infrared temperature sensor is mounted in a thermally insulating sensor housing such that the sensor is located within the interior of a CVT housing and aimed at the component. The component can be a belt in the CVT system or a stationary sheave in one of the two clutches of the CVT system. The sensor housing can have a cup and a stem with the sensor being positioned within that portion of the sensor housing positioned within the interior of the CVT housing. When the stem is in the interior of the CVT housing, a nut can be used to secure the sensor housing to the CVT housing while protecting the infrared sensor from damage. An air temperature sensor in the exhaust port can provide supplemental temperature readings.

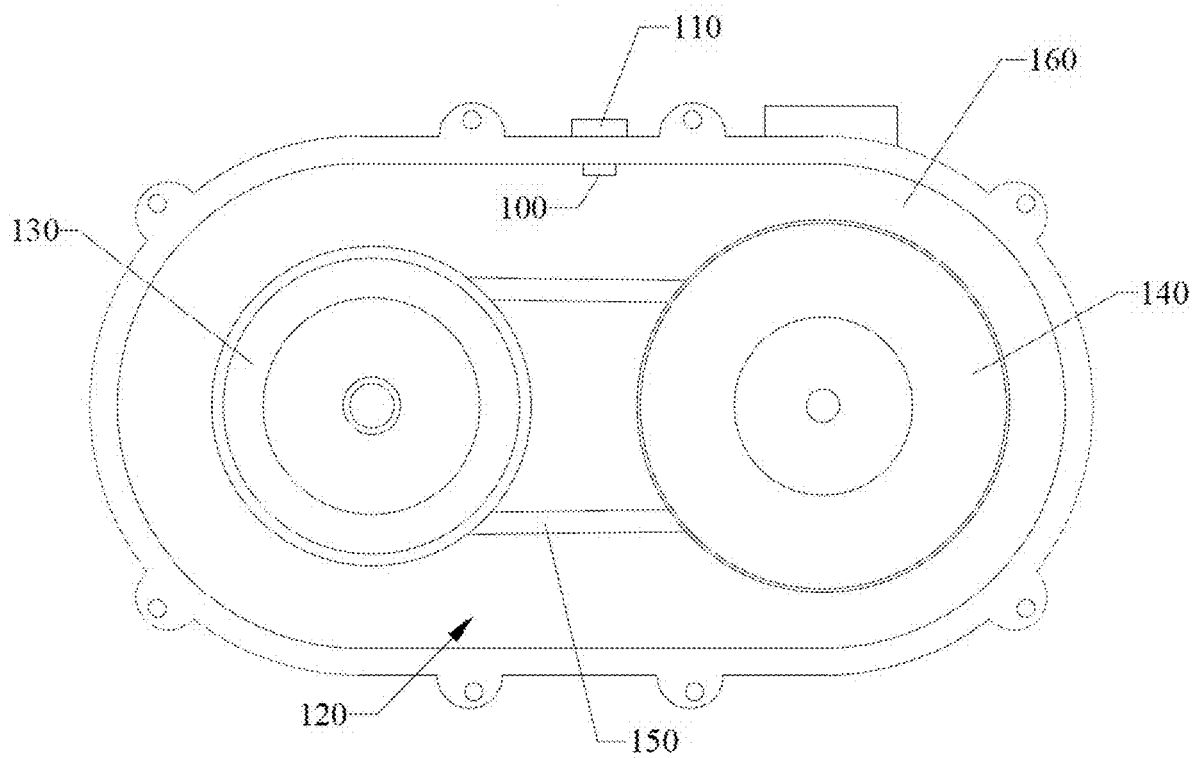
FIG. 1 is a front plan view of a continuously variable transmission (CVT) inside a CVT housing that contains an infrared temperature sensor aimed at the belt of the CVT.

Multiple embodiments have been discovered that successfully measure operating temperature in a CVT in order to avoid belt failures. One embodiment measures the belt temperature directly using a thermally isolated infrared sensor. FIGS. 1-3 shows such an embodiment in the context of a Continuously Variable Transmission ("CVT") 120. The CVT 120 consists primarily of a primary clutch 130 attached to an engine, a secondary clutch 140 attached to a transmission or transaxle, and a belt 150. A temperature sensor 100 is positioned to read the temperature of a belt 150 of the CVT 120. The sensor 100 in one embodiment is an infrared heat sensor secured in a sensor housing 110. The sensor housing 110 is positioned above the belt 150 within a CVT housing 160. The CVT housing 160 surrounds the CVT 120 including the primary clutch 130, the secondary clutch 140, and the belt 150. Although the CVT housing 160 is shown as covering only the rear side of the CVT 120 in FIG. 2 and the right side in FIG. 3, this is because only half of the housing 160 is shown in order to reveal the components of the CVT 120. In practice, a second half of the housing 160 (along with a gasket) would completely enclose and seal the CVT 120. The second half and gasket would attach to the shown portion of the CVT housing 160 along lip or edge 162. FIGS. 2 and 3 show an exhaust air port 170 for the CVT housing 160. As explained above, air passes through the CVT 120 in order to cool the components. The heated air then leaves the interior of the CVT housing 160 through port 170.

It is clear from FIGS. 1-3 that the sensor 100 sits on the inside of the CVT housing 160, as the sensor 100 is positioned proximate to the end of the stem 210, and this end is positioned within the interior of the CVT housing 160. It would be possible to mount the sensor 100 on the exterior of the CVT housing 160 with the sensor 100 reading the temperature of the belt 150 through a hole in the CVT housing 160. In this way, the sensor housing 110 passes through the hole in the CVT housing 160 but leaves the actual sensor 100 on the outside of the CVT housing 160 looking through that hole. Unfortunately, this configuration distances the sensor 100 from the belt 150 being measured. Furthermore, it is likely that the infrared sensor 100 located in this type of configuration would read the temperature of a portion of the sensor housing 110 that passes through the CVT housing 160. The configuration shown in FIGS. 1-3 avoids this issue.

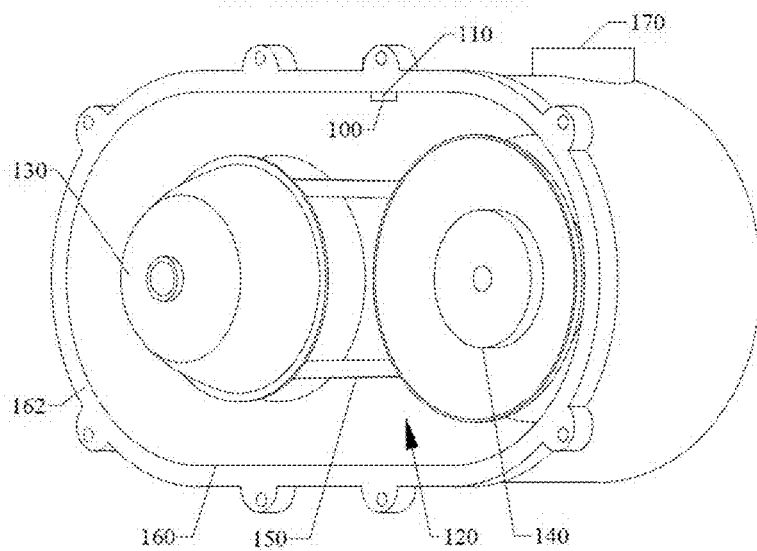
Infrared Sensor Over Belt

FIG. 2 is an isometric view of the CVT of FIG. 1

The RTD sensor assembly 1550 is designed to read the temperature of the air that passes through the interior of the CVT housing 160. In FIGS. 16 and 17, the RTD sensor assembly 1550 is shown as inserted into the interior of the CVT housing 160. In fact, the location of insertion is similar to the location where the infrared temperature sensor 100 was positioned to read the temperature of the belt 150 shown

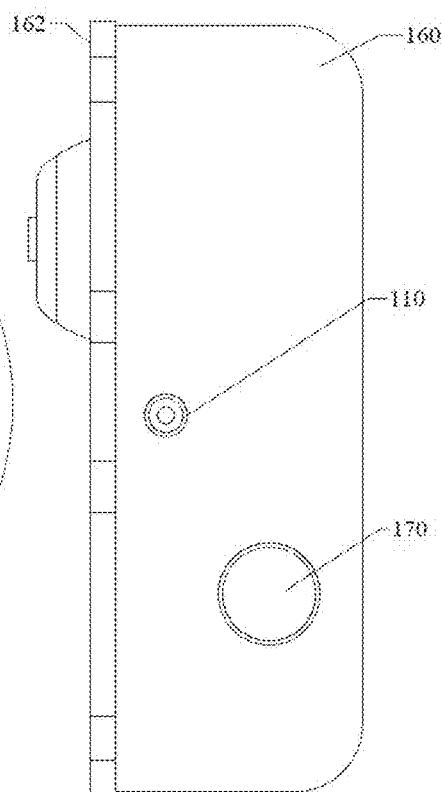
FIG. 3 is a top plan view of the CVT and CVT housing of FIG. 1

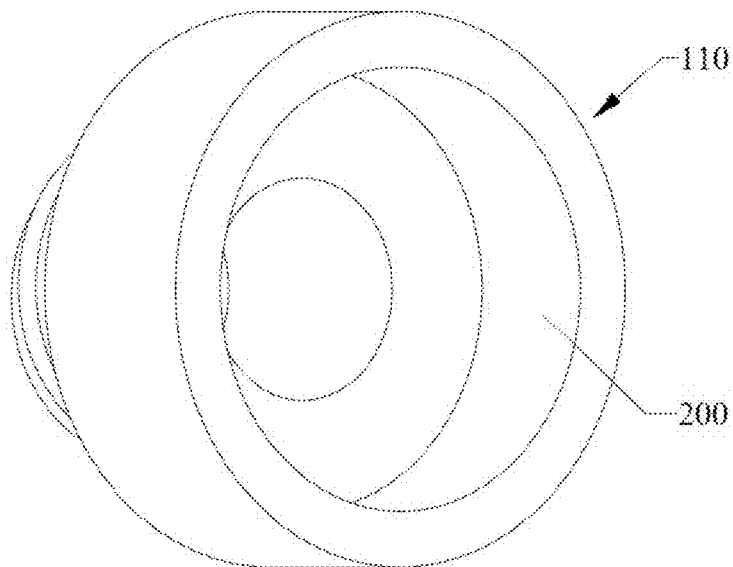
FIG. 4 is a photograph of a sensor housing.

The sensor housing 110 is shown in more detail in FIGS. 4-8. The housing consists of a cup 200 and a stem 210. As can be seen in those figures, both the cup 200 and the stem 210 have a circular cross-section, with the width of the cross-section being greater at the cup 200 than the stem 210.

In one embodiment, both the cup 200 and the stem 210 are made up of a material called polytetrafluoroethylene (PTFE). PTFE is better known by its tradename "Teflon," and one producer is DuPont de Nemours, Inc. ("DuPont") of Wilmington, Del. DuPont has identified the thermal conductivity of PTFE, which, per ASTM method D435, is 0.25 W/m-K. The chart 900 of thermal conductivity shown in FIG. 9 reveals that, with this thermal conductivity, PTFE is a very poor thermal conductor. In fact, PTFE is generally considered to be a thermal insulator.

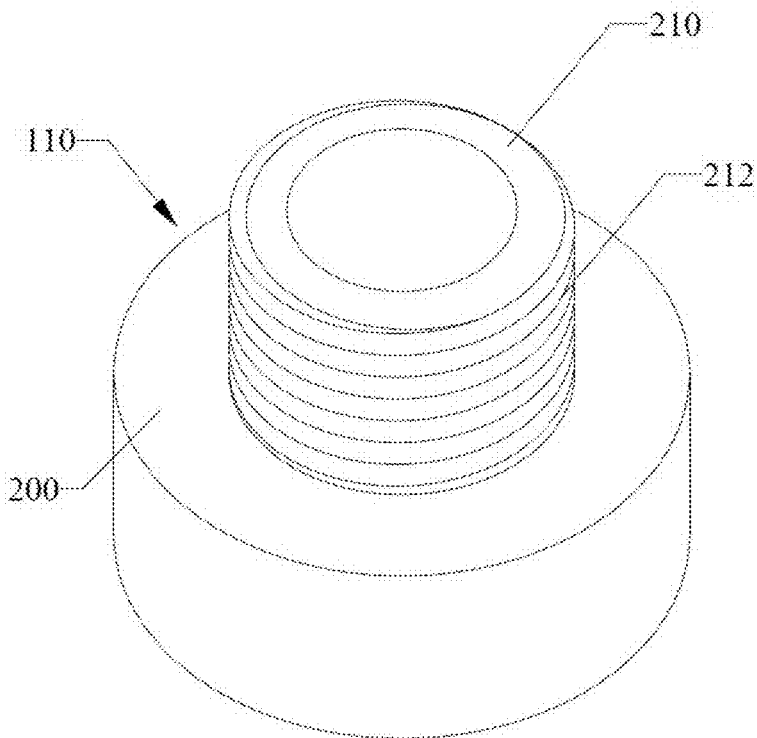
FIG. 5 is a second photograph of the sensor housing of FIG. 4.

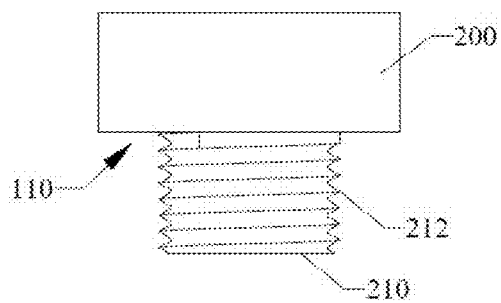
FIG. 6 is a front view of a sensor housing showing hollowed out portions in dashed lines.

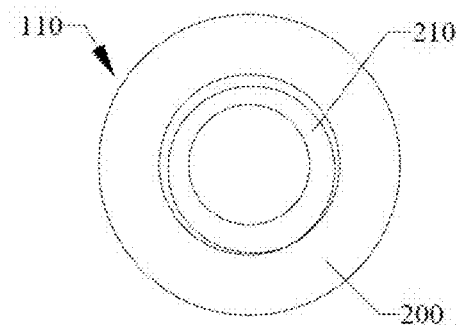
FIG. 7 is a top view of the sensor housing of FIG. 6.

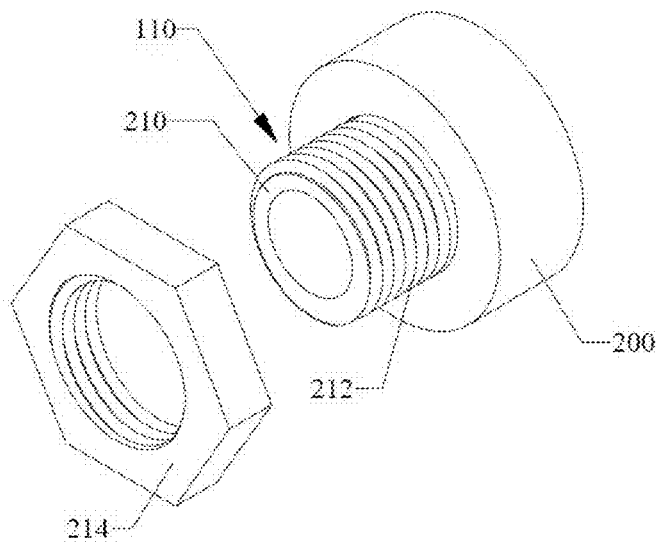
FIG. 8 is a side-bottom isometric view of the sensor housing of FIG. 6.

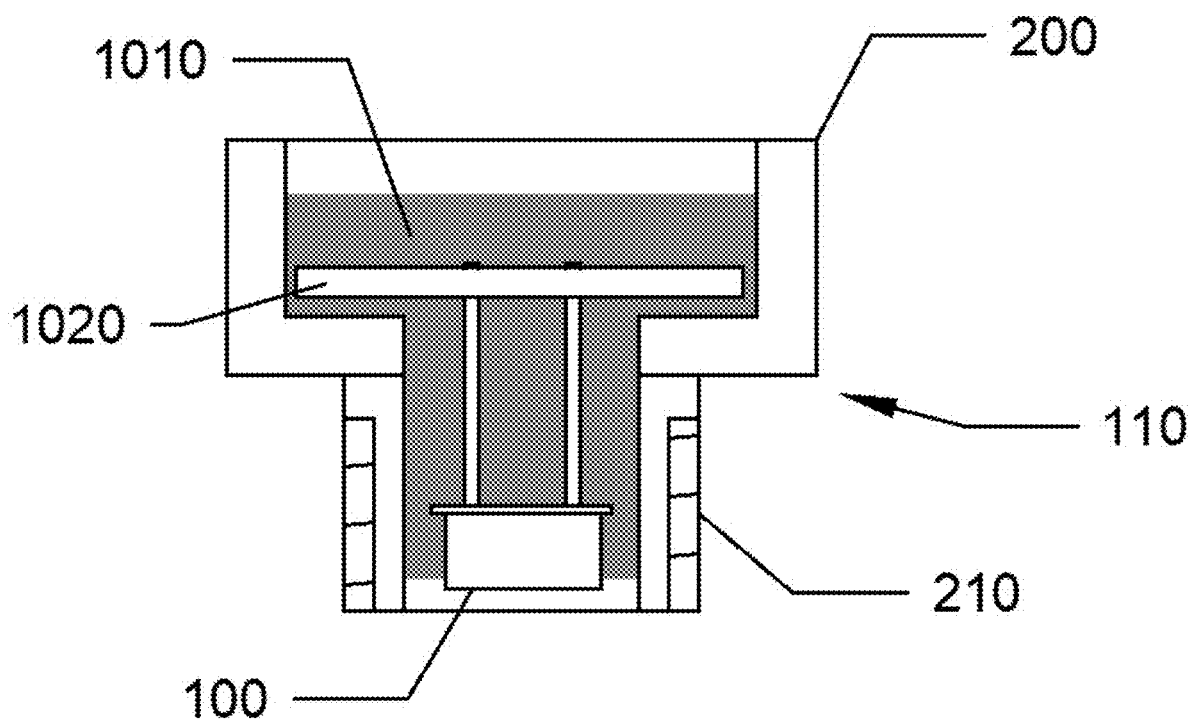
FIG. 10 is a partial cut-away view of an infrared temperature sensor mounted in a sensor housing.

The protective feature of the nut 214 is important because, as shown in FIG. 10, the actual infrared sensor 100 is placed into this end portion of the stem 210. The wiring for the sensor 100 passes through the stem 210 into the cup 200 of the sensor housing 110 where the wiring connects to the sensor mounting circuit board 1020. The circuit board 1020 will generally be larger than the actual sensor 100 and will generally be large enough that it would not fit within the interior of the stem 210. The cup 200 can be sized so as to allow the circuit board 1020 to fit within it. In some embodiments, the circuit board 1020 is round or circular in shape and sized to fit within, but to mostly fill, the cup 200, which allows for ease in centering the board 1020 and the attached sensor 100 during construction.

The sensor 100 and sensor mounting circuit board 1020 is held in place using a ScotchWeld Epoxy Adhesive DP110 (Gray) from 3M (Maplewood, Minn.). This adhesive 1010 was selected due to its poor thermal conductivity. According to 3M, this adhesive has a thermal conductivity of 0.104 BTU ft/(h ft<sup>2</sup>° F.) or 0.18 W/m·K. This epoxy 1010 is located between the sensor 100 and the stem 210 portion of the housing 110 in which the sensor 100 sits.

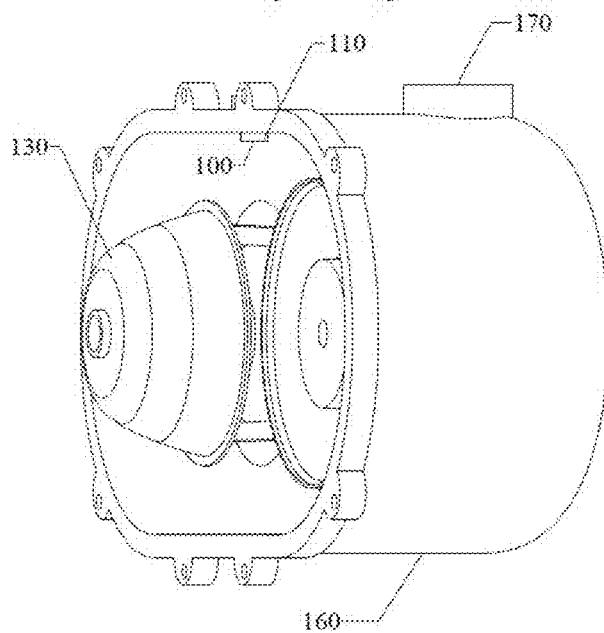
Infrared Sensor Over  
Stationary Primary Sheave

FIG. 11 is an isometric view of a CVT inside a CVT housing that contains an infrared temperature sensor aimed at the stationary primary sheave of the CVT.

FIGS. 11 and 12 shows another embodiment where the infrared sensor 100 is mounted in its sensor housing 110 directly over the primary sheave of the primary clutch 130. The primary sheave is stationary in the primary clutch. Thus, by positioning the sensor 100 over the stationary portion of the primary clutch 130, the sensor 100 is able to determine the temperature of the primary clutch 130. This configuration can have advantages over reading temperatures from the belt 150 as the stationary primary sheave will not move distance wise from the infrared temperature sensor 100 during operation. The belt 150, in contrast, will move closer and further from the stationary temperature sensor 100 when the configuration of FIGS. 1-3 is used, which make it more complicated to select the perfect field of vision of the sensor 100 with respect the distance and width of the belt 150. The configuration of FIGS. 11 and 12 faces no such difficulty.

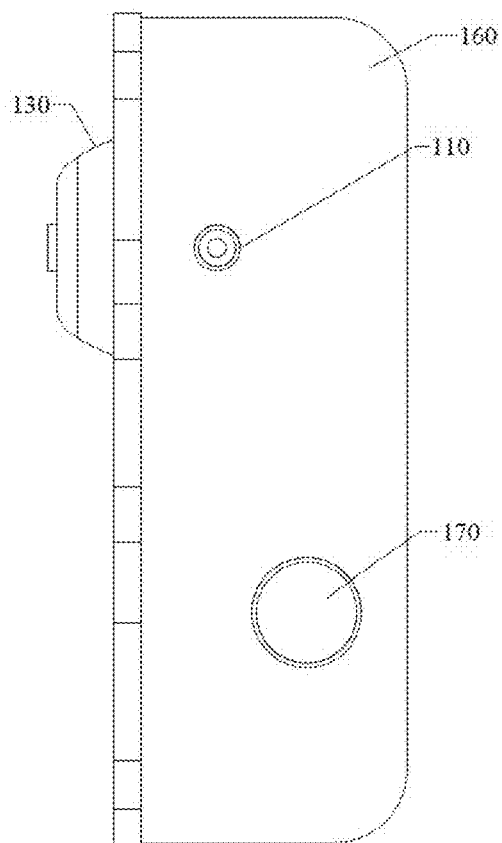
FIG. 12 is a top plan view of the CVT of FIG. 11.

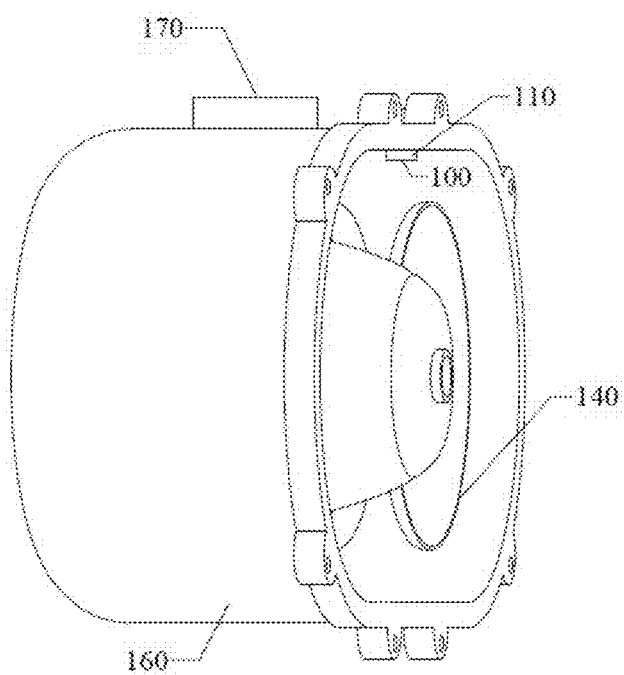
Infrared Sensor Over  
Stationary Secondary Sheave

FIG. 13 is an isometric view of a CVT inside a CVT housing that contains an infrared temperature sensor aimed at the stationary secondary sheave of the CVT.

Similarly, FIGS. 13 and 14 show the infrared temperature sensor 100 positioned so as to read the temperature of the stationary secondary sheave of the secondary clutch 140. This configuration has the same advantages as reading the temperature of the sheave of the primary clutch 130, shown in the configuration of FIGS. 11 and 12. All configurations would ideally read a similar temperature, as the temperatures of these various components 130, 140, 150 will all be similar during operation of the CVT 120.

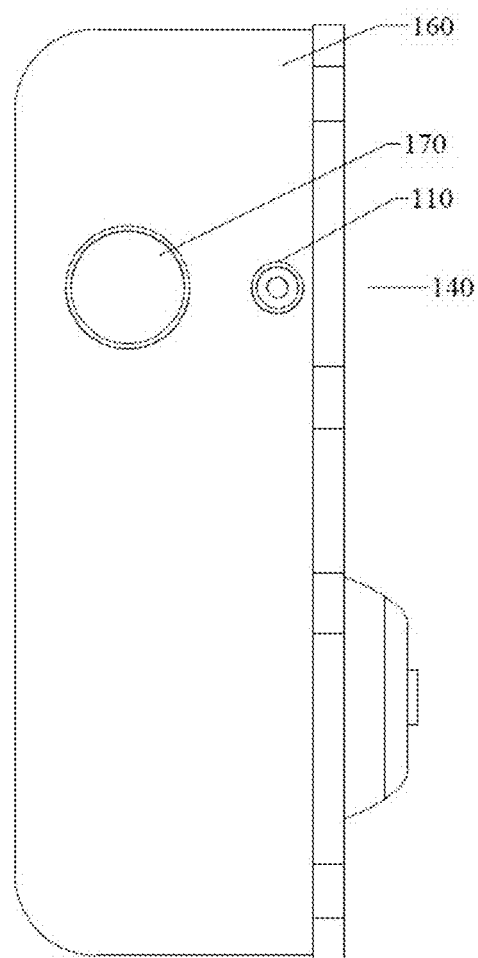
FIG. 14 is a top plan view of the CVT of FIG. 13.

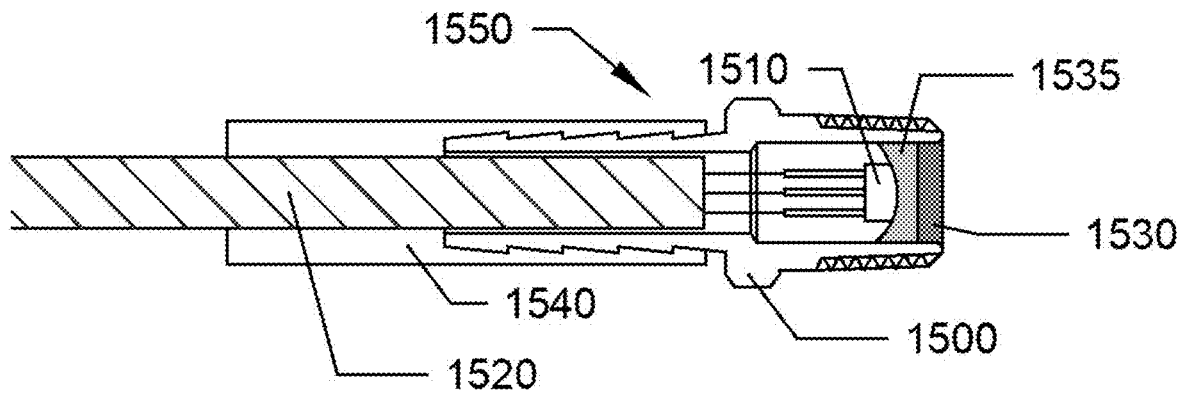
FIG. 15 is a partial cut-away view of a resistance temperature detector (RTD) in a thermowell receptacle.

FIG. 15 shows a resistance temperature detector (or RTD) 1510 inside a thermowell 1500 to create a sensor assembly 1550. A thermowell 1500 is a receptacle for a temperature sensor (such as an RTD 1510) that chemically (and pressure-wise) separates the sensor 1510 from the environment without limiting its ability to sense the temperature of that environment. In the embodiment shown in FIG. 15, the RTD sensor 1510 is mounted at the end of a metal thermowell 1500 with its wires passing through the thermowell 1500 to a connected, shielded cable 1520. The RTD sensor 1510 is fixed in place inside of the hollow end of the metal thermowell 1500 using an epoxy seal 1530 and thermally conductive putty 1535. This seal 1530 also isolates the RTD sensor 1510 from contaminants in the environment being sensed. The thermowell 1500 is fixed to the end of the shielded cable 1520 using an adhesive lined shrink tubing 1540. The tubing 1540 is stretched over (or positioned and shrunk over) a ridged tubing connection portion of the metal thermowell 1500 and the adhesive inside the tubing 1540 prevents accidental disassembly of the RTD sensor assembly 1550. It is possible to use a hose barb with a hose end and a thread end as the thermowell 1500, although this is not a requirement as alternative constructions are possible.

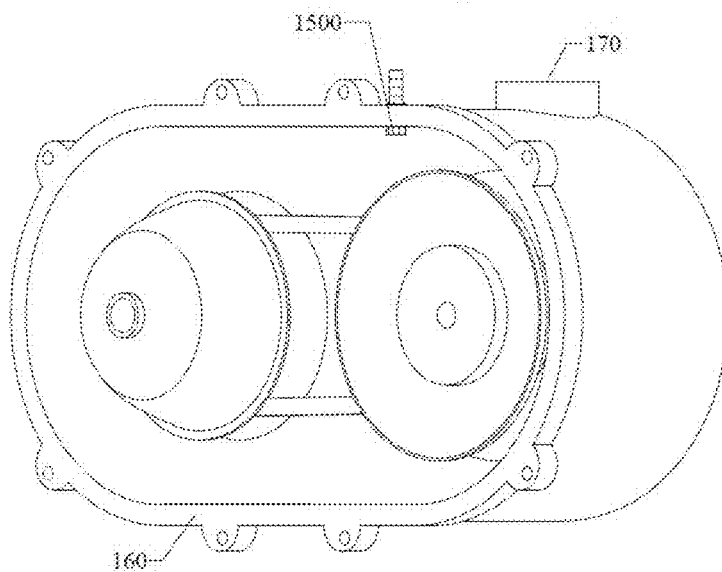
RTD Thermowell Positioned  
Inside CVT Housing

FIG. 16 is an isometric view of a CVT inside a CVT housing that contains a resistance temperature detector in a thermowell receptacle that can read air temperature inside the CVT housing.

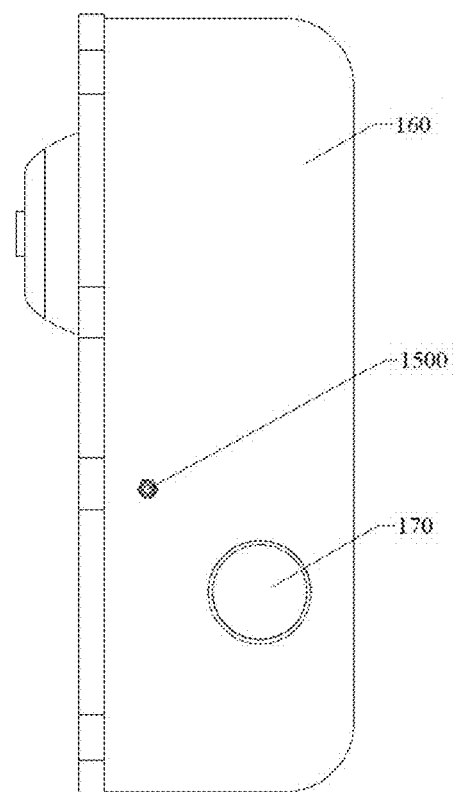
FIG. 17 is a top plan view of the CVT of FIG. 16.

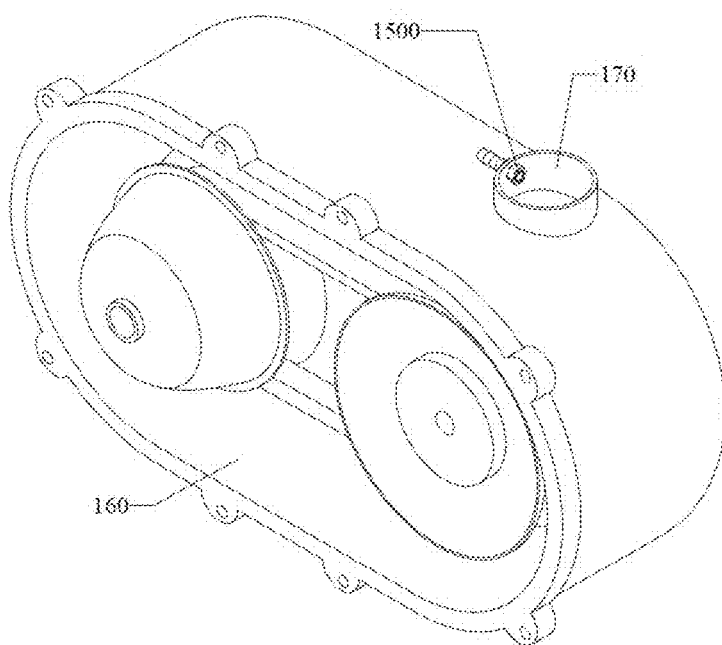
RTD Thermowell Positioned  
Inside CVT Housing Exhaust

FIG. 18 is an isometric view of a CVT inside a CVT housing for which a resistance temperature detector in a thermowell receptacle has been positioned in the exhaust port to read air temperature inside the exhaust port.

In FIGS. 18 and 19, the RTD sensor assembly 1550 is positioned not to read the temperature of the air inside the CVT housing 160, but to read the temperature of the air that is being exhausted from that housing 160 through exhaust port 170. In these Figures, the temperature sensor assembly 1550 is positioned extending into the exhaust port 170 of the CVT housing 160. In other embodiments, an air tube could be connected to that port 170, and the temperature sensor 1550 could be positioned within that air tubing. It is preferred to position the RTD sensor assembly 1550 as close as possible to the interior of the CVT housing 160.

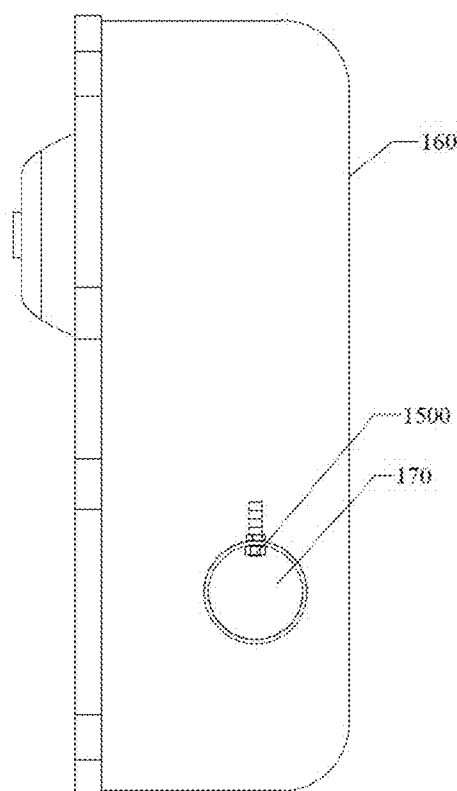
FIG. 19 is a top plan view of the CVT of FIG. 18.

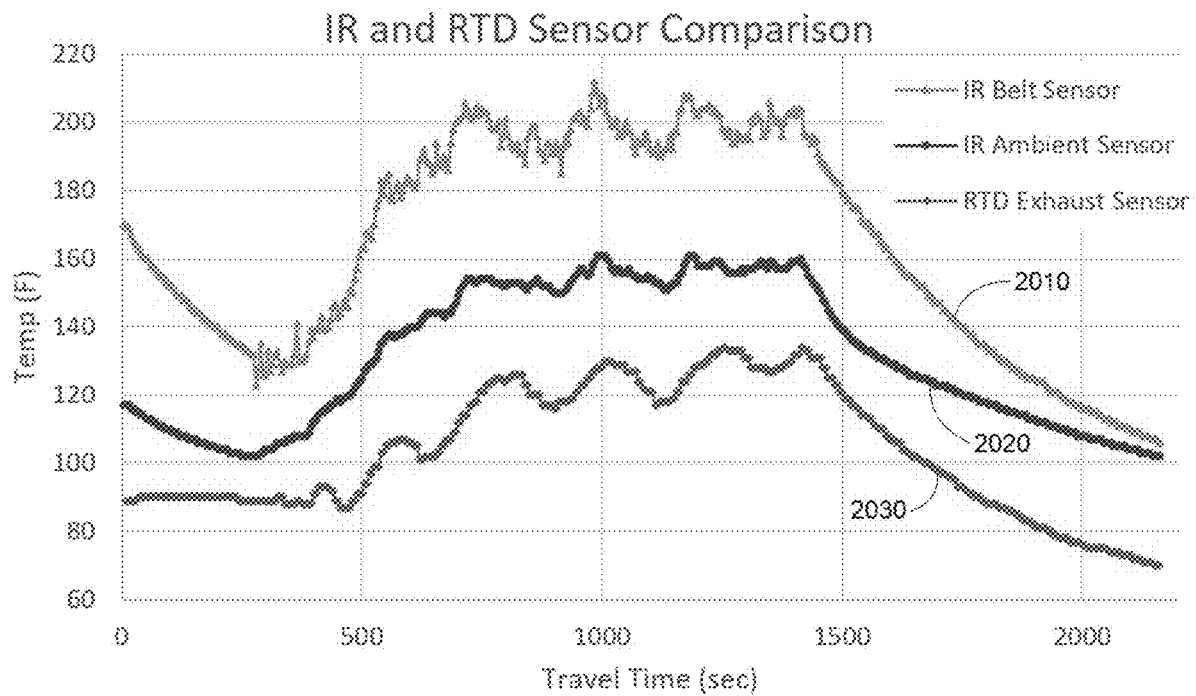
FIG. 20 is a data chart showing simultaneous temperature readings from different sensor types.

Testing confirms that using an RTD to measure air temperature in the exhaust port 170 or in the CVT housing 160 can offer similar results to using an infrared sensor reading the temperature of components within the CVT housing 160. This is shown in the test results shown in FIG. 20, in which a first line 2010 shows the reading from an infrared sensor 100 reading the temperature of belt 150, the second line 2020 shows the reading from an RTD sensor 1510 reading the air temperature inside the CVT housing 160, and a third line 2030 reading the air temperature at the exhaust port 170. Based on this data, the infrared sensor 100 reading directly from the belt 150 yields the highest reading 2010. This reading is considered the most accurate and responsive of the measurements. Ambient temperature readings from the CVT housing air 2020 yields lower, less responsive accuracy. While the housing air temperature 2020 follows the belt temperature trend 2010, the air temperature 2020 is not responsive to the heat spikes read from the belt. The exhaust air temperature 2030 also follows the belt temperature 2010, although reading a lower temperature than both belt reading 2010 and ambient IR reading 2020. In addition, there appears to be a slight delay between the peak infrared belt temperature 2010 and the peak exhaust port temperature 2030. This is likely caused by the difference in how fast the air moves through the CVT 120 and gets to the exhaust sensor.

Regardless of these differences, a reproduceable relationship exists between the RTD exhaust temperature 2030 and the infrared belt temperature 2010 that can be used to set safety temperature threshold points for the CVT 120 using either sensor configuration. However, the infrared belt sensor 2010 shall be more responsive to temperature spikes on the belt 150 and the RTD exhaust alarm threshold values must be set lower than the infrared belt alarm values.

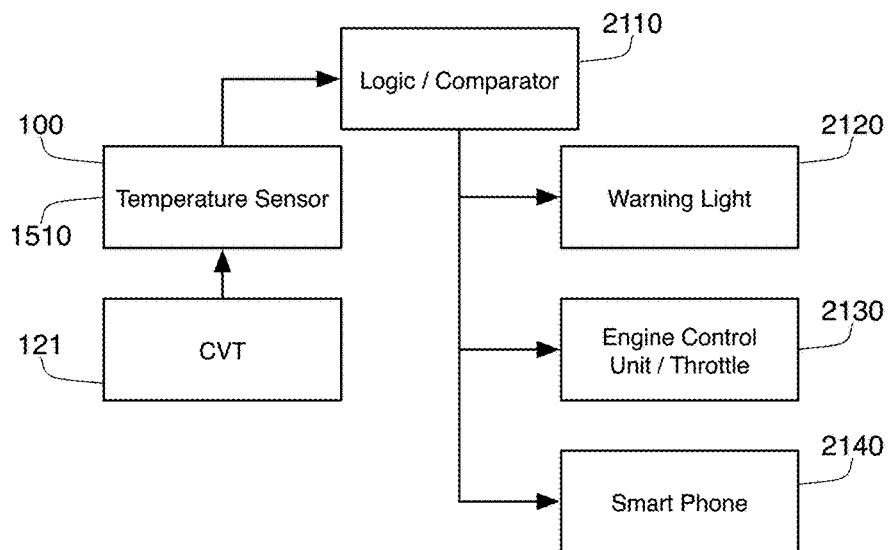
FIG. 21 is a schematic diagram of a system incorporating an embodiment of the present invention.

FIG. **21** shows a system for notifying users of excessive heat in the CVT **120** using the above-described systems and methods. A temperature sensor **100**, **1510** reads a temperature from the CVT **120**. As explained above, this can occur by using an infrared temperature sensor **100** to read the temperature of the belt **150**, primary clutch **130**, or secondary clutch **140** or by using an RTD sensor **1510** to read the air temperature inside the CVT housing **160** or exhausted air port **170** or passageway. Logic **2110**, which may take the form of digital logic or a programmed processor, or may take the form of a simple comparator or switch, determines whether the determined temperature exceeds a warning value. The warning value can be determined for each method of reading temperature so as to reflect minor variations in the resulting temperatures from the differing methods described above. In one embodiment, the warning value for an RTD sensor **1510** reading air temperature is 155 degrees Fahrenheit, while the warning value for an infrared temperature sensor **100** reading the temperature of a belt **150** or clutch component is 170 degrees Fahrenheit. If this warning value is exceeded, the user of the vehicle incorporating the CVT **120** is warned. This warning can take place by illuminating a warning light **2120**, by limiting the throttle or speed of the device **2130**, and/or by submitting a warning notification to an app running on a mobile device such as a smart phone **2140**.

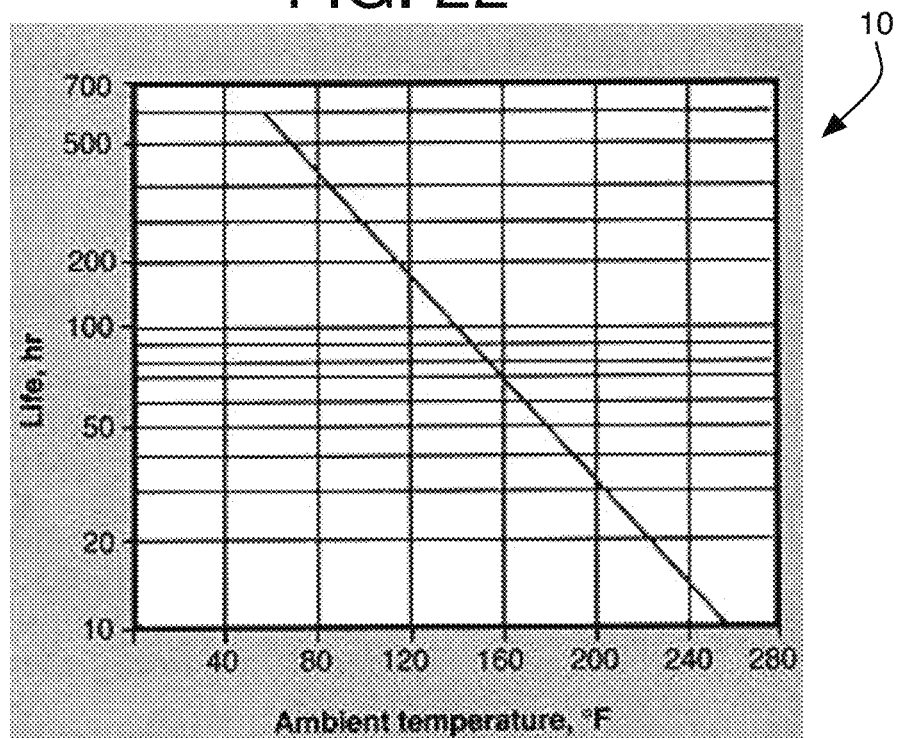
FIG. 22 is a data chart comparing belt life to ambient temperature.

Even under normal conditions, drive belts heat up just from the friction of the belt contacting the surface of the clutches or from the heat of the engine that is transferred to the clutches and transferred to the belt when it contacts the clutches. Belt manufacturers account for this and design drive belts to be temperature resistant up to "defined" temperature limits. Exceeding these temperature limits will diminish the life of the belt. Belt overheating describes a condition where the belt exceeds manufacturer temperature limits. The result of belt overheating depends upon how far the belt exceeds these manufacturer temperature limits. For example, in one technical article, Gates (a popular drive belt manufacturer) claims that "acceptable service" from a belt will occur if a belt's temperature is maintained below 160° F. GatesFacts Technical Information Library, "Hot and Cold Running Belts," The Gates Rubber Company (now Gates Corporation, or "Gates"), Denver, Colo., October 1992. This Gates article contains a chart 10, shown in FIG. 22, that maps service life for a belt against ambient temperatures. Gates mentions that drivers are often willing to accept decreased belt performance that comes from running belt temperatures above 160° F. While this is true, there is a difference between decreased belt performance (belt lifetime) and eminent belt failure.

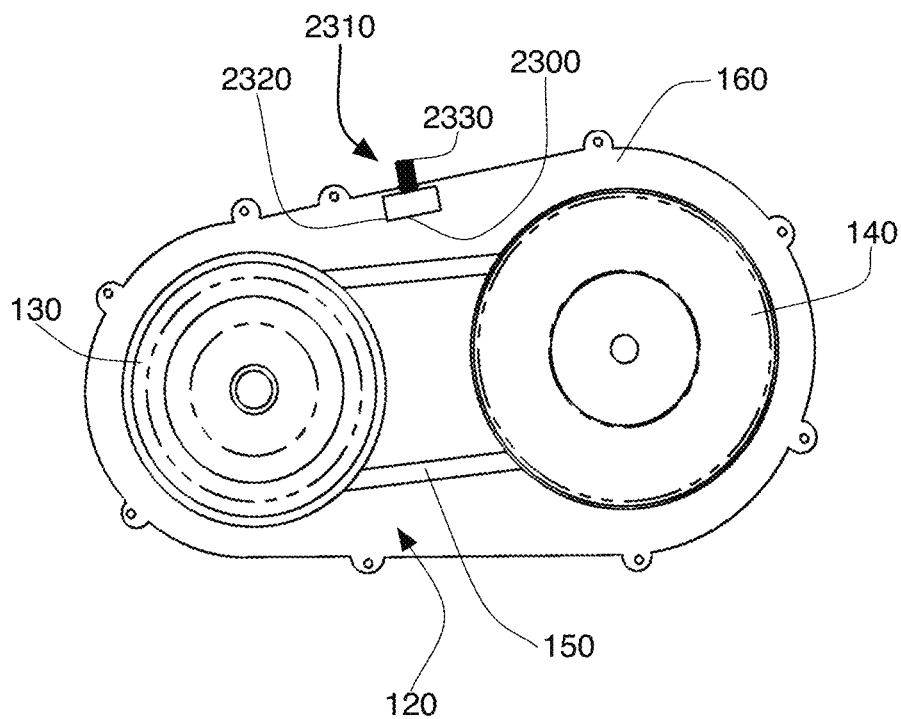
FIG. 23 is a front plan view of a CVT of FIG. 2 with an alternative configuration for a temperature sensor housing.

FIG. **23** shows another embodiment for an infrared sensor **2300** within a thermally insulating sensor housing **2310**. This housing **2310** is again positioned through a hole in the CVT housing **160** so as to position the infrared sensor **2300** to read the temperature directly off of the belt **150**. The housing **2310** has both a cup portion **2320** and a stem portion **2330**, but this time the infrared sensor is positioned within the cup portion **2320** instead of the stem portion **2330**. Furthermore, in this embodiment the cup portion **2320** is positioned within the interior of the CVT housing **160** with the stem **2330** being positioned primarily on the outside of the CVT housing **160**. As explained above, the reverse configuration of cup and stem shown in FIG. **1** is beneficial because it is easier to reduce the exposure of the infrared sensor **2300** to damage within a lower profile provided by the stem **210** and the protection provided by the nut **214**. However, it is sometimes difficult to fit the infrared sensor **2300** within an interior bore of the stem **2330**, thus the configuration of FIG. **23** places the sensor **2300** within the relatively large dimensions of the cup portion **2320**. Other than this configuration difference, the embodiment shown in FIG. **23** is capable of providing all of the benefits described above for the other configurations.

It is also possible to position the cup 200 on the interior of the CVT housing 160 with the stem passing through a hole to the exterior of the housing 160 as shown in FIG. 23. While this construction provides a good ability to obtain an infrared temperature reading on the components of the CVT, the cup 200 itself has a thicker profile than the portion of the stem 210 that extends through to the interior of the CVT housing 160 as shown in FIG. 1. Because of this thicker profile, configuring the sensor housing 110 so that the cup 200 is in the interior of the CVT housing 160 subjected the housing 110 and the sensor 100 to more damage than the reverse configuration of FIG. 1.

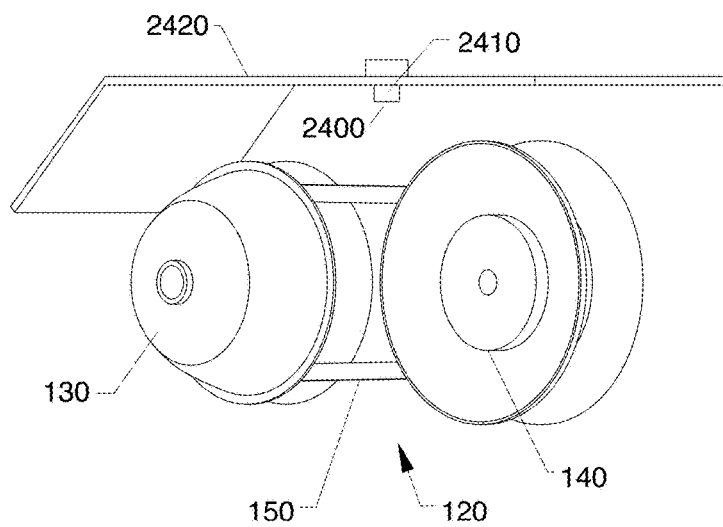
FIG. 24 is an isometric view of a CVT with a belt guard.

FIGS. **24** and **25** show an embodiment of the present invention in which the Continuously Variable Transmission ("CVT") **120** is not fully enclosed in a CVT housing **160**, but is, in fact, left exposed to the elements. In this embodiment, the CVT **120** is located physically near a belt guard **2420**. The belt guard **2420** can take the form of a metal sheet. In FIGS. **24** and **25**, the belt guard **2420** takes the form of a single, bent metal sheet. The actual shape or configuration of the belt guard **2420** is not relevant to the operation of this embodiment.

An infrared sensor **2400** located within a sensor housing **2410** is mounted on the belt guard **2420** in such a position that the infrared sensor **2400** is able to read the temperature of the belt **150**. In FIG. **24**, the sensor **2400** and sensor housing **2410** can be identical to the sensor **100** and sensor housing **110** described above. The open (or non-enclosed) nature of the CVT **120** will not change the operation of the infrared sensor **2400**, since this sensor **2400** directly reads the temperature off of the belt **150**. In particular, the sensor **2400** will remain thermally isolated from the belt guard **2420** through the use of a thermally insulating sensor housing **2410**.

As shown in FIG. **24**, the sensor **2400** and the sensor housing **2410** are configured such that the sensor **2400** is positioned in a narrow stem portion of the housing **2410**. The sensor **2400** is on the "inner" side of the belt guard **2420** (meaning that it is on the side of the belt guard **2420** facing the CVT **120**). A wider, cup portion of the sensor housing **2410** is on the outer side of the belt guard **2420** (on the side opposite the inner side). Similarly, the sensor **100** of FIG. **1** is on the inner side of the CVT housing **160** while the cup portion **200** of the sensor housing **110** is on the outer side of the CVT housing **160**. Of course, as was the case with the embodiment of FIG. **23**, the cup portion of the sensor housing **2410** can be reversed so that it is on the inner side of the belt guard **2420**, with the sensor **2400** then being mounted within this cup portion.

FIGS. **24** and **25** show the sensor **2400** and sensor housing **2410** positioned on the belt guard **2420** to read the temperature of the belt **150**. In other embodiments, the sensor **2400** and sensor housing **2410** are positioned on the belt guard **2420** to read the temperature from the stationary sheave of

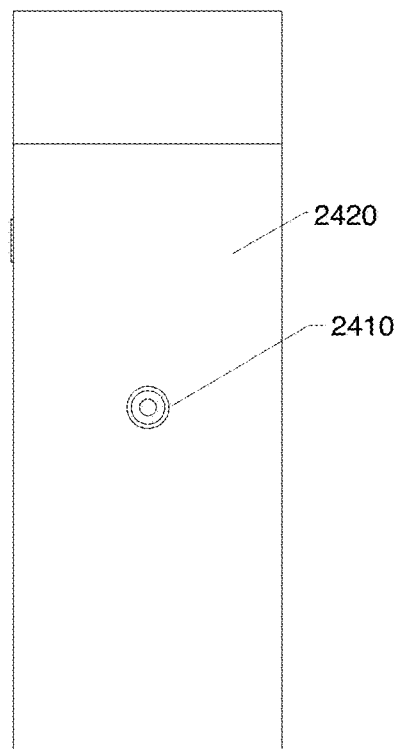
FIG. 25 is a top plan view of the CVT and the belt guard of FIG. 25.
