**EP 3 664 663 B1**

## EUROPEAN PATENT SPECIFICATION

(54) **INTERCHANGEABLE BASE STEEL STRUCTURE STORAGE ASSEMBLY**

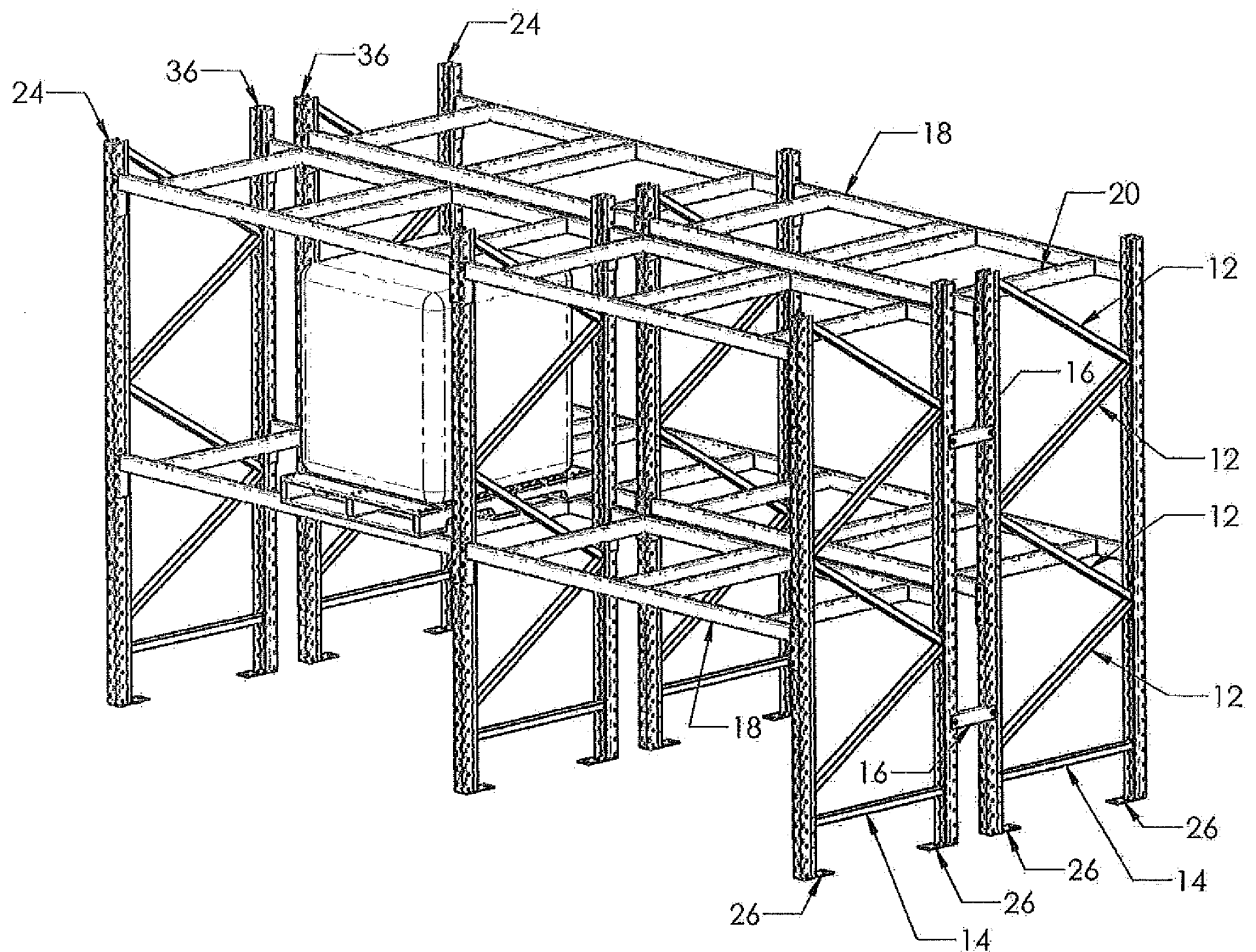
PRIOR ART  
*FIG. 1*

FIG. 1 is a side perspective view of a prior art storage rack;

[0031] FIG. 1 shows an example of a prior art storage rack that may be retrofitted to make a rack in accordance with the present invention. A preferred embodiment of the present invention is shown in FIGS. 2-11. The rack of FIG. 1 has a multitude of forward columns **24**, and a multitude of rear columns **36**, and horizontal load beams **18** interconnecting the forward and rear columns **24**, **36** to form levels to support palletized material. Each pair of forward and rear columns **24**, **36** extends from a baseplate **26** and also includes horizontal forward-to-rear braces **14** and diagonal forward-to-rear braces **17**. In this configuration, the back to back columns **36** have row spacers **16** that control the flue dimension. This rack is

prone to damage from material handling equipment (MHE) when the operator is interfacing with the racking system. It is then very problematic and costly to repair the damage uprights as discussed above.

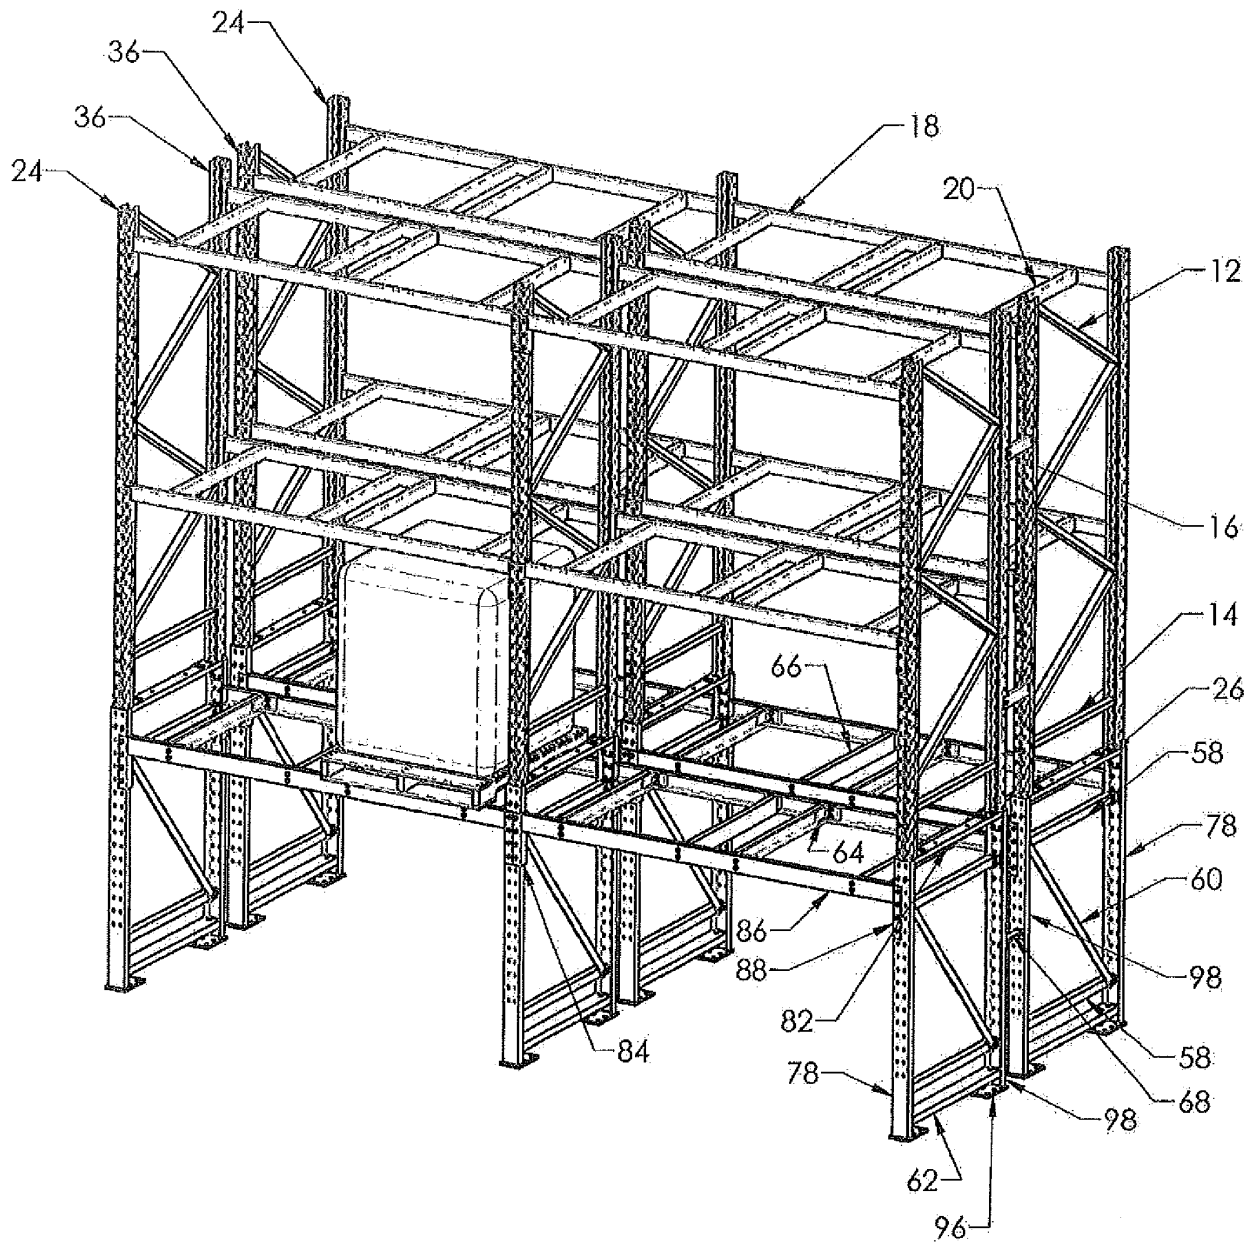
FIG. 2 is a side perspective view of a first embodiment of a storage system made in accordance with the present invention;

MATERIAL AND DIMENSIONS WILL CHANGE TO SUIT  
ENGINEERING AND SYSTEM REQUIREMENTS.

BRACING MAY BE K, X OR Z.

[0032] FIG. 2 shows a storage rack with a base steel structure assembly made up of structural components to greatly reduce the damage due to impact by the MHE. The upper portion of the front columns terminate above the first load beam level as the load beam connection adds additional durability and rigidity to the base steel structure assembly. This rack may be made in this form initially, or it may be made by retrofitting the prior art rack of FIG. 1. This rack also has a front column **78**, rear column **98**, horizontal load beams **86** and horizontal pallet supports **66**. The columns are supported by bolted horizontal forward-to-rear braces **58** and bolted diagonal forward-to-rear braces **60**. The pallet supports interconnect via an angle bracket **64** to the front and rear horizontal load beams **86**. A horizontal member **82** is bolted connected to the top of the front column **78** and the rear column **98**. This horizontal member has an identical hole punch pattern on the front face of the material which corresponds to the baseplates' **26** hole pattern, this allows for a bolted connection between the upper and lower columns. Once fully assembled, the entire assembly is then anchored to an underlying floor via holes extending through baseplates **70** attached to the front columns **78** and baseplates **96** attached to the rear columns **98**.

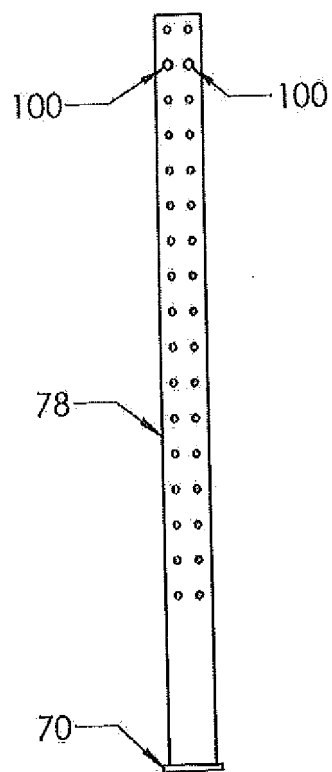
FIG. 3 is a front view of a base portion of the storage system of FIG. 2;

[0033] FIG. 3 shows front column **78** with corresponding baseplate **70**. The front column is punched with round holes to accept bolted connections as required.

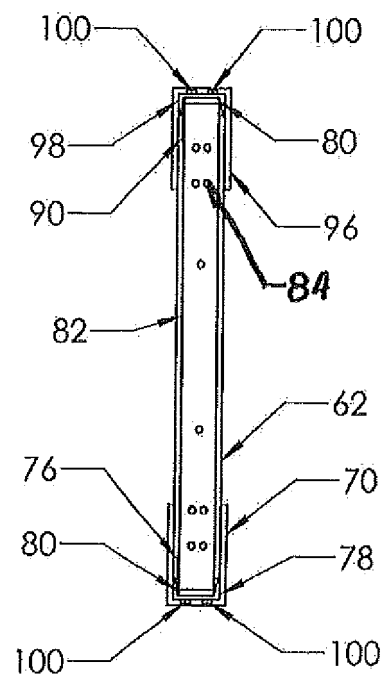
FIG. 4 is a top view of the base portion of the storage system in FIG. 2;

[0034] FIG. 4 shows a top view of the horizontal member **82** with corresponding front column **78** and rear column **98**. The horizontal member would have holes **84**, punched or otherwise formed on the front face of the material which correspond to the holes in the baseplate **26** in FIG. 2 to allow for a bolted connection. The front baseplate **70** and rear baseplate **96** which allow for the assembly to be anchored to the floor are also illustrated. A plate **80** is welded to each end of the horizontal structural member **82** which allows for a bolted connection between the front column **78** and the rear column **98**.

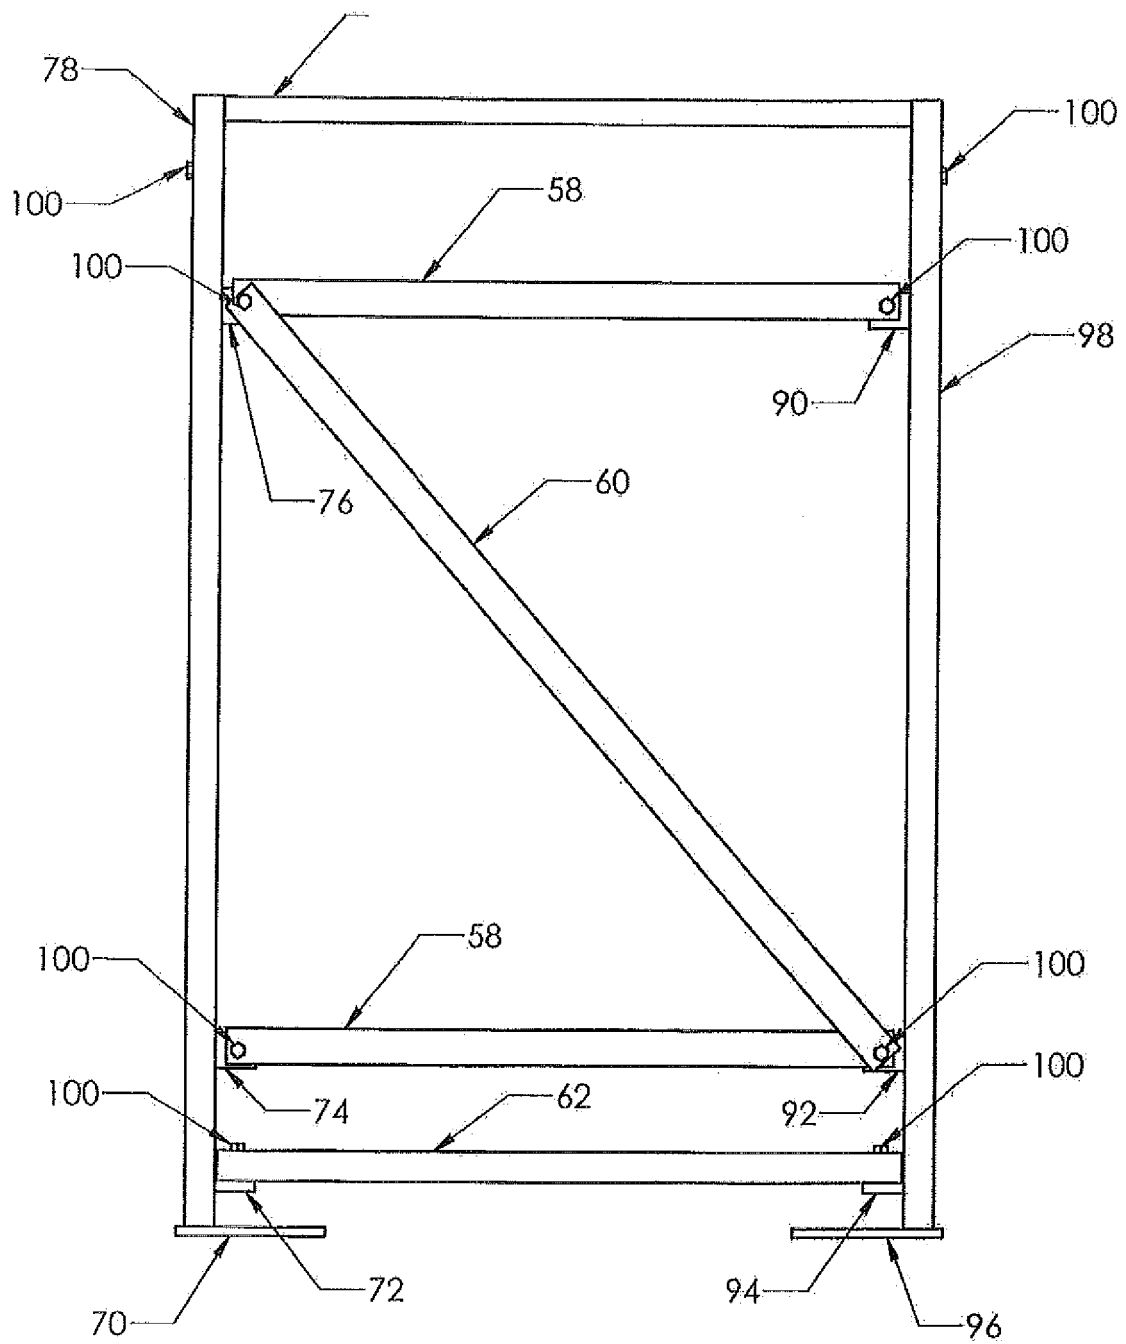
FIG. 5 is a side view of the base portion of the storage system in FIG. 2;

[0035] FIG. 5 shows the base steel structure assembly fully assembled and prior to being connected to the above storage system. Bolted connections **100** allow for quick and easy replacement of damaged components all while the above storage system stays in place. The front column **78** and rear column **98** are typically rectangular or C-shaped structural members. The columns are supported by horizontal forward-to-rear braces **58** and diagonal forward-to-rear braces **60**. The braces are bolted to tabs **74** and **76** on the front column and tabs **90** and **92** on the rear column. Before being welded to the columns the tabs are provided with holes through punching or otherwise to accept a bolted connection which allows for easy replacement of braces if ever damaged. The horizontal member **82** which is positioned at the top of the assembly is bolted to the front column **78** and rear column **98**. This

horizontal member allows for the columns in the above storage rack to remain in place during the replacement of any damaged structural component as it supports the load from both columns and is connected by bolts through said columns baseplates **26** in FIG. 1. A vertical load jack **200** (Figs. 9 and 11) may be installed under the horizontal member to take the above load while the required repairs are being completed. The horizontal channel **62** which is bolted to tabs **72** and **94** acts as a guard rail to further protect the critical bracing panel above from damage. This structural channel is considered a sacrificial component and is generally not considered in the engineering of the base steel structure assembly. Once assembled to the storage rack above, the entire assembly is anchored to the floor via the front and rear baseplates **70** and **96**.

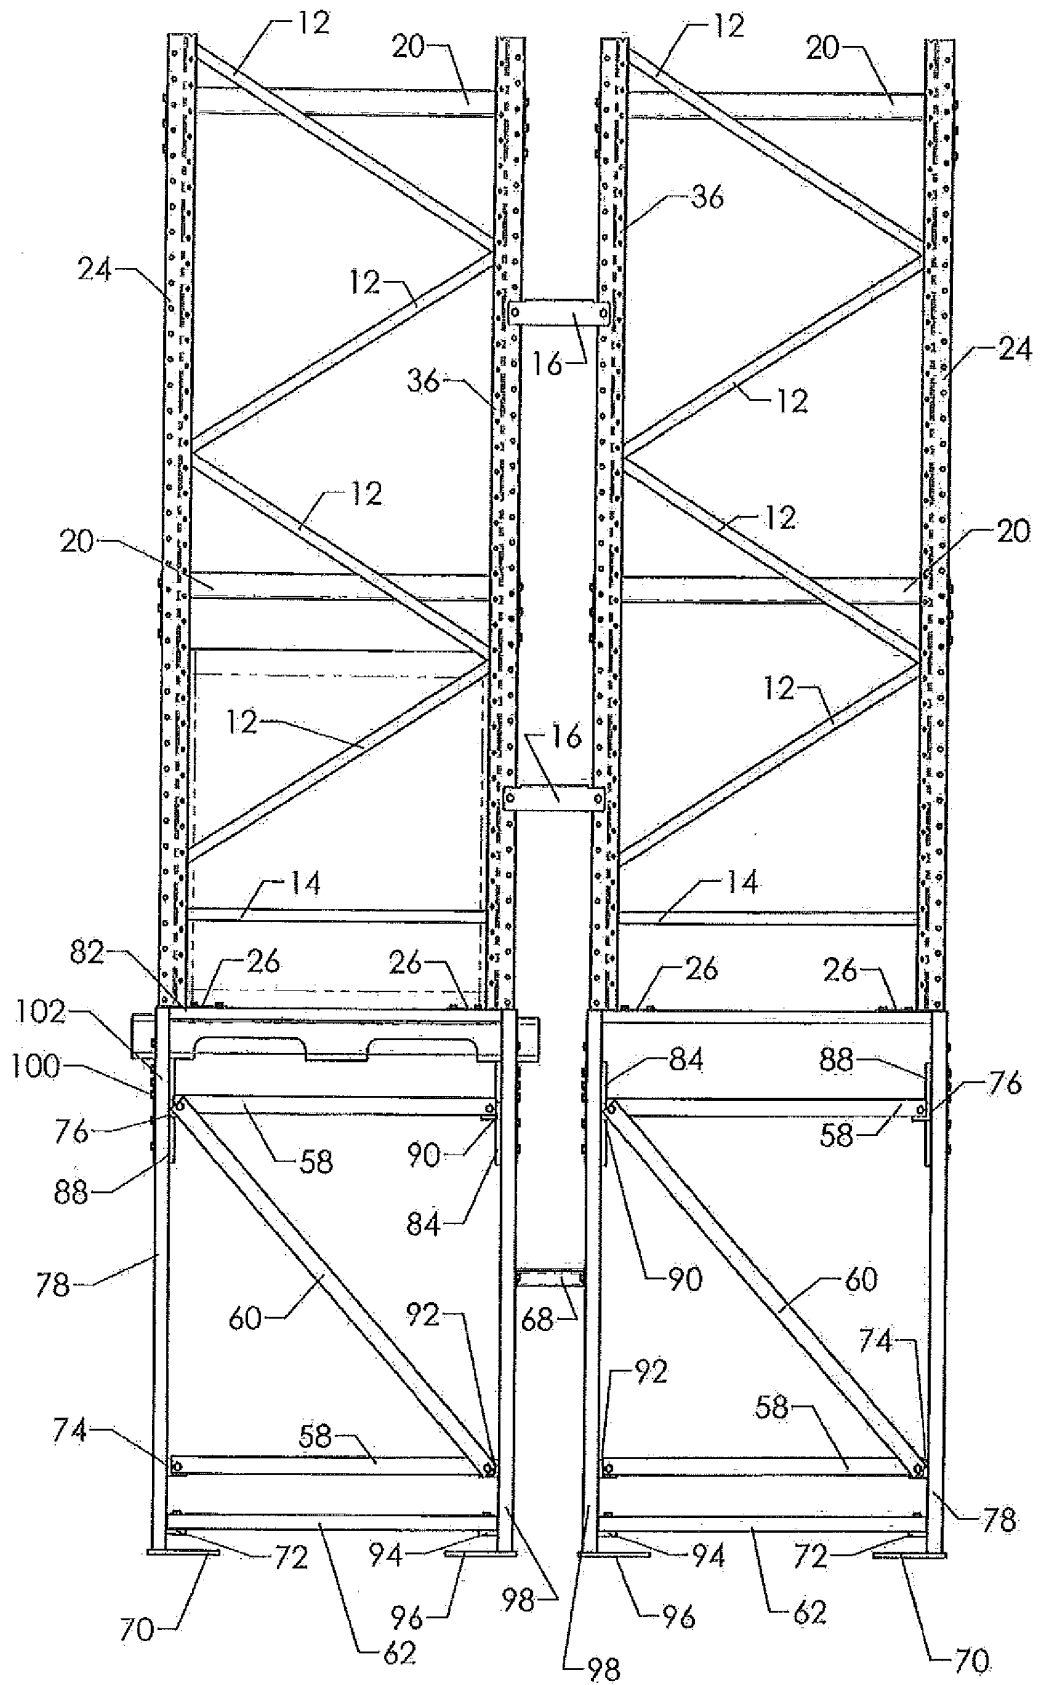
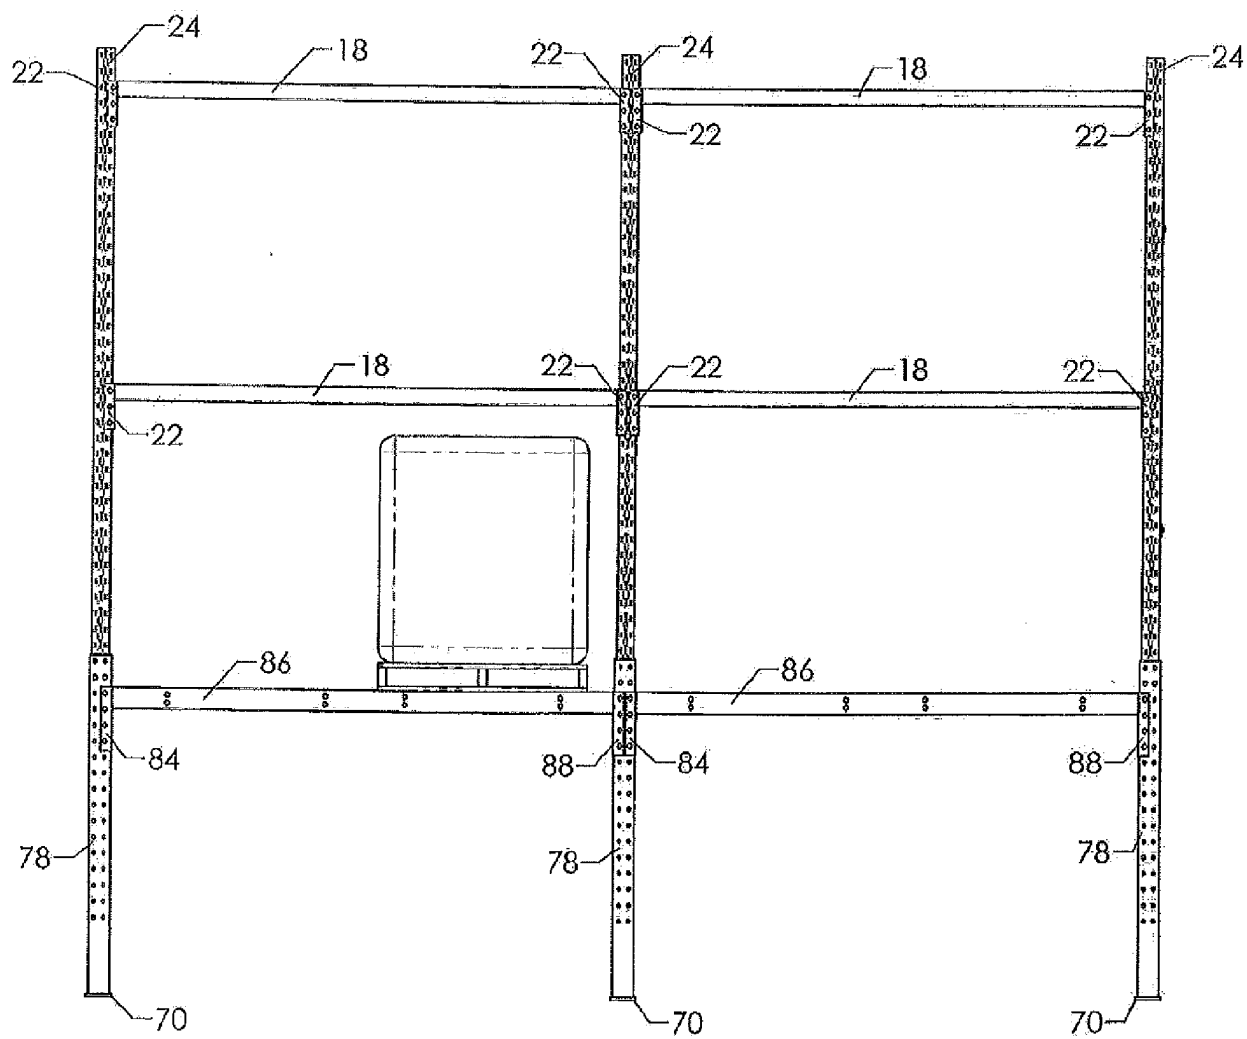
FIG. 6 is a side view of the storage system of FIG. 2;

FIG. 7 is a front view of the storage system of FIG. 2;

**[0036]** FIG. 6 and 7 shows the base steel structure assembly connected to the above storage rack assembly as per the present invention. The front column **78** should terminate above the first load beam **86** as any lower and the lighter column material **24** in the above storage rack would be exposed to damage as it would more than likely fail before the structural material below. The structural bolted angle connectors **84** and **88** which are positioned on either end of the load beam **86**, add further rigidity and durability to the base assembly and greatly restricts the transfer of forces from the MHE further up the column **78**. This design configuration keeps the damage below the top horizontal member **82** in FIG. 5 thus allowing damage components to be replaced without the dismantling of the above storage rack.

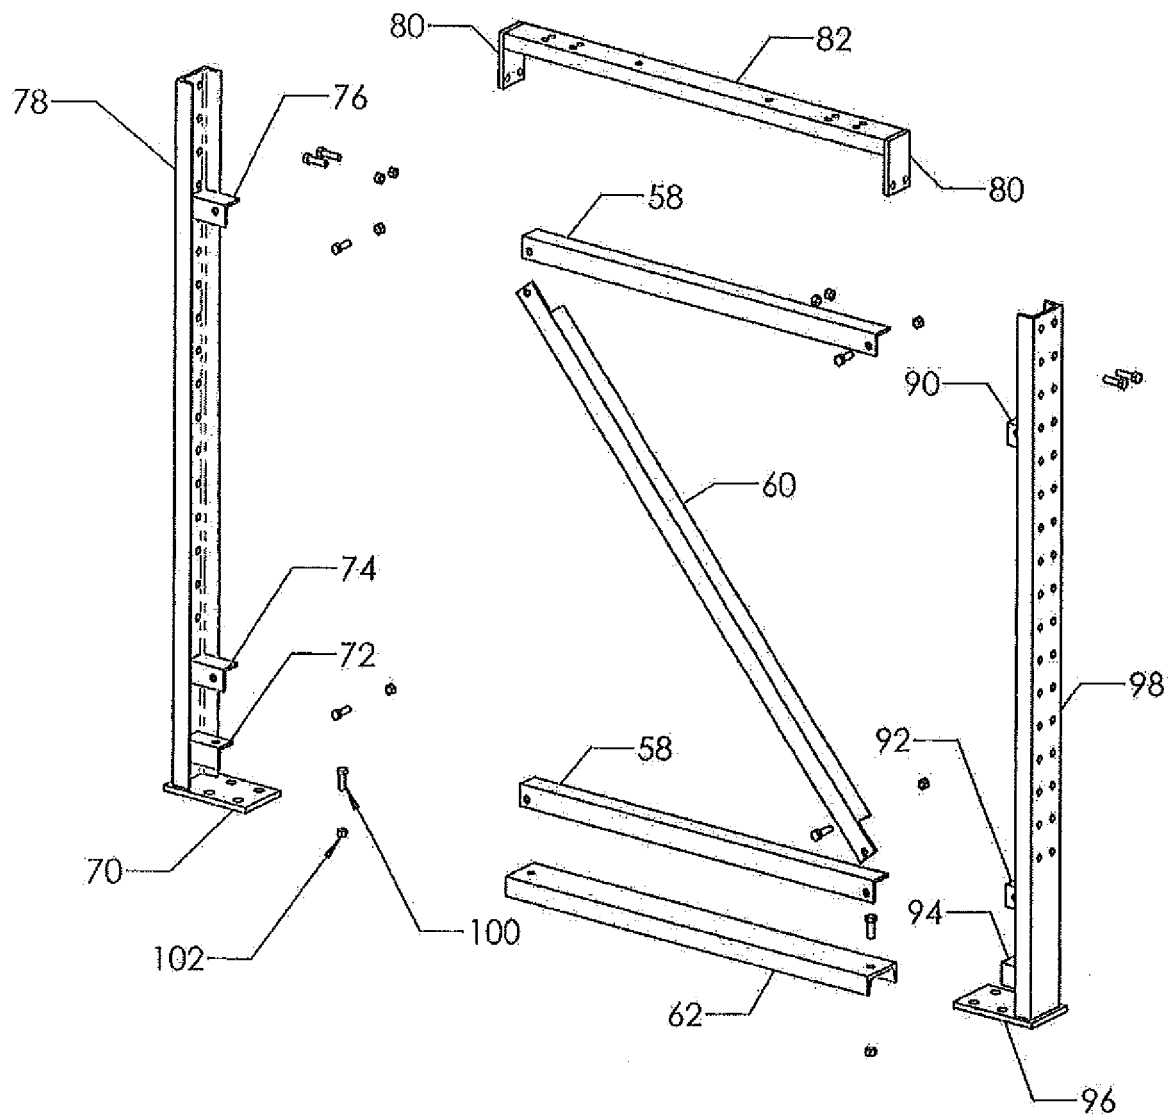
FIG. 8 is a side perspective view of a dismantled base;

**[0037]** FIG. 8 shows the base steel structure assembly completely dismantled or prior to assembly as well as all the locations of the bolt **100** and nut **102** connections. This further shows the ease in which the front column or braces can be replaced in the event of damaged caused by the MHE. This view of the front column **78** further details the tabs **72**, **74** and **76** which may be punched and welded to the web of the column. The plates **80** on either end of the top horizontal channel **82** may be punched and welded to allow for a bolted connection with the front column **78** and rear column **98**. Having the plates **80** welded to the horizontal member **82** allows for the front column **78** to pull away without restriction from the assembly when being replaced due to damage. Having the lower horizontal members **58** and **62** bolted to the front column **78** and rear column **98** allows for them to be installed after the anchoring of the assembly has been completed. This allows for proper alignment of the anchoring hardware as these members **58** and **62** do not impede the vertical alignment of the drilling process.

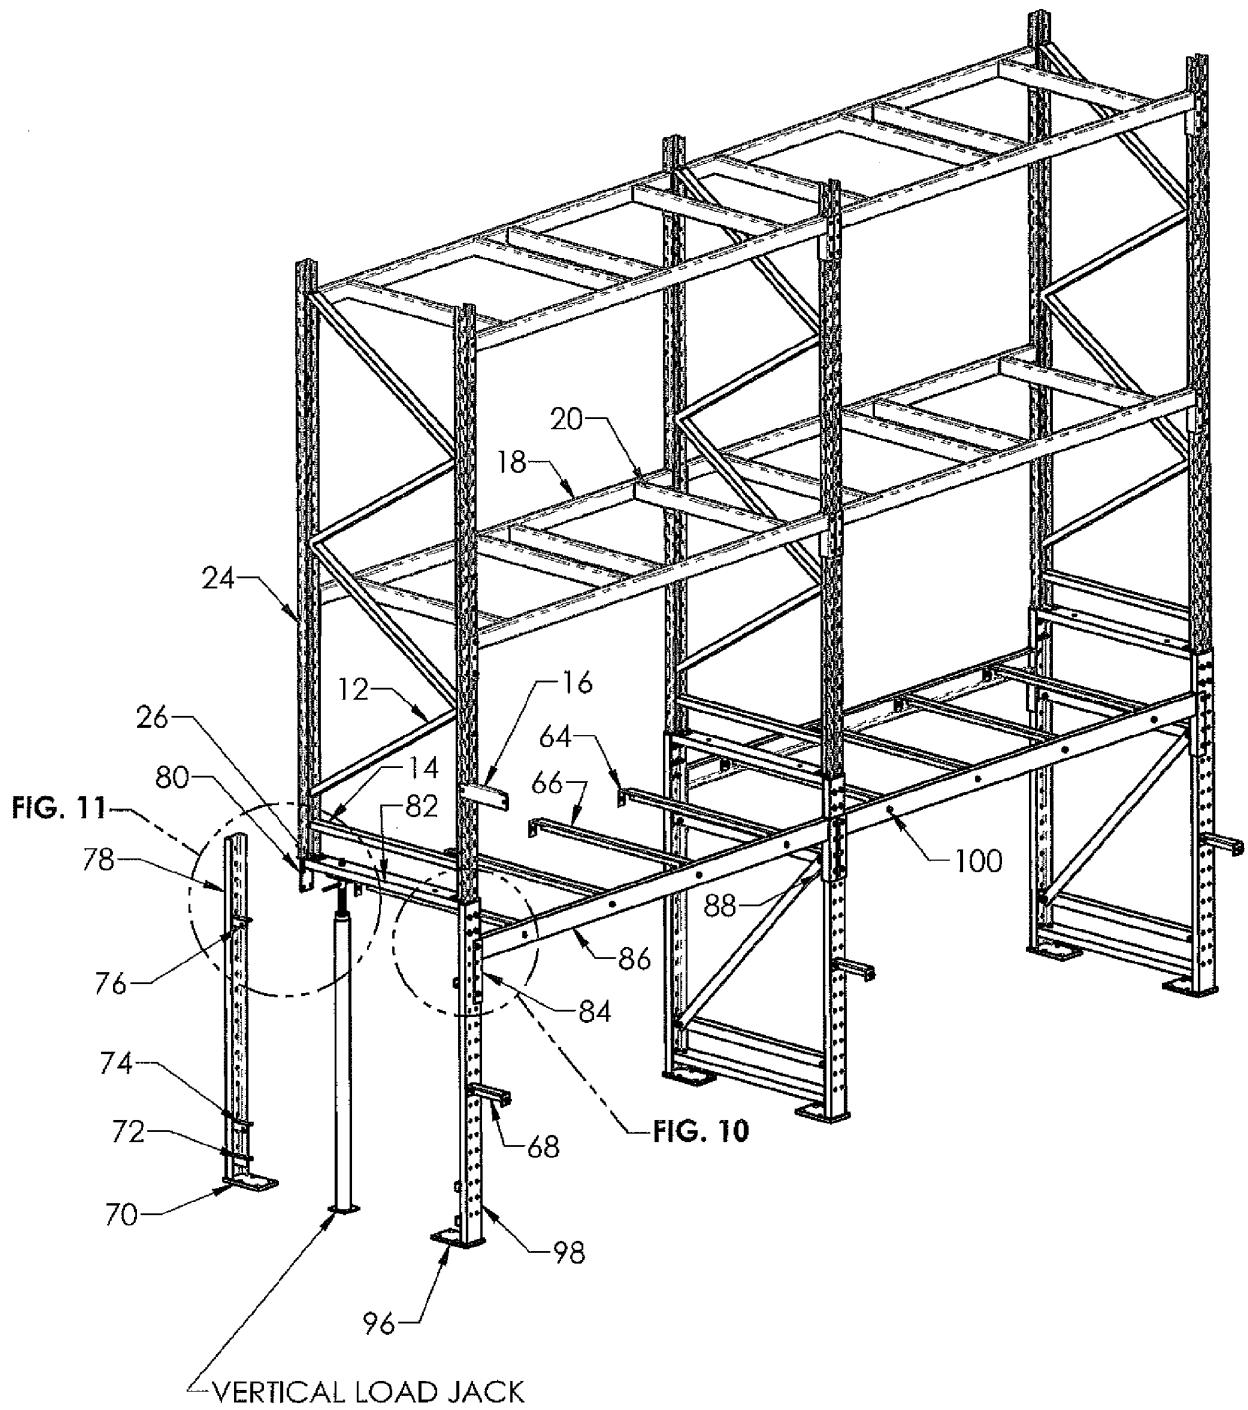
FIG. 9 is a side perspective view of the base being repaired while being supported by the load jack;

**[0038]** FIG. 9 shows the base steel structure assembly's front column **78** under repair. In the event of damage to either the front column **78**, rear column **98**, diagonal brace **60** or horizontal braces **58**, the vertical load jack **200** is installed under the top horizontal member **82** and fastened in place via a nut on the fixed bolt of the jack. The horizontal member **82** has pre-punched hole loca-

tions at either end of the member (FIG. 11) to allow for the bolt from the vertical load jack to be positioned into as an added safety feature. The vertical load jack would then be ratcheted up to pick up the load from the above storage rack and release the shear load on the bolted connections of the base steel structure assembly below. Upon removal of all bolted connections **100**, the damaged component would be simply removed and a new component would be installed with new hardware. The vertical load jack would then be unbolted from the horizontal member **82** returning the above load to the base assembly below.

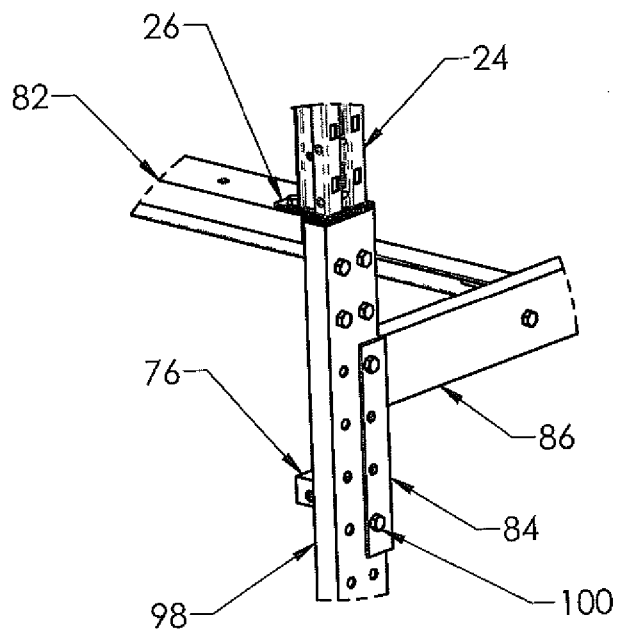
FIG. 10 is an enlarged perspective view of the encircled area 10 in Fig. 9 of the base and above upright connection;

**[0039]** FIG. 10 shows a detail view of the load beam **86** being bolted with bolts **100** through the beam connector **84** to the rear column **98**. The above storage rack rear column **24** is bolted via the rear columns baseplate **26** to the base assemblies' top horizontal member **82**. in the event of a repair to the base steel structure assembly, the top horizontal member **82** remains fixed to the above storage rack.

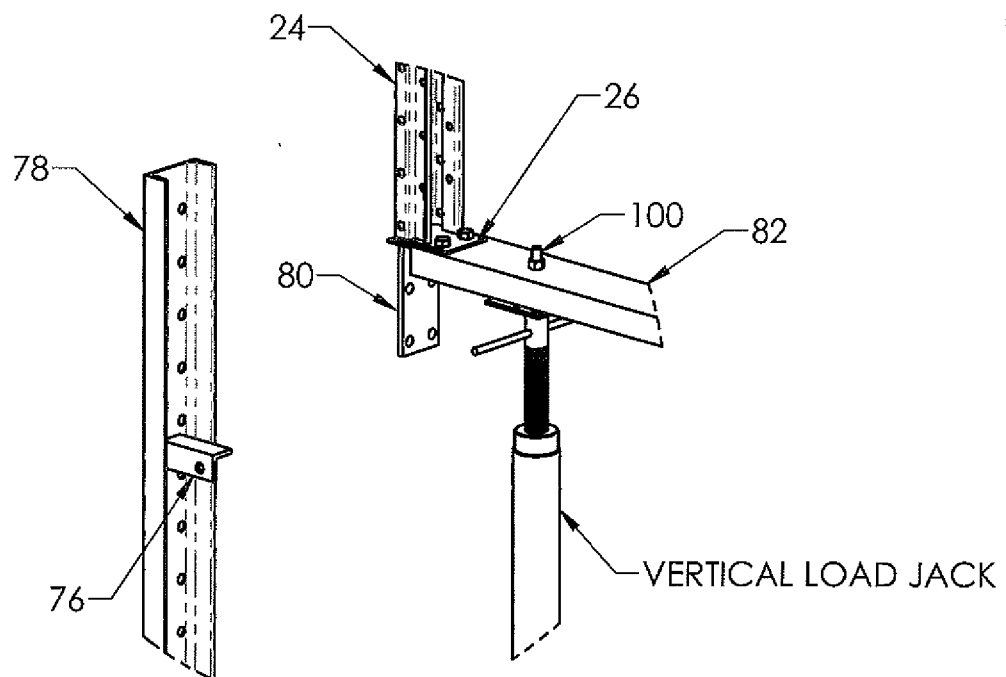
FIG. 11 is an enlarged perspective view of the encircled area 11 in Fig. 9 showing the base and above upright connections as well as a portion of the sub assemblies while under repair;

**[0040]** FIG. 11 shows a detail view of the front column **78** of the base assembly being repaired. The vertical load jack is positioned with the bolt **100** through the top horizontal member **82** for the duration of the repair. The position of the top horizontal member plate **80** is instrumental in allowing the front column **78** to be removed without restriction upon the removal of all hardware. The punched and welded tab **76** has been released from the horizontal brace **58** and diagonal brace **60** by a single bolt connection. The front column **24** and subsequent baseplate **26** remain bolted to the top horizontal member **82** for the duration of the repair thus simplifying the entire process and greatly reducing the high cost associated with a complete dismantle.

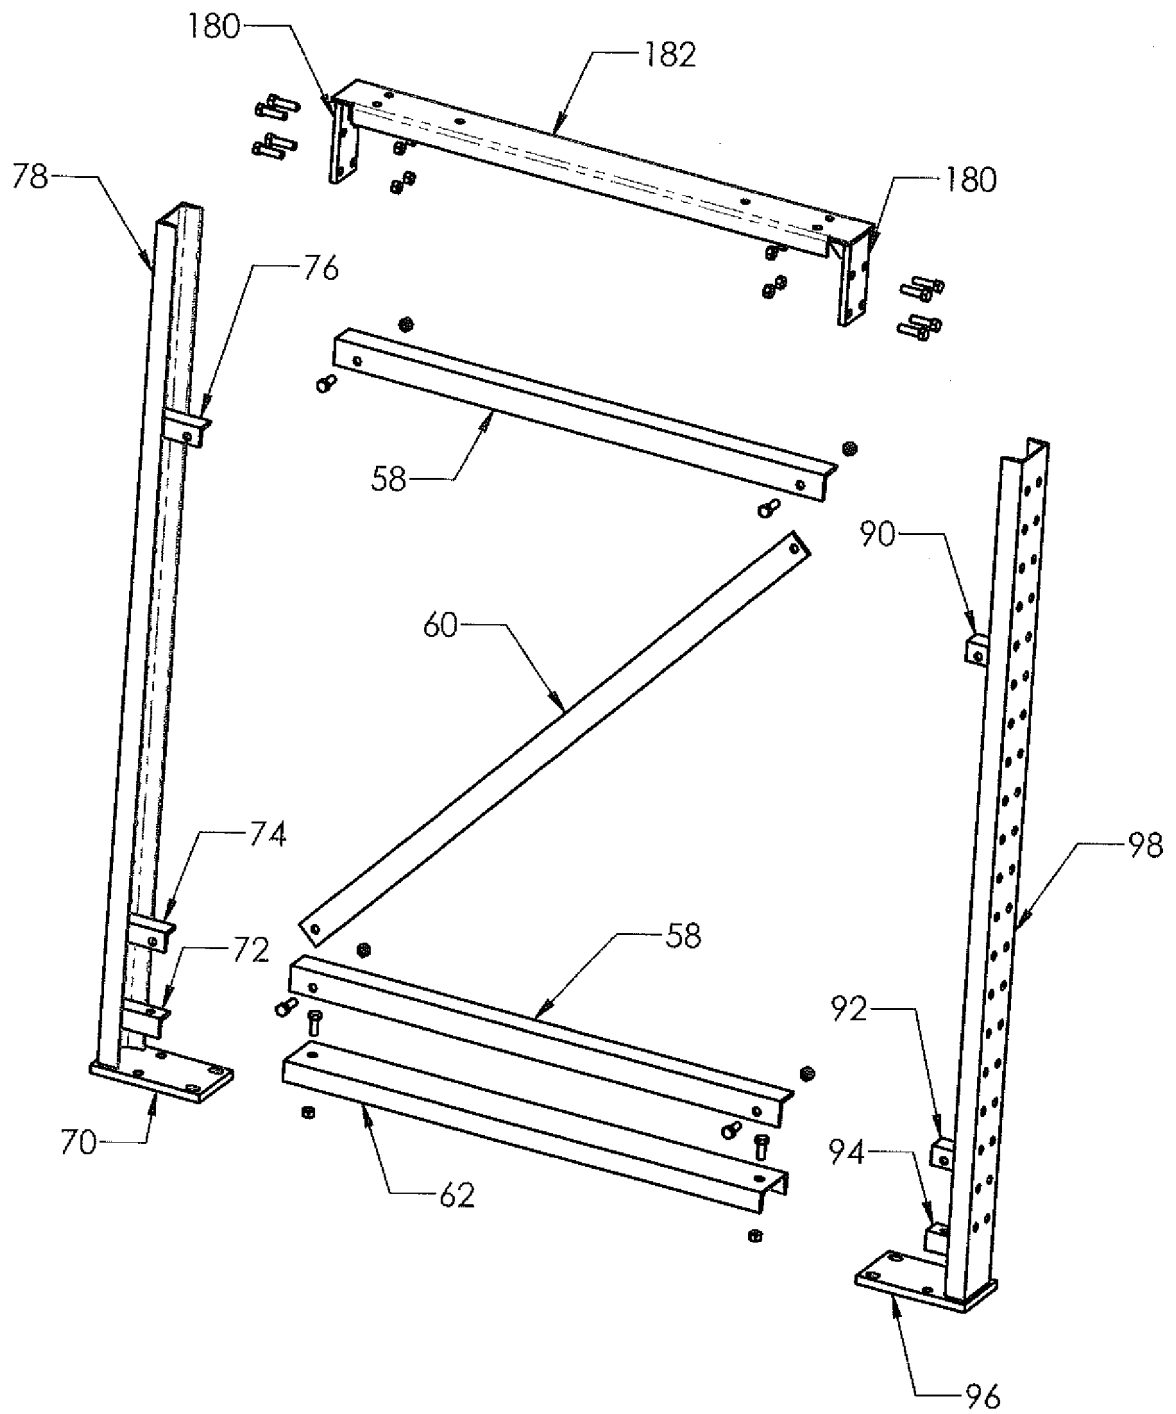
FIG. 12 is a side perspective view of the dismantled base of an alternate embodiment of the storage system; and

**[0041]** FIG. 12 shows the base assembly completely dismantled or prior to assembly with enhancements to the plates **180** and the top horizontal member **182** as compared to prior embodiments **80** and **82**. All else remains the same. By changing the structural material of **182** from channel to (formed and notched) plate, it allows for a wider more stable platform for the upper column **24** and subsequent baseplate **26** to sit on. The wider platform also allows for the acceptance of various baseplate **26** dimensions and anchor locations. The prior narrower embodiment **82** would have required manufacturers to modify their baseplates to suit causing reduced market acceptance and additional costs. Further, the plates **180** which are now welded to the underside of **182** have been slightly recessed from either end of the top horizontal member thus allowing the plate material to extend to the front face of the front column **78** and rear column **98**. This enhancement guarantees that the top horizontal member **182** always sits above the front column **78** and the rear column **98**. Prior embodiments may have allowed for the top horizontal member **82** to rest below the front column **78** and rear column **98** creating unwanted stress on the above baseplates **26**.

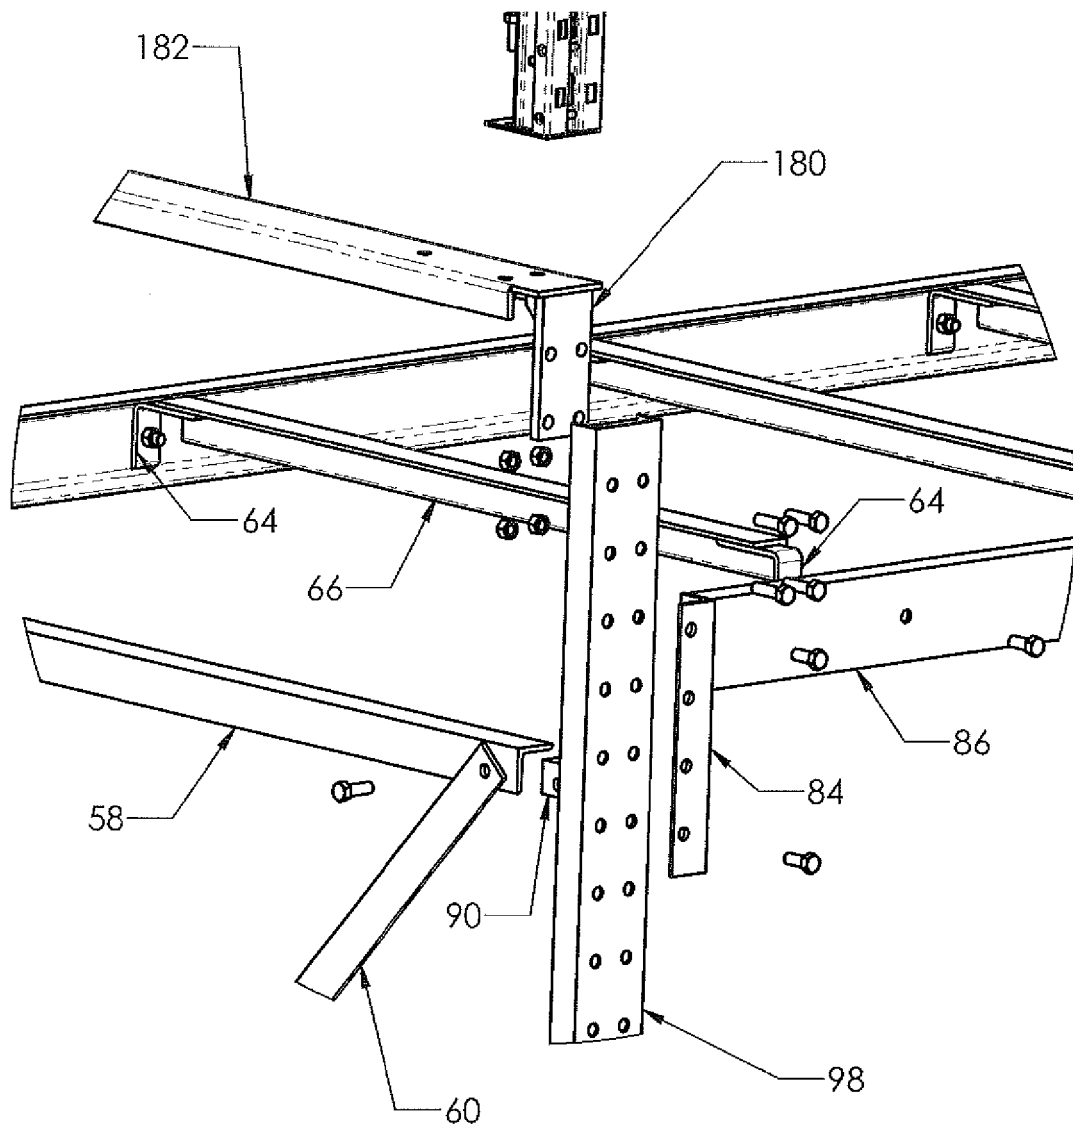
FIG. 13 is an exploded side perspective view of the upper right portion of the base showing an enhanced connection detail.

**[0042]** FIG. 13 shows the base assemblies in an ex-

ploded view for the rear column 98, the enhanced top horizontal member 182, the repositioned plate 180 as well as the horizontal brace 58 and diagonal brace 60. The explanation for enhancements to both 180 and 180 are explained in FIG. 12.
