(12) **United States Patent**
Juarez et al.

(54) **METHOD AND MEANS TO ANALYZE THERMOGRAPHIC DATA ACQUIRED DURING AUTOMATED FIBER PLACEMENT**

(71) Applicant: **United States of America as represented by the Administrator of NASA**, Washington, DC (US)

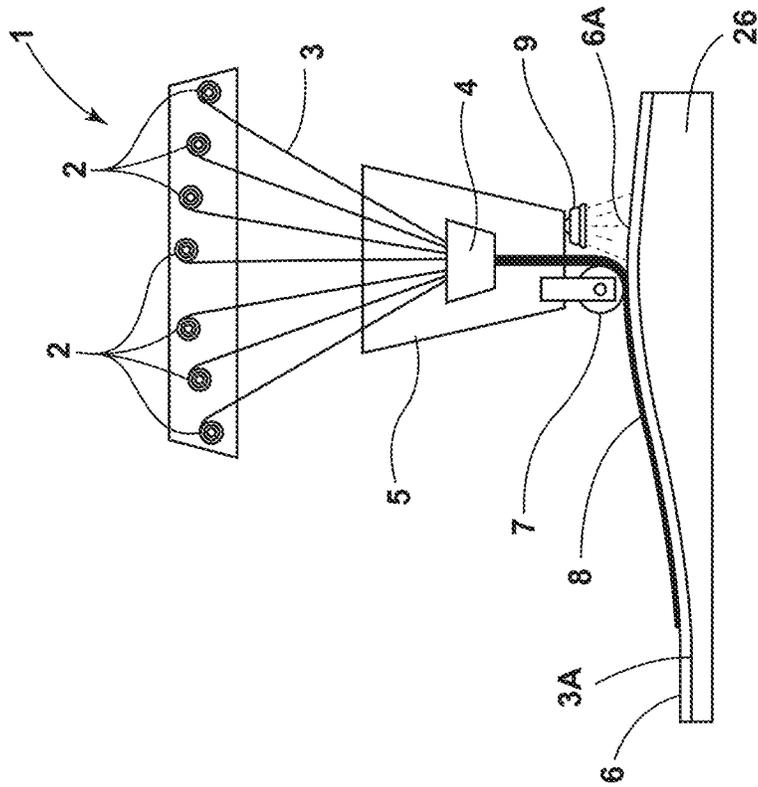
FIG. 1 (PRIOR ART)

With reference to FIG. 1, a known AFP system 1 may include a plurality of spools 2 that feed carbon fiber tape 3 to a collimator 4 of AFP head 5. The AFP head 5 may be mounted on a robotic arm (not shown) that is controlled by a control system to move the head 5 in a predefined manner relative to a substrate 6. An applicator such as a compaction roller 7 compacts and positions a layer of tape 8 onto substrate 6. A heat source such as lamp 9 mounted on AFP head 5 heats a region 6A of substrate 6 before the carbon fiber tape 3 is deposited onto substrate 6. The heating facilitates bonding between the carbon fiber tape 3 that is being applied and the substrate 6. Substrate 6 may comprise layers 3A of carbon fiber tape 3 that have previously been deposited onto a tool 26 corresponding to a surface shape of a finished part that is to be fabricated by the AFP system 1.

FIG. 1 is a schematic view of a prior art automated fiber placement (AFP) device;

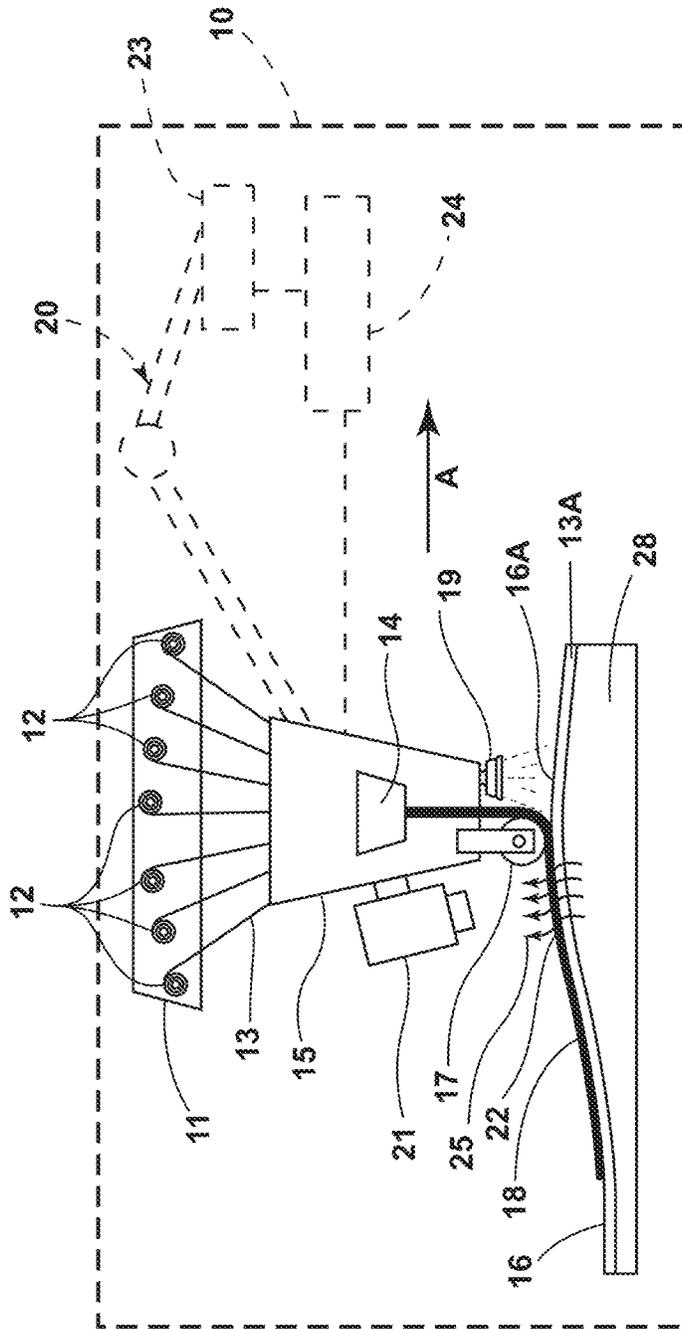
FIG. 2 is a schematic view of an AFP system and infrared camera according to one aspect of the present invention;

With reference to FIG. 2, an automated fiber placement (AFP) system 10 includes a fiber dispensing system 11 that feeds prepreg composite tape 13 to a movable head 15 from spools 12. The tape 13 may comprise prepreg carbon fiber tape or other tape as required for a particular application. The head 15 may include a collimator 14 and applicator such as compaction roller 17 that positions a layer 18 of tape 13 onto a substrate 16 that has been heated by a heat source such as a lamp 19. An infrared (thermal) camera 21 may be mounted to the head 15 to capture thermal image data from surface 22 of layer 18 immediately after the layer 18 is deposited onto heated surface 16A of substrate 16. Thermal camera 21 may comprise an FLIR A65, which uses an uncooled microbolometer sensor to capture 14 bit linear

The AFP system 10 may include a robotic arm 20 having a base 23. The head 15 is mounted to robotic arm 20, and a controller 24 may be programmed to cause robotic arm 20 to move head 15 relative to substrate 16 along a plurality of predefined paths to thereby position the composite tape according to a predefined design or configuration. During operation, the head 15 may move relative to substrate 16 in the direction of the arrow “A.” The substrate 16 may be stationary relative to robotic arm 20, or the substrate 16 may be movable (e.g., rotatable) relative to the robotic arm 20. The robotic arm 20 comprises a modified industrial robotic arm that is movably mounted on a linear track (not shown) whereby the base 23 of robotic arm 20 travels along a horizontally linear path relative to substrate 16. The robotic arm 20 may comprise an existing robotic arm developed for the Integrated Structural Assembly of Advanced Composites (ISAAC) project. However, it will be understood that various automated fiber placement (AFP) systems have been developed, and the present invention is not limited to a particular AFP device or system.

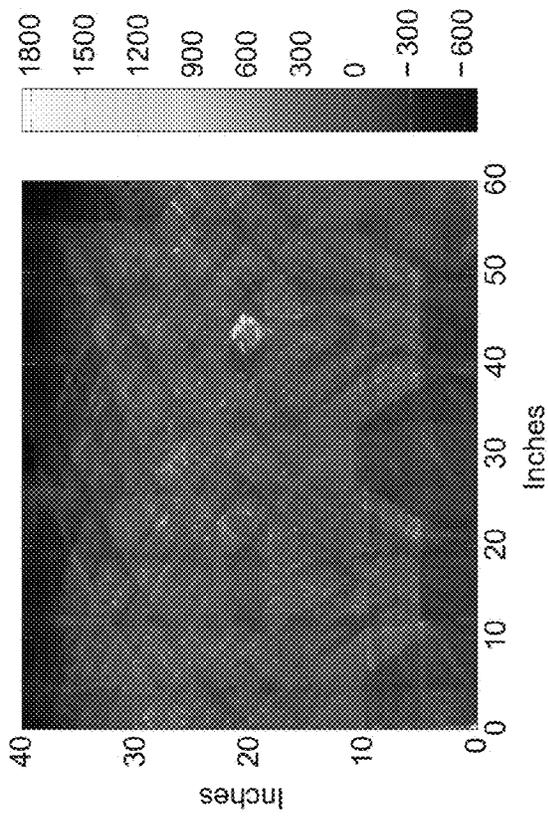
FIG. 3A is an image showing temporally aligned (“composite”) in situ thermography data, showing deviation from an expected value before a debulking cycle;

FIGS. 3A and 3B are temporally aligned images showing deviation from an expected value for a composite structure. FIG. 3A shows the deviation from the expected value prior to a debulk process, and FIG. 3B shows the deviation from the expected value post-debulk.

Comparing FIGS. 3A and 3B, it is apparent that the number of hot spots is reduced significantly post debulk. Most notably one of the build up patches on the part (the yellow region at about 40, 20 inches) appears to be a very hot in FIG. 3A prior to debulk, implying it has very poor adhesion with the substrate prior to debulking. This spot completely disappears after debulk (FIG. 3B).

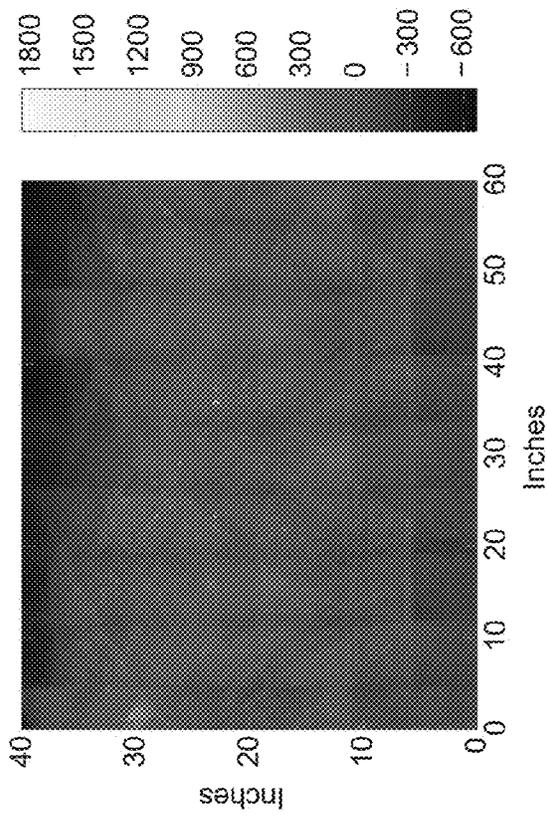
FIG. 3B is an image showing temporally aligned in situ thermography data, deviation from an expected value after debulking cycle;

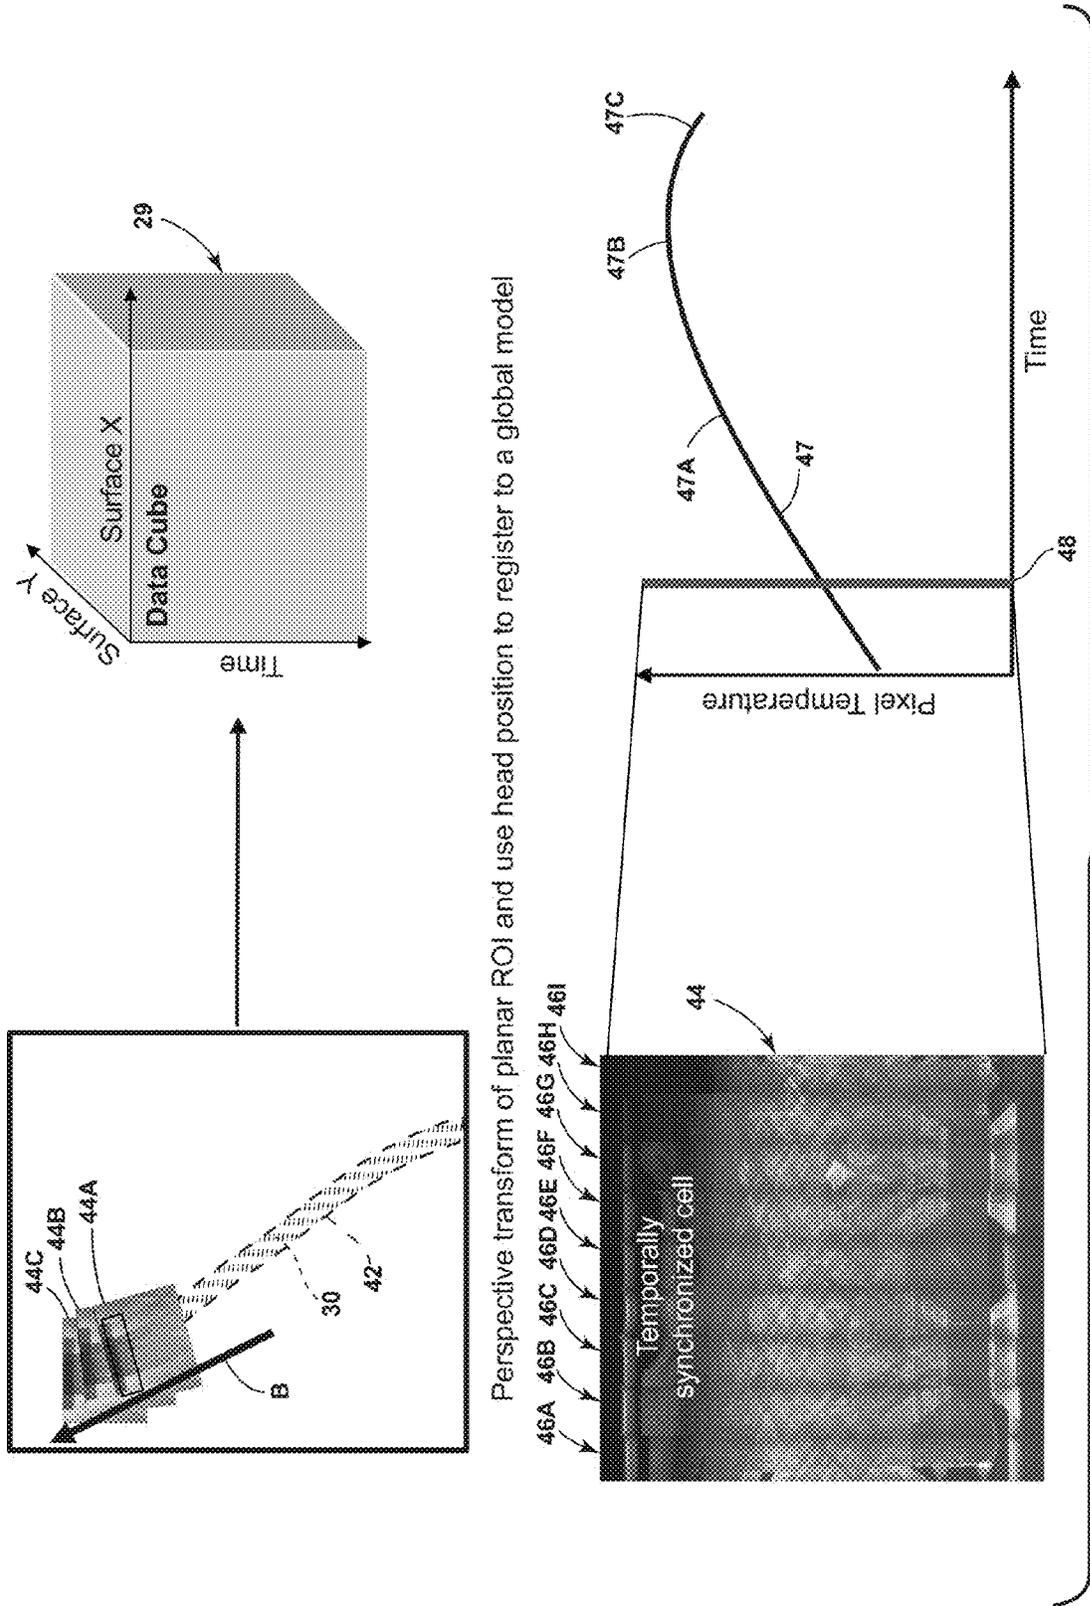
FIG. 3C is a post cure thermal line scan of a part, wherein the data is temporally aligned and spatially registered;

In order to establish a relationship with post-cure part quality thermal line scan data of a composite structure may be collected after cure. This process does not necessarily require use of an AFP system. For example, in one test this scan was completed in a laboratory where the composite structure (a cylinder) was placed in a rig that rotated the cylinder at a constant speed. A thermal camera was placed at various positions along the length of the cylinder, and the thermal camera collected data for a complete rotation. The part was heated by a line source located below the thermal camera. FIG. 3C shows the temporally aligned and spatially registered data for part of the length of the cylinder (the cylinder is not the same part used to generate FIGS. 3A and 3B). This data (FIG. 3C) is not deviation from the expected value; it is raw counts. Brighter areas may be areas where the laminate is thinner or areas where heat is not being conducted through the thickness as efficiently as darker areas. Likewise, areas that are darker may be thicker. The bright yellow "X-like" areas in the lower half of FIG. 3C (and less obviously, in the upper half) correspond to the areas between tow-steered plies that are thinner. There also appears to be some overlap of tow-steered plies or thickening of those plies at the edges of a course. This may be the result of tow peel-up. One feature that was not observed in the pre-cure data was the strip of varying width (outlined by a blue box) on the left side of FIG. 3C. This strip of lighter areas may be from a helical ply.

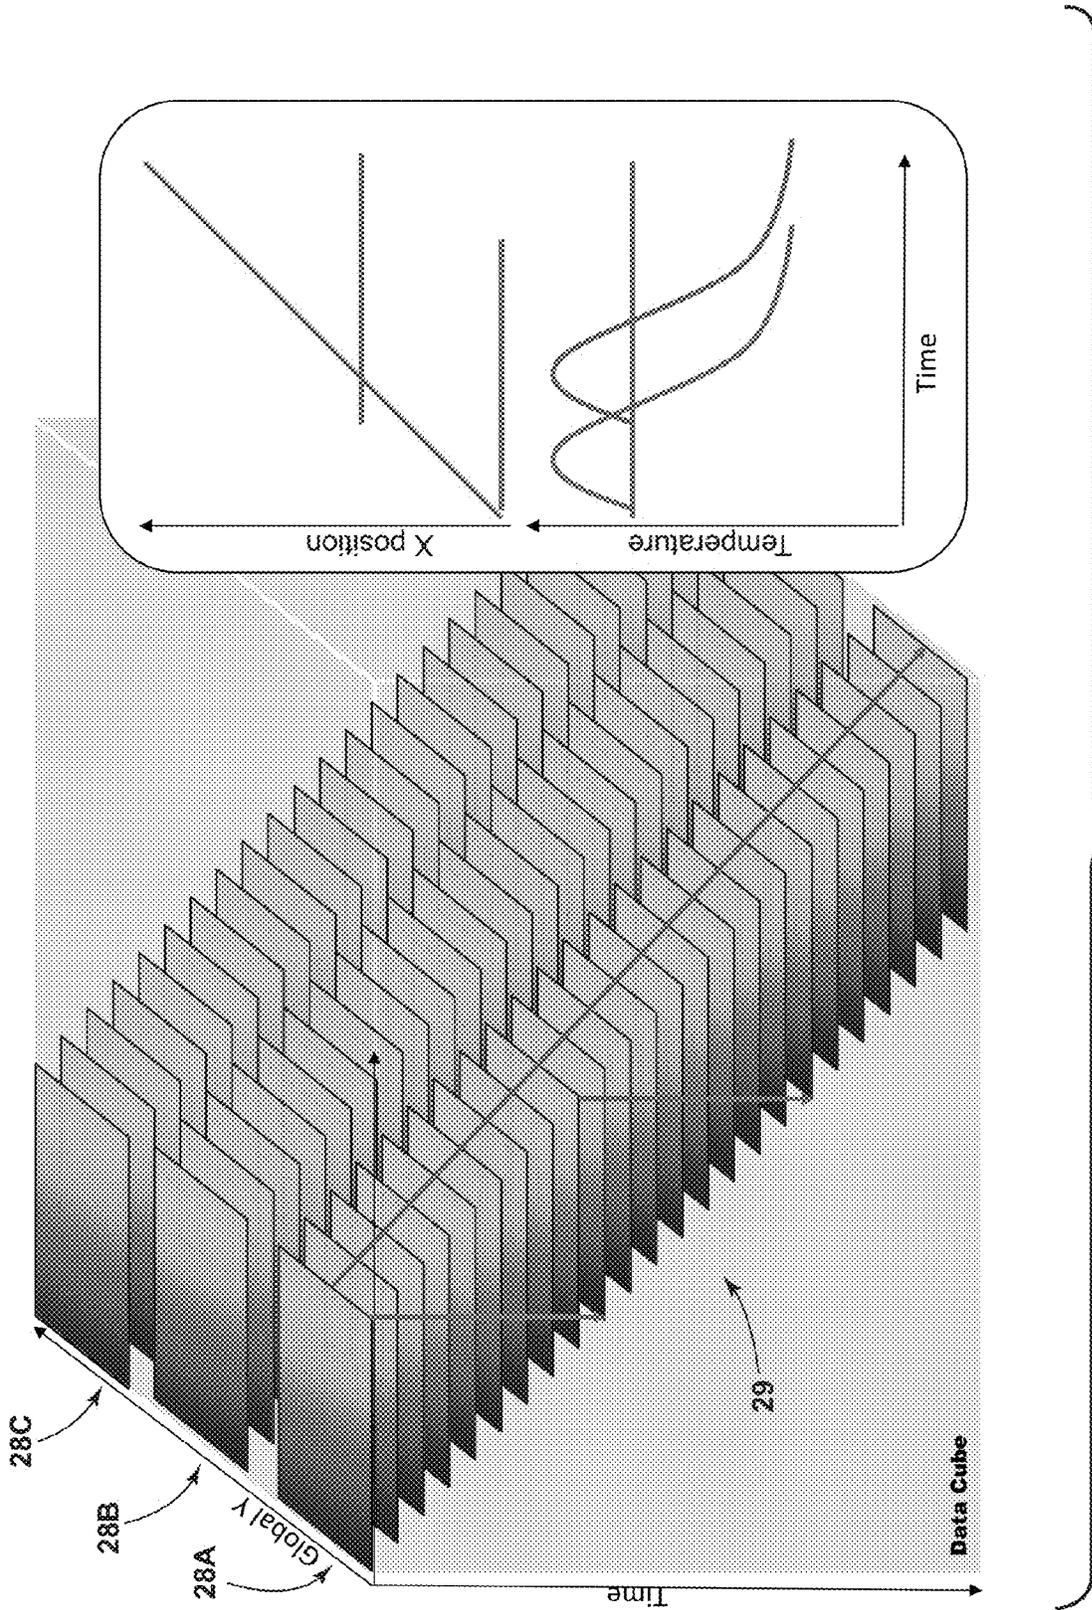
FIG. 4A is an isometric schematic view of an AFP system, infrared camera, and image data;

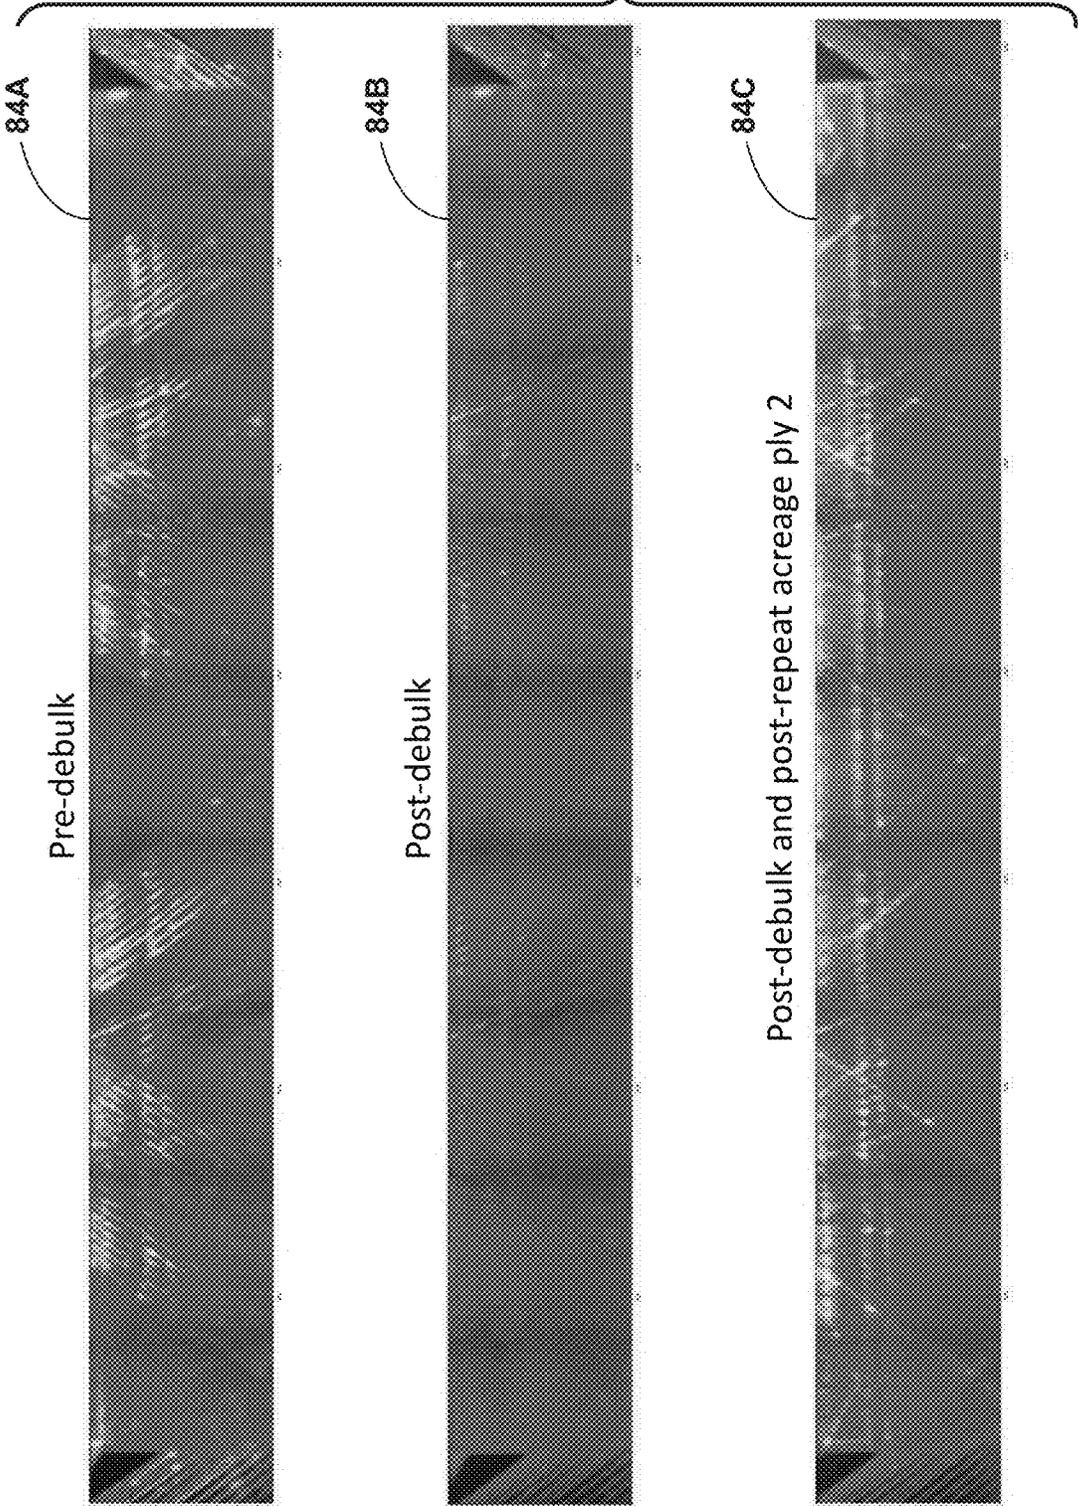
FIG. 12 comprises temporally aligned thermographic image data from FIGS. 9, 10, and 11 for a composite structure pre-debulk, post-debulk, and post-repeat acreage ply 2; and

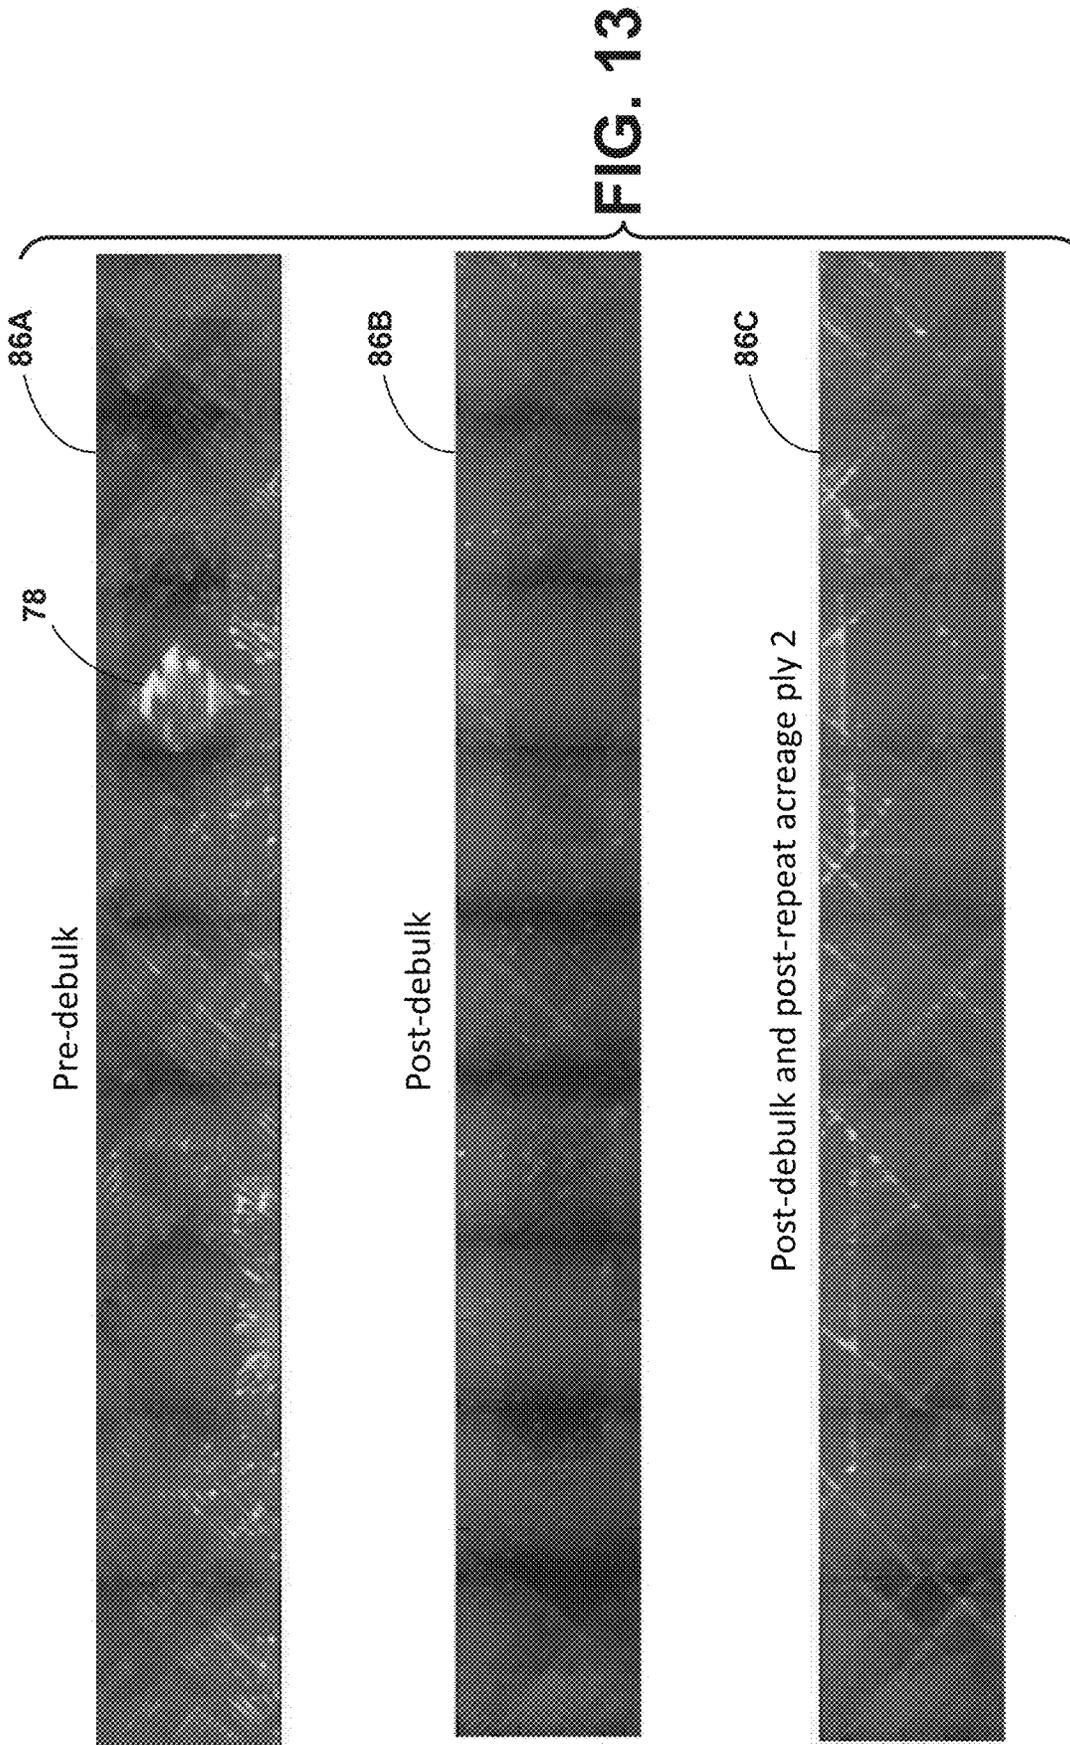
FIG. 13 comprises temporally aligned thermographic image data for a composite structure pre-debulk, post-debulk, and post-repeat acreage ply 2.

With further reference to FIG. 13, a thermal image 86A was generated pre-debulk as prepreg tow was being applied. Thermal image 86B is the same area of a composite structure after a debulk procedure. As discussed above in connection with FIGS. 9 and 10, a bright spot 78 in thermal image 86A corresponds to a region or patch of material that disbanded from the substrate when new material was laid over it. The pressure and direction of the roller 17 may cause it to ‘bunch

up’ and disbond (lose adhesion), resulting in a defect due to poor adhesion. Image 86B shows that the defect was eliminated by the debulking process. Thermal image 86C shows the same surface region of a composite structure post-debulk and post-repeat acreage ply 2. The images show that the debulk cycle reduced the areas of poor adhesion, except in areas where poor adhesion is expected as a result of geometry.
