(12) **United States Patent**
Loy et al.

(54) **USING THERMAL IMAGING TO PREVENT LOSS OF STEAM TURBINE EFFICIENCY BY DETECTING AND CORRECTING INADEQUATE INSULATION AT TURBINE STARTUP**

(73) Assignee: **General Electric Company**, Schenectady, NY (US)

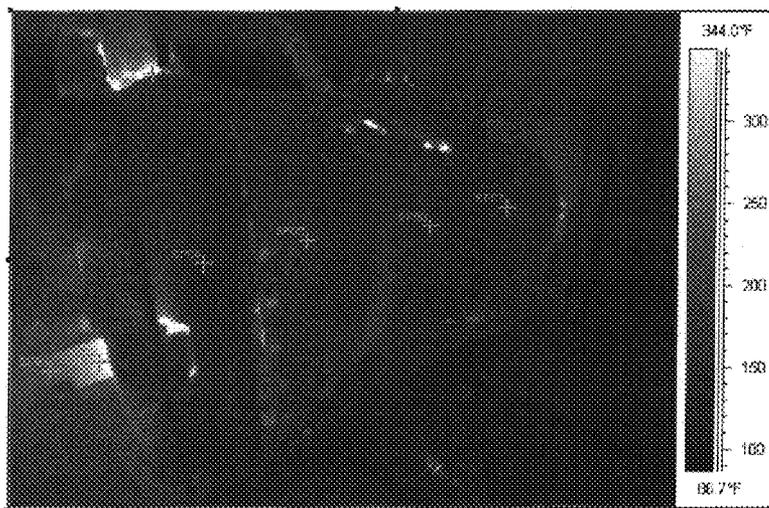
The invention involves the use of thermal imaging equipment to take infrared images of a steam turbine during start-up. The exterior temperatures developed from the infrared images are correlated with turbine vibration data to determine which insulation temperature patterns reflect insulation poor enough to cause packing seal teeth to rub and the turbine to vibrate during operation or shut-down. From the thermal images and vibration data, control limits are developed for insulation surface temperature. Insulation is added, before the steam turbine is shut down, in accordance with the obtained data and control limits.

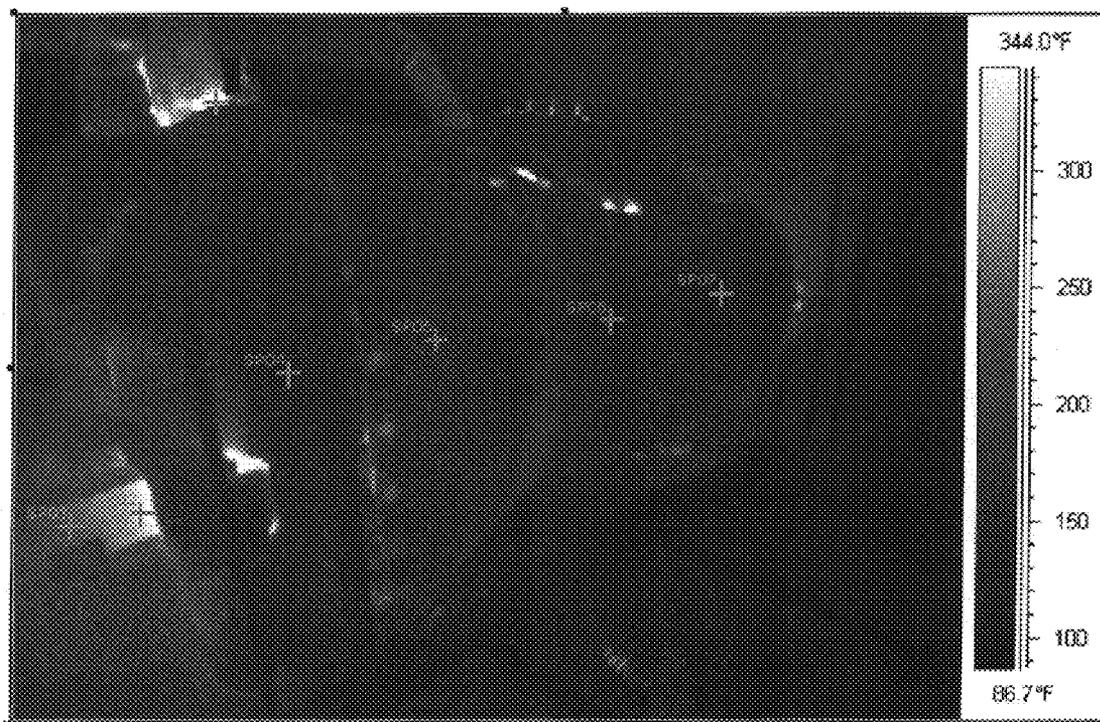
Figure 1

FIG. 1 is an example of an infrared image of a steam turbine taken during start-up by digital thermal imaging equipment.

Vibration data is frequently acquired during steam turbine startup. FIG. 1 shows an example of an infrared image taken of a steam turbine with new insulation, by digital thermal imaging equipment, and which can then be used in conjunction with acquired vibration data. As shown, in FIG. 1, location SP02 reflects a temperature more than 200° F. hotter than location SP04.
