(10) **Patent No.:** **US 11,490,456 B2**
(45) **Date of Patent:** **Nov. 1, 2022**

(54) **AUTOMATIC ANALYSIS AND WARNING METHOD OF OPTICAL CONNECTION BETWEEN BBU COMBINATION AND RRU OF RADIO STATION**

(71) Applicant: **VIETTEL GROUP**, Ha Noi (VN)

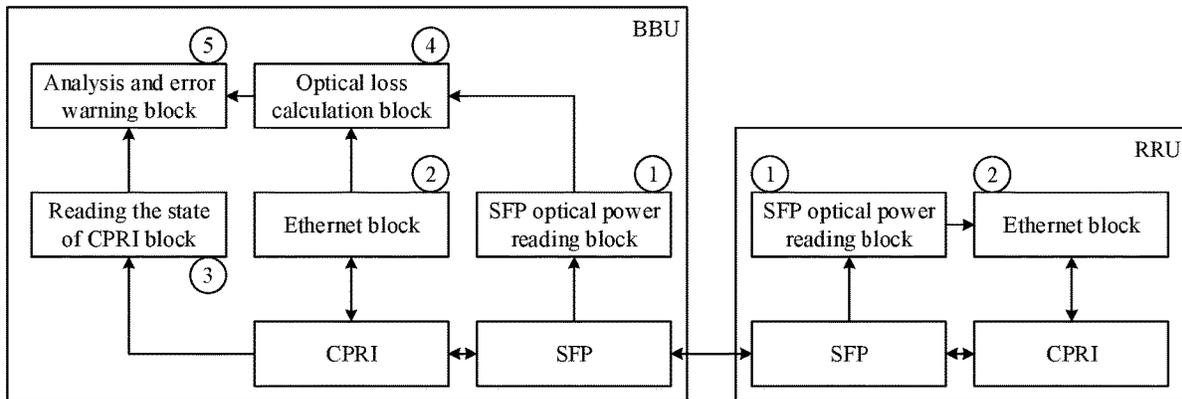
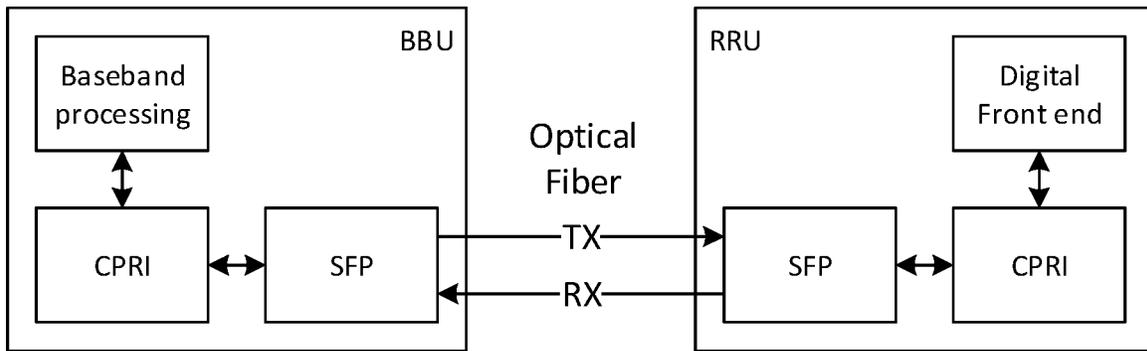
Figure 1

FIG. 1 depicts a radio reception station using CPRI and optical transmission.

FIG. 1 illustrates a conventional radio base station, consisting of 2 main components: BBU and RRU. These two components are connected to each other via the CPRI interface standard, with the transmission device being the fiber optic cable and the SFP module. Fiber optic cable consists of 2 fibers, 1 fiber transmits signals from BBU to RRU, 1 fiber transmits signals from RRU to BBU. SFP modules consist of a transmit (TX) and a receive (RX) port. The RRU is installed on high poles and is several tens of meters to tens of kilometers away from BBU. Therefore, when optical connection failure occurs, it will take engineers who operate the system to find and correct the error.

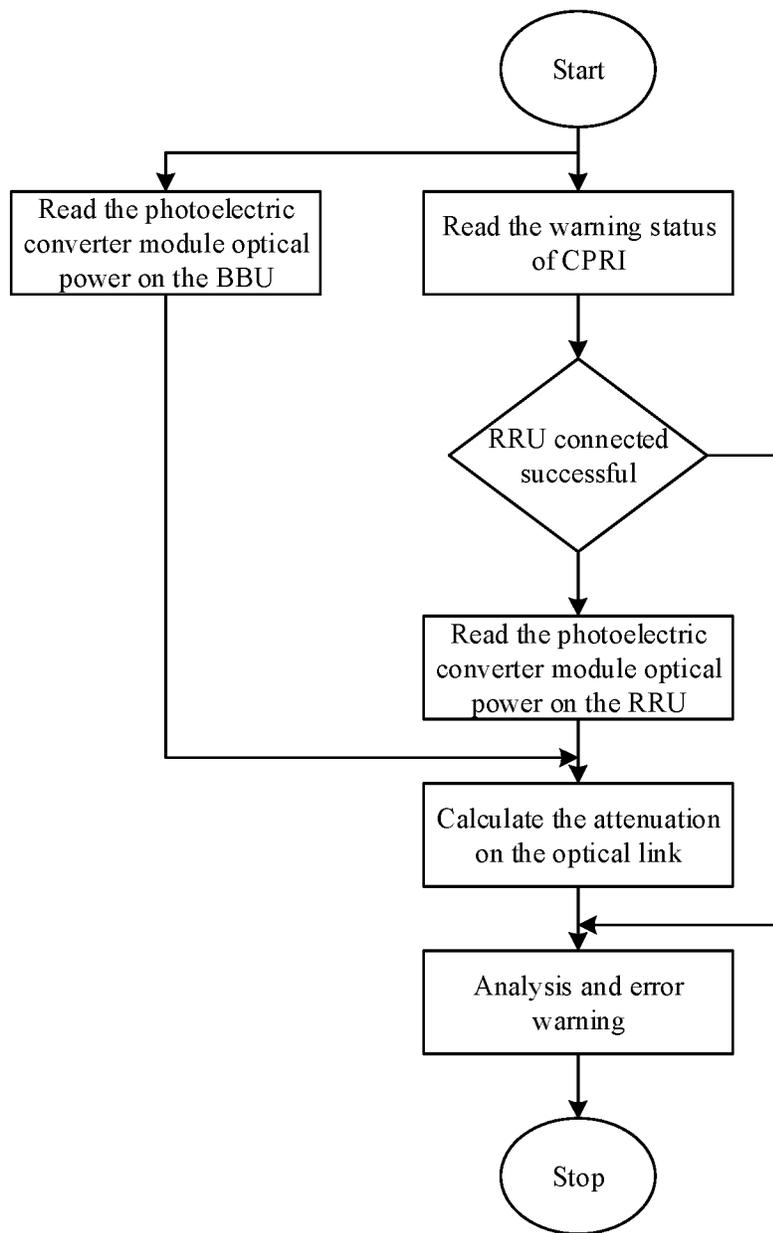
Figure 2

FIG. 2 shows a flowchart of the implementation steps of the AWOT method according to the invention.

The following section describes in detail the method of automatic analysis and warning of optical connection status between the BBU unit and the RRU unit in the radio base station. As shown in FIG. 2, the AWOT method under the invention includes the following 5 steps:

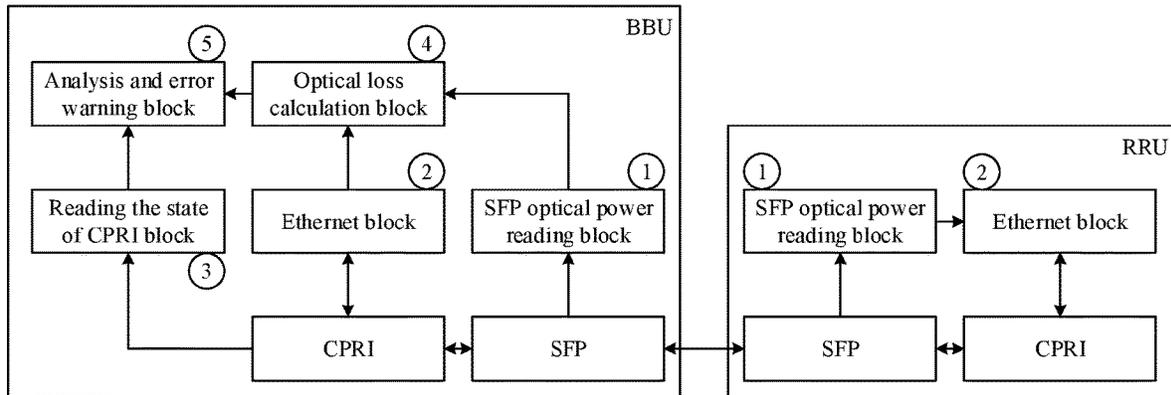
Figure 3

FIG. 3 shows a drawing of a radio base station using the AWOT method.

As shown in FIG. 3, when integrated into BBU and RRU, the system adopts the AWOT method consisting of the following 5 processing blocks:

- SFP optical power reading block;
- Ethernet communication block;
- Reading the state of CPRI block;
- Optical loss calculation block;
- Analysis and error warning block.
