[11] Patent Number: **5,475,246**

[54] **REPAIR LINE STRUCTURE FOR THIN FILM ELECTRONIC DEVICES**

[73] Assignee: **General Electric Company**, Schenectady, N.Y.

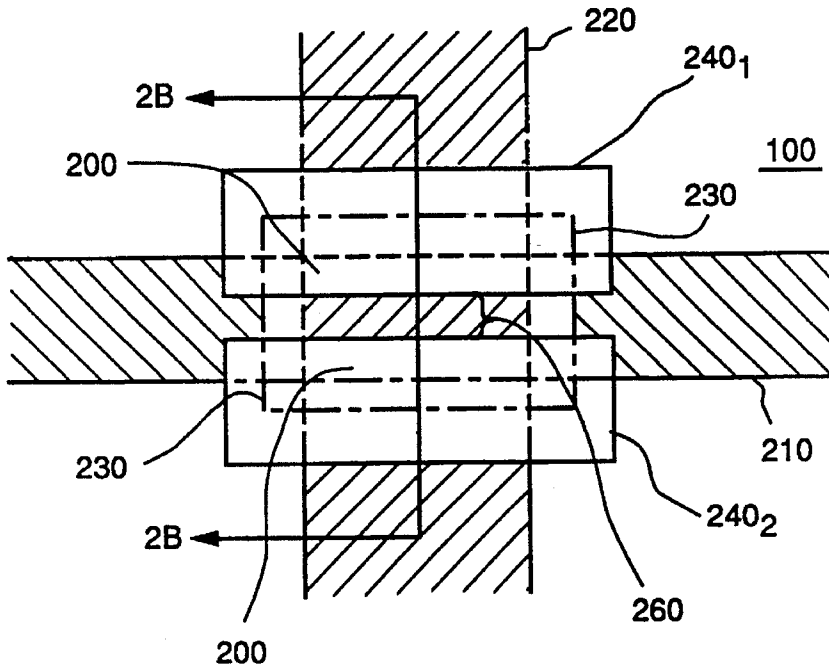
FIG. 2(A) is a plan view of a repair crossover area in accordance with one embodiment of the present invention.

In accordance with this invention, a first protective layer 240₁ and a second protective layer 240₂ are disposed on the upper conductive lines (e.g., the auxiliary lines 115, 120) in each repair crossover region 200 (FIG. 2(A)) in an imager device. As used herein, "repair crossover region" refers to the position in the photosensor array at which an auxiliary line is in vertical alignment with an underlying scan line, or alternatively, an auxiliary line is in vertical alignment with an underlying extension shunt 107 of a data line. As the basic structure is the same for each repair crossover region in the device, for purposes of illustration in FIGS. 2 the underlying, that is, scan line, is referred to as a first conductive line 210, and the overlying, that is, auxiliary line, is referred to as a second conductive line 220.

In the plan view of FIG. 2(A), a semiconductor material island 230 is disposed between first conductive line 210 and second conductive line 220. The typical width of first conductive line 210 is in the range between about 10 μm and 30 μm , and the typical width of second conductive line 220 is between about 10 μm and 30 μm . Semiconductor material island 230 typically is substantially centered on repair crossover region 200 and has dimensions in the range between about 20 μm by 20 μm to 50 μm by 50 μm , such that

the lateral boundaries of semiconductor material island 230 extend beyond the area of vertical alignment of first and second conductive lines. First and second protective layers 240₁, 240₂, are disposed on respective sides of second conductive line 220 so as to leave a repair area 260 therebetween in the crossover repair region 200 in which second conductive line 220 is in vertical alignment with first conductive line 210. Repair area 260 provides an area sufficient to effect the laser welds, typically having an area between about 100 μm^2 and 1000 μm^2 . To facilitate welding, it is desirable that the material comprising protective layers 240 not be disposed in repair area 260. In repair of an imager device, usually about 3 welds having a dimensions of about 10 μm^2 each are desired to ensure satisfactory electrical contact between the first and second conductive lines.

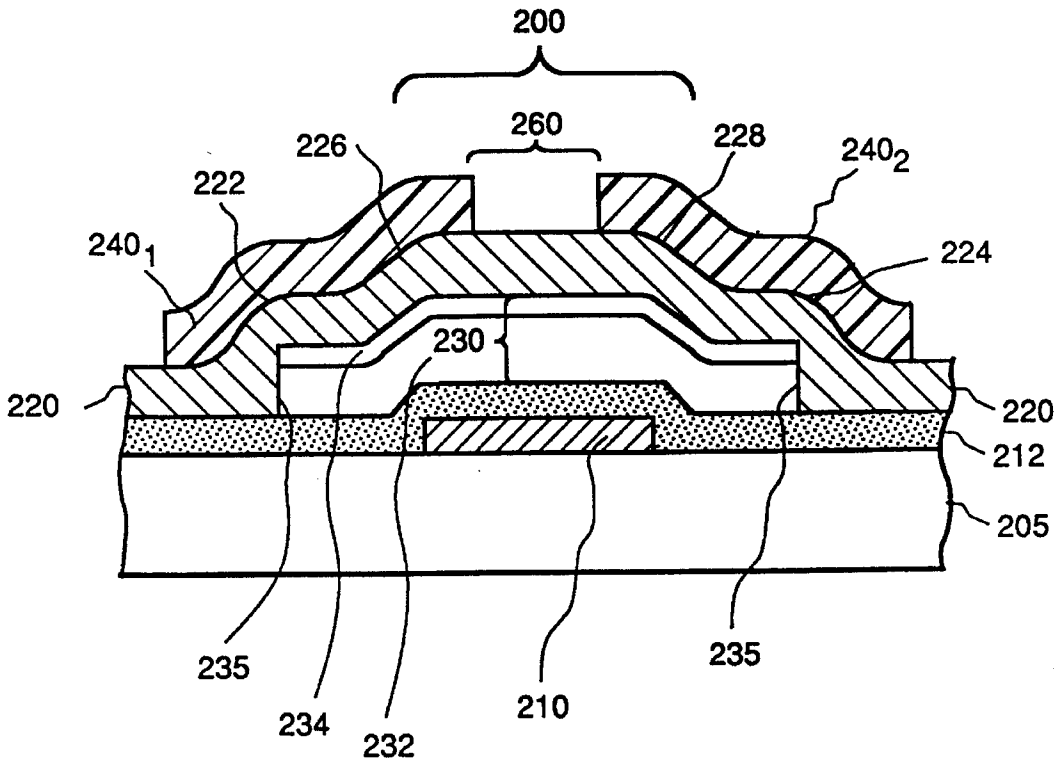
FIG. 2(B) is a cross sectional view of a repair crossover area taken along lines 2B—2B of FIG. 2(A).

FIG. 2(B) presents a cross-sectional view along the lines 2B—2B of the portion of imager device 100 illustrated in FIG. 2(A). First conductive line 210 is disposed on a substrate 205, comprising glass or the like. First conductive line comprises a conductive material such as chromium, molybdenum, titanium, aluminium, or the like. A dielectric layer 212 is disposed over first conductive lines 210 and typically comprises an inorganic dielectric material such as silicon nitride, silicon oxide, a combination of these material, or the like.

Semiconductor material island 230 is commonly disposed over first conductive line 210 in the vicinity of repair crossover region 200 and comprises semiconductor material of the type used in the fabrication of TFTs in the photosensor array (thereby enabling the semiconductor material island to be deposited and patterned simultaneously with the formation of the TFTs). Semiconductor material island 230 typically comprises a first layer 232 of intrinsic amorphous silicon, and a second layer 234 (in the regions underlying second conductive line 220) of amorphous silicon doped to exhibit n type conductivity. In regions of semiconductor material island 230 that do not underlie second conductive line 220, doped silicon layer 234 is typically removed as a result of processing steps in the fabrication of the photosensor array.

Second conductive line 220 is disposed such that it substantially conforms to the surface topography of semiconductor material island 230 as it passes over the semiconductor material island in repair crossover region 200. The bends, or steps, of second conductive line as it extends over the contour of the topography often are the site of intrinsic defects in the step coverage of the conductive metal that are most susceptible to damage from exposure to etchants later in the fabrication process because the overlying dielectric protective layers tend to be thinner over steps, and hence more prone to fail to protect the underlying step from damage during subsequent etching steps. Second conductive line 220 comprises a first step 222 in the vicinity where the conductive line adjoins a sidewall 235 on one side of semiconductor material island 230 and a second step 224 in the vicinity where the conductive line adjoins the opposite sidewall 235 of semiconductor material island 230. The topography of semiconductor material island further comprises a ridge that corresponds to the underlying first conductive line 210 (that is, a ridge where semiconductor material island 230 extends up and over the underlying first conductive line 210), and second conductive line 220 further comprises a third step 226 and a fourth step 228 in the vicinity where the conductive line extends over the ridge of semiconductor material island 230 generally above the edges of first conductive line 210.

first protective layer 240₁ is disposed to cover both first and third steps 222, 226, and second protective layer 240₂ is disposed to cover both second and fourth steps 224, 228 of second conductive line 220. First and second protective layers 240 each typically comprise an inorganic dielectric material such as polyimide, which is typically deposited in a spin coating process to a thickness in the range between about 0.5 μm and 3 μm.

In this arrangement, protective layers 240 provide protection to the steps (that is, portions of the second conductive line having edges where it passes over underlying structures) at which the structural integrity of conductive line 220 is most subject to attack during fabrication processing steps for imager device 100, while still leaving repair area 260 with ample space in which laser ablation welds can be made readily between first and second conductive lines. For example, first and second protective layer 240 provide protection for the covered portions second conductive line 220 from reactive ion etchants such as HCl, Ar, O₂, acetone, or combinations thereof that are typically used in fabrication etching steps in the formation of the indium tin oxide photosensor array common electrode or removal of portions of passivation coatings on the array. Absent protective layers 240, the second conductive line is otherwise exposed to these etchants during the normal fabricating steps for the imager device.

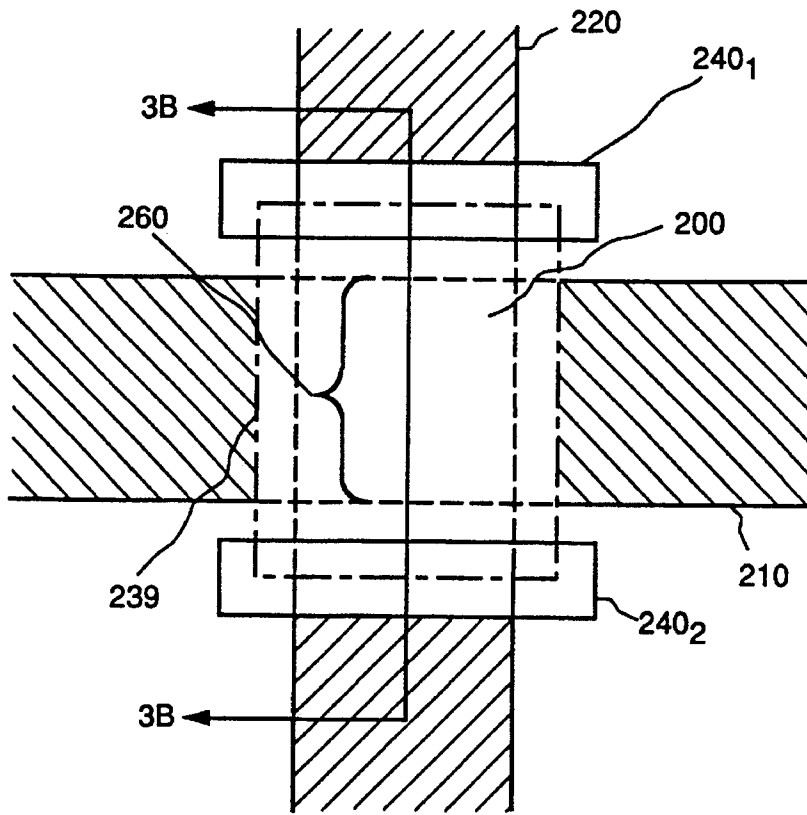
FIG. 3(A) is a plan view of a repair crossover area in accordance with another embodiment of the present invention.

Another embodiment of the present invention is illustrated in FIGS. 3(A) and 3(B), which illustrates a repair crossover region 200 in an imager device 100 that is the same as described above with respect to FIGS. 2(A) and 2(B), except as noted below. As illustrated in FIGS. 3(A) and 3(B), first protective layer 240₁ is disposed so as to cover first step 222 of second conductive line 220 but does not extend to cover third step 226 of the second conductive line. Similarly, second conductive layer 240₂ is disposed so as to cover second step 224 of second conductive line 220 but does not extend to cover fourth step 228 of the second conductive line. In this arrangement, protective layers 240 provide protection to the most critical (that is vulnerable to degradation as a result of exposure to subsequent processing steps) steps of second conductive line 220 while providing the largest available repair area 260 for laser ablation welds to be made between first and second conductive lines. First and second steps comprise the most vulnerable steps in second conductive line 220 due to the steep slope required for the conductive line to extend up and over sidewalls 235 of semiconductor material island 230 (e.g., the thickness of semiconductor material island at the sidewalls is in the range between about 0.3 μm to 0.6 μm, while the thickness of first conductive line 210 is typically about 0.1 μm to 0.3 μm).

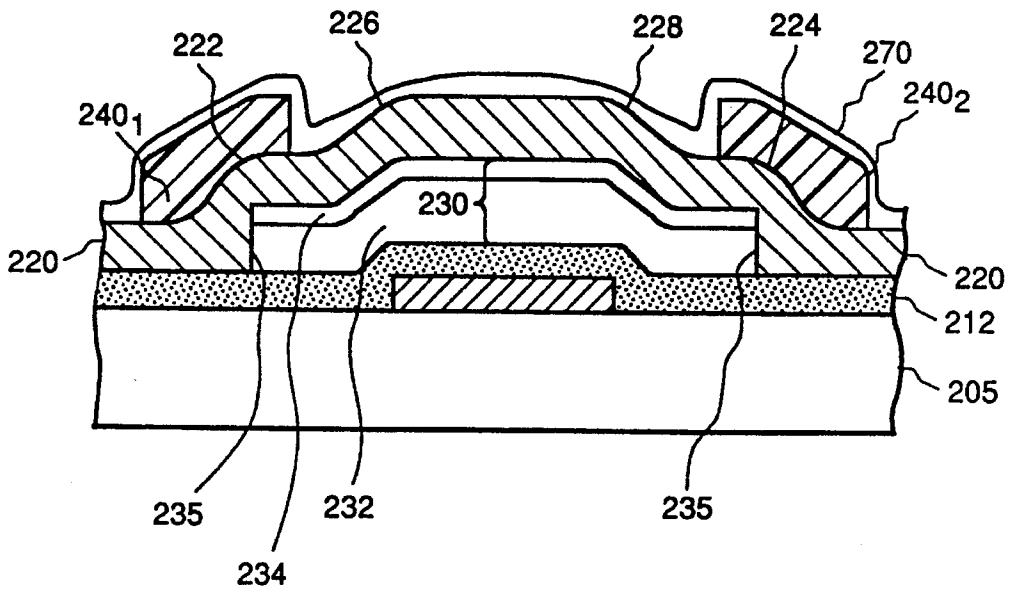
FIG. 3(B) is a cross sectional view of a repair crossover area taken along lines 3B—3B of FIG. 3(A).

A further embodiment of the present invention illustrated in FIG. 3(B) comprises a third protective layer 270 disposed over the array so as to cover at least both first and second protective layers 240 and the remaining portions of repair crossover region 200 (although shown for illustration purposes in FIG. 3(B), this embodiment of the invention is equally applicable to the structure of first and second protective layers illustrated in FIGS. 2(A) and 2(B)). Third protective layer 270 typically comprises an inorganic dielectric material, such as silicon nitride or the like, and typically has a thickness in the range between about 0.1 μm and 2 μm. Third protective layer 270 provides further protection of the repair crossover region, second conductive line 220, and first and second protective layer from attack during removal of the silicon nitride from the repair crossover region, usually by dry etching using a combination of CF₄, O₂, SF₆, and Cl₂.

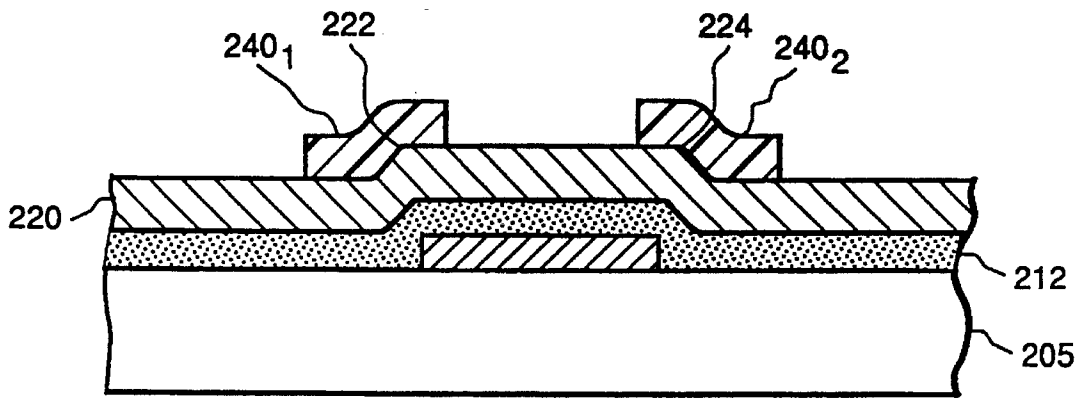
FIG. 4 is a cross sectional view of a repair crossover area in accordance with another embodiment of the present invention.

Another embodiment of this invention is illustrated in FIG. 4, which illustrates a repair crossover region 200 in an imager device 100 that is the same as described above with respect to FIGS. 2(A) and 2(B), except as noted below. In this embodiment, no semiconductor material island 230 is disposed in repair crossover region. Thus, the surface topography in this region comprises the contour of dielectric layer 212 where that layer extends over the underlying first conductive line 210; protective layers 240₁ and 240₂ are disposed on first and second steps 222, 224 of second conductive line 220 where the conductive line extends over the contour of dielectric layer 220.
