US010344434B2

(10) **Patent No.:** **US 10,344,434 B2**

(54) **DETECTABLE WARNINGS**

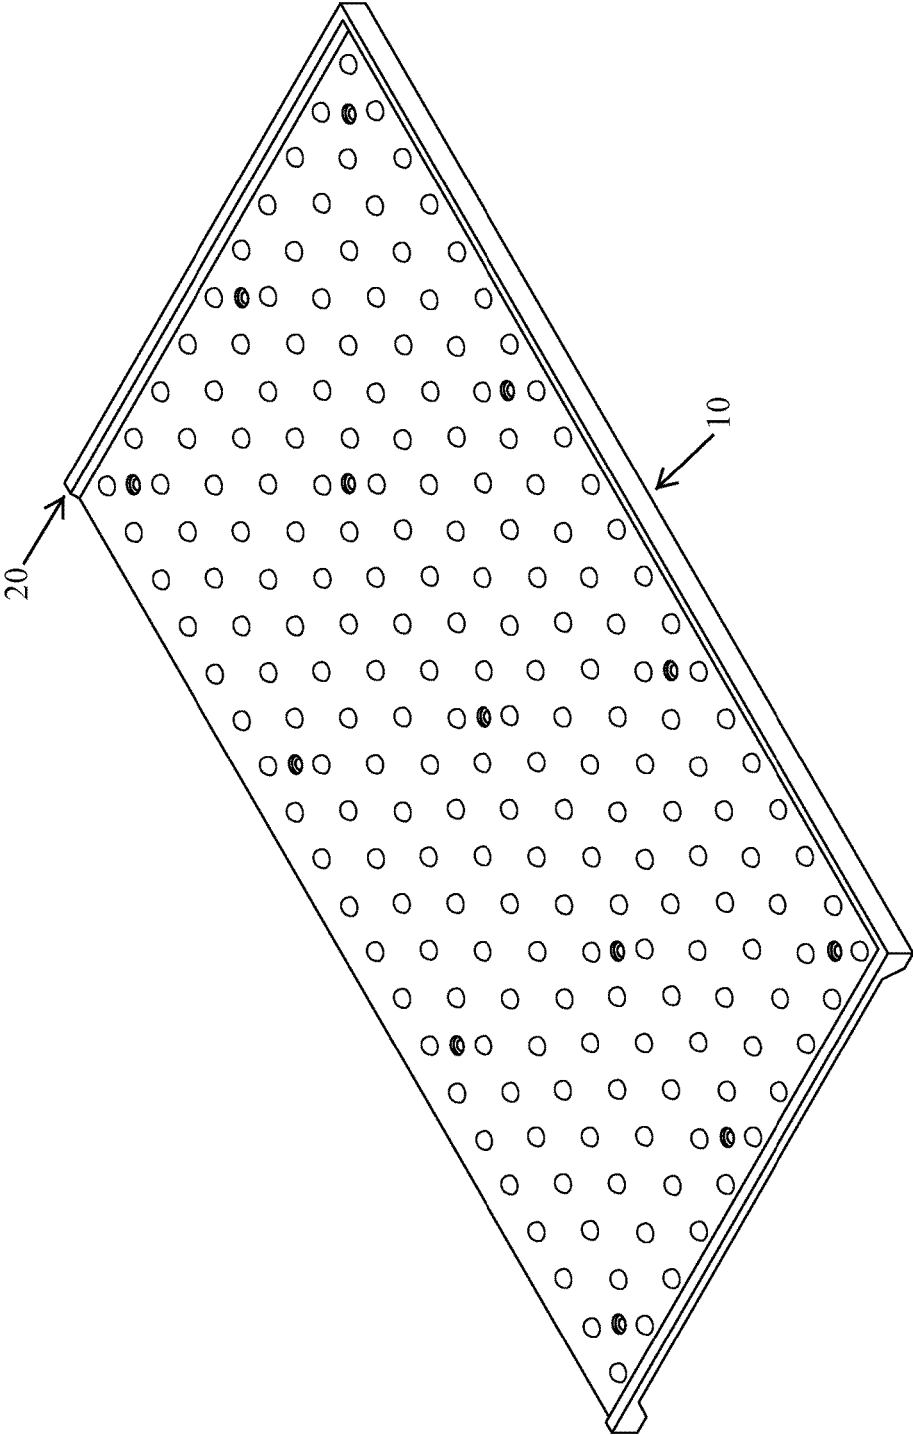
FIG. 1A is a schematic picture of a replaceable detectable warning tile with a protective upper lip and lower flanges on two opposing edges but not on the other two edges.

FIG. 1A shows schematically a tile with underside flanges on only two opposing sides, with the other two opposing sides left without any flange. Some wet-set, replaceable, detectable warning tiles have underside flanges on all (typically four) sides of the tile. By leaving some sides of the tile with no underside flange, buckling may be reduced. In

particular, FIG. 1A shows a tile with a long direction, presumably perpendicular to the direction in which pedestrian will walk over the tile, and a short direction, parallel to the direction of pedestrian traffic. In FIG. 1A, the tile has underside flanges on the long sides, running perpendicular to the direction pedestrian traffic, and no flanges on the short sides parallel to pedestrian traffic. As shown in detail in FIG. 1B, the underside flanges are separated by the shorter horizontal dimension of the tile. Longer flanges separated by the shorter direction of the tile may cause less buckling than shorter flanges separated by the longer direction of the tile. But in either case, leaving one or more sides with no flange, may reduce buckling. More generally, a tile may reduce buckling where at least one, in some cases both, of two opposing sides has no flange.

A second problem with some detectable warning tiles is damage to the truncated domes when a snow plow or shovel is scraped across the top of the tile. Where detectable warnings protrude above the level of the surrounding walking surface, a plow or shovel that travels along the walking surface may shear off or otherwise damage a truncated dome. FIG. 1A shows a detectable warning tile with an upward facing lip to address this problem. The upper surface of the tile is generally flat, punctuated by truncated domes. The lip protrudes upward from the tile to a greater height than the truncated domes. In this way, the blade of a snow plow or shovel may ride along the upper lip without ever contacting the truncated domes. Thus the lip protects the truncated domes from damage. Where tiles are intended to be installed adjacent to one another, the upper lip may extend only along some sides of the tile. In that way, an upper lip can be formed around a collection of tiles with no upper lip along the internal seams between tiles. FIG. 1A shows a tile with an upper lip along only three of its four sides.

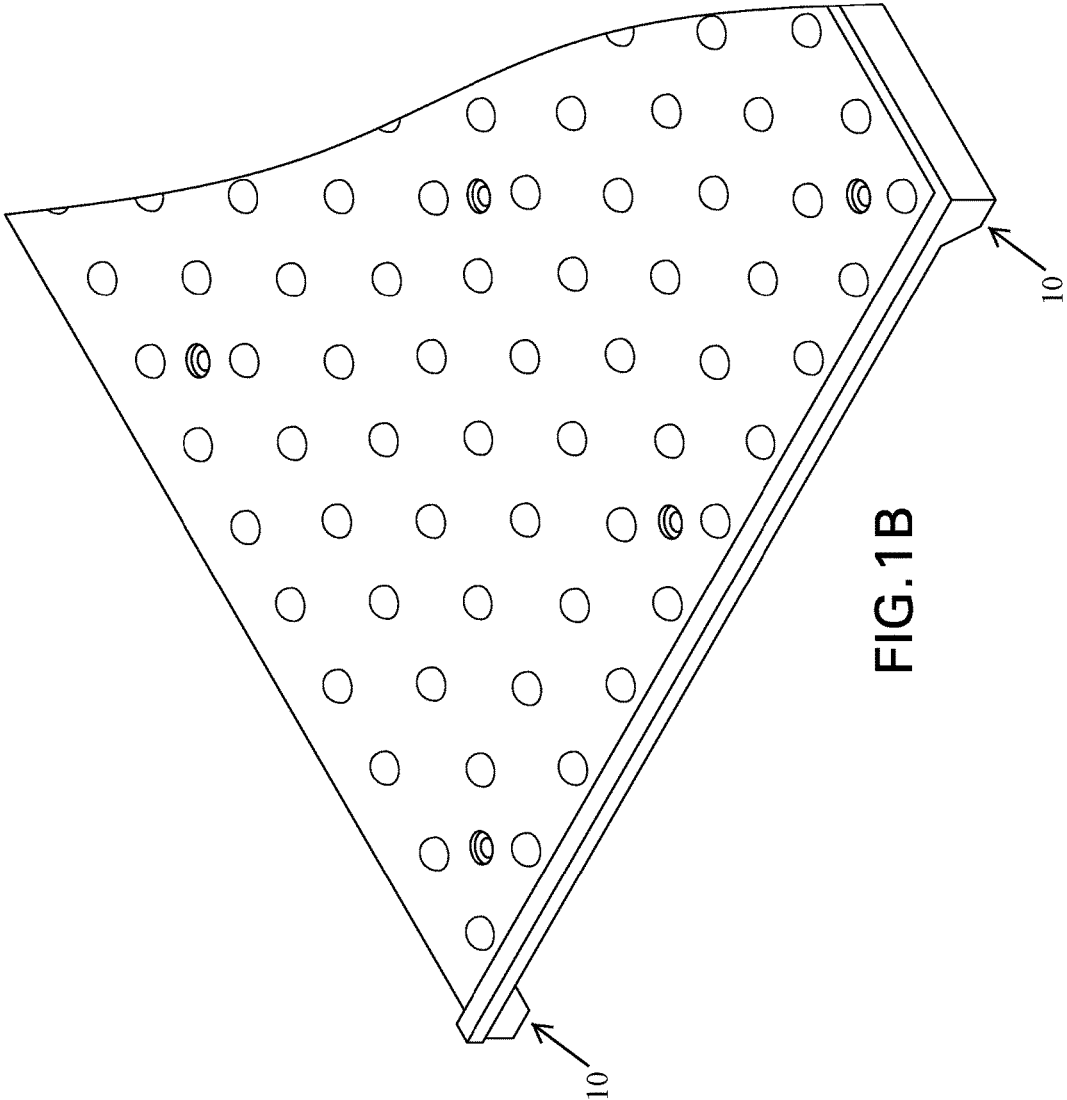
FIG. 1B is a close up schematic picture of the same tile depicted in FIG. 1A.

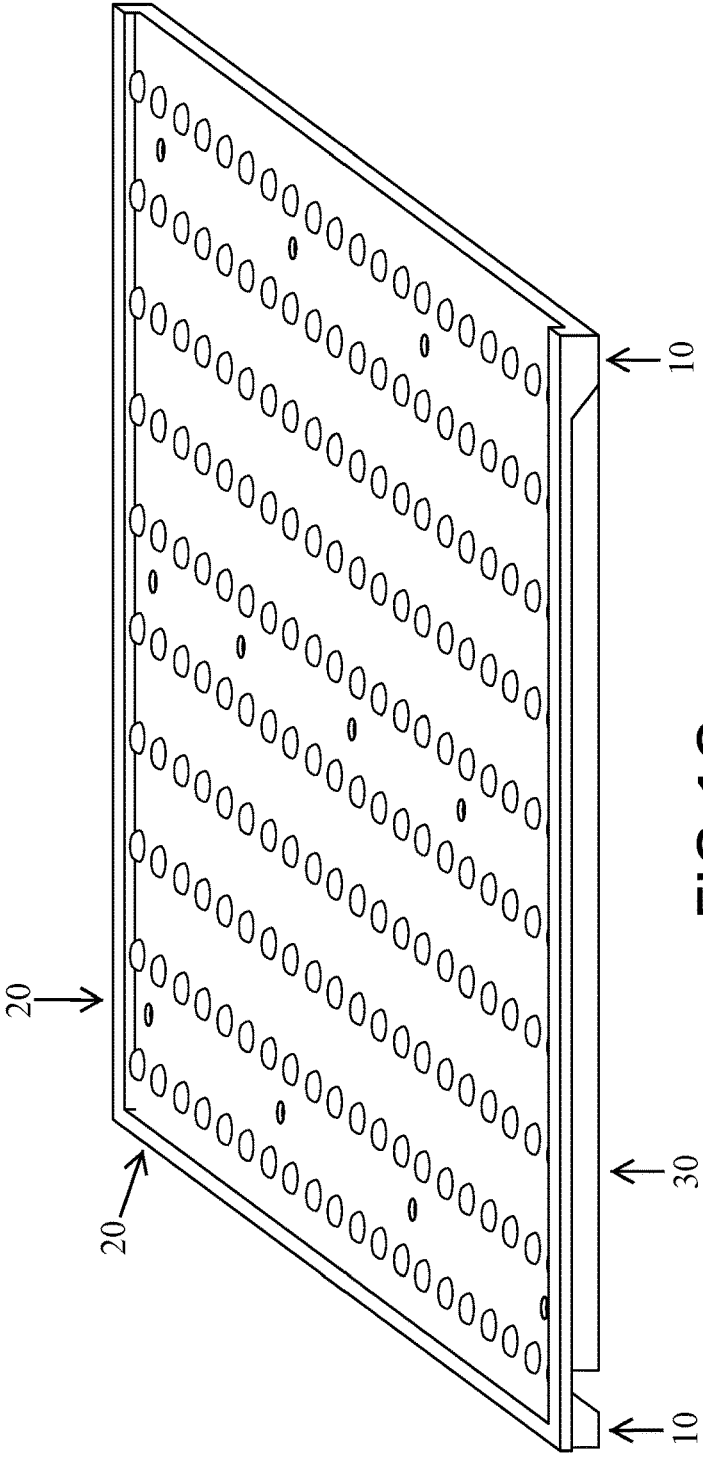
FIG. 1C is a schematic picture of the same tile depicted in FIG. 1A looking along the long axis of the tile.

FIGS. 1C and 1D also show a different type of anchor that mimics a rib on the underside of the tile. This rib-anchor is fastened to the tile by multiple fasteners at different locations unlike the single-fastener, hexagonal anchors also shown. Ribs can be used to provide stiffness or strength to the tile, and the multi-fastener anchor can mimic those effects.

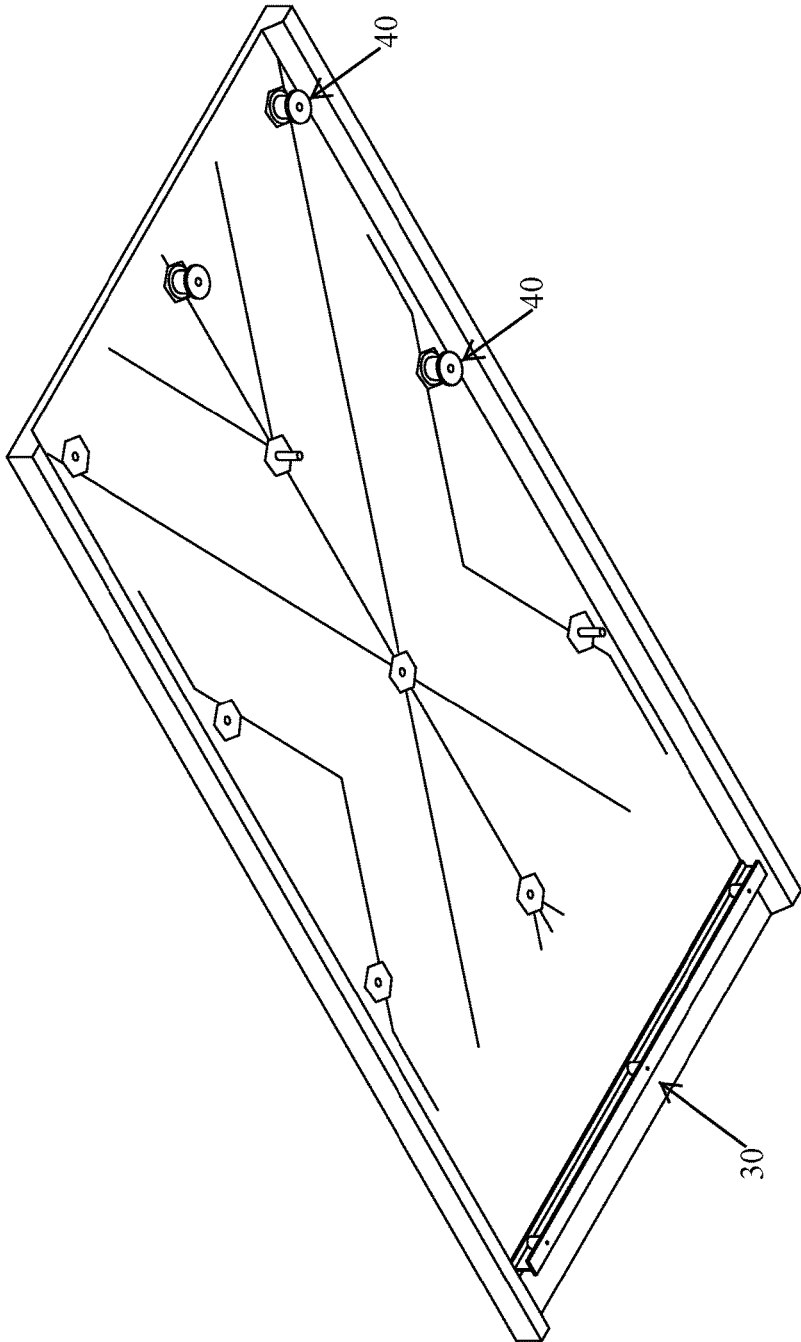
FIG. 1D is a schematic picture of the same tile depicted in FIG. 1A looking from underneath.

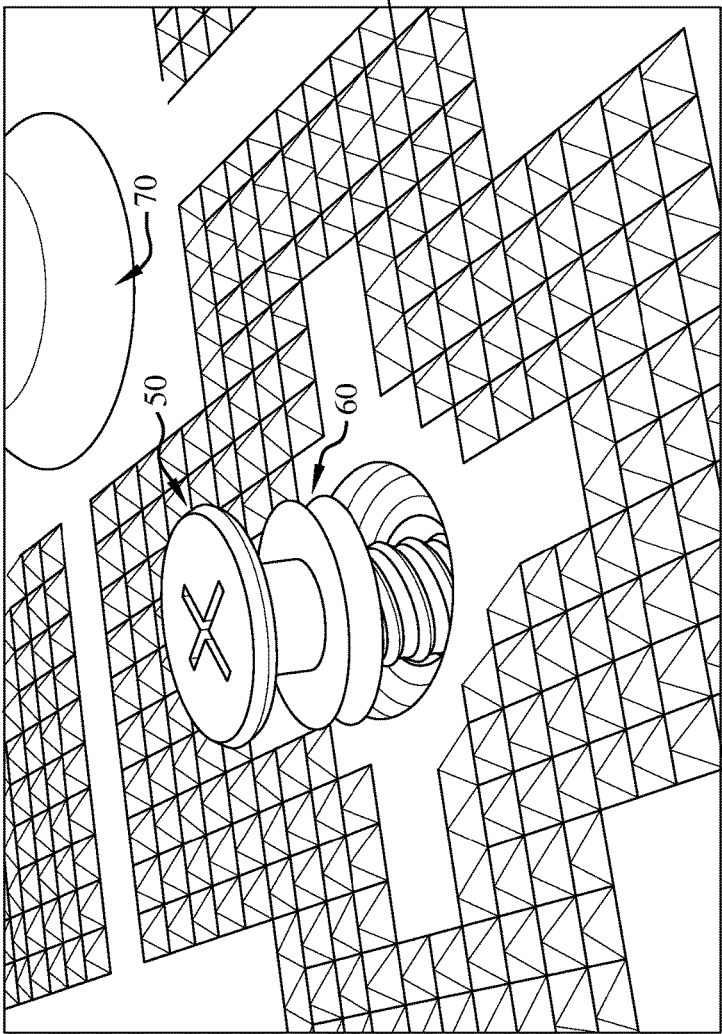
FIG. 2 is a photograph of an example of a tile including a flexible grommet surrounding a fastener.

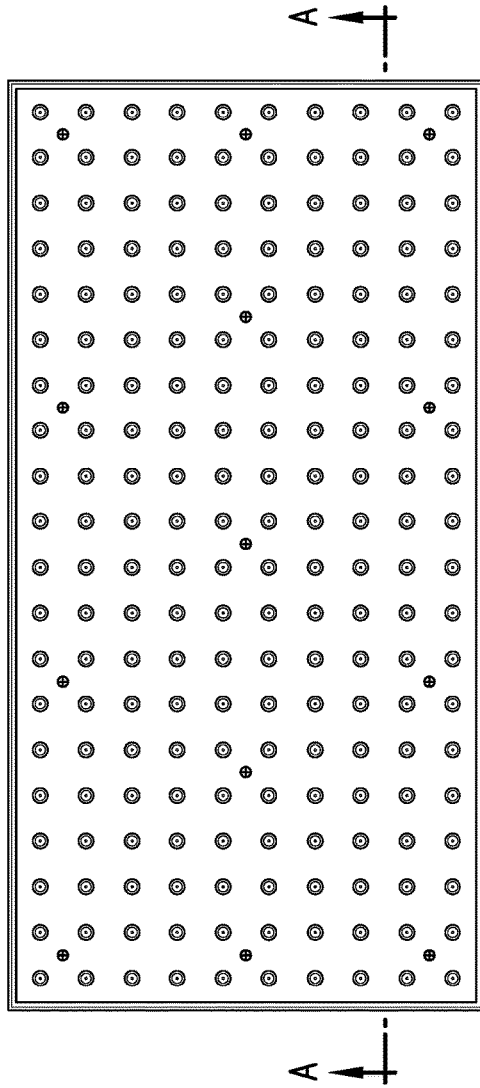
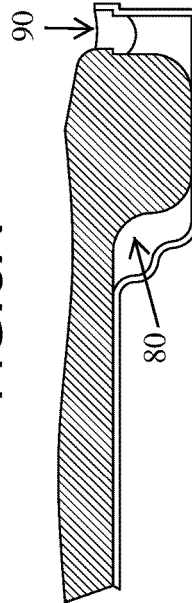
FIG. 3 is a series of schematic drawings of a tile assembly including an isolation tray.

FIG. 3 shows yet another way of addressing the problem of buckling, by installing the tile in an isolation tray. In this embodiment, a tray is affixed to the tile. The fasteners pass through the tile, through the tray and then into the anchors. The isolation tray is larger than the tile, leaving room for the tile to expand and contract horizontally inside the tray. An exposed gap between the tray and the tile can be sealed, for example with a flexible caulking that allows for expansion and contraction of the tile while preventing debris from falling into the tray. The presence of the tray leaves a horizontal gap between the tile and the surrounding concrete, allowing the tile to expand and contract relative to the concrete without buckling. This is also beneficial when used with a replaceable tile in that the tray keeps the tile from coming directly in contact with the concrete, making the tile

easier to remove. Moreover, because the tile is not embedded directly in the concrete, underside protrusions can be any shape, including wider at their lowest point, without compromising replaceability. The isolation tray may be made from a variety of materials, and in particular, could be made from a material whose thermal expansion characteristics mimic those of concrete.

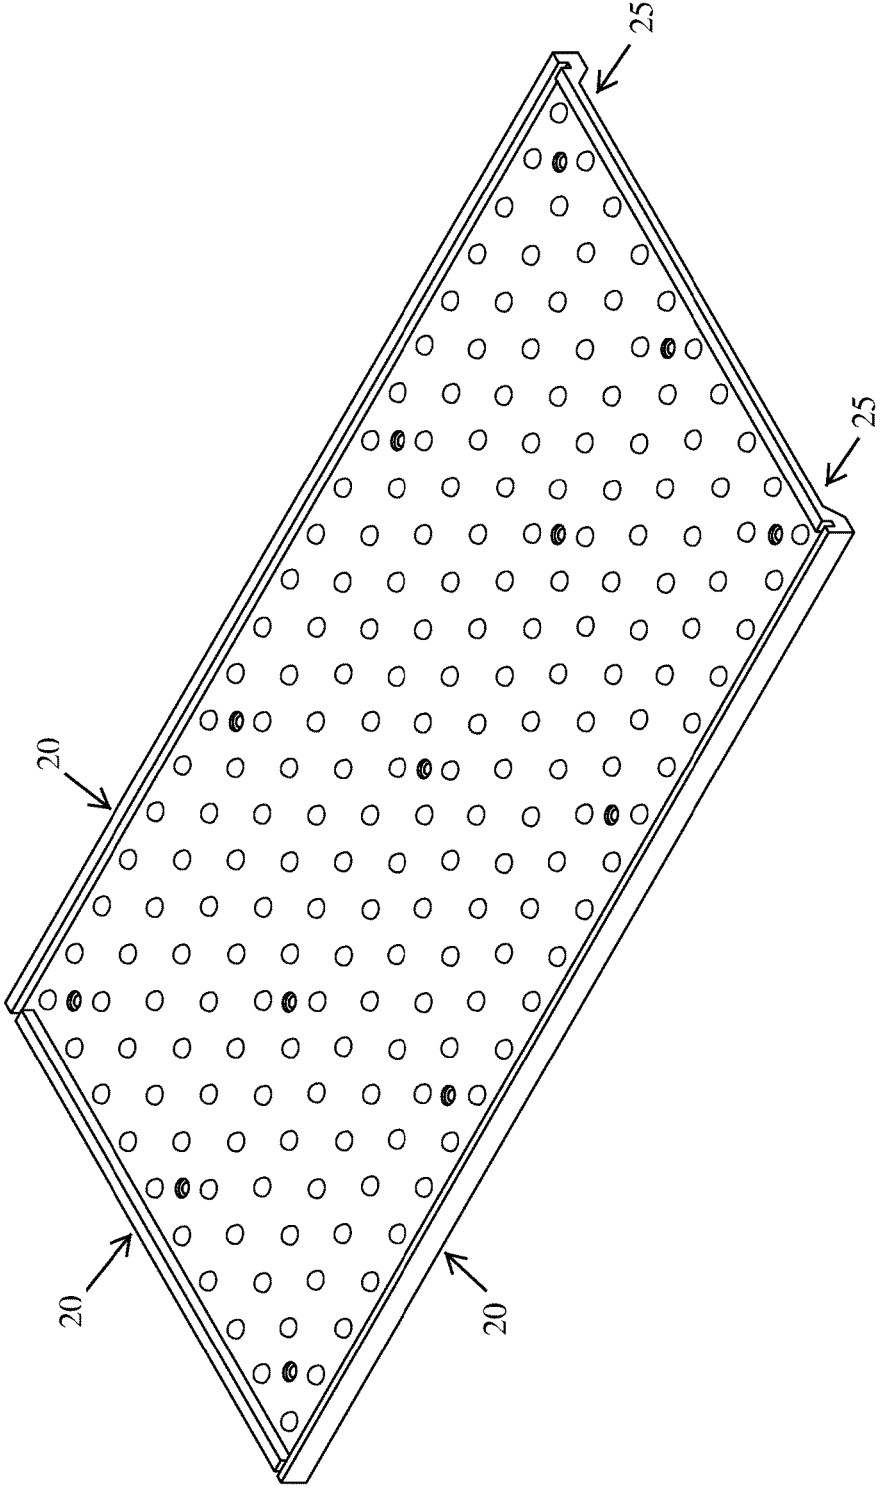
FIG. 4A is a schematic picture of a replaceable detectable warning tile with a protective upper lip designed to promote self-cleaning.

A third problem with some detectable warning tiles is the difficulty of cleaning the tile. FIG. 4A shows a detectable warning tile designed to be at least partially self-cleaning. The unit has an upper lip to protect the detectable warnings from snow plows as described above. In this case, the upper lip is broken at locations on the long sides of the tile, near the corner. In this way the upper lip defines one or more openings. The upper lip along the long sides of the tile is also wider at the center than at the corners. In FIGS. 4A-4C the long sides of the upper lip have triangular peaks, but many such shapes will suffice. When such a tile is installed on a slope, for example in a curb ramp, or curb cut, with one long side below the other long side, debris will roll or flow down the slope, hit the lip on the lower edge of the tile, then roll or flow along the sloped lip down to the corner where it can be channeled away through the break in the lip. In this way, the upper lip can be shaped to promote self-cleaning when installed on a slope. Although only the downhill side of the tile needs to have the above-described shape and openings to work as described, the upper lip as shown in FIGS. 4A-4C is symmetrical for ease of installation, so that the tile can be installed with either long edge at the top or bottom of the slope.

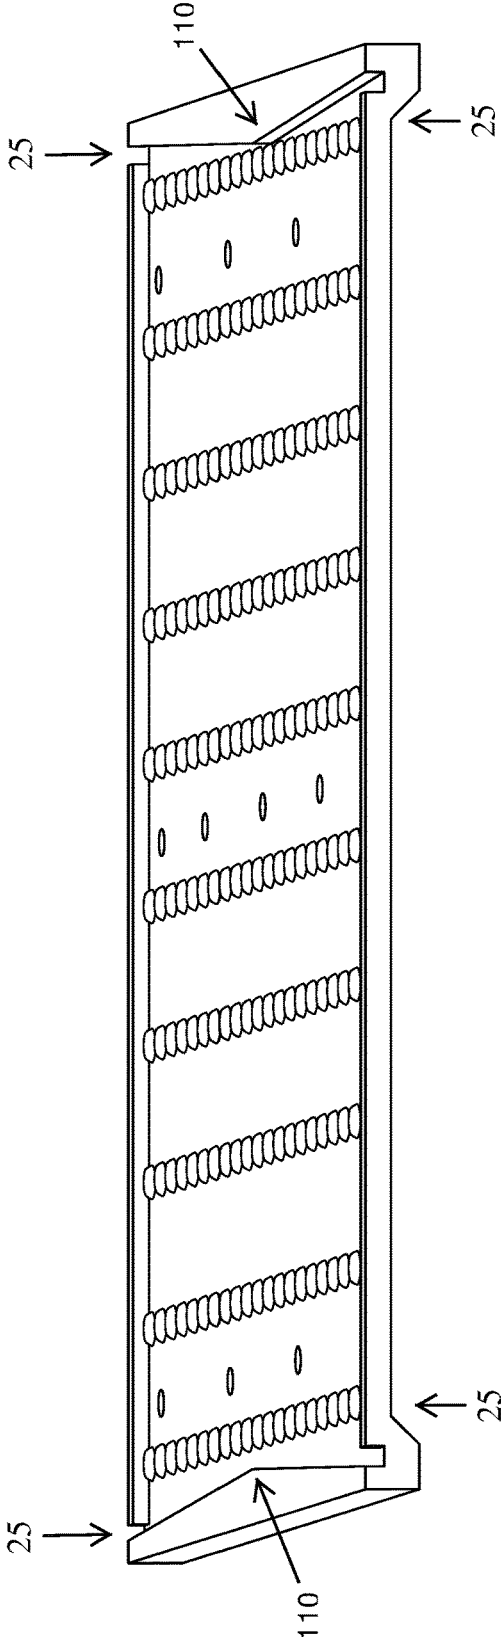
FIG. 4B is a schematic picture of the same tile depicted in FIG. 4A looking along the long axis of the tile to emphasize the triangular shape of the upper lip.

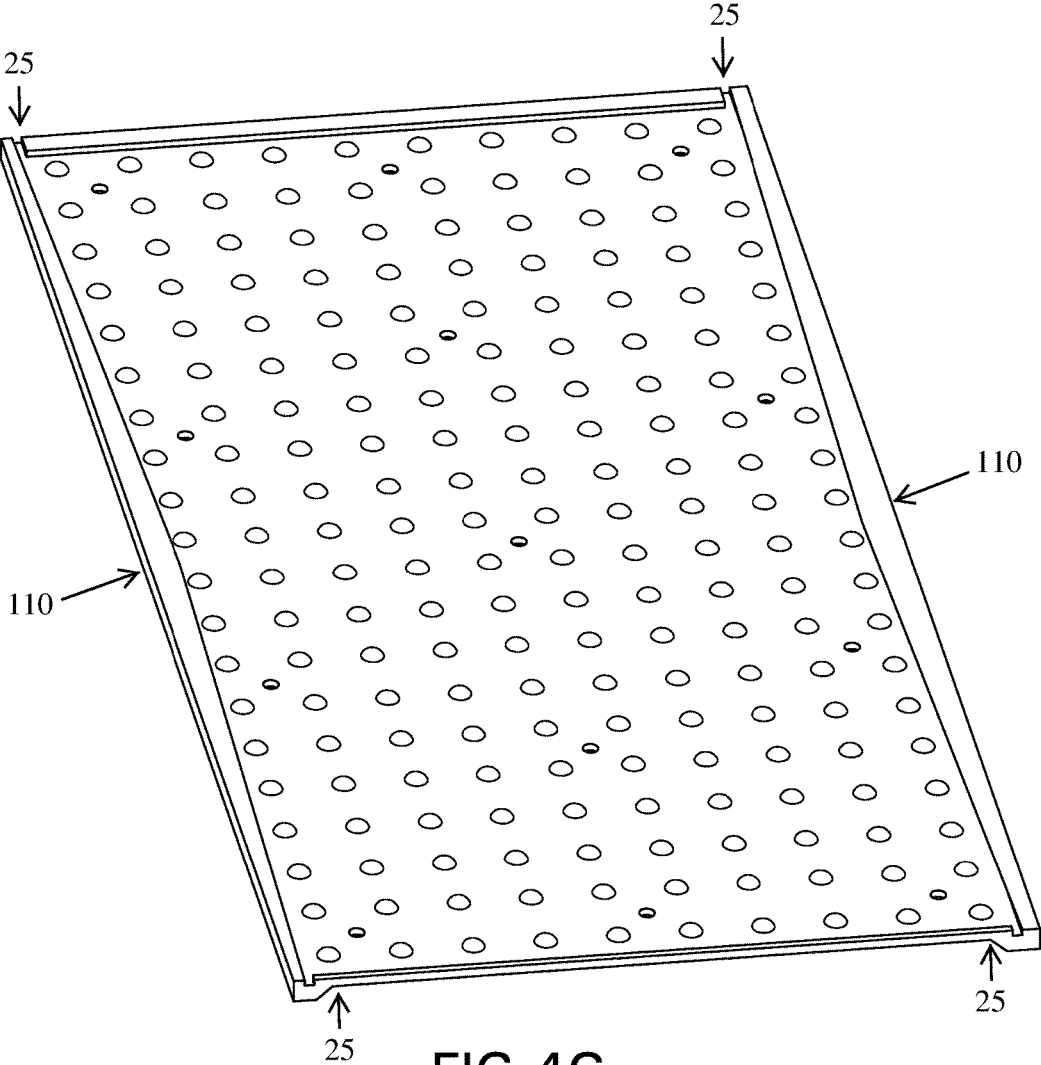
FIG. 4C is a schematic picture of the same tile depicted in FIG. 4A.

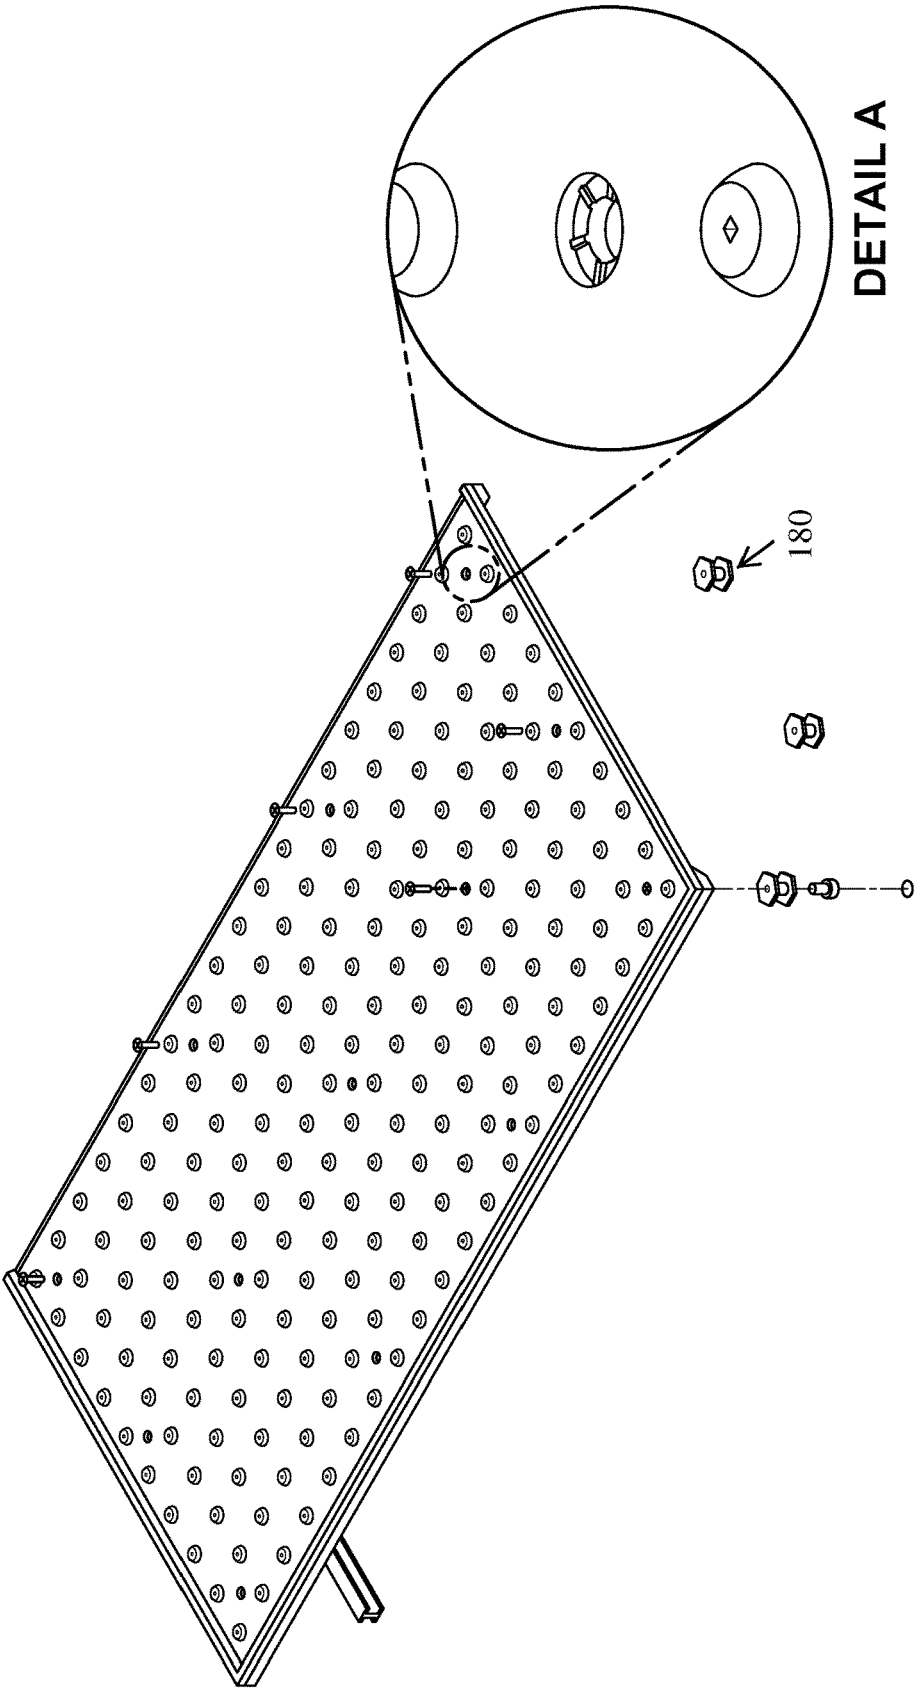
FIG. 5A is a schematic picture of a replaceable detectable warning tile with features designed to allow venting from below to above the tile.

Venting can also be achieved by leaving room for air to flow around the fasteners. FIG. 5A shows two ways of allowing venting around the fasteners. Detail A of FIG. 5A shows a hole through the tile. The fastener passes through the hole and attaches to the anchor. As the fastener is tightened in the anchor, the anchor becomes held to the tile. But the hole shown in Detail A is not merely a countersink to allow the screw head to be recessed. The horizontal and vertical surfaces of the hole include channels that allow air to flow from below the tile to above the tile, even when a screw is seated in the countersink. When the screw is tightened down, it seats against the horizontal surface of the countersink, leaving channels underneath the screw that continue to the underside of the tile. This is shown in more detail in FIG. 5B.

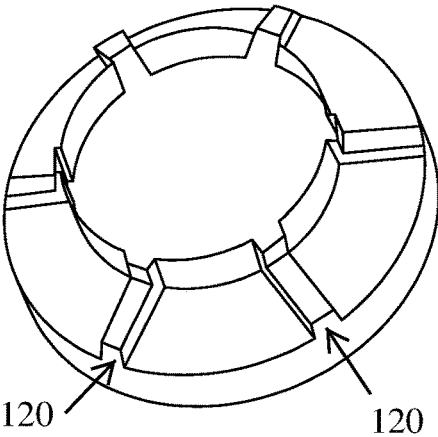
FIG. 5B is a close up schematic picture of the tile depicted in FIG. 5A.

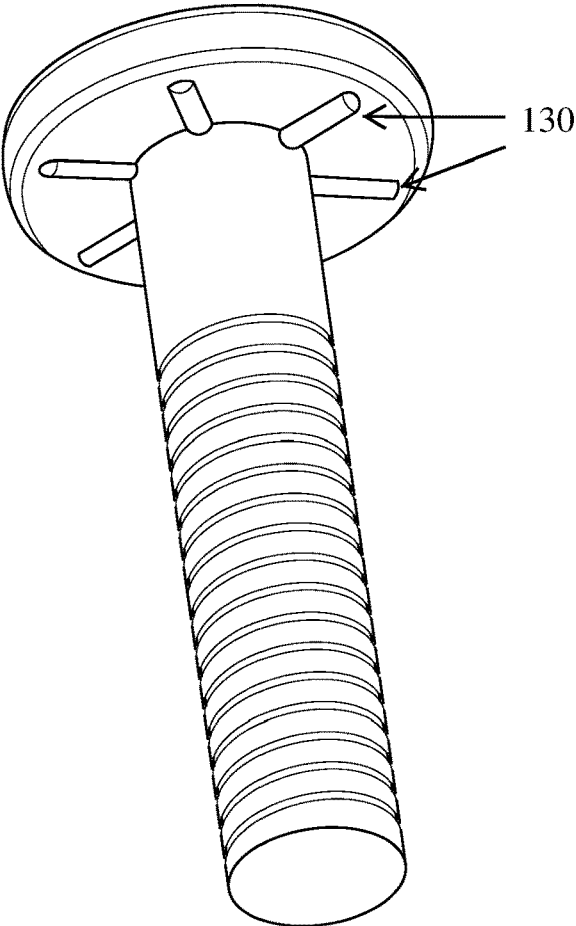
FIG. 5C is a schematic of a screw with ribs on the underside of the screw head.

FIG. 5C shows a screw with protruding ribs on the underside of the screw head. This screw similarly serves to allow venting around the screw from below to above the tile. When the screw is tightened down against the tile, the ribs contact the horizontal surface of the countersink, leaving the rest of the screw head removed from the tile. As long as the screw does not completely fill the through hole and the head does not completely fill the countersink, the ribbed screw will thus leave openings for air to flow from below the tile to above the tile.

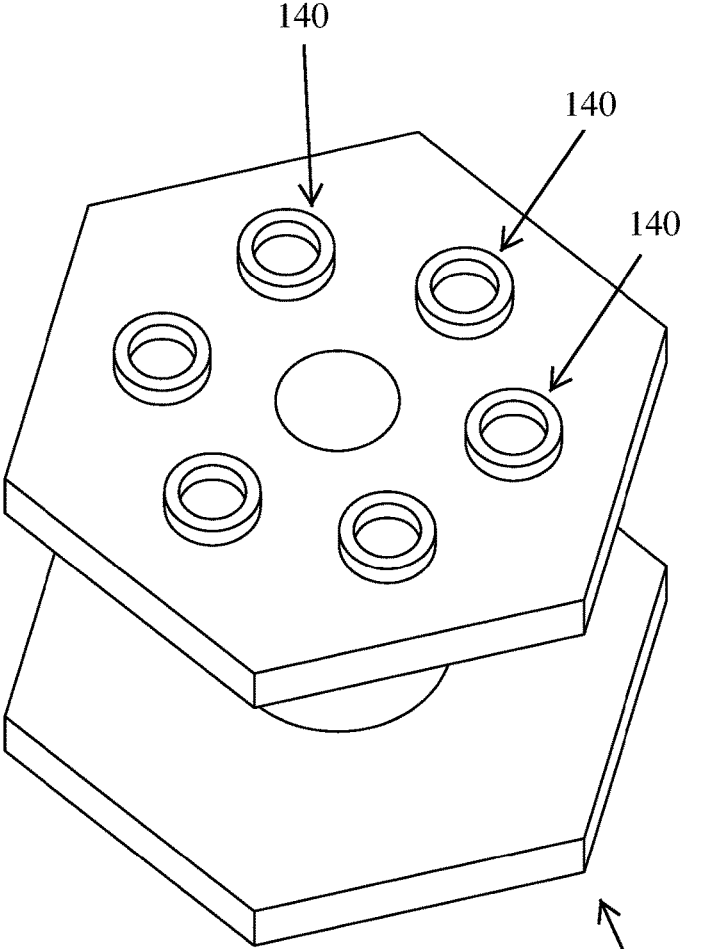
FIG.5D

FIG. 5D is a schematic of an anchor that allows venting.

The fasteners attach to anchors that seat tightly against the underside of the tile. In order for air to flow around the fastener, the anchor cannot be allowed to completely block the hole. FIG. 5D shows an anchor with six circular bosses that allow the anchor to stand off from the underside of the tile even when firmly attached to the tile. An anchor like the one in FIG. 5D can be used with any combination of fasteners and holes that allows for venting.
