(11) **EP 1 535 664 A1**

(71) Applicant: **NGK INSULATORS, LTD.**

(54) **Ceramic honeycomb structure**

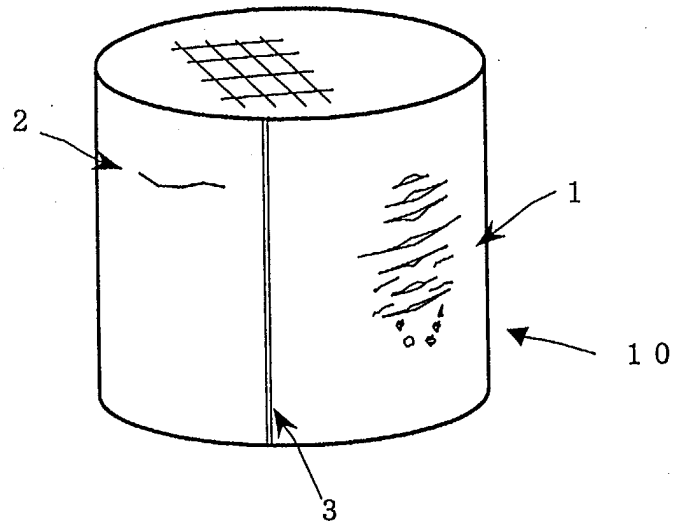
FIG. 1 is a perspective view showing schematically the examples of the defects formed in the outer walls of a ceramic honeycomb structure.

25 **[0005]** Therefore, in the case of such a honeycomb structure, the open defects including a fissure and a crack extending through the outer wall, for example, various defects extending through the outer wall as shown in FIG. 1 (open tears 1, lateral fissure 2, vertical fissure 3) occur inevitably in a certain ratio in drying or firing steps.

**[0027]** First, the outer wall defect of the ceramic honeycomb structure and the problems thereof will be explained in detail. As shown in FIG. 1, various through defects may occur in the outer walls of the ceramic honeycomb structure. The numeral 1 is referred to as the "open tears", which occurs in the case the material supply for the outer wall formation is short at the time of forming. Small ones become a hole. Depending on the state, it can be a split, and furthermore, a crack may be formed from the end. The numeral 2 is referred to as the "lateral fissure", which occurs by quick partial drying of the outer walls or drastic contraction of the outer circumferential part at the time of firing. The numeral 3 is referred to as the "vertical fissure", which becomes apparent in the drying and firing step due to insufficient pressure bonding of the material at the time of forming or it occurs by the contraction by drastic drying and firing of the outer wall part.

**[0046]** 40 pieces of ceramic honeycomb structures having an open tears 1 (see FIG. 1) before firing were prepared. The open tears were in a split state like a lip having a 0.3 mm to 4 mm maximum opening width, a 4 to 10 mm length and a maximum 5 mm crack on the end and extending in the direction perpendicular to the passage, and 5 pieces to 21 pieces form a row at a length portion of 30mm in the entire length direction. As the honeycomb structure material, a raw material to become cordierite by firing was used. 10 pieces out of them were repaired by coating paste prepared by kneading the same material with oil onto the defective portions so as to make the coated surface thereon at the same plane as the outer walls. Thereafter, they were fired with 30 pieces having the open tears without repair and 10 pieces without the external appearance defect such as the open tears so as to obtain the cordierite honeycomb structures having a 0.065 mm rib thickness, 140 passages/cm<sup>2</sup>, and  $\Phi 106$  mm diameter  $\times$  114 mm height size. Those repaired were referred to as the example 4, those without the repair were referred to as the comparative example 3, and those without the defect were referred to as the comparative example 4.

**[0056]** 40 pieces of the ceramic honeycomb structures before firing, having 5 lines of the vertical fissure 3 (see FIG. 1) within 180 degrees were prepared. The vertical fissure extended by about a 0.4 mm width in the outer walls along the entire length. For the depth (radial direction), some had the vertical fissure extending in the outer wall and the next two walls. As in the example 4, 10 pieces were repaired by coating a material kneaded with oil. Thereafter, they were fired with those without the repair so as to obtain the cordierite honeycomb structures having a 0.09 mm rib thickness, 62 passages/cm<sup>2</sup>, and diameter  $\Phi 106$  mm  $\times$  height 114 mm.

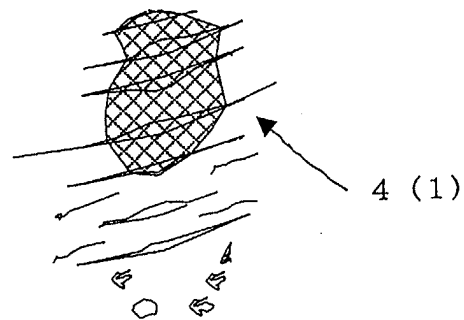
FIG. 2 is a partial perspective view showing schematically the lacking part by peel off of the outer wall in the part adjacent to the 3 to 4 mm width opening of the open tears in the comparative example 3.

**[0054]** As to the mechanical strength test, the examples 4, 5 and the comparative example 4 had the exactly same state as before the test. In contrast, those not repaired (comparative example 3) had the portions of the outer wall peeled adjacent to the opening of the open tears having the width of 3 to 4 mm, and as a consequence, the deficient portion 4 of about  $5 \times 4$  to  $10 \times 8$  mm which was formed from 3 to 4 pieces of the open tears as a unified defective portion (the hatching part in FIG. 2). Moreover, those not repaired (comparative example 3) showed a low destruction value at the open tear portion. In contrast, those repaired (examples 4, 5, comparative examples 4, 5) were not destructed at the repaired portions but at other portions. As a consequence, the improvement in the mechanical strength by the repair was confirmed.
