**EP 1 808 266 A2**

**(54) Turbine platform repair using laser clad**

(57) A method of restoring a gas turbine engine component (32) includes removing a defect section (44) of a turbine engine component (32) according to a template (54). The template (54) has a standardized shape and is used in a standardized location on the turbine engine

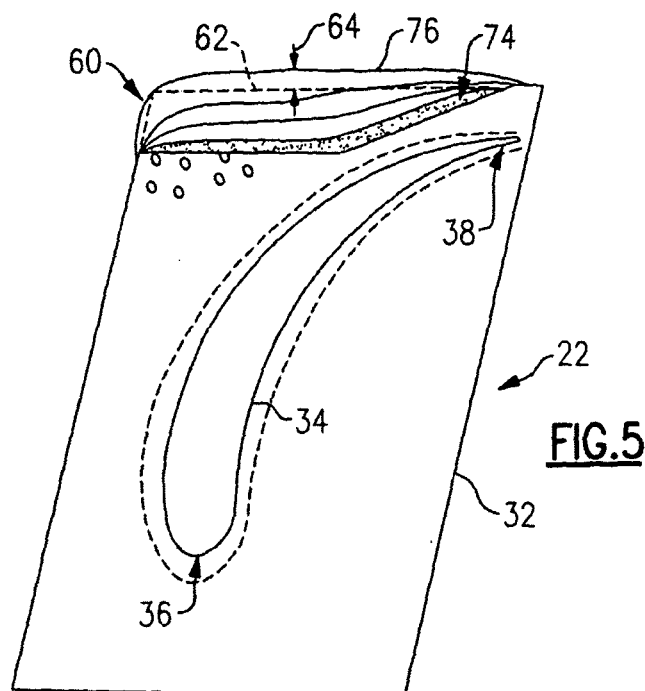
**FIG.5**

Figure 5 shows the defect section of the turbine blade of Figure 4 removed and laser cladding a replacement section.

**[0019]** Referring to Figure 5, after removal of the defect section 44, a laser cladding is deposited to rebuild the platform 32. A filler material 74 is deposited in place of the defect section 44 in a known manner as a powder or other type of filler material to gradually build-up a replacement section 60. In one example, the filler material 74 is of a similar composition to the superalloy used to originally form the blade 22 to promote a strong bond between the cladding and the original superalloy of the blade 22. In another example, the filler material is a composition according to the standard set forth in AMS 5837.

**[0020]** A laser consolidates (i.e., melts and fuses) the deposited filler material 74 in a known manner. The melting and fusing of the filler material 74 is relatively rapid and accurate, which provides the benefit of a fast blade 22 repair cycle time and a high degree of repeatability. Furthermore, laser cladding melts and fuses a relatively small volume of the platform 32 and filler material 74 to minimize the size of the heat affected zone of the platform 32, which is a drawback of prior art brazing and welding that results in relatively large heat affected zones and residual stress.

**[0021]** The consolidated filler material 74 builds-up to form an oversized cladded portion 76 that is bonded to the original superalloy material of the blade 22. The oversized cladded portion 76 is larger than an original surface location 62 by an amount 64. This provides the benefit of ensuring that replacement section 60 completely restores the shape and dimensions of the platform 32.

**[0022]** The oversized cladded portion 76 is then machined to the original surface dimension 62 (Figure 5). In one example, the machining includes known grinding, grit blasting, polishing, or other known machining method that provides a smooth transition from the replacement section 60 to the original, non-repaired portions of the platform 32.

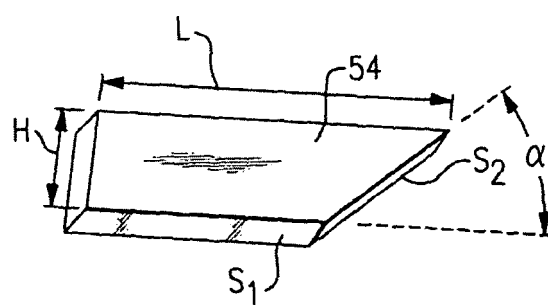
**FIG. 3**

Figure 3 shows a repair template for outlining a standardized defect shape and location on a turbine blade.

**[0016]** Once a pattern of defects has been identified, the pattern is used to produce a repair template 54 (Figure 3), such as a metal cutout or other material that is formed to provide an outline. In one example, the repair template 54 is a computer file. In another example, the repair template 54 is useable with an automated repair process. The repair template 54 will be used to repair future blades that are likely to exhibit a similar defect pattern to the blades 22a, 22b, 22c (i.e., test blades). The dotted line 56 indicates a boundary of a standardized section that the repair template 54 covers on the blades 22a, 22b, 22c and has a specific shape to cover a significant amount of the cracks 46. The identified standard section is a distance D, about 0.150 inches (3.8 mm) in the example, from the corner C (upper right corners of

**[0017]** In the illustrated example, the repair template 54 has a polygonal shape having a length L and a height H. Side  $S_1$  forms an angle alpha of  $20^\circ$  with side  $S_2$ . In one example, the length L is approximately 0.170 inches (4.3 mm).

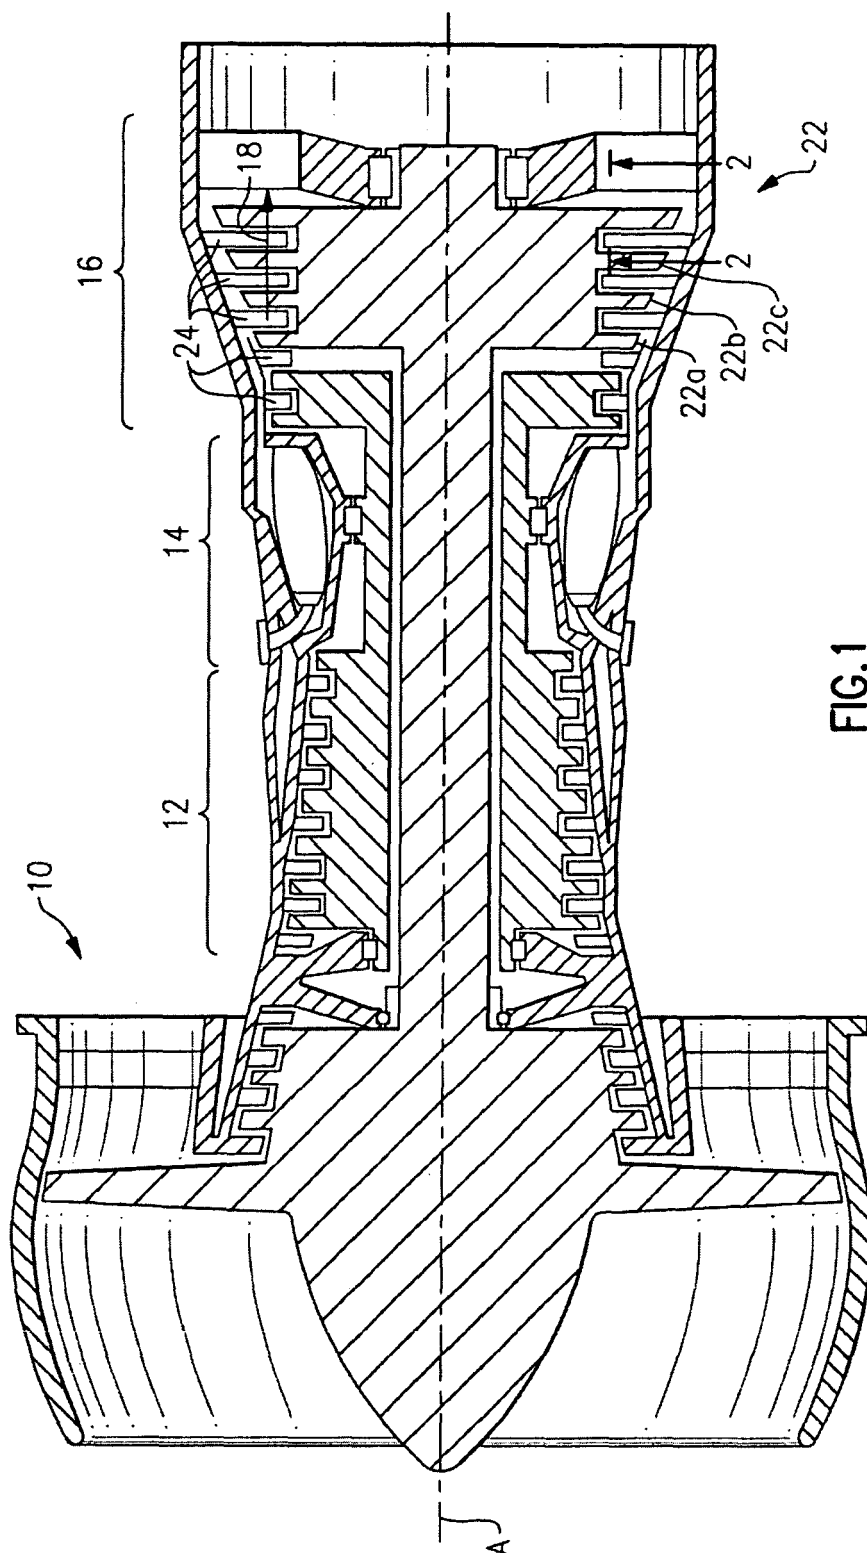
FIG. 1

Figure 1 shows an example combustion engine.

[0010] Figure 1 illustrates selected portions of an example combustion engine 10, such as a gas turbine engine for an aircraft. In this example, the combustion engine 10 includes a compressor section 12, a combustor section 14, and a turbine section 16. The combustion engine 10 operates in a known manner, feeding compressed air or oxidizer from the compressor section 12 to the combustor section 14. The compressed air or oxidizer is mixed with fuel and reacts to produce a flow of hot gases 18. The turbine section 16 transforms the flow of hot gases 18 into mechanical energy to drive the compressor section 12. An exhaust nozzle 20 directs the hot gases 18 out of the combustion engine 10 to provide thrust to the aircraft or other vehicle.

[0011] In the illustrated example, the turbine section 16 includes alternating rows of rotary airfoils or blades 22a, 22b, 22c and static airfoils or vanes 24. The vanes 24 are arranged in various stages, such a first stage, a second stage, a third stage, a fourth stage, etc. The blades 22a, 22b, 22c and vanes 24 are formed from a superalloy metal material, such as a cobalt or nickel superalloy in a casting, forging, or other known manufac-

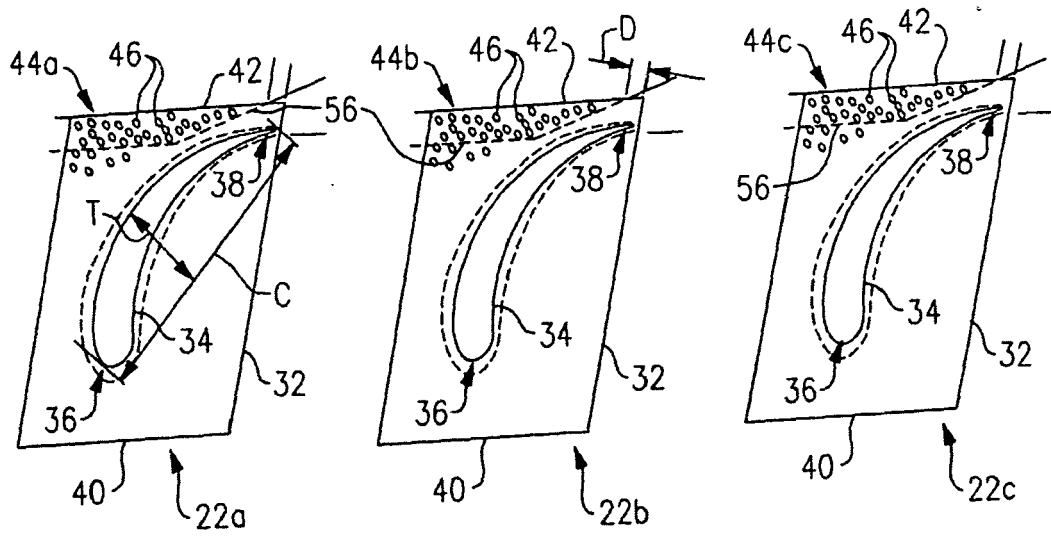
**FIG. 2**

Figure 2 shows a plurality of test turbine blades from which a defect pattern is identified.

**[0012]** Figure 2 shows a radially outward view of the individual blades 22a, 22b, 22c according to the sectioning shown in Figure 1. Each of the blades 22a, 22b, 22c includes a platform 32 and an airfoil 34 having a leading edge 36 and a trailing edge 38. The leading edge 36 is generally located toward the combustor section 14 and the trailing edge 38 is generally located toward the exhaust nozzle 20 in the combustion engine 10 (Figure 1).

**[0013]** The leading edge 36 and the trailing edge 38 define a chordwidth C of the blade 22. In the illustrated example, an aspect ratio of the chordwidth C to a thickness T of the airfoil 34 at least partially determines an aerodynamic efficiency of each blade 22a, 22b, 22c. That is, a relatively larger aspect ratio corresponds to a greater aerodynamic efficiency, while a relatively smaller aspect ratio corresponds to a lesser aerodynamic efficiency.

**[0014]** Each platform 32 includes a leading edge 40 and a trailing edge 42 that correspond, respectively, to the airfoil 34 leading edge 36 and trailing edge 38. In the illustrated example, the platforms 32 each include a respective defect section 44a, 44b, 44c, such as a section containing microcracks or corrosive pitting, near the trailing edges 42 of the platforms 32. In the illustration, the defect sections 44a, 44b, 44c each include cracks 46 that are the result of fatigue for example. Alternatively, or in addition to the cracks 46 there may be corrosive pitting, also known as hot corrosion, which is usually caused by sulphates such as  $\text{Na}_2\text{SO}_4$  and other contaminants in the hot gas 18.

**[0015]** In this example, the defect sections 44a, 44b, 44c are commonly located near a corner (upper left corner in the illustration) of the trailing edges 42 of each of the blades 22a, 22b, 22c. The cracks 46 on each defect section 44a, 44b, 44c also cover a similarly shaped area on the respective platforms 32 of the blades 22a, 22b, 22c. Thus, in this example, the blades 22a, 22b, 22c exhibit a defect pattern, which may be the result of cyclic stress in that part of the platform 32 for example. Given this description, one of ordinary skill in the art will recognize that, although the blades 22a, 22b, 22c are shown as having originated from the same engine, blades from different engines may also exhibit a defect pattern.

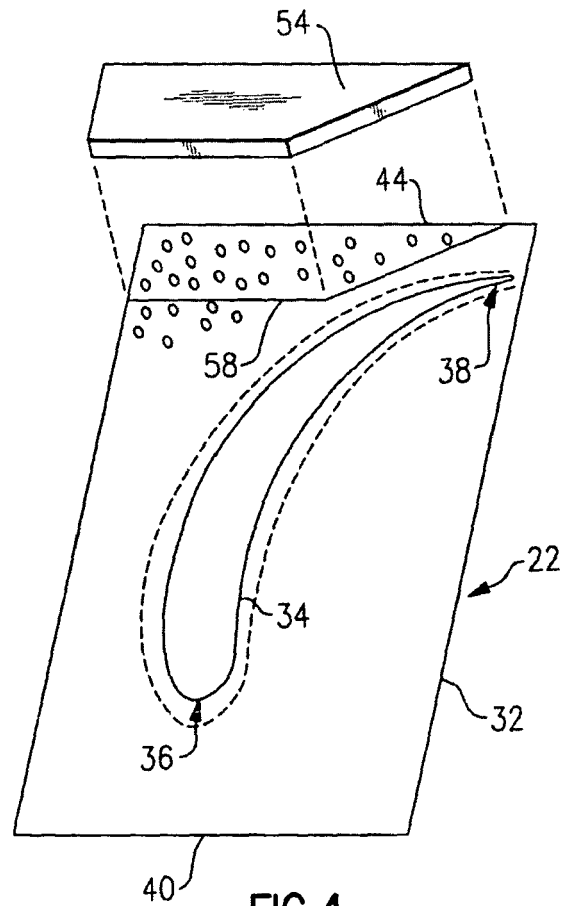
**FIG. 4**

Figure 4 illustrates marking an outline on a turbine blade using the template of Figure 3.

**[0018]** Referring to Figure 4, in one example, the repair template 54 is used to mark a line 58 on a blade 22 that is to be repaired. The line 58 serves as a guide to cutout the defect section 44 from the platform 32 to repair the blade 22. The defect section 44 is cutout using a known cutting device. Optionally, removal is conducted in an automated fashion via computer control of the cutting device according to a computer file repair template 54.

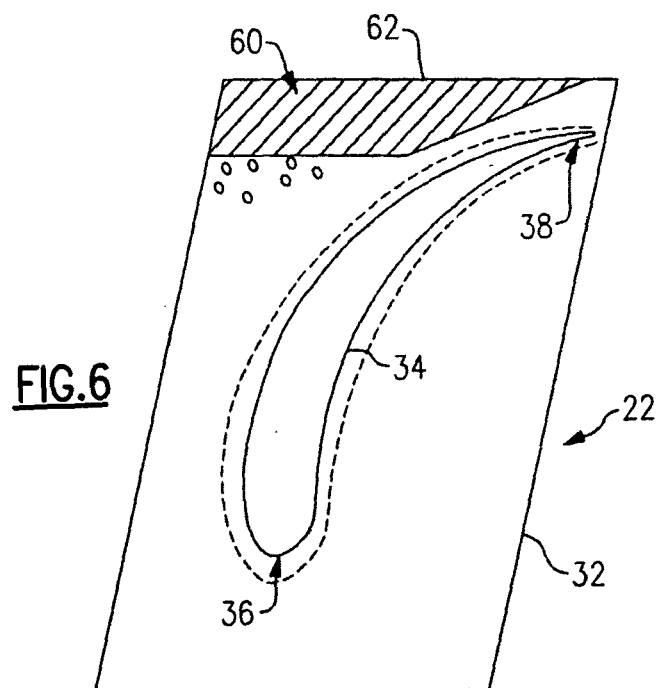
Figure 6 shows the turbine blade of Figure 5 having a replacement section in place of the removed defect section.

**[0023]** The above example discloses a method for restoring the blade 22, or other gas turbine engine component. The platform 32 of the blade 22 exhibits a defect pattern similar to defect sections of prior test blades. The defect section 44 of the platform 32 is removed according to a template 54. The template 54 has a standardized shape and is used in a standardized location on the platform 32. The template 54 is based upon common defect

sections from prior blades 22a, 22b, 22c. A laser cladding is used to build a replacement section 60 on the platform 32 in place of the defect section 44. Thus, the blade 22 is restored to near its original shape to extend the life of the blade 22.
