[11] Patent Number: **5,690,469**

[54] **METHOD AND APPARATUS FOR REPLACING A VANE ASSEMBLY IN A TURBINE ENGINE**

[73] Assignee: **United Technologies Corporation**, Hartford, Conn.

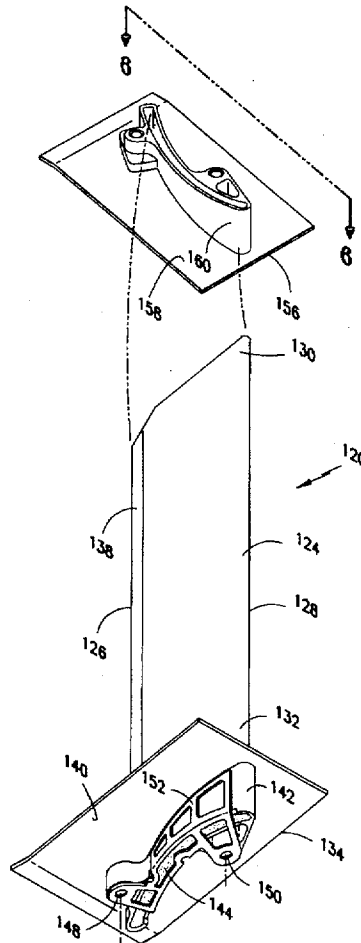
A repair kit for replacing an unserviceable vane assembly in a turbine engine includes a serviceable vane subassembly **120** having a serviceable airfoil **124** with a base **134** attached to the root end thereof and an opposing base **156** which is unattached to but slidably engagable with the serviceable airfoil. The opposing base is slipped over the tip end of the airfoil and slid toward the opposing base. The vane subassembly and opposing base are pivoted into position between inner and outer engine cases in place of an unserviceable vane assembly so that receptor sockets **148**, **150** in the attached base engage support pins **72** extending from the inner case. An adhesive **182** is applied to the tip end of the serviceable airfoil and the opposing base is translated into its installed position near the tip end of the airfoil. Upon curing of the adhesive, the opposing base becomes attached to the airfoil. The base is secured to the outer case by studs **196** and nuts **198**.

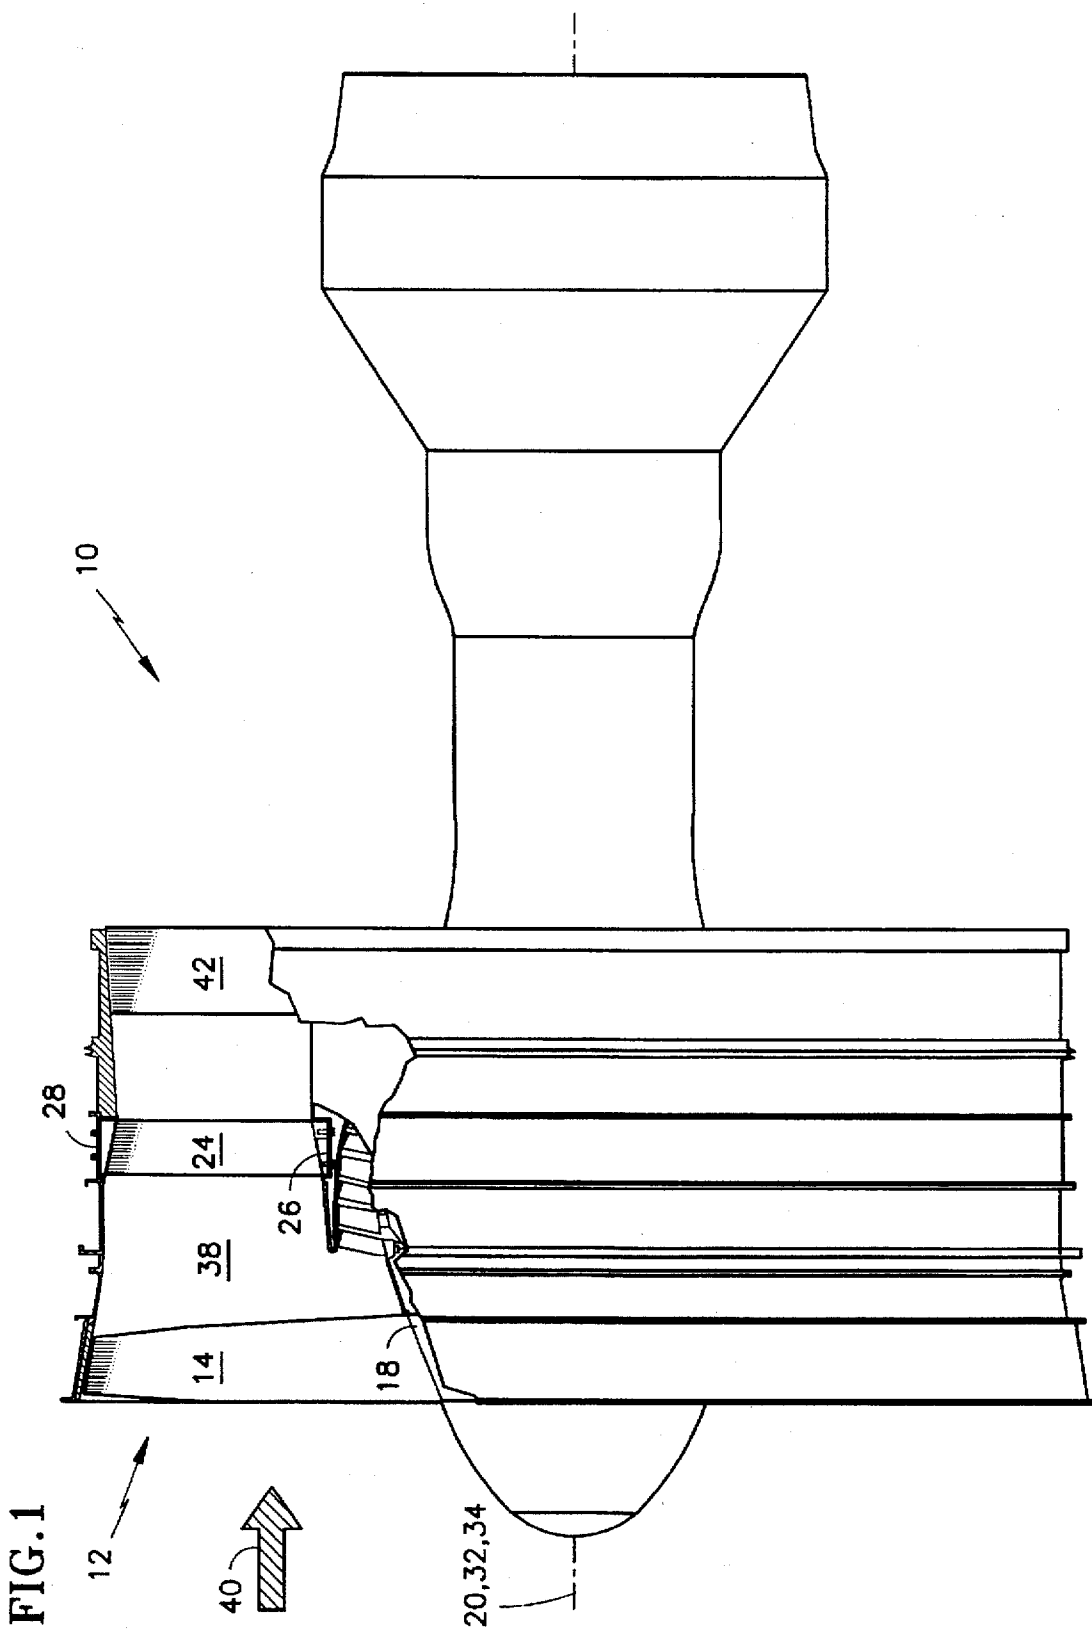
FIG. 1 is a schematic, partially sectioned side view of a turbine engine.

Referring to FIG. 1, a gas turbine engine 10 of the type used for aircraft propulsion includes a fan section 12 having an array of fan blades such as representative blade 14 extending radially outward from hub 18. The hub and blades are rotatable about an engine axis 20. The fan also includes an array of fan exit guide vane assemblies, such as representative guide vane assembly 24, which extends radially between inner and outer cases 26, 28 whose axes 32, 34 are common with the engine axis 20. A fan flowpath 38 extends through the fan section and a working medium fluid, such as air, flows through the flowpath in the direction generally indicated by directional arrow 40.

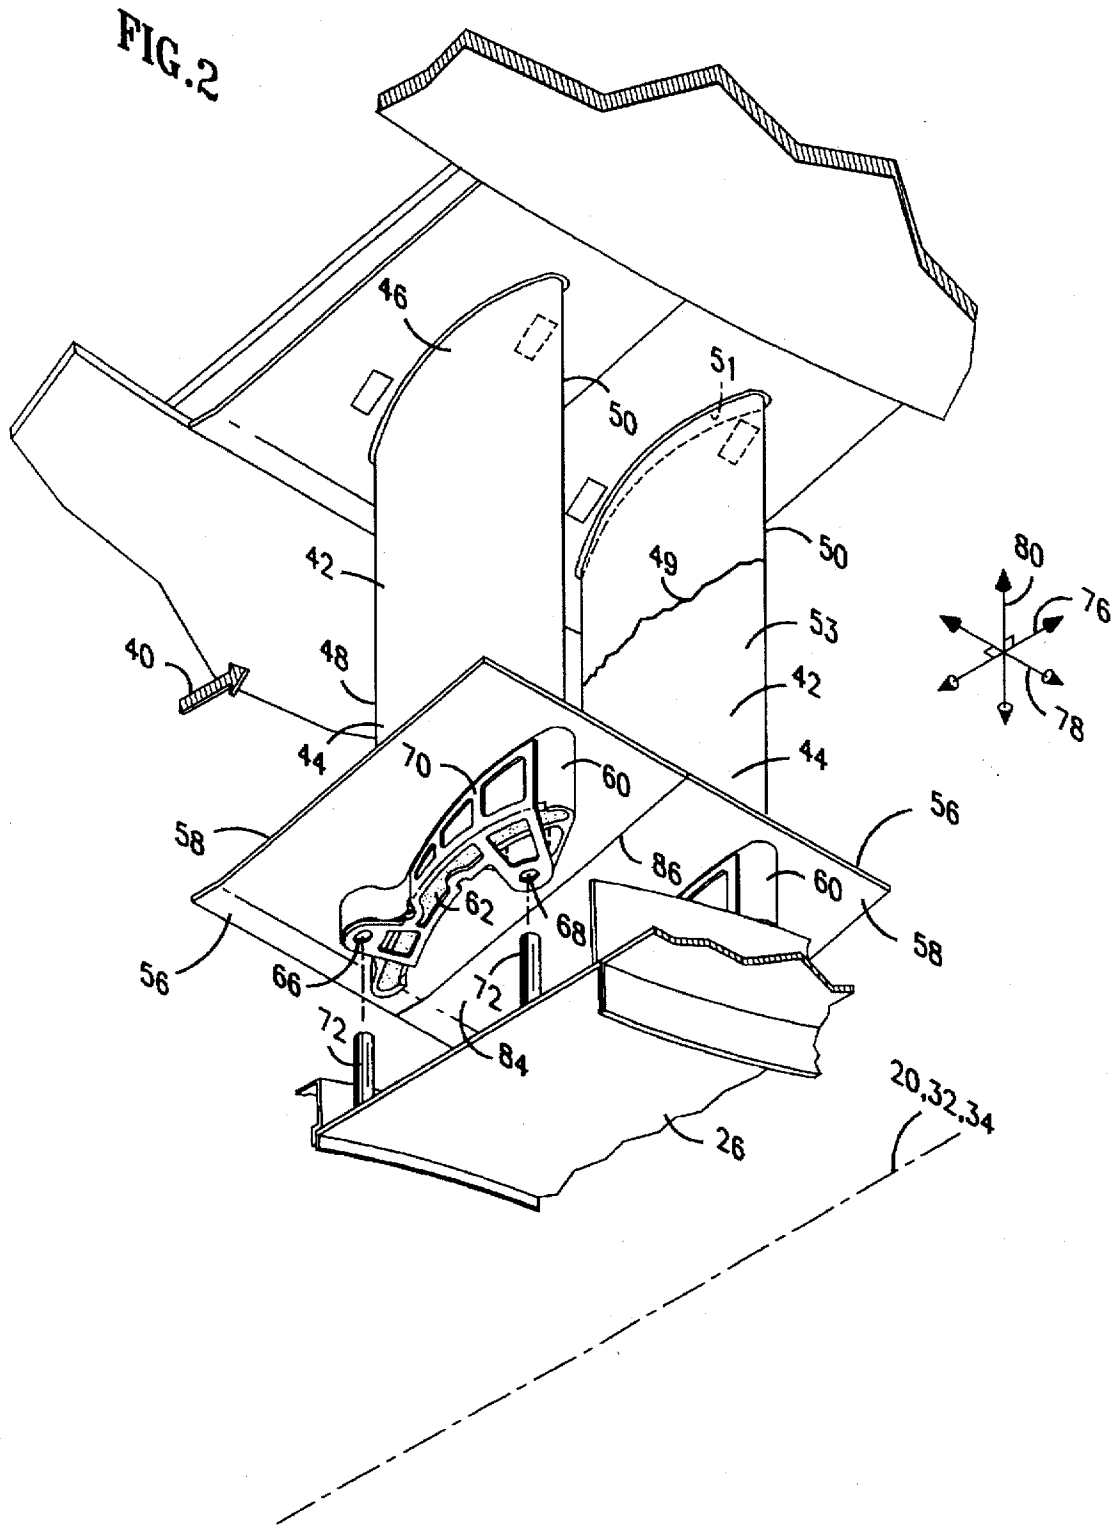
FIG. 3 is a partially exploded perspective view showing a portion of the fan section of a turbine engine including a fan exit guide vane assembly and the means by which the guide vane assembly is secured to an outer case.

Additional features of the vane assemblies are visible in FIGS. 2 and 3. Each vane assembly includes an airfoil 42 having an inner end 44 an outer end 46, a leading edge 48 and a trailing edge 50. Each vane assembly also includes a nonmetallic inner base 56 having a platform 58 and a sleeve 60 with a resilient polyurethane material 62 disposed therein. The inner end of the airfoil extends into the polyurethane material which damps airfoil vibrations and grips the inner end of the airfoil to attach the airfoil to the inner base. As discussed more fully in U.S. Pat. No. 5,411,370, the inner base also includes front and rear pin receptor sockets 66, 68 containing a polyurethane or silicone rubber material and a metallic shoe 70 which protects the base in the event of abnormal engine vibration. Each receptor socket corresponds to a support pin 72 extending radially outwardly from the inner case 26 (the view of FIG. 2 is slightly exploded so that the pins and receptor sockets are visible).

When fully assembled, each support pin engages its receptor socket to secure the inner base, and therefore the vane assembly, to the inner case, so that the base is radially spaced from the inner case to accommodate thermal expansion and contraction. The pinned connection secures the base to the inner case so that axial displacement (parallel to the engine axis as indicated by direction 76) and lateral displacement (tangent to the case as indicated by direction 78) are resisted while radial (direction 80) separation between the vane assembly and the case is unrestricted. Typically, a foam seal, not shown, is installed in the cavity 84 bounded by the inner case, the abutting platforms of neighboring inner bases and the sleeves associated with the neighboring inner bases. The foam seal minimizes leakage of air from the flowpath through seam 86 between abutting platforms.

The vane assembly also includes an outer base 90. The outer base has a platform 92 and a sleeve 94 with a polyurethane material 96 disposed therein. The outer end of the airfoil extends into the polyurethane material which damps airfoil vibrations and grips the outer end of the airfoil to attach the airfoil to the outer base. Stud 98 project radially outward from the outer base and extend through holes 100 in the outer case 28. (the view of FIG. 3 is slightly exploded so that the outer sleeve and studs are visible). Nuts 102 threaded onto the studs positively secure the outer base, and therefore the outer end of the vane assembly, to the outer case. A foam seal, not shown, is typically installed in the cavity 104 bounded by the outer case, the abutting platforms of neighboring outer bases and the sleeves associated with the neighboring outer bases. The foam seal minimizes leakage of air from the flowpath through seam 106 between abutting platforms.

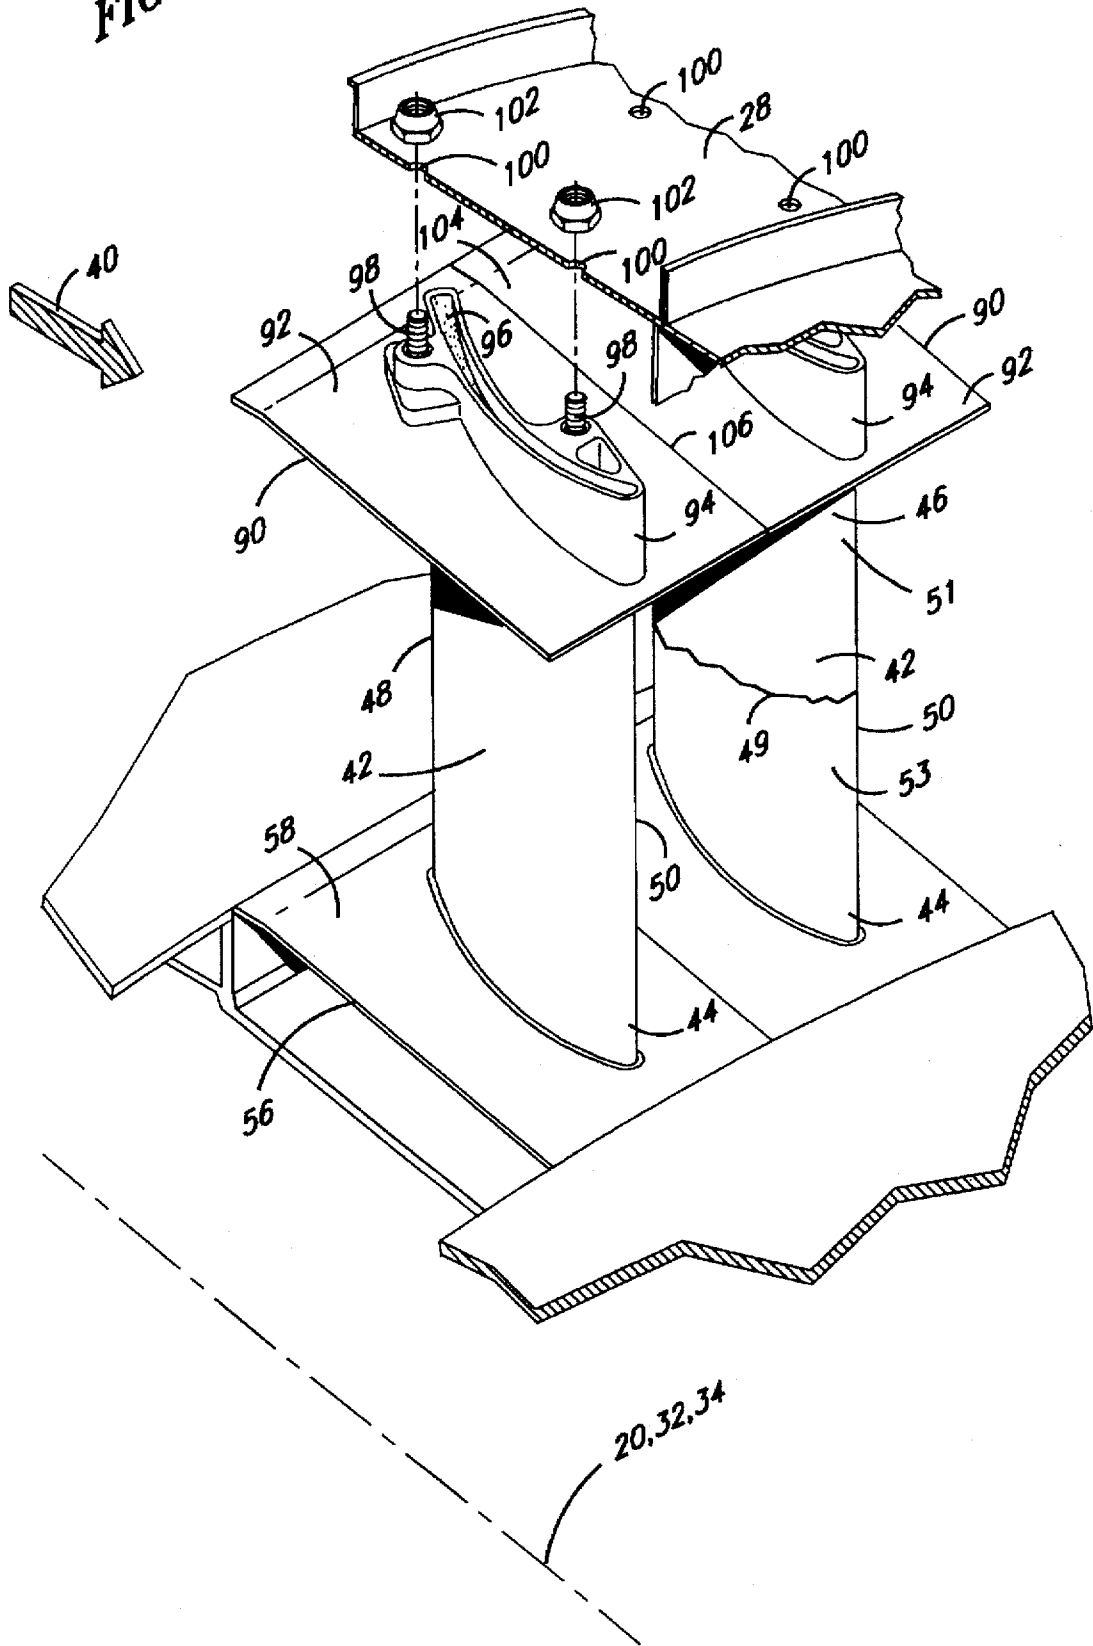
FIG. 4 is a schematic illustration of a portion of a fan exit guide vane array viewed parallel to the rotational axis of a turbine engine to demonstrate a prior art method of replacing an unserviceable vane assembly.

An alternate technique for removing and replacing a vane assembly is referred to as "shingling". Referring to FIG. 4, a sector 110 of neighboring vane assemblies, which are circumferentially adjacent to an unserviceable vane assem-

bly 24a (or the opening left by a previously removed vane assembly), is identified. The outer end of the vane assembly 24b most remote from the unserviceable vane assembly is disconnected from the circumscribing fan case 28. The disconnected vane assembly is slid radially inwardly along its case support pins 72 so that its outer platform is radially displaced from the platforms of its neighbors 24c, 24d. A circumferentially directed force, such as force F, is applied to the outer end of the vane assembly. The resilient polyurethane material in the pin receptor sockets 66, 68 (FIG. 2) deforms elastically in response to the force so that the vane assembly tilts away from the unserviceable vane assembly without becoming disengaged from the support pins. The outer end of the vane assembly is urged circumferentially until its outer platform 92b overlaps or "shingles" the outer platform 92c of its neighbor. Each vane assembly in the sector is similarly disconnected and shingled with its neighbor. By shingling a large enough sector of vane assemblies, sufficient circumferential clearance is accumulated that the unserviceable vane assembly 24a, if not previously removed, can also be tilted circumferentially and disengaged from its support pins. The unserviceable vane assembly is then removed axially from the vane array and a serviceable vane assembly is installed by reversing the procedure just described. While this shingling procedure is simpler and less time consuming than disassembling the fan section, it is nevertheless labor intensive, requiring approximately six hours of effort by a qualified mechanic to replace a single vane assembly.

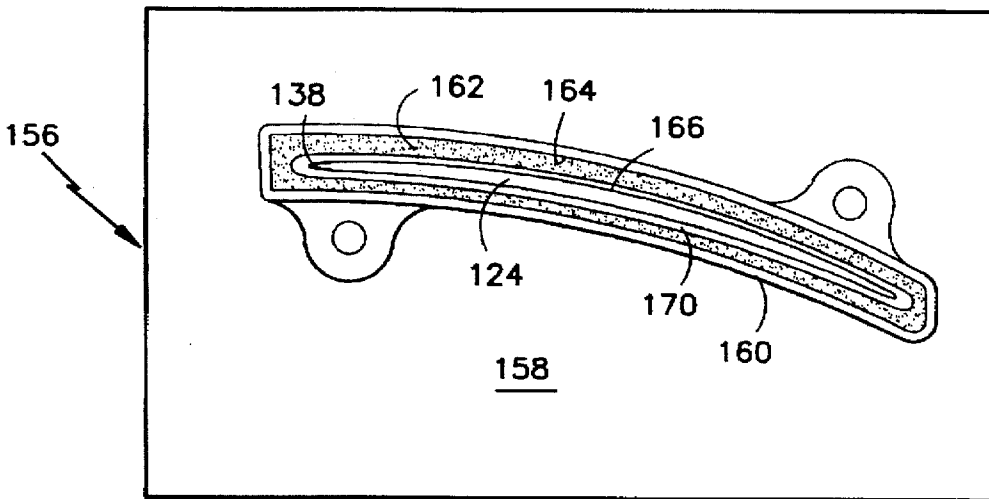
FIG. 6 is a plan view, taken essentially in the direction 6—6 of FIG. 5 showing further details of the opposing base.

Referring now to FIGS. 5, 6 and 7, a repair kit for substantially simplifying the replacement of an unserviceable fan exit guide vane assembly is illustrated. The repair kit includes a serviceable vane subassembly 120 comprising a serviceable airfoil 124 having a leading edge 126 a trailing edge 128, a tip end 130, a root end 132 and a nonmetallic base 134 attached to the root end. The airfoil is a resin impregnated carbon fiber compression molded airfoil having an erosion resistant coating and a stainless steel erosion guard 138 extending along the leading edge. The airfoil may, however, be made of aluminum or any other suitable material. The chord C (FIG. 7) of the airfoil extends generally from the leading edge to the trailing edge and the span S of the airfoil extends generally from the root to the tip. The attached base 134 has a platform 140 and a sleeve 142 with a resilient polyurethane vibration damping material 144 disposed therein. The root end of the serviceable airfoil extends into the polyurethane material which grips the root end to attach the serviceable airfoil to the base and to damp vibrations of the airfoil. The attached base also includes front and rear pin receptor sockets 148, 150 containing a polyurethane or silicone rubber material and a metallic shoe 152 which protects the base in the event of abnormal engine vibration. The repair kit also includes an opposing base 156 comprising a platform 158 and a sleeve 160. A polyurethane vibration damping material 162 (FIG. 6) is bonded to interior wall 164 of the sleeve leaving an opening 166 which is slightly larger than but generally of the same shape as the serviceable airfoil 124. The opposing base 156 is unattached to the serviceable airfoil but, because opening 166 is larger than the airfoil, is slidably engagable with the airfoil. That is, the opposing base can be slipped over the tip end of the airfoil and slid in the spanwise direction toward the attached base 134 so that the tip end of the airfoil projects through and is embraced by the sleeve. When so engaged, the damping material in the sleeve cooperates with the serviceable airfoil to define a peripheral gap 170 around the perimeter of the airfoil.

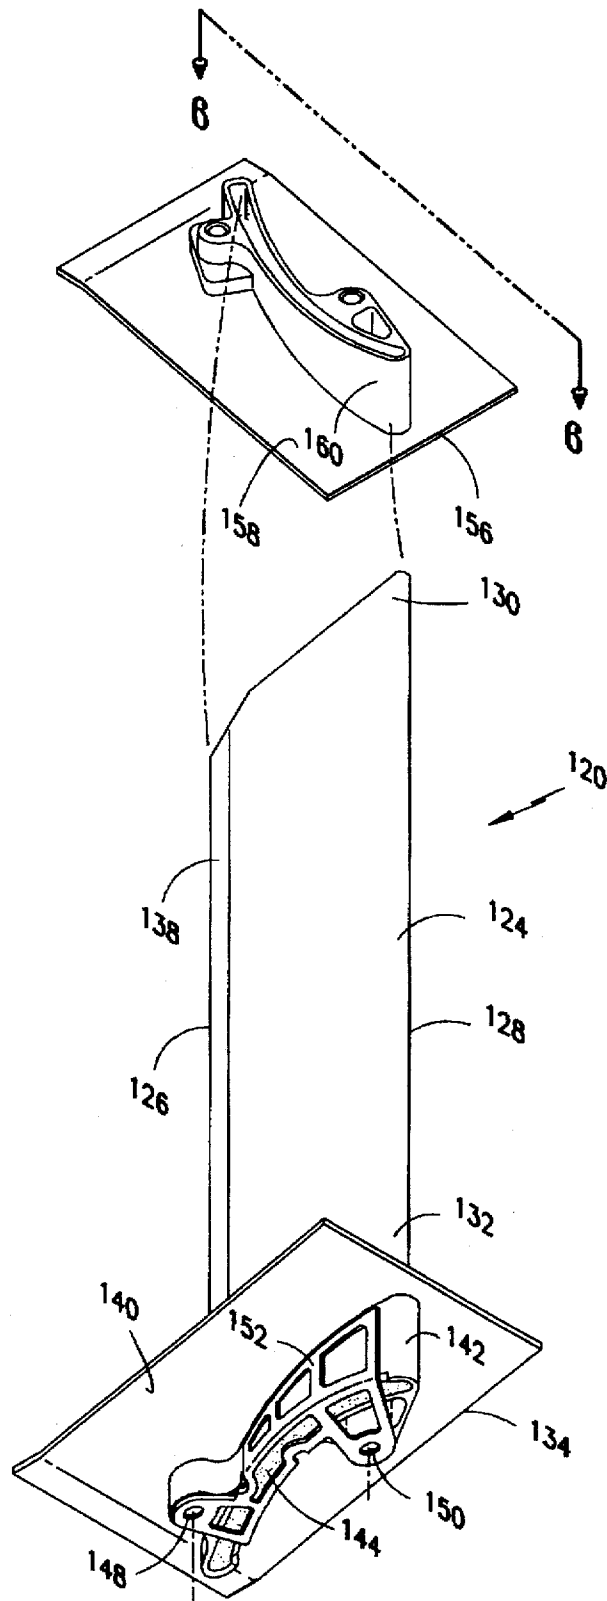
FIG. 7 is a side view of a serviceable vane subassembly of the present invention.

The tip of the serviceable airfoil, unlike that of the prior art airfoil, has a tapered region 174 from approximately 28% chord to 100% chord (i.e. to the trailing edge) so that the trailing edge span  $S_T$  is approximately 97% as great as the leading edge span  $S_L$ . In addition, the span of the leading edge of the serviceable airfoil is approximately 98% of the leading edge span of an unserviceable airfoil. As explained more fully below, the taper and reduced span of the serviceable airfoil facilitate the installation of the serviceable vane subassembly into the vane array.

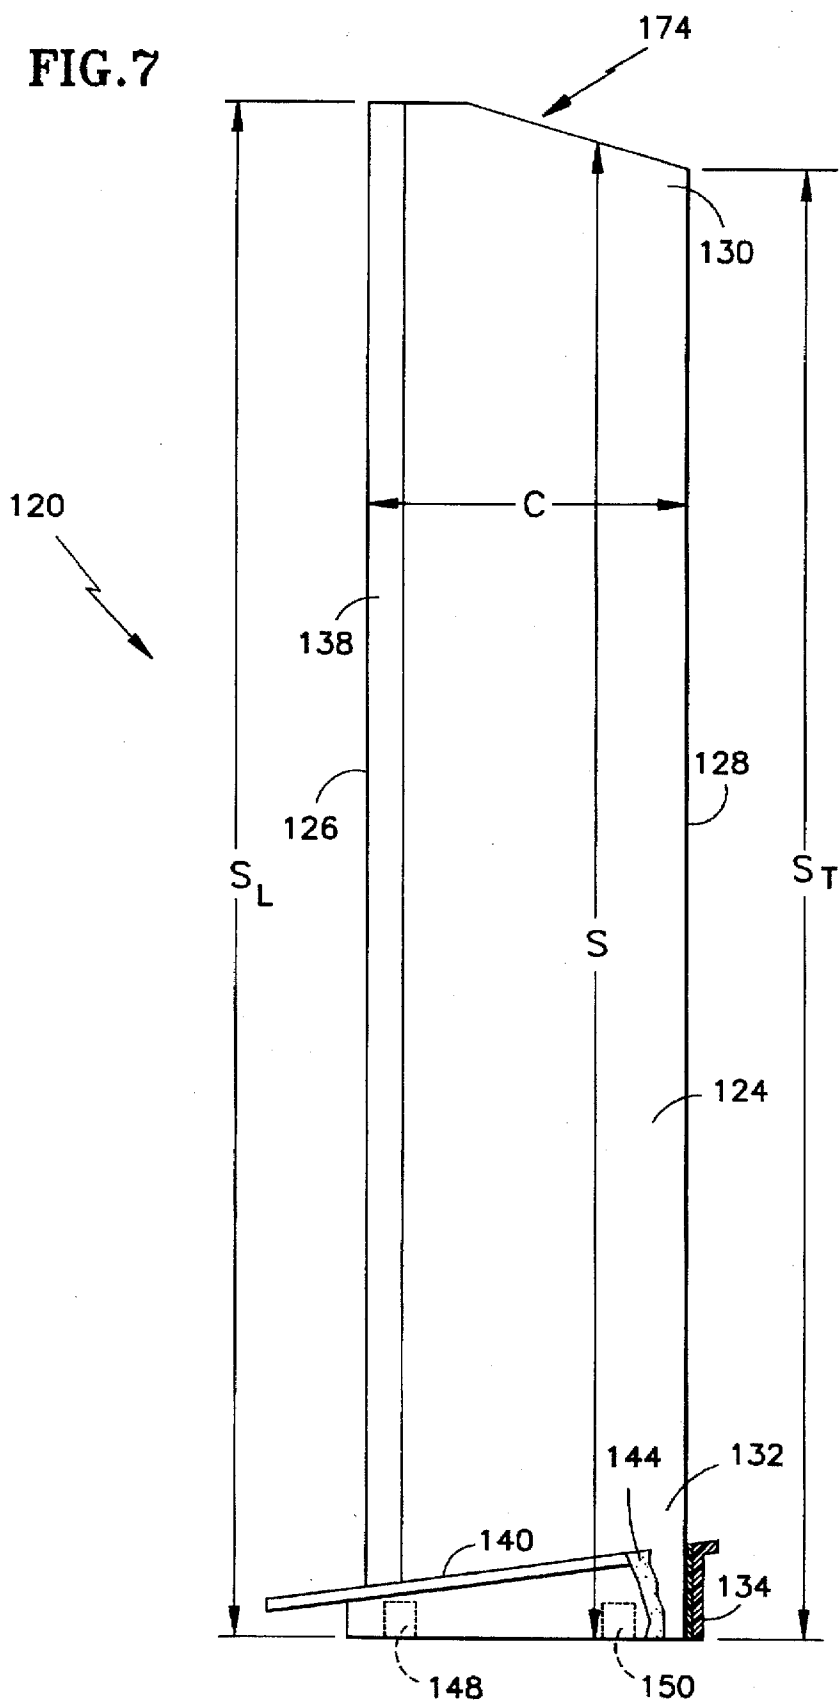
FIG. 8 is a side view of a serviceable vane subassembly and an opposing base of the present invention partially pivoted into position between an inner case and an outer case.

Referring now to FIGS. 8, 9, and 10, the method of replacing the unserviceable vane assembly includes sliding the opposing base 156 over the tip end 130 of the serviceable airfoil 124 and spanwisely toward the attached base so that the serviceable airfoil projects through and is embraced by the opposing base. The serviceable vane subassembly and opposing base are positioned, as best seen in FIG. 8, so that the attached base is in close proximity to the inner case 26 and the forward receptor socket 148 is partially engaged with its corresponding support pin 72. The subassembly is pivoted about an essentially lateral axis 176 and is urged radially inwardly along the support pins until each support pin completely engages its receptor socket. The tapered region 174 at the tip end 130 of the serviceable airfoil, along with the reduced length of the airfoil in comparison to a prior art airfoil, prevent interference between the tip end and the outer case 28 as the vane subassembly is pivoted into position. A urethane adhesive 182 is applied to the serviceable airfoil near its tip end so that the opposing base can subsequently be bonded to the tip end of the serviceable airfoil. In the preferred embodiment, the adhesive is applied around the entire perimeter of the airfoil and, as seen best in FIG. 8, extends from the extremity of the tip end toward the root a distance  $d_1$  approximately equal to the depth  $d_2$  of the damping material 162 to ensure completeness of the bond between the base and the airfoil.

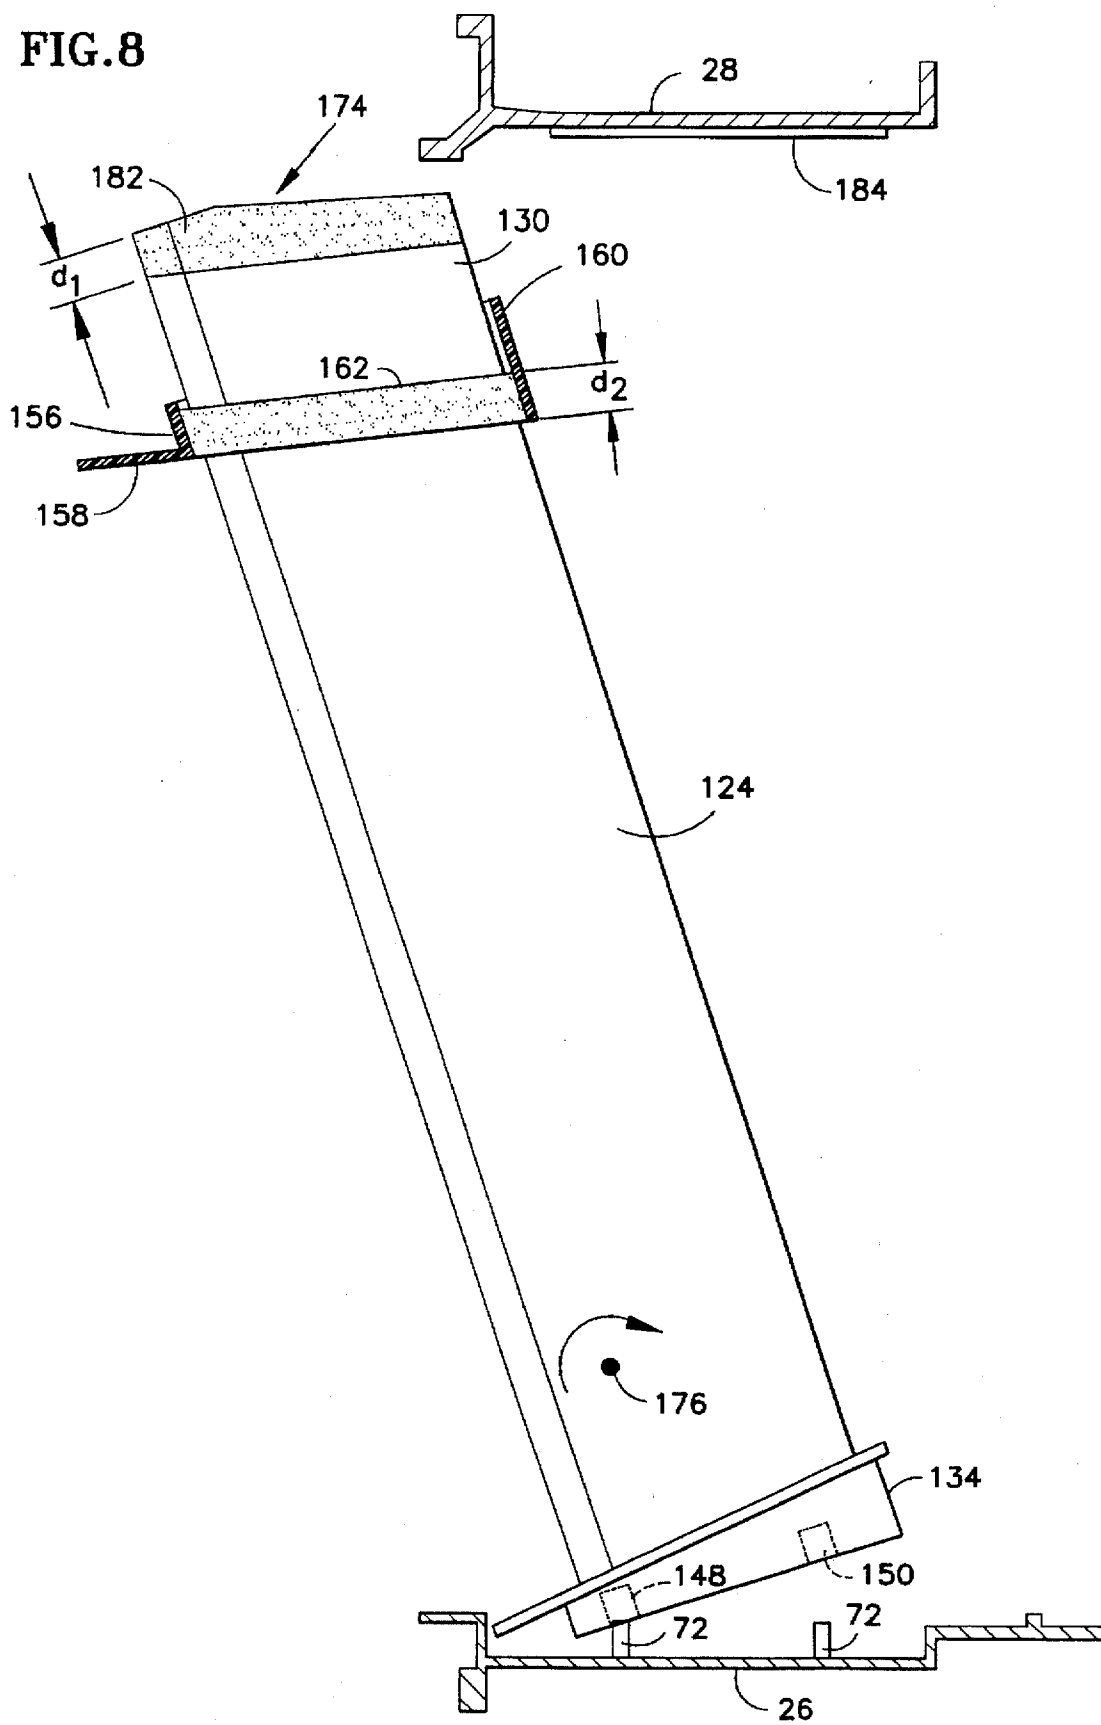
FIG. 9 is a side view of a serviceable vane subassembly and an opposing base of the present invention after having been installed between an inner case and an outer case.

Once the subassembly has been pivoted into position between the inner and outer cases, the opposing base is translated radially outward toward the tip end of the airfoil so that the adhesive 182, which cures in approximately four hours at 21 degrees C. (70 degrees F.), bonds the airfoil to the damping material 162 (FIG. 6) and therefore attaches the base to the airfoil. In the preferred embodiment a mask 184 is applied to the outer case prior to translating the opposing base radially outward. The mask may be a polyester film masking tape or any other mask which adheres nonpermanently to the case. Any adhesive 182 which is squeezed out of the peripheral gap 170 (FIG. 6) during the radially outward translation of the outer base contacts the tape rather than the outer case. Thus, the mask guards against the formation of an adhesive bond between the opposing base or airfoil and the outer case, thereby ensuring that the airfoil and the opposing base can, if necessary, be subsequently disassembled from the outer case. A retainer, which in the preferred embodiment is a metallic peg 188, is inserted into holes 190, 192 in the airfoil and opposing base so that the peg protrudes slightly into the fan flowpath 38 (FIG. 10).

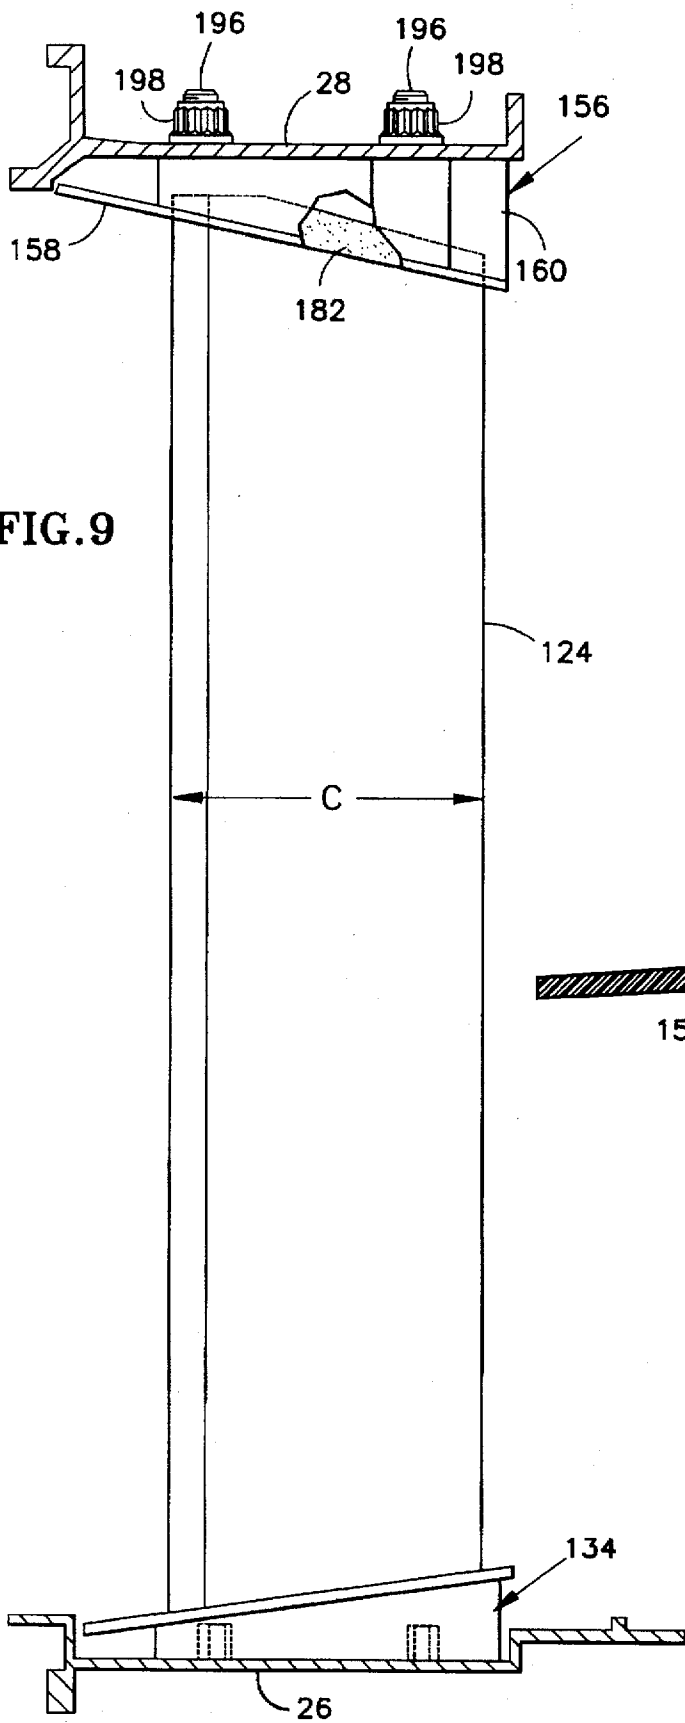
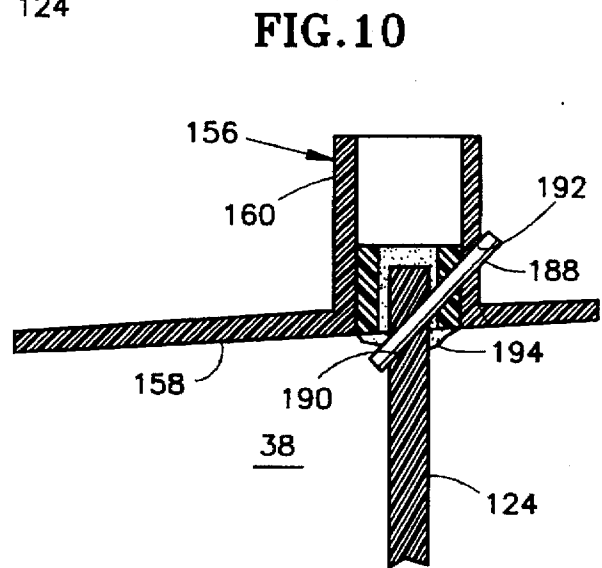
FIG. 10 is a view taken parallel to the engine axis showing a retaining pin projecting through a hole in the outer end of a serviceable airfoil and into an opposing base.

The retainer positions the opposing base relative to the airfoil and limits the displacement of the opposing base relative to the vane subassembly in the event that the adhesive bond between the airfoil and the opposing base fails. An additional quantity 194 of adhesive is applied to the juncture of the airfoil and the damping material to augment the bond and to hold the retaining peg in place. As seen best in FIG. 9, the opposing base is positively secured to the outer case by studs and nuts 196, 198 so that platform 158 is flush with the neighboring platforms (as seen in FIG. 2 for a prior art fan blade array).
