[54] METHOD OF DETECTING DEFECTIVE PORTIONS OF METALLIC TANK HAVING THERMALLY PROTECTIVE COATING OF POLYURETHANE FOAM

[73] Assignee: Nippon Oil Company, Limited, Tokyo, Japan

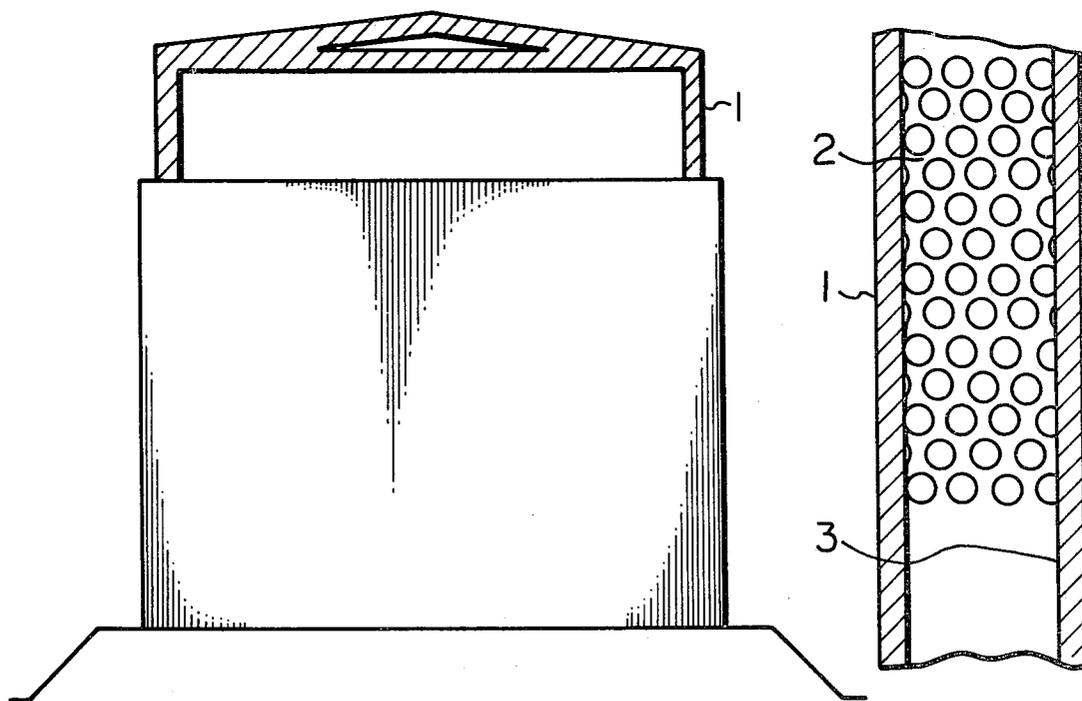
Fig. 1

FIG. 1 shows a tank in side elevation with a protective coating applied on the side walls thereof, and an enlarged detail of the applied protective coating of a polyurethane-forming composition;

Since about 1969, there has been adopted a method of construction wherein a protective coating of rigid polyurethane foam is formed in situ on the side wall of the tank by gun-spraying. This is because such a method is advantageous in various aspects. Among others, this material can be of a closed cell structure and, thus, when compared with the conventional thermally protective porous or fibrous materials, it has a reduced water regain or water uptake and exhibits an enhanced ability of keeping warmth. In addition, thereto, no covering material, such as zinc-plated steel panel is required. The cost of construction is cheap. The period of time required for construction is short. It is easy to repair, and no scaffold is required. As shown in FIG. 1, the coating of polyurethane foam may be applied to the side wall of the tank by spraying onto the outer surface of side wall 1 of the tank a rigid polyurethane-forming composition, primarily comprised of at least one polyol and at least one polyisocyanate, together with a foaming agent, such as "Freon", to form a layer of foamed polyurethane 2.

In order to impart flame retardant properties to the resulting rigid polyurethane foam, halogen- or phosphorus-containing organic compounds may be usually added to the polyurethane-forming composition, or polyurethane-forming reactants containing halogen and/or phosphorus atoms in the molecule may be employed. If desired, a fire proof coating 3 may be applied by spraying on the outer surface of the rigid polyurethane foam coating 2.

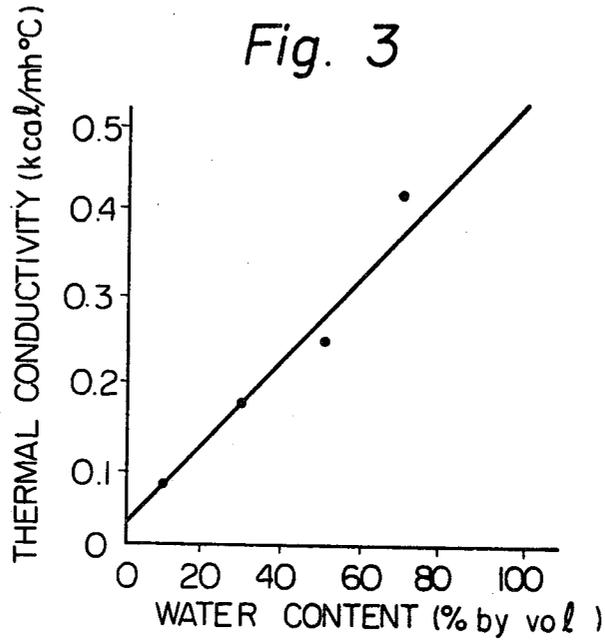
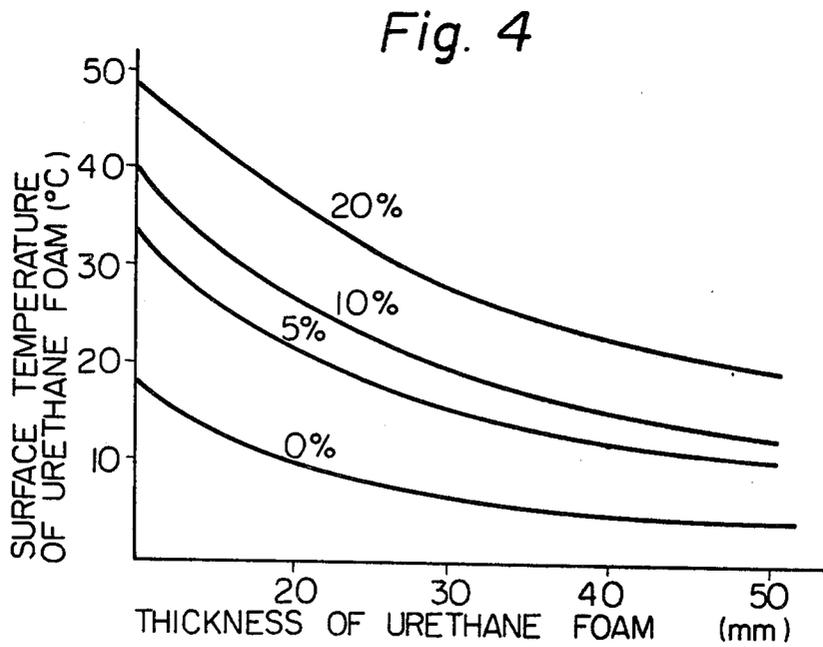
FIG. 4 shows the relationship between the surface temperature of polyurethane foam and the thickness thereof at different water contents;

It is reasonably expected that the surface temperature of the polyurethane foam will depend not only upon the water content of the foam but also upon the thickness of the foam. Therefore, we have checked the relation between the surface temperature and the thickness of the coating with respect to each of various coatings of polyurethane foam with different water contents. The results are shown in FIG. 4.

As a result, it has been found that within the practical thickness range of at least about 20 mm, the surface temperature of the coating is affected by the water content of the coating to a greater extent than by the thickness of the coating. This means that a slight variation in the thickness of the sprayed and foamed layer of polyurethane does not seriously affect the surface temperature of the resultant coating of polyurethane foam, and suggests that it is possible to determine approximate water contents of sections of the polyurethane foam coating of the tank by measuring surface temperatures of the respective sections of the coating.

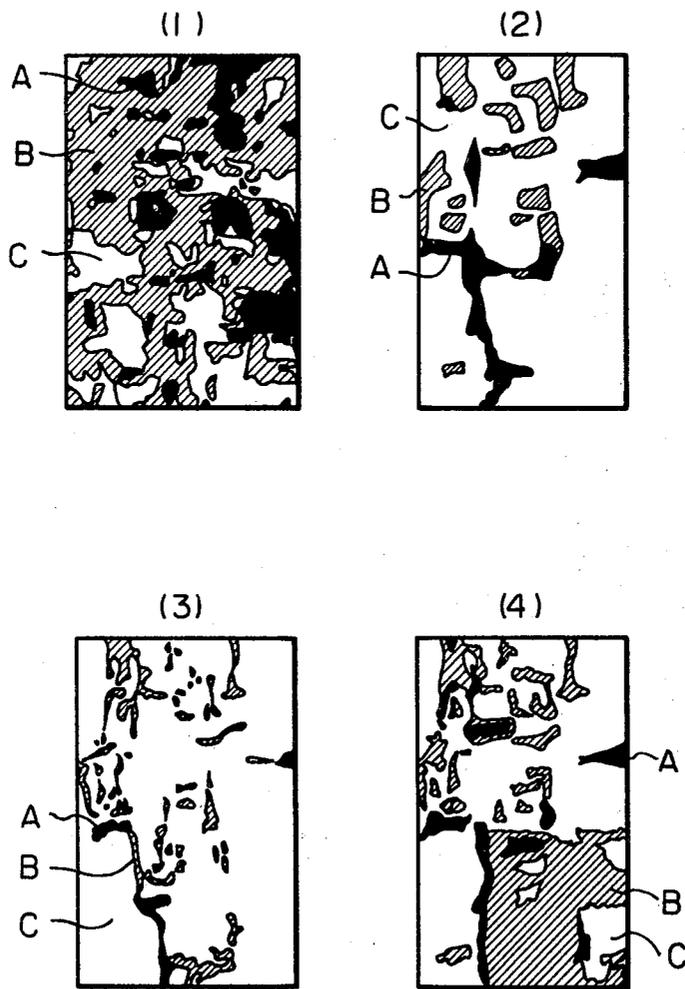
Fig. 5

FIG. 5 (1) shows a section of a coating of polyurethane foam peeled from a tank showing the distribution of the thickness of the foam;

FIG. 5 (2) shows the section of the coating of polyurethane foam peeled from the tank showing the distribution of water contents of the foam;

FIG. 5 (3) shows the distribution of corroded areas in the side wall of the tank; and

FIG. 5 (4) shows the section of the coating of the polyurethane foam peeled from the tank showing the distribution of the surface temperatures of the foam.

Using a thermography device applicable for detecting temperatures of -20°C. to 1850°C. , and having a temperature resolution ability of 0.1°C. and the number of image elements of 20,000, an infrared thermal image of a polyurethane coated tank filled with fuel oil at 75°C. was taken at night. The coating of polyurethane foam was peeled off and cut into small square sections. For each section of polyurethane foam, the thickness and water content were determined and the area of the side wall underlying the section was examined so as to find the extent of corrosion. The results are shown in FIGS. 5 (1) through (4). FIG. 5 (1) shows the distribution of thickness of the foam, in which A stands for relatively thick sections, B for sections of intermediate thickness and C for relatively thin sections. FIG. 5 (2) shows the distribution of water contents of the foam, in which A stands for sections of relatively high water uptake, B for sections of intermediate water uptake and C for relatively low water uptake. FIG. 5 (3) shows the distribution of corroded areas in the side wall of the tank, in which A stands for fairly corroded areas, B for slightly corroded areas and C for non-corroded areas. FIG. 5 (4) shows the distribution of surface temperatures of the foam, in which A stands for sections of relatively high temperatures, B for sections intermediate temperatures and C for sections of relatively low temperatures.

It can be seen from FIGS. 5 (2), (3) and (4) that the distribution of the distribution of surface temperatures of the polyurethane foam depicted in FIG. 5 (4) fairly

corresponds to the distribution of water contents of the foam shown in FIG. 5 (2) and to the distribution of corroded areas in the side wall as shown in FIG. 5 (3). Furthermore, FIG. 5 (1) reveals that the involved variation in the thickness of the foam is totally irrelevant to the distributions of the other parameters.
