(10) **Patent No.:** **US 9,085,010 B2**

(54) **COATING FOR COOLING AIR HOLES**

(71) Applicant: **United Technologies Corporation**,  
Hartford, CT (US)

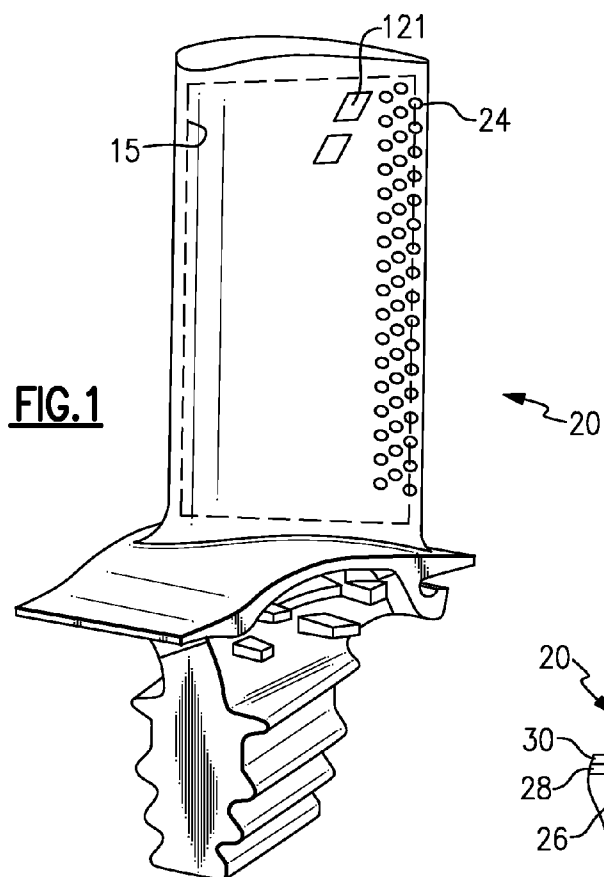
FIG. 1 shows a component 20 which may typically be a gas turbine engine turbine blade or vane. The component has a coating, as known, and the coating has been distressed as shown schematically at 121. This may be the coating breaking away from the surface of the component 20, and may be a problem known as spallation or liberation. The coating may be a thermal barrier coating which is typically used to assist the component in surviving in the extreme temperatures faced during normal operation. However, other type coatings may benefit from the teaching of this application.

A plurality of cooling air holes 24 are shown in the component 20. As known, the component 20 has internal cavities, shown in phantom at 15. Those cavities receive air, as known, and may deliver the air outwardly to a skin of the component through the cooling air holes 24.

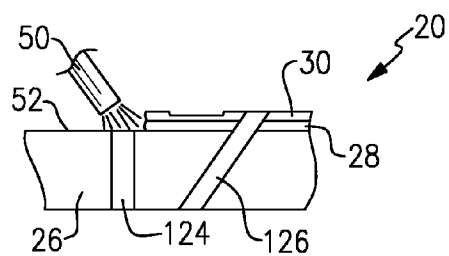
FIG. 2A shows a first step in repairing the coating on the component 20. As shown, the component 20 has a base metal 26, an outer bond layer 28 on the base metal, and the coating layer 30. The coating layer 30 may be a thermal barrier coating. As shown, cooling air holes 124 and 126 extend through both coating layers 28 and 30. For original equipment manufacture, the cooling air holes 124 and 126 may be cut through the coating layers 28 and 30, and the body 26 at the same time. As shown, there is a distressed area 121 which is requiring the component be recoated.

Holes used for this sort of function may be on the order of 0.020-0.050 inch (0.050-0.127 cm). Holes such as hole 124, may be drilled normal to the surface, and may be angled in a range of 20-45 degrees.

Thus, as shown in FIG. 2B, a cleaning instrument, such as a water jet tool, shown schematically at 50, removes the coating layers 28 and 30. As shown, there is a "cleaned" area 52. Once the component has its entire coating 28 and 30 removed, subsequent bond coating 54 and a subsequent coating, such as the thermal barrier coating 56, are deposited on the metal body 26.

As can be appreciated from FIG. 2C, there will be dimples 58 associated with the coatings aligned with the openings 124 and 126 in the recoated component 120. These dimples provide an indication of the location of the underlying holes, but require removal before the component can be returned to operation.

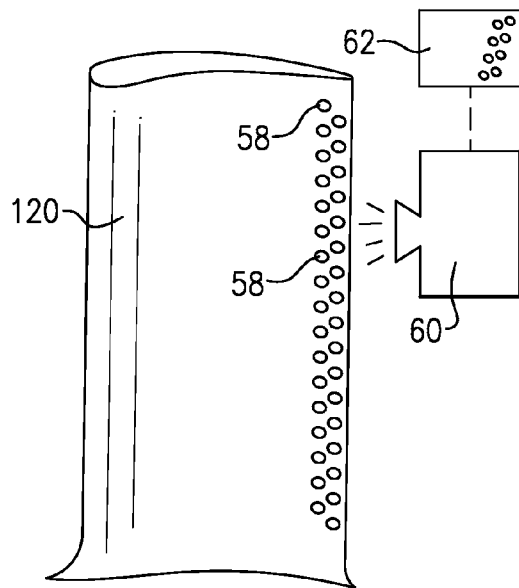
**FIG. 4A**

FIG. 4A shows the component 120 after the depositing of the coating as shown in FIG. 2C. As shown, there are a plurality of dimples or indicators 58 associated with the cooling air holes.

Some visual inspection technique will be utilized to determine the location of these dimples, or other indicators, of an underlying hole underneath the coating layers. This is shown as a visual camera 60 communicating with an appropriate electronic machine such as a computer 62. A map of the location of the dimples 58 is captured and stored in the computer 62. White light inspection, blue light inspection or other vision systems, laser scanning or simple or complex part probing may be utilized to capture the location of the dimples 58.

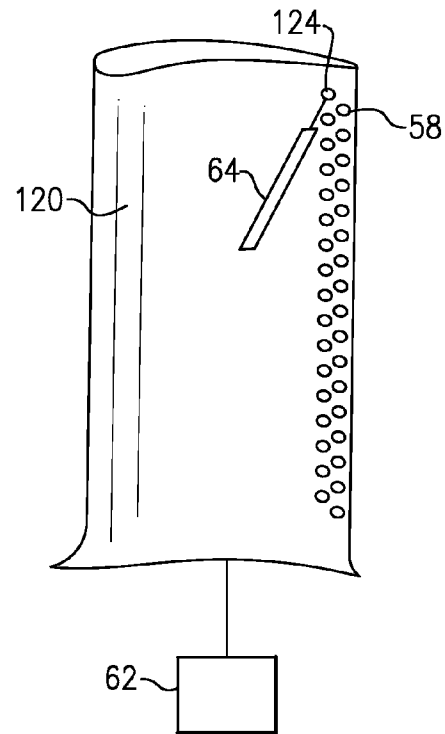
**FIG. 4B**

Once the location of the dimples is found, the holes are recut through the new coating as shown in FIG. 4B. A cutting tool, such as a water jet or laser 64 communicates with the computer 62 and utilizes the previously identified location of the indicators to control where to clean the holes as shown at 124. In addition, the newly captured location of the dimples may be utilized in combination with the known location where the holes were believed to have been formed initially.

The term "tool" is broadly intended in this application. As an example, the water jet or laser 64 would be a "tool." Other tools may include mechanical means, including grinding or drilling. Also, abrasive techniques could be utilized, such as grit or sandblasting. Finally, electro-discharge machining is an option. All of these would come under the broad term "tool" as would other methods of removing the material.

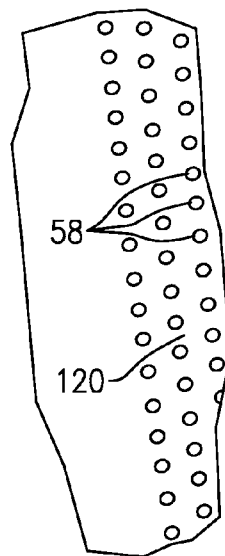
**FIG. 3**

FIG. 3 shows these dimples or other indicators 58 on the side of a component 120.
