(12) **EUROPEAN PATENT APPLICATION**

(71) Applicant: **RTX Corporation**  
**Farmington, CT 06032 (US)**

(54) **ARTICLE AND METHOD OF MAKING AN ARTICLE BY CHEMICAL VAPOR INFILTRATION**

(57) A method of repairing a nonconforming article (102) includes applying a machinable coating (106) to an article (102) with a nonconformance (104). The article (102) includes a preform at least partially infiltrated with a matrix material, to form a repaired article (100). The

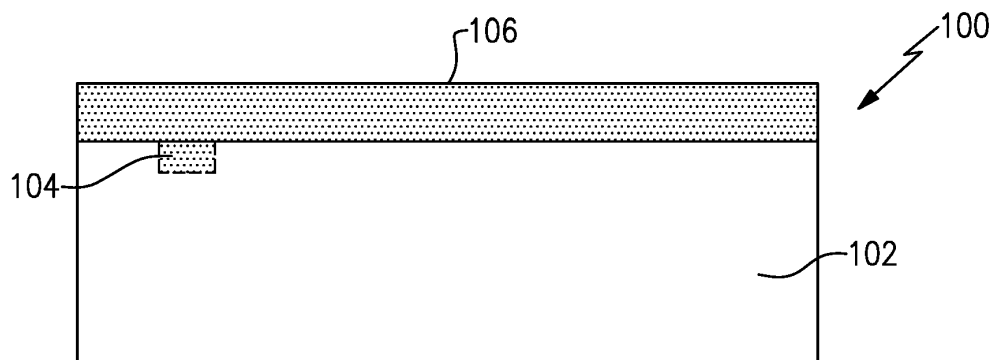
**FIG.2**

method also includes machining the machinable coating (106) and completing infiltration of the repaired article (100) with the matrix material. A method of repairing an article (100) is also disclosed.

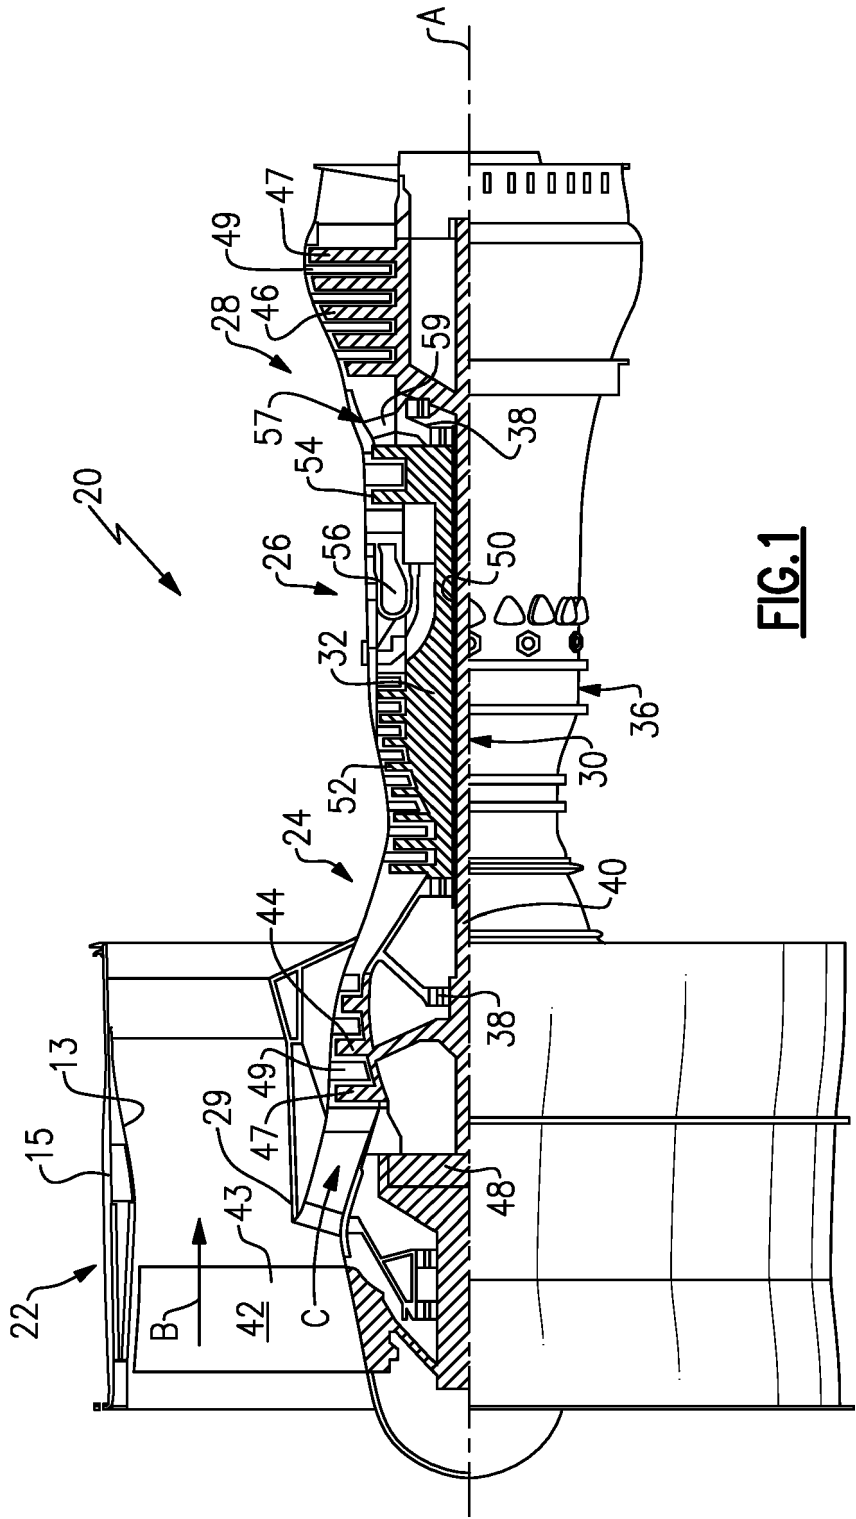
**FIG.1**

Figure 1 schematically illustrates an example gas turbine engine.

**[0024]** Figure 1 schematically illustrates a gas turbine engine 20. The gas turbine engine 20 is disclosed herein as a two-spool turbofan that generally incorporates a fan section 22, a compressor section 24, a combustor section 26 and a turbine section 28. The fan section 22 may include a single-stage fan 42 having a plurality of fan blades 43. The fan blades 43 may have a fixed stagger angle or may have a variable pitch to direct incoming airflow from an engine inlet. The fan 42 drives air along a bypass flow path B in a bypass duct 13 defined within a housing 15 such as a fan case or nacelle, and also drives air along a core flow path C for compression and communication into the combustor section 26 then expansion through the turbine section 28. A splitter 29 aft of the fan 42 divides the air between the bypass flow path B and the core flow path C. The housing 15 may surround the fan 42 to establish an outer diameter of the bypass duct 13. The splitter 29 may establish an inner diameter of the bypass duct 13. Although depicted as a two-spool turbofan gas turbine engine in the disclosed nonlimiting embodiment, it should be understood that the concepts described herein are not limited to use with two-spool turbofans as the teachings may be applied to other types of turbine engines including three-spool architectures. The engine 20 may incorporate a variable area nozzle for varying an exit area of the bypass flow path B and/or a thrust reverser for generating reverse thrust.

**[0025]** The exemplary engine 20 generally includes a low speed spool 30 and a high speed spool 32 mounted for rotation about an engine central longitudinal axis A relative to an engine static structure 36 via several bearing systems 38. It should be understood that various bearing systems 38 at various locations may alternatively or additionally be provided, and the location of bearing systems 38 may be varied as appropriate to the application.

**[0026]** The low speed spool 30 generally includes an inner shaft 40 that interconnects, a first (or low) pressure compressor 44 and a first (or low) pressure turbine 46. The inner shaft 40 is connected to the fan 42 through a speed change mechanism, which in the exemplary gas turbine engine 20 is illustrated as a geared architecture 48 to drive the fan 42 at a lower speed than the low speed spool 30. The inner shaft 40 may interconnect the low pressure compressor 44 and low pressure turbine 46 such that the low pressure compressor 44 and low pressure turbine 46 are rotatable at a common speed and in a common direction. In other embodiments, the low pressure turbine 46 drives both the fan 42 and low pressure compressor 44 through the geared architecture 48 such that the fan 42 and low pressure compressor 44 are rotatable at a common speed. Although this application discloses geared architecture 48, its teaching may benefit direct drive engines having no geared architecture. The

high speed spool 32 includes an outer shaft 50 that interconnects a second (or high) pressure compressor 52 and a second (or high) pressure turbine 54. A combustor 56 is arranged in the exemplary gas turbine 20 between the high pressure compressor 52 and the high pressure turbine 54. A mid-turbine frame 57 of the engine static structure 36 may be arranged generally between the high pressure turbine 54 and the low pressure turbine 46. The mid-turbine frame 57 further supports bearing systems 38 in the turbine section 28. The inner shaft 40 and the outer shaft 50 are concentric and rotate via bearing systems 38 about the engine central longitudinal axis A which is collinear with their longitudinal axes.

**[0027]** Airflow in the core flow path C is compressed by the low pressure compressor 44 then the high pressure compressor 52, mixed and burned with fuel in the combustor 56, then expanded through the high pressure turbine 54 and low pressure turbine 46. The mid-turbine frame 57 includes airfoils 59 which are in the core flow path C. The turbines 46, 54 rotationally drive the respective low speed spool 30 and high speed spool 32 in response to the expansion. It will be appreciated that each of the positions of the fan section 22, compressor section 24, combustor section 26, turbine section 28, and fan drive gear system 48 may be varied. For example, gear system 48 may be located aft of the low pressure compressor, or aft of the combustor section 26 or even aft of turbine section 28, and fan 42 may be positioned forward or aft of the location of gear system 48.

**[0028]** The low pressure compressor 44, high pressure compressor 52, high pressure turbine 54 and low pressure turbine 46 each include one or more stages having a row of rotatable airfoils. Each stage may include a row of vanes adjacent the rotatable airfoils. The rotatable airfoils are schematically indicated at 47, and the vanes are schematically indicated at 49.

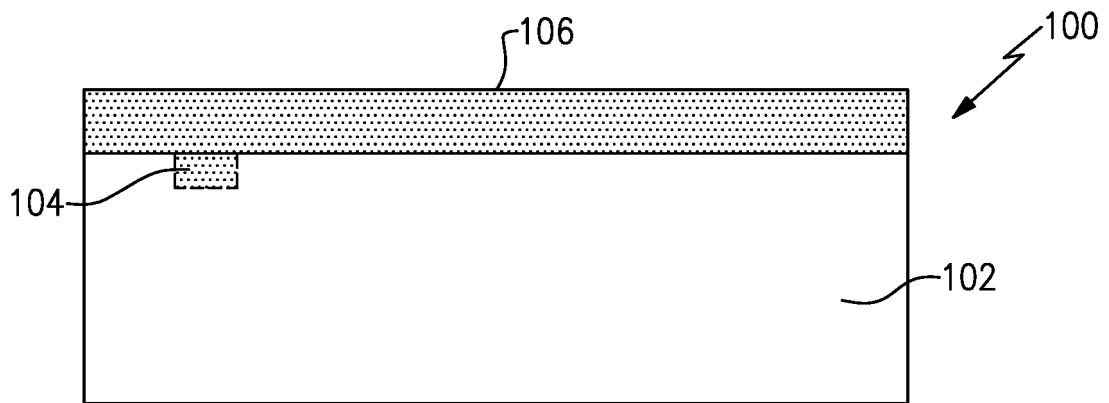
**FIG.2**

Figure 2 schematically illustrates an article with a defect that has been repaired.

**[0033]** Figure 2 schematically illustrates a repaired article 100. The repaired article 100 includes a nonconforming article 102 with a nonconformance 104 which in this case is a dent/depression, hole, or the like. In order to repair the nonconforming article 102 during the CVI process, the nonconforming article is removed from the reactor in which CVI is being performed when the preform is only partially infiltrated with matrix material. In one particular example, the nonconforming article 102 is removed from the reactor towards the end of the CVI process, when at least about 50% of the desired matrix has been infiltrated into the preform. In a more particular example, at least about 75% of the desired matrix has been infiltrated into the preform when the nonconforming article 102 is removed from the CVI reactor.

**[0034]** A machinable coating 106 is applied to a surface of the nonconforming article 102, filling in the nonconformance 104. The coating 106 is "machinable" in that it can be subject to grinding, ultrasonic machining, water guided laser, milling, reaming, or another machining method to reduce its thickness and/or smooth its surface without any negative effects to its integrity or the integrity of the CMC nonconforming article 102.

**[0036]** The machinable coating 106 is then machined by grinding, ultrasonic machining, water guided laser, milling, reaming, or another machining method to reduce its thickness and/or smooth its surface, and to provide a desired surface profile for the repaired article.

**[0037]** The repaired article 100 may then be returned to the reactor and CVI is completed until the desired matrix infiltration is complete. In this case, the machinable coating 106 is selected to withstand the temperatures at which CVI occurs, which may be greater than about 1000 degrees C, without degrading or otherwise compromising its integrity. In an alternative approach, the machinable coating 106 is applied and machined after the CMC is completely infiltrated. In this case, the machinable coating would not need to be able to withstand the CVI process environment, and so material selection of the coating 106 would not need to be based on this criterion which may expand the possibilities. Still, any of the example materials discussed above could be used.

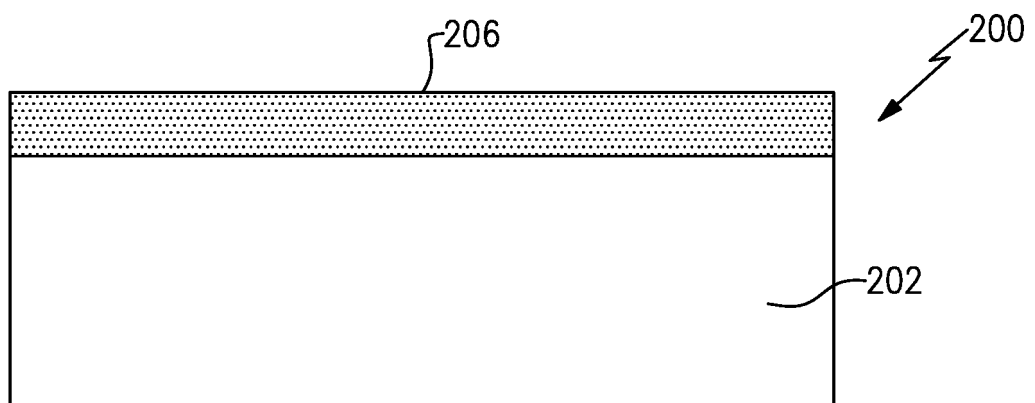
**FIG.3**

Figure 3 schematically illustrates an article that has

been repaired to address a size nonconformance.

**[0038]** Figure 3 schematically illustrates another example repaired article 200. The repaired article 200 includes a nonconforming article 202 with a nonconformance which in this case is that the nonconforming article

202 is too small in some respect. The nonconforming article 202 is repaired in the same way as the nonconforming article 102 discussed above except that the machinable coating 206 is applied to build up a surface or area of the nonconforming article 202 such that the nonconforming article 202 has a desired geometry/size after being machined as described above. That is, the machinable coating 206 is first applied with a thickness/geometry that is greater than the desired thickness/geometry, and then machined down to the desired thickness/geometry as discussed above. The machinable coating 206 can have the same composition(s) as the machinable coating 106 discussed above.
